General Information

3. Type of Structure / Levels

The structure is three level commercial building.

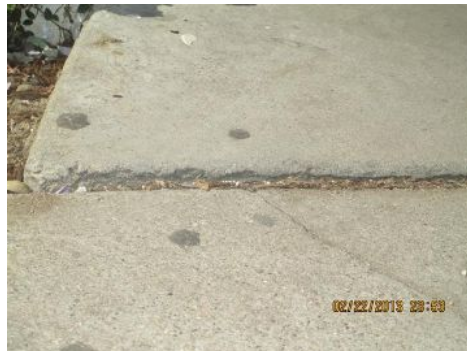
2.2. The sidewalk material was raised and may pose a possible tripping hazard. Caution is recommended in this area.

side walk has raised surface

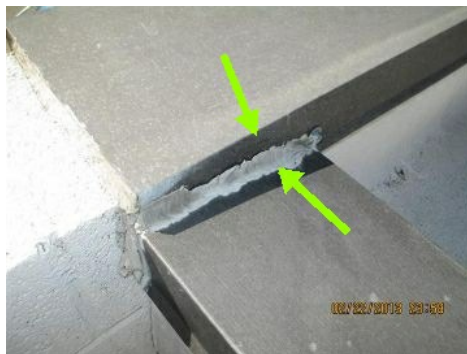
4.4. The parapet wall cap possesses areas which were in need of typical maintenance and requires a mastic or other type of sealant to forestall moisture intrusion.

sealant suggested at the parapet wall cap

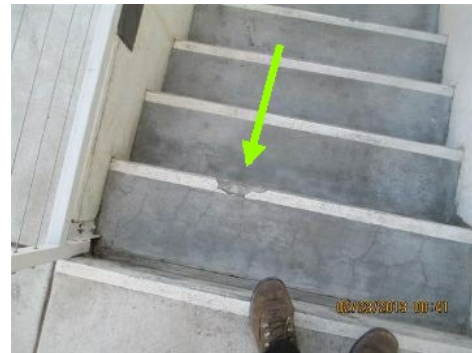
9.2. The steps located at the front of the structure were damaged and are in need of repair as a safety preventative issue. We recommend the further review, advice and services of a masonry contractor.

damaged was observed at the front patio / concrete steps

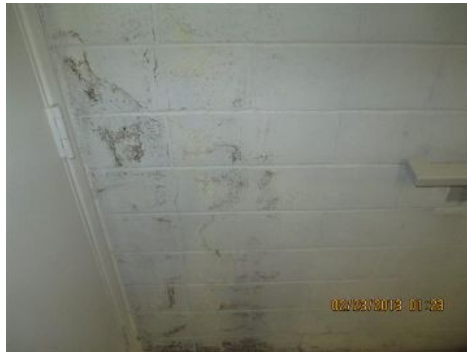
1.1. Cracks were observed in the lower hallway north block. Such cracks may be a result of the curing process, seismic activity, ordinary settling, or the presence of expansive soils. We can elaborate, but you may wish to have a structural engineer confirm this.

cracking was observed in the lower level hallway north block

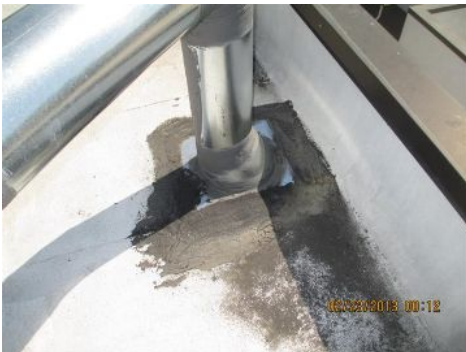
2.2. We observed quite a few duct penetrations into the existing roofing materials. These penetrations are in many cases the source of many leaks if not properly maintained. In light of this finding, we suggest consulting with the roofing contractor present, and inquire as to their recommended maintenance regiment for this condition.

flat roof penetration from ductwork

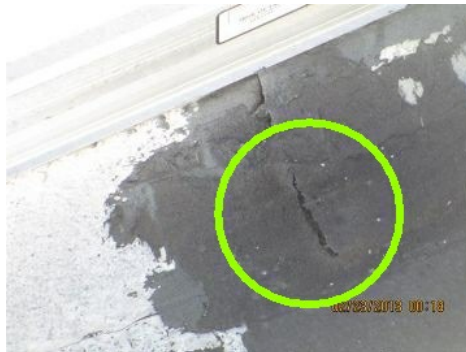
2.4. There are open seams, or splits, in the mineral cap sheet of the parapet walls that should be sealed before the close of escrow, to forestall any possibility of moisture intrusion.

loose materials observed here / sealant is suggested here

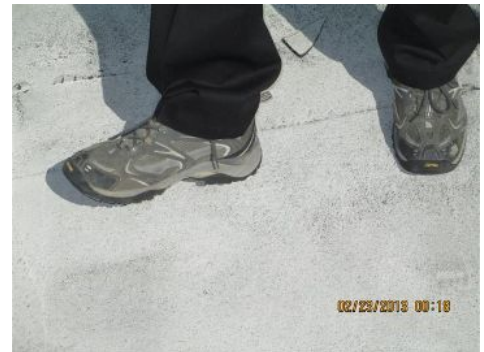
2.1. The roof deck was spongy at the northwest side of the roof. The reason for this condition is not clear as the roofing materials were intact, however, there were no visible indications of moisture damage at this location, from the interior. We cannot, however, see under the roofing material or from the attic as there is no attic at this location. Therefore, the buyer is suggested to monitor this area on a regular basis by a roofing contractor and repaired if any abnormalities is discovered. Infrared scans of the roof surface on an annual basis is recommended to detect any leaks or moisture beyond the surface.

spongy area observed in flat roof covering material

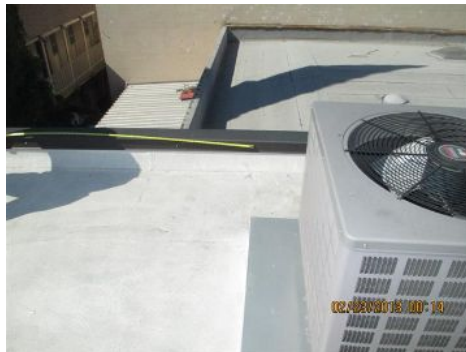
1.1. In accordance to current building standard, the mechanical components on the roof are suggested to possess railing / barriers within the current building standard setback to any / all mechanical equipment located on the roof deck.

1013.5 Mechanical equipment. Guards shall be provided...

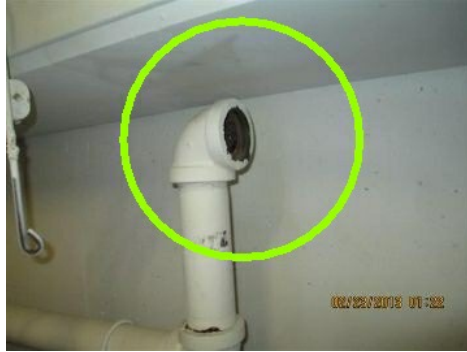
2.1. The DWV piping located in the lower level cage is missing a clean out cover.

drain or vent piping located in the low level locker missing cover

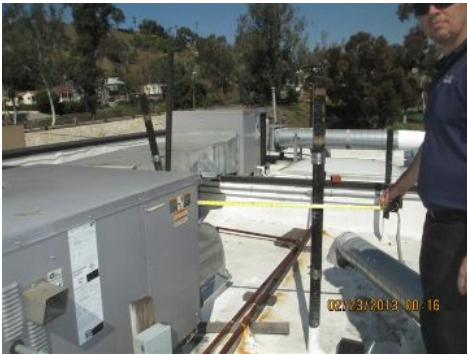
3.1. We observed DWV vent stacks at the roof level which were damaged and in some cases, too short within the listed proximity to the mechanical package forced air units.

DWV too short in close proximity to package HVAC unit

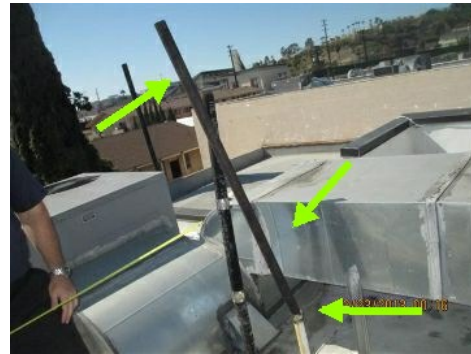
damaged and loose DWV piping

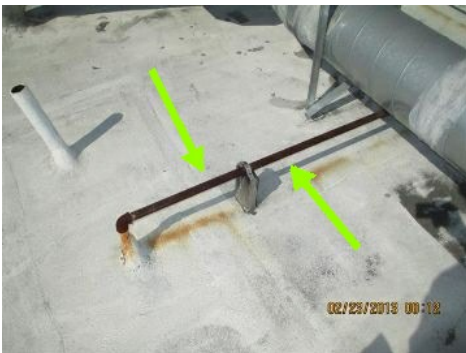
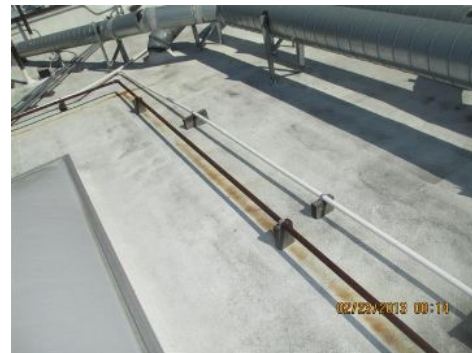
3.1. The rusted fuel lines on the roof are suggested to be painted for protection.

fuel piping is rusted suggested to be painted

rusted fuel piping observed

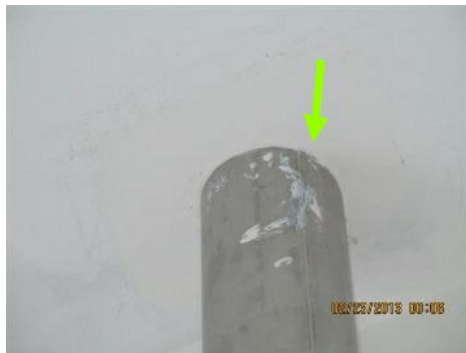
1.1. The vent pipe of the gas water heater is too close to combustible material (wood, drywall, ductwork & insulation), and should be serviced. A singlewalled vent pipe should be six inches away from any combustible material, and a doublewalled vent pipe (and transite) should be one inch away.

vent too close to combustibles

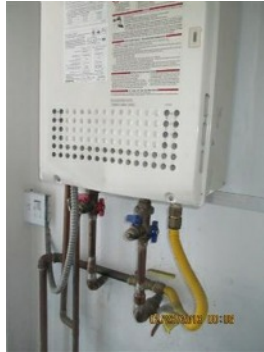
3.1. There was a tankless water heater present on site. A tankless water heater was installed. We therefore suggest that the buyer contact the local building and safety department to see if permits were obtain for the installation of this element.

this building is served by a tank less water heater

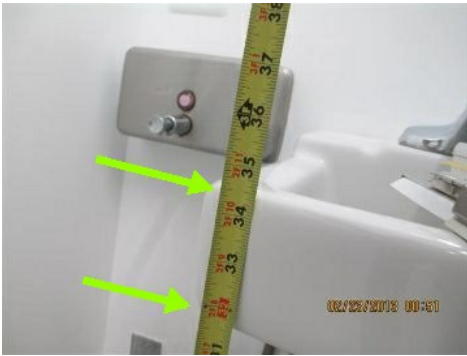
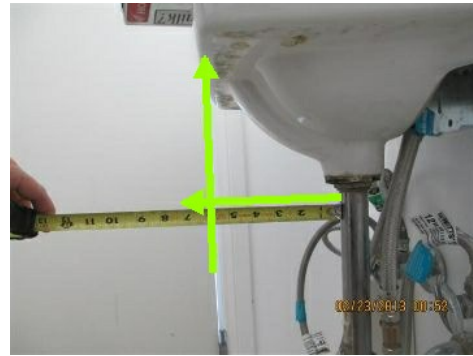
1.2. The lavatory installed, although functional, does not appear to comply with ADA requirements.

29 / 34 inch clearances are not met here

clearances of lav not met here

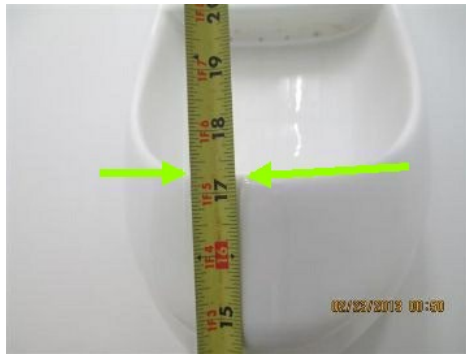
3.1. The urinal installed although functional, does not appear to comply with ADA requirements.

17" max

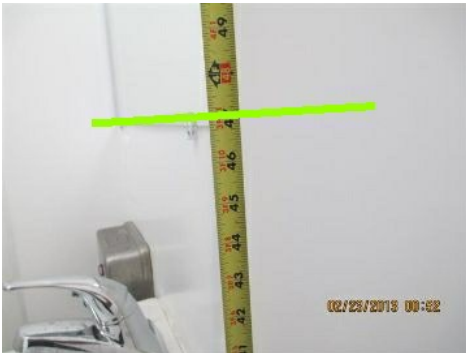
4.1. The fixtures installed in this unisex restroom do not comply with ADA standards.

mirror is too high

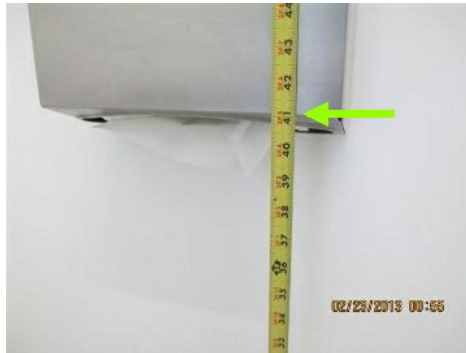
paper towel dispenser is too high

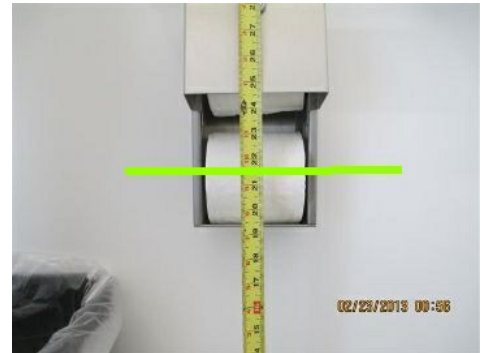
toilet paper roll too high

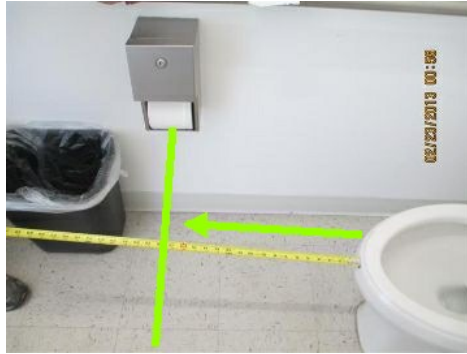
5.1. Although the toilet was functional, the toilet did not comply with ada requirements.

toilet paper roll holder to far from toilet
