# General Information

The structure is three level commercial building.

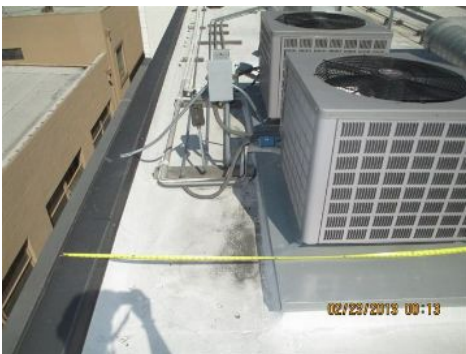
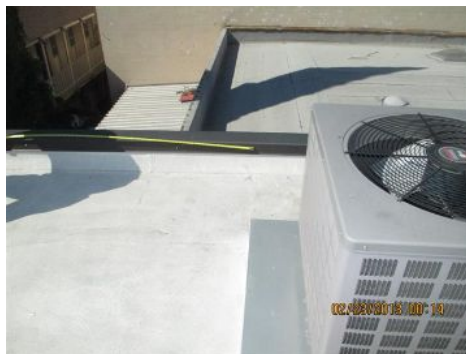
1.1. In accordance to current building standard, the mechanical components on the roof are suggested to possess railing / barriers within the current building standard setback to any / all mechanical equipment located on the roof deck.

1013.5 Mechanical equipment. Guards shall be provided...

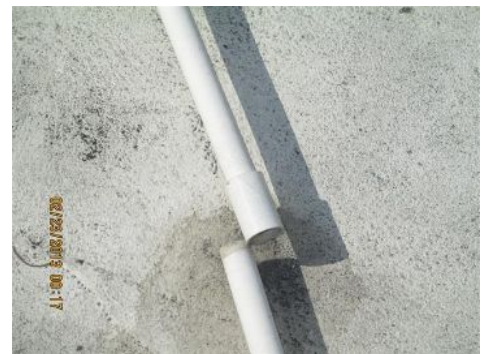
disconnected condensate drain piping

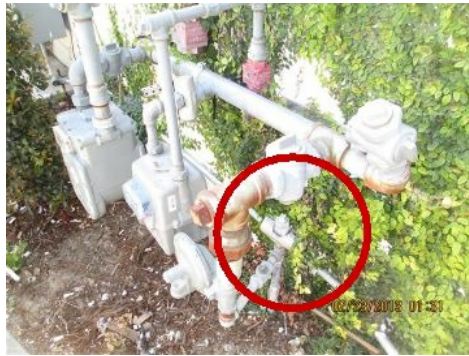
2.1. The gas is off at the main. The gas company will turn it on and safety check all of the gas appliances, but this should be scheduled within the inspection period so that you could be alerted to any potential deficiencies or recommended upgrades that could affect your evaluation of the property. At the time of the inspection, all appliances which use gas as fuel were not tested. Appliances such as water heaters, ranges, ovens, furnaces, pool heaters or barbecues.

fuel meter was terminated

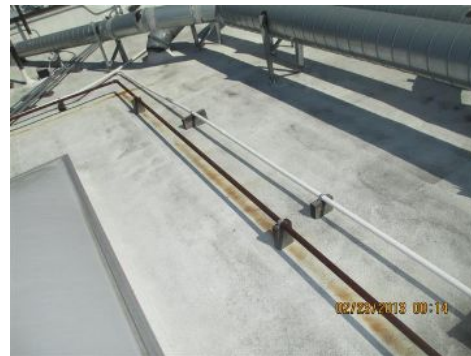
rusted fuel piping observed
