General Information

The structure is three level commercial building.

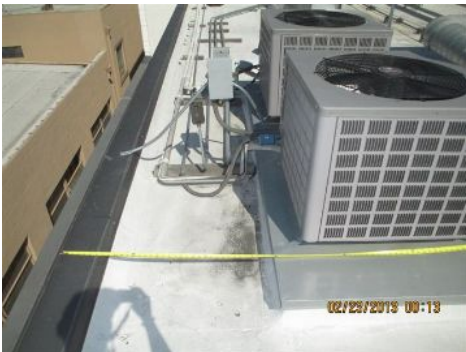
1.1. In accordance to current building standard, the mechanical components on the roof are suggested to possess railing / barriers within the current building standard setback to any / all mechanical equipment located on the roof deck.

1013.5 Mechanical equipment. Guards shall be provided...

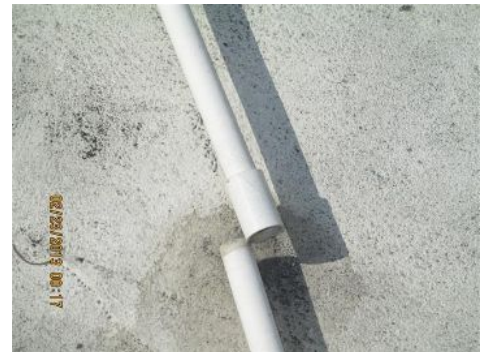
disconnected condensate drain piping
