www.sewerinspectionpros.com

07 April, 2014

Date of inspection : April 07 , 2014 - Time : 11:00 a.m. Technician : Charles Brunsmann.

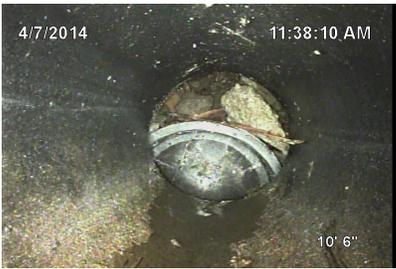
10' 6"

4/7/2014 11:38:11 AM  
Sewer line not connected at guest house

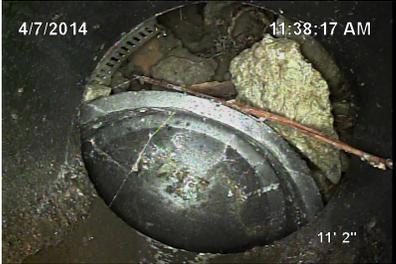
11' 2"

4/7/2014 11:38:18 AM  
Sewer line not connected at guest house

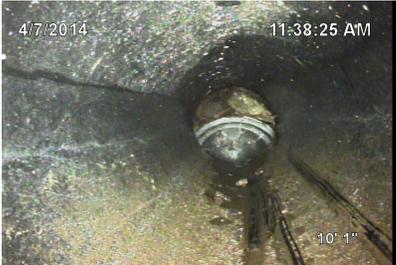
10' 1"

4/7/2014 11:38:25 AM  
Sewer line not connected at guest house

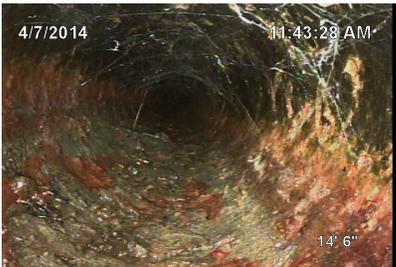
14' 6"

**SEWER LINE OBSERVATIONS :** After running camera through a total of 41 feet of 4 inch Cast iron and A.B.S. plastic sewer line from house connection, the conclusion was there was an obstruction 29 feet into the main line of the home after going into 4 inch sewer main line at 3 inch cleanout in primary garage of home. Large root intrusions and dirt appear to be obstructing flow of waste after cleanout transition before or near kitchen sink. Pipe is potentially broken or collapsed when high amounts of dirt are in sewer system. Although water is draining, it is at an insufficient flow. Inner walls of pipe have a moderate buildup of corrosion and scale due to age of pipe. Camera could not go beyond root intrusion to view pipe in front yard that connects to city sewer. Repairs must be completed before front of home can be viewed. It was also noted that 4 inch A.B.S. plastic sewer pipe for guest house above secondary garage was not tied into the main line sewer. Pipe appears to have a 4 inch rubber jim cap that is partially on. The pipe has also been burried in the ground before connection to live sewer was performed. It is important that sewer line on this portion of the home is not used until the line is connected by a licensed plumber to prevent debris from the ground entering the system causing potential back ups.

4/7/2014 11:43:29 AM  
Scale and corrosion in main line of home

**RECOMENDATONS :** Hire a licensed Plumber to Clear 4 inch main line of root intrusions by means of 1/2 inch snake cable and cutting tip. Cost is estimated at \$300.00. Also have main line sewer jettted with high pressure water jetter to remove all debris from root intrusions and scale buildup off inner walls of pipe. Cost is estimated at \$400.00. Due to potential broken or collapsed pipe it is also recommended to have a plumber inspect area of root intrusion for damage to pipe and estimate price to repair pipe. Recommendation costs are only estimates as there are a wide range of contractors that charge various prices for their work.

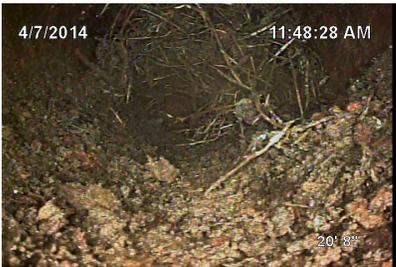
20' 8"

4/7/2014 11:48:28 AM  
Root intrusion and possible collapsed pipe

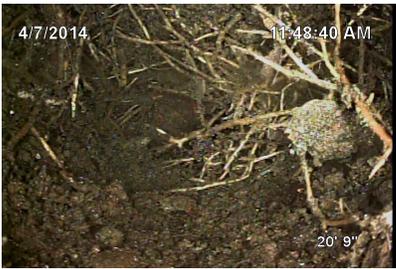
20' 9"

4/7/2014 11:48:40 AM

Root intrusion and possible collapsed pipe
