www.sewerinspectionpros.com

07 April, 2014

Date of inspection : April 07 , 2014 - Time : 11:00 a.m. Technician : Charles Brunsmann.

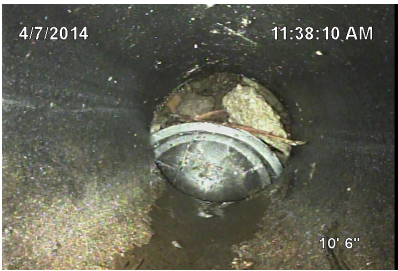
10' 6"

4/7/2014 11:38:10 AM
Sewer line not connected at guest house

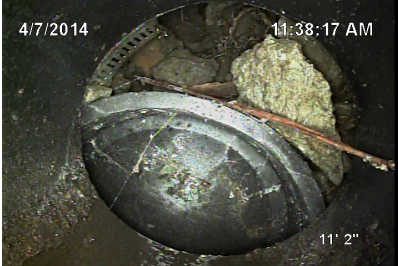
11' 2"

4/7/2014 11:38:17 AM
Sewer line not connected at guest house

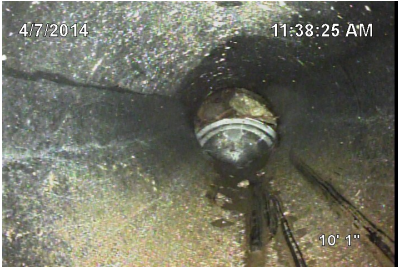
10' 1"

4/7/2014 11:38:25 AM
Sewer line not connected at guest house

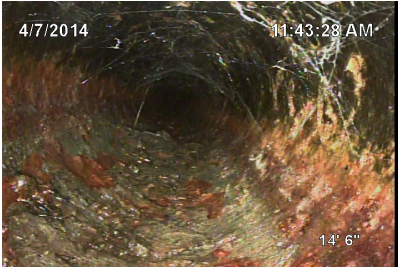
14' 6"

4/7/2014 11:43:28 AM
Scale and corrosion in main line of home

RECOMENDATONS : Hire a licensed Plumber to Clear 4 inch main line of root intrusions by means of 1/2 inch snake cable and cutting tip. Cost is estimated at \$300.00. Also have main line sewer jettted with high pressure water jetter to remove all debris from root intrusions and scale buildup off inner walls of pipe. Cost is estimated at \$400.00. Due to potential broken or collapsed pipe it is also recommended to have a plumber inspect area of root intrusion for damage to pipe and estimate price to repair pipe. Recommendation costs are only estimates as there are a wide range of contractors that charge various prices for their work.

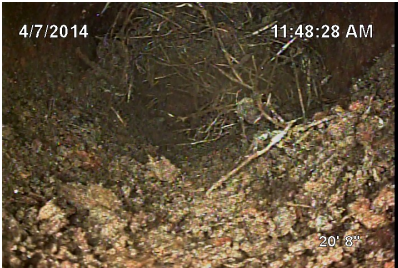
20' 8"

4/7/2014 11:48:28 AM
Root intrusion and possible collapsed pipe
