Date of inspection : April 07 , 2014 - Time : 11:00 a.m. Technician : Charles Brunsmann.

This is a video inspection of the main sewer line. This is the portion of the waste pipe system that carries the waste from the structure to the city sewer connection. This report is based on the video inspection of the sewer line only. Any other parts of the water supply system are not included. The report is not intended as a code inspection or to list each flaw noted. It gives an overall picture of the condition of the main line and the opinion of the technician at the time of inspection.

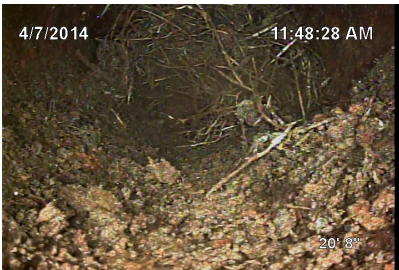
20' 8"

4/7/2014 11:48:28 AM
Root intrusion and possible collapsed pipe

RECOMENDATONS : Hire a licensed Plumber to Clear 4 inch main line of root intrusions by means of 1/2 inch snake cable and cutting tip. Cost is estimated at \$300.00. Also have main line sewer jettted with high pressure water jetter to remove all debris from root intrusions and scale buildup off inner walls of pipe. Cost is estimated at \$400.00. Due to potential broken or collapsed pipe it is also recommended to have a plumber inspect area of root intrusion for damage to pipe and estimate price to repair pipe. Recommendation costs are only estimates as there are a wide range of contractors that charge various prices for their work.
