[www.sewerinspectionpros.com](http://www.sewerinspectionpros.com)

07 April, 2014

Date of inspection : April 07 , 2014 - Time : 11:00 a.m. Technician : Charles Brunsmann.

This is a video inspection of the main sewer line. This is the portion of the waste pipe system that carries the waste from the structure to the city sewer connection. This report is based on the video inspection of the sewer line only. Any other parts of the water supply system are not included. The report is not intended as a code inspection or to list each flaw noted. It gives an overall picture of the condition of the main line and the opinion of the technician at the time of inspection.

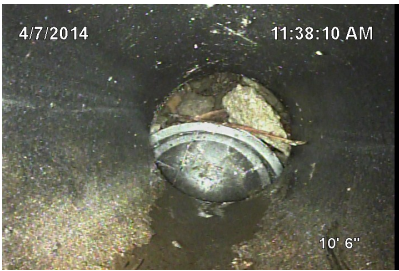
10' 6"

4/7/2014 11:38:10 AM  
Sewer line not connected at guest house

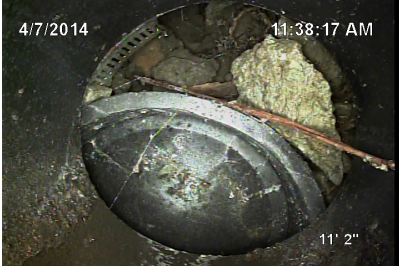
11' 2"

4/7/2014 11:38:17 AM  
Sewer line not connected at guest house

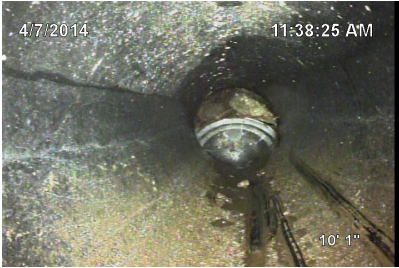
10' 1"

4/7/2014 11:38:25 AM  
Sewer line not connected at guest house

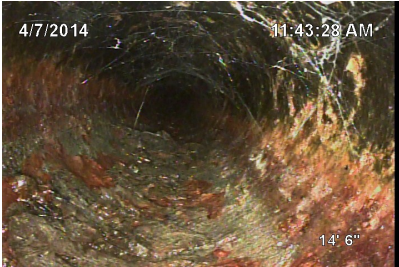
14' 6"

4/7/2014 11:43:29 AM  
Scale and corrosion in main line of home

**RECOMENDATONS :** Hire a licensed Plumber to Clear 4 inch main line of root intrusions by means of 1/2 inch snake cable and cutting tip. Cost is estimated at \$300.00. Also have main line sewer jettted with high pressure water jetter to remove all debris from root intrusions and scale buildup off inner walls of pipe. Cost is estimated at \$400.00. Due to potential broken or collapsed pipe it is also recommended to have a plumber inspect area of root intrusion for damage to pipe and estimate price to repair pipe. Recommendation costs are only estimates as there are a wide range of contractors that charge various prices for their work.

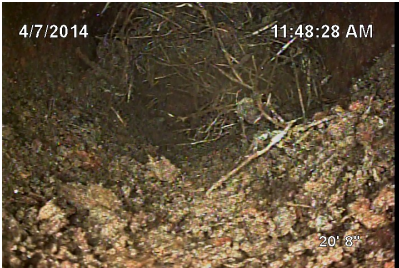
20' 8"

**SEWER LINE OBSERVATIONS :** After running camera through a total of 41 feet of 4 inch Cast iron and A.B.S. plastic sewer line from house connection, the conclusion was there was an obstruction 29 feet into the main line of the home after going into 4 inch sewer main line at 3 inch cleanout in primary garage of home. Large root intrusions and dirt appear to be obstructing flow of waste after cleanout transition before or near kitchen sink. Pipe is potentially broken or collapsed when high amounts of dirt are in sewer system. Although water is draining, it is at an insufficient flow. Inner walls of pipe have a moderate buildup of corrosion and scale due to age of pipe. Camera could not go beyond root intrusion to view pipe in front yard that connects to city sewer. Repairs must be completed before front of home can be viewed. It was also noted that 4 inch A.B.S. plastic sewer pipe for guest house above secondary garage was not tied into the main line sewer. Pipe appears to have a 4 inch rubber jim cap that is partially on. The pipe has also been burried in the ground before connection to live sewer was performed. It is important that sewer line on this portion of the home is not used until the line is connected by a licensed plumber to prevent debris from the ground entering the system causing potential back ups.

4/7/2014 11:48:28 AM  
Root intrusion and possible collapsed pipe

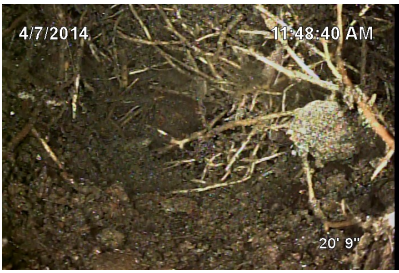
20' 9"

4/7/2014 11:48:40 AM

Root intrusion and possible collapsed pipe
