Property Inspection Report

Monday, February 1, 2016

Inspector, Marc Mazza
Mazza Inspection Group
(866) 996-2992
CA 776512

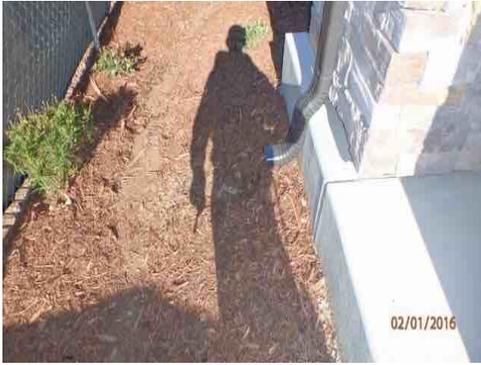
15: - We recommend routing all of the downspout(s) away from the structure, or installing the downspout directly into the subsurface drainage, if present. The downspout(s) should discharge water at least five (5) feet from the house or drain into existing sub surface drainage. Storm water should be encouraged to flow away from the building at the point of discharge. Splash blocks are further suggested.

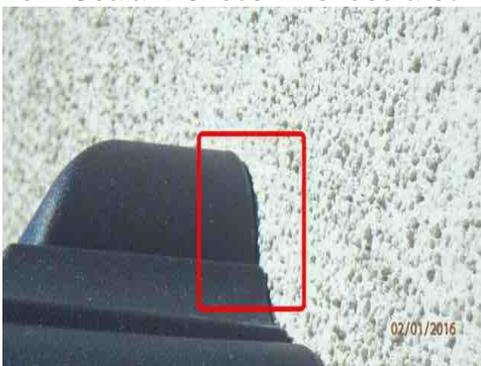
20: - Sealant is recommended around the exterior light fixture to wall connection(s).

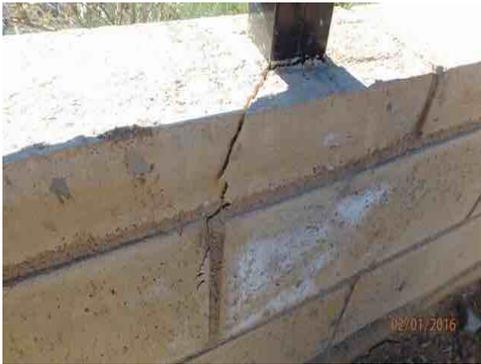
s-1: - Cracks were observed in the brick cap of the block fence.

26: - Cracks were observed in the brick cap of the block fence.

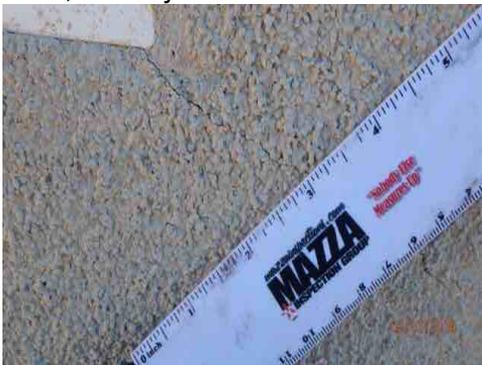
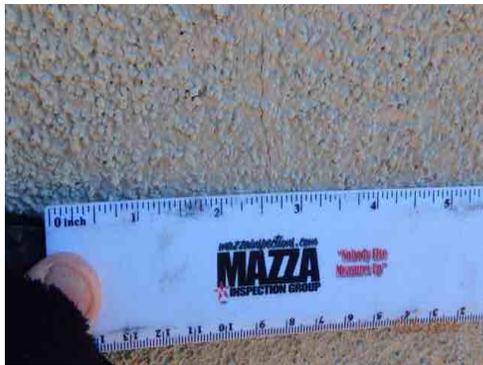
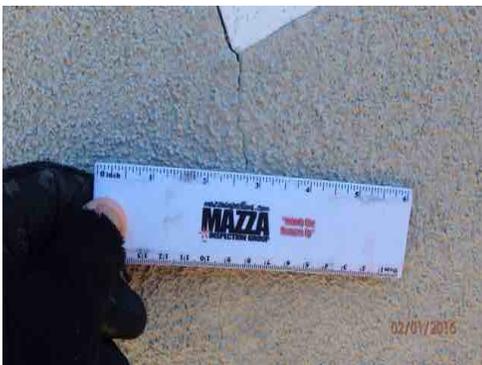
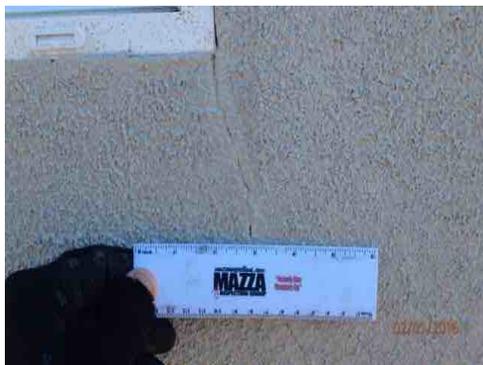
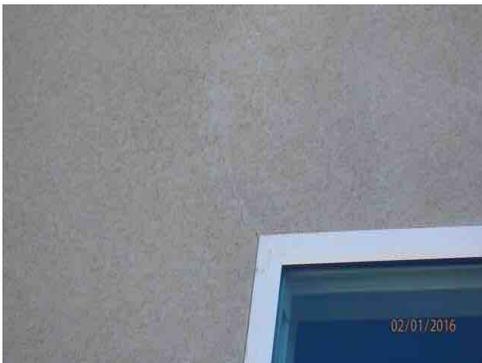
31: - Cracks were noted at the exterior wall covering materials. These cracks suggest that either some type of movement within the structure has occurred. It is well beyond our scope, as well as, our expertise to attempt to draw a definitive conclusion as to the cause of these cracks without additional investigations, which may include destructive testing. In light of these findings, we must suggest the buyer employ the services of a contractor who is familiar with structural movement and/or other reasons for stucco cracking. At the very least, the buyer should monitor the cracks for further movement.

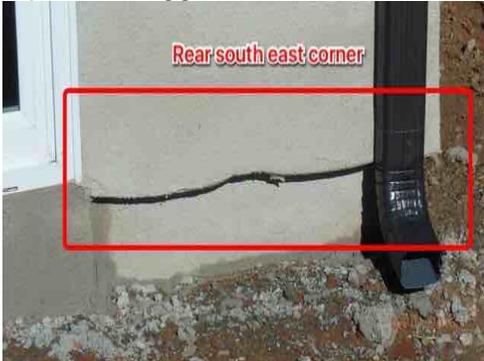
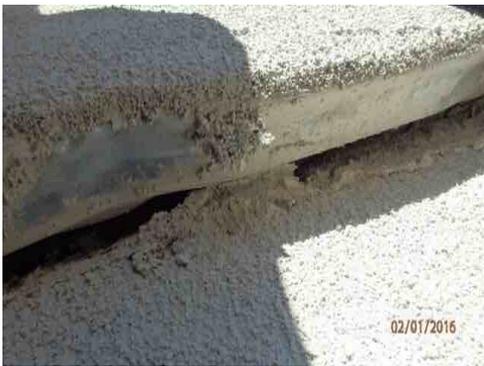
32: - Evidence of prior repairs / patching was viewed at exterior wall(s). We are unable to determine if the repairs were performed in a manner which is consistent with minimum building standards. Our concern is that the building paper is not breached or damaged. Further investigation as to the reason for the patching / repairs is suggested.

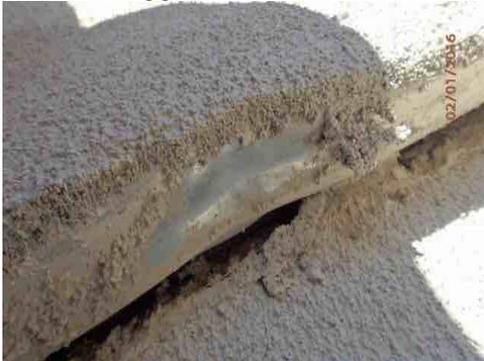
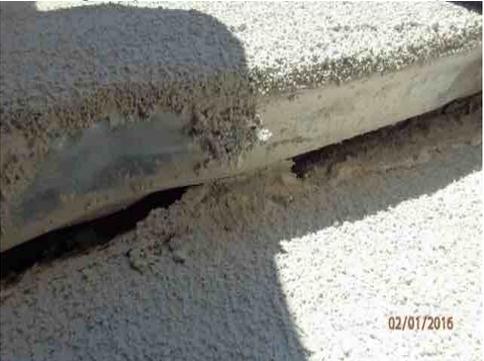
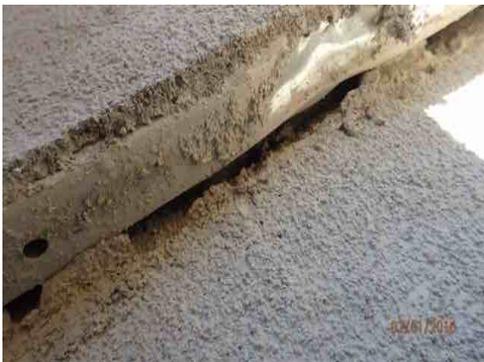
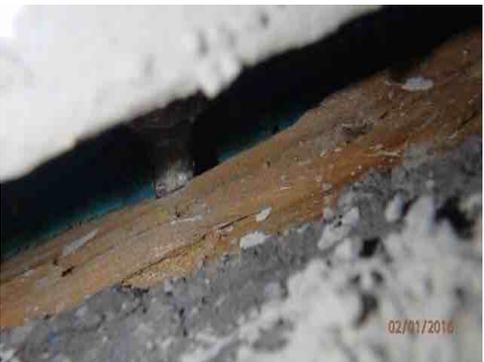
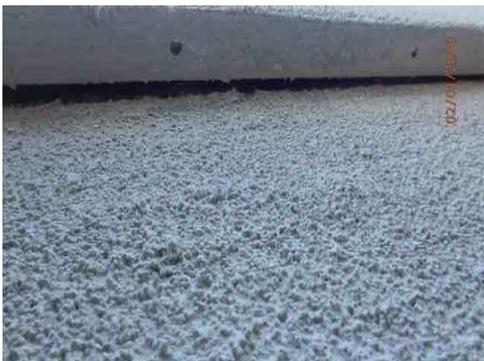
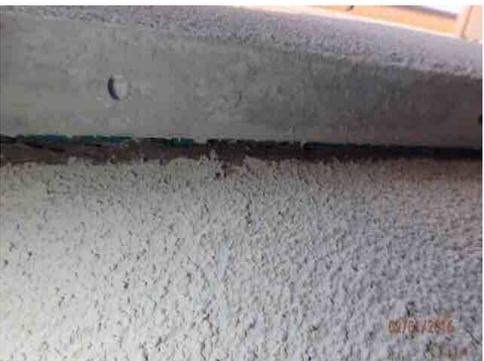
34: - We observed a significant separation between the weep screed and the exterior wall exposing the interior wall covering materials around the perimeter of the building as pictured. Without original structural drawings we won't be able to say definitively that the separation is substandard, however, conventional wisdom suggests that the interior of the buildings system should not be exposed to the elements.

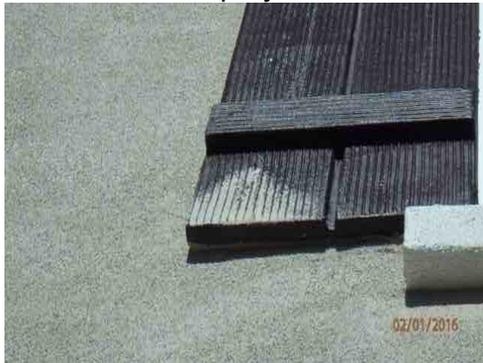
40: - Paint overspray was observed at the rear shutters as pictured.

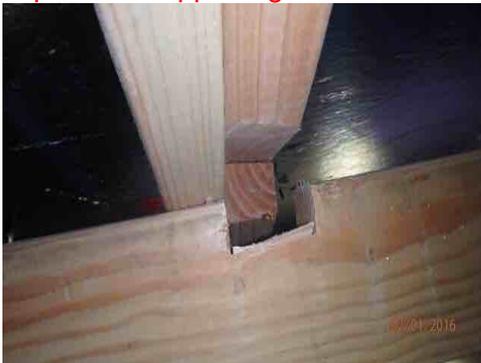
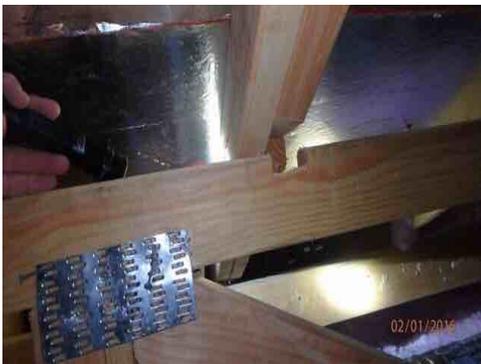
**s-2:** - Notches have been cut into the trusses pictured. In accordance with building code, trusses are not to be cut, notched or otherwise modified without the manufacturer's approval.

Code Reference R802.10.4 Alterations to Trusses

Truss members shall not be cut, notched, drilled, spliced or otherwise altered in any way without the approval of a registered design professional. Alterations resulting in the addition of load (e.g., HVAC equipment, water heater) that exceeds the design load for the truss shall not be permitted without verification that the truss is capable of supporting such additional loading.

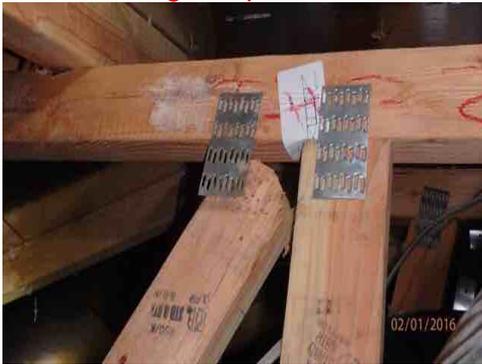
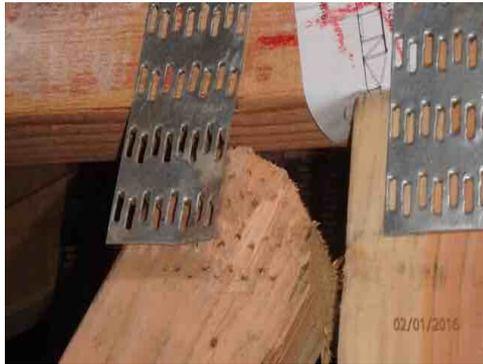
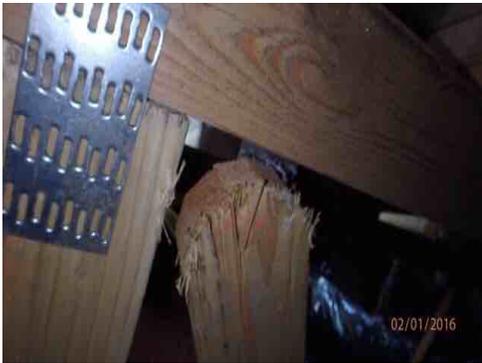
s-3: - Multiple mending plates within the truss system observed in the attic are damaged, loose or completely unattached. The mending plates are recommended to be properly attached to maintain the structural integrity of the framing components.

47: - Multiple mending plates within the truss system observed in the attic are damaged, loose or completely unattached. The mending plates are recommended to be properly attached to maintain the structural integrity of the framing components.

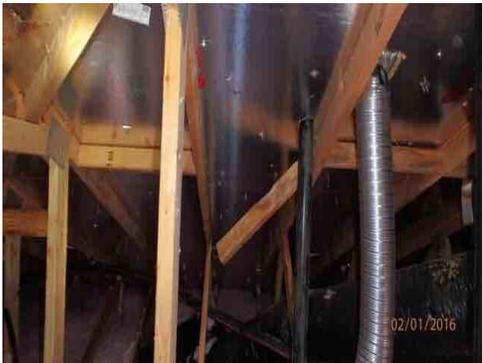
48: - We observed truss braces which were damaged within the attic. These braces are used to horizontally brace the trusses.

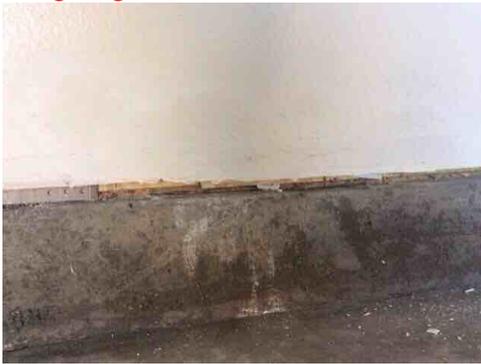
s-6: - Holes and / or missing wall separation wall covering were noted in the fire rated wall that connects the garage to the main structure. The walls and ceilings of the attached garages should be well sealed where they abut the interior of a house to maintain the integrity of the fire rated materials. Dwelling/garage opening/penetration protection. Openings and penetrations through the walls or ceilings separating the dwelling from the garage shall be in accordance with Sections R302.5.1 through R302.5.3.

83: - Holes and / or missing wall separation wall covering were noted in the fire rated wall that connects the garage to the main structure. The walls and ceilings of the attached garages should be well sealed where they abut the interior of a house to maintain the integrity of the fire rated materials. Dwelling/garage opening/penetration protection. Openings and penetrations through the walls or ceilings separating the dwelling from the garage shall be in accordance with Sections R302.5.1 through R302.5.3.

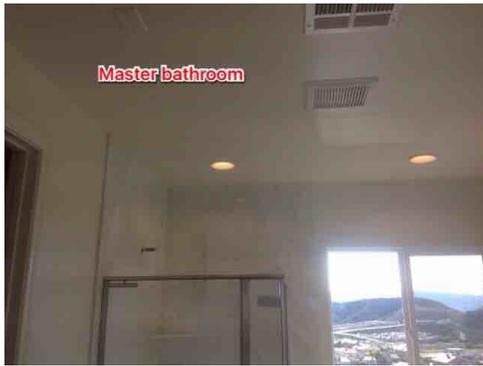
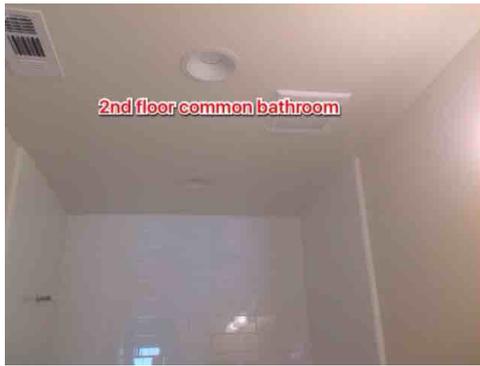
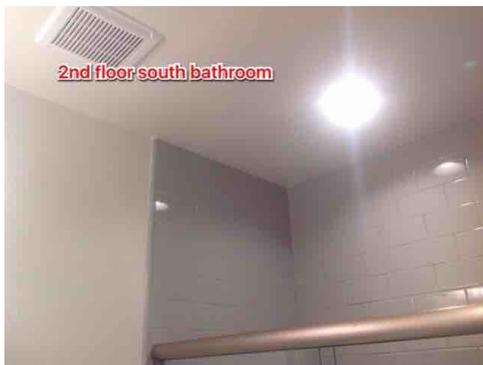
112: - Under normal circumstances there are only certain vent fixture types or light trim types which are allowed to be installed in "wet locations", specifically the 8X3 enclosure zone. We are unable to determine the type currently installed without removal of the fixture. For some older structures, this may be an older code requirement, however, improvements are always suggested as old or new code is the minimum standard and is always suggested to be exceeded. Verification is suggested.

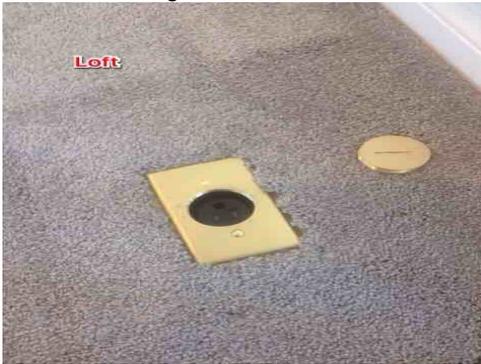
119: - There are outlets that are loose or not screwed in tightly when tested at various locations. We recommend that the loose outlets be repaired as necessary to avoid the possibility of future damage or shock - NEC 2014 §406.5.

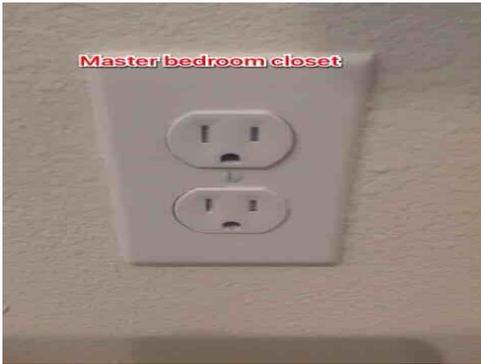
120: - There are receptacles that have been painted over at various locations within the interior of the house. It is recommended that these outlets be replaced prior to continuous use.

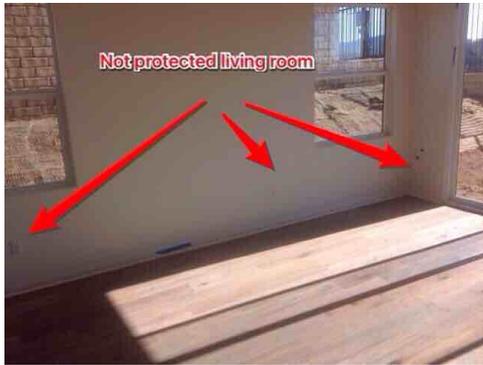
121: - 210.12(A) Where Required. All 15A or 20A, 120V branch circuits in dwelling units supplying outlets in family rooms, dining rooms, living rooms, parlors, libraries, dens, bedrooms, sunrooms, recreation rooms, closets, hallways, or similar rooms or areas must be protected by a listed AFCI device of the combination type.

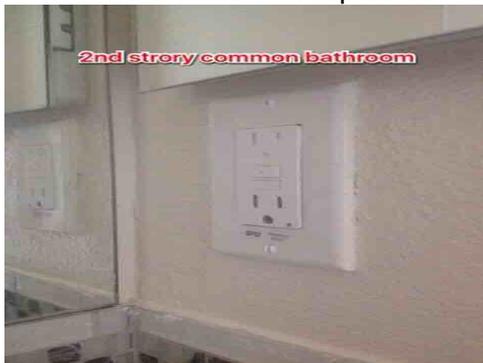
s-9: - A ground fault circuit interrupter (GFCI) outlet in the upstairs common bathroom was not tested because it has been painted over. This receptacle should be replaced as a safety precautionary measure.

122: - A ground fault circuit interrupter (GFCI) outlet in the upstairs common bathroom was not tested because it has been painted over. This receptacle should be replaced as a safety precautionary measure.

123: - There are GFI receptacles that have been painted over and, are therefore, suggested to be replaced.

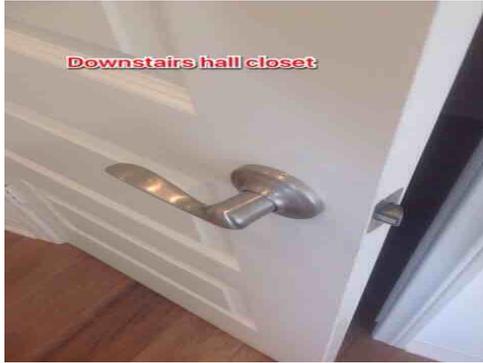
128: - Various door knobs are loose and suggested to be better secured for proper operation.

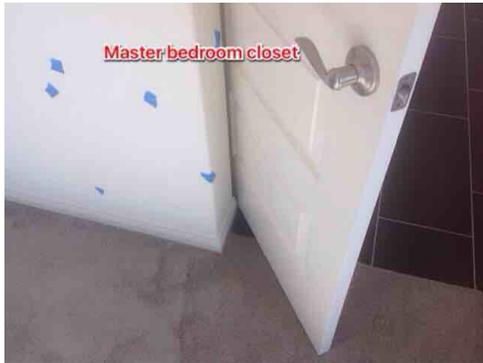
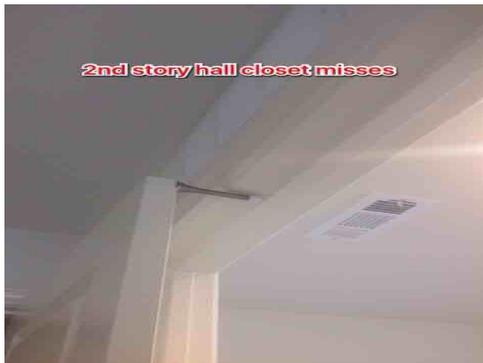
129: - Missing / damaged door stops noted. Installation or repair is recommended to prevent damage to the walls.

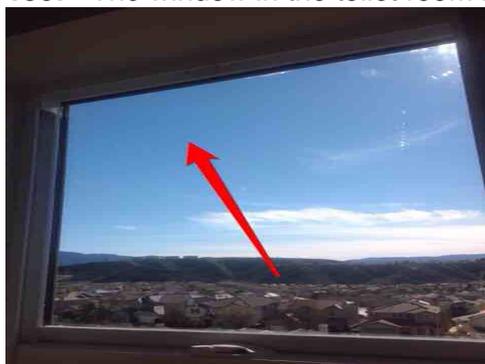
136: - The window in the toilet room in the master bathroom is scratched.

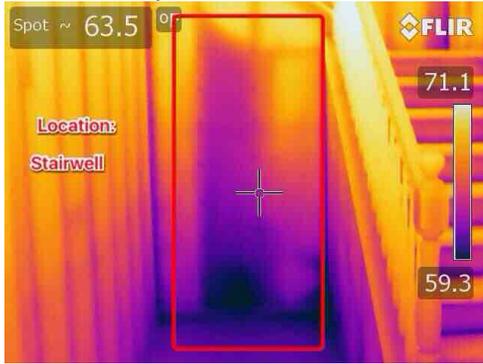
138: - It was noted upon inspection of the structure via infrared, that an anomaly presented itself on/within the interior in various locations. We should note that the infrared thermal signature of the image displays a difference in temperature in various/multiple areas of up to 10 degrees farenheit which is typical of missing or minimal insulation within such a cavity.

Infrared imagery is not 100% conclusive and must be followed up by destructive testing where necessary to confirm suspicions based on infrared signatures, such as in this case.

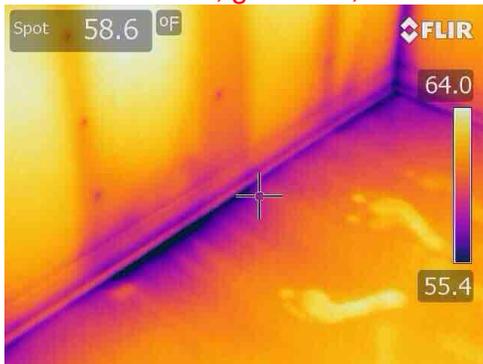
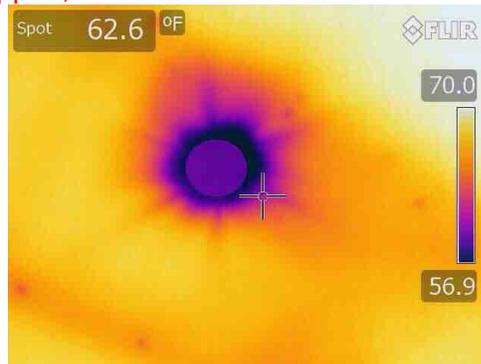
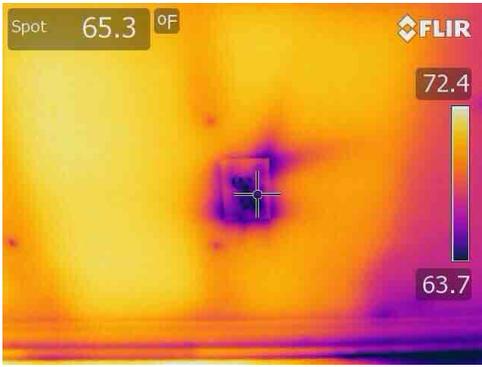
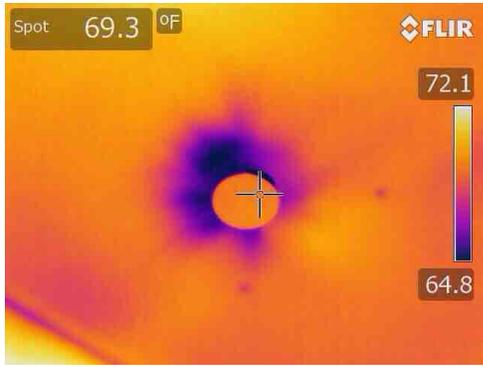
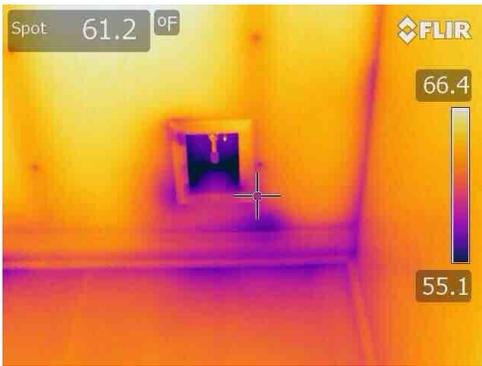
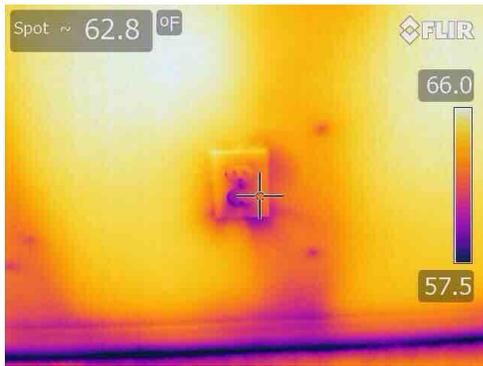
s-10: - Air infiltration was visible within multiple locations throughout the building at the sill plate, receptacles, ceiling lights and doors as pictured via the infrared images. This condition is considered a breach within the integrity of the thermal envelope.

139: - Air infiltration was visible within multiple locations throughout the building at the sill plate, receptacles, ceiling lights and doors as pictured via the infrared images. This condition is considered a breach within the integrity of the thermal envelope.

Section 110.7 - Mandatory Requirements to Limit Air Leakage

All joints, penetrations and other openings in the building envelope that are potential sources of air leakage shall be caulked, gasketed, weather stripped, or otherwise sealed to limit infiltration and exfiltration.

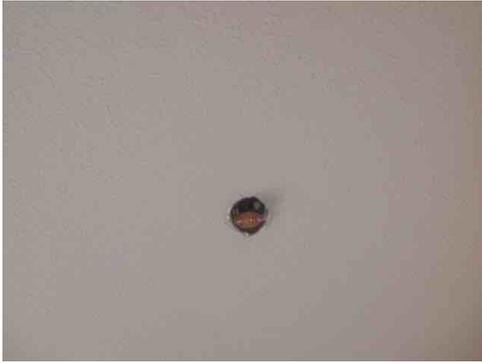
141: - Holes noted on the ceilings in the east bedroom. These holes are suggested to be sealed as necessary.

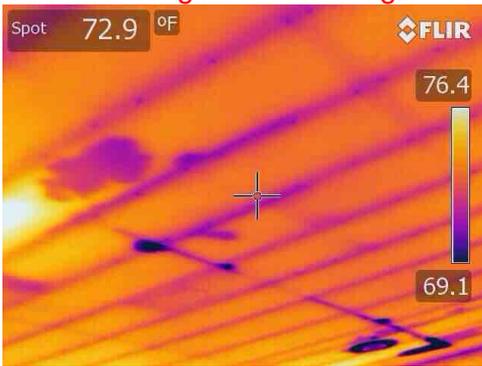
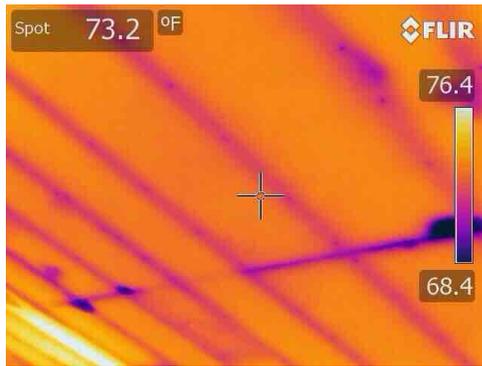
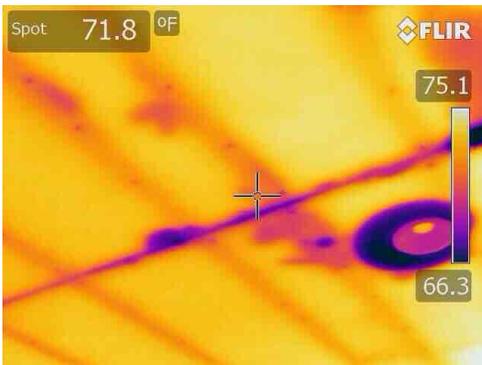
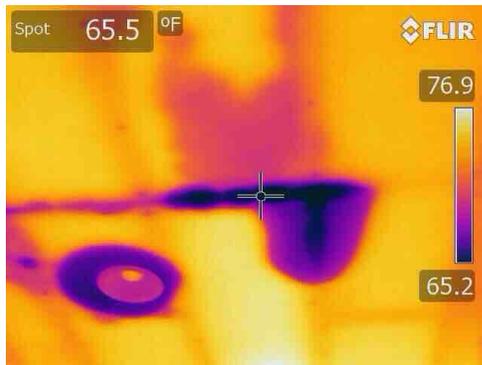
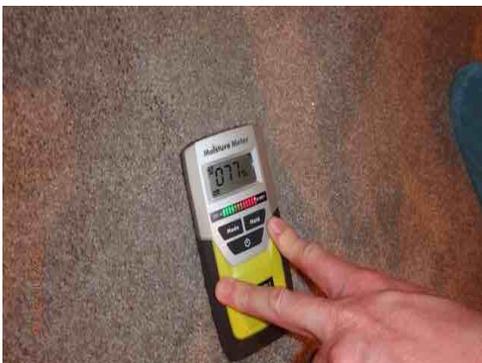
s-11: - Active moisture was observed at the ceiling in the living room. Repairs are recommended, however, a professional contractor is suggested to conduct necessary inspections and investigations prior to repairs to isolate the origin of the damage.

142: - Active moisture was observed at the ceiling in the living room. Repairs are recommended, however, a professional contractor is suggested to conduct necessary inspections and investigations prior to repairs to isolate the origin of the damage.

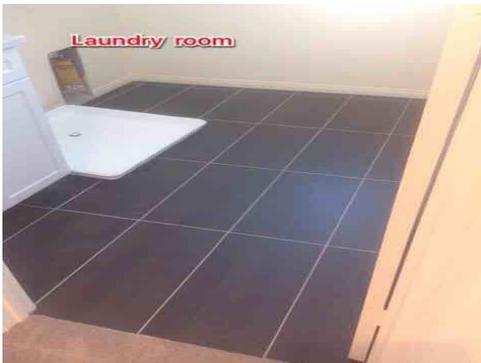
NOTE 144: - We cannot determine what substrate if any, was used under the tile flooring added. Typically, tile flooring will get a solid masonry like substrate prior to installing the tile for a more solid base, especially on a second level or raised foundation. With masonry installations, a vapor barrier or slip sheet will typically be used to reduce cracks, this material is not visible however (if installed).

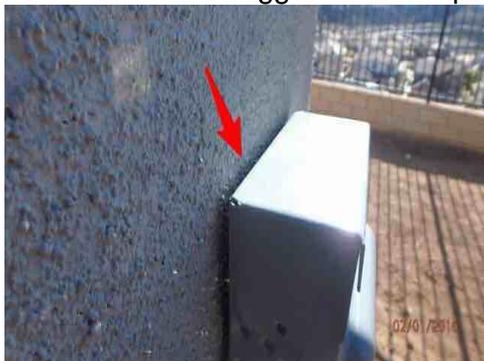
187: - Sealant is suggested at the panel box connection to the house as typical maintenance.

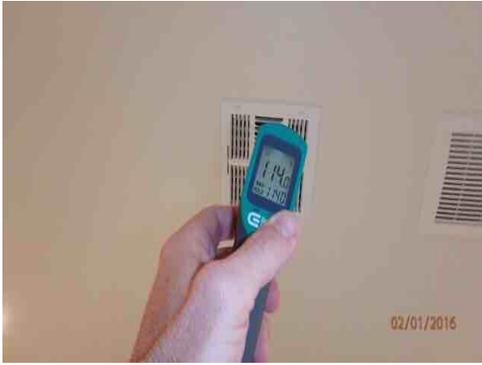
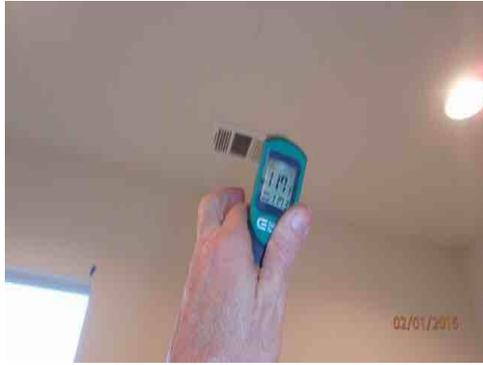
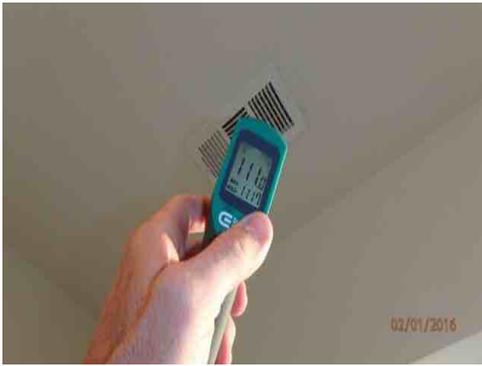
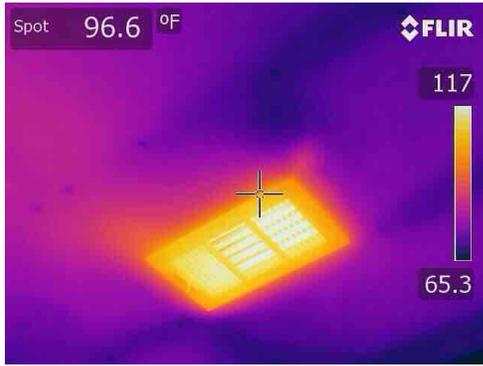
s-13: - The ducts include thermostatically controlled dampers. The dampers were tested (via thermostats) and found that there were in fact differences in temperature between the lower ambient temperature and the registers of the upstairs area while the downstairs was "on". It should be noted that when this test was performed, the lower system was off. We also feel it prudent to mention that the same test was performed for the upper level and there were no such differences in temperature. It is therefore our opinion based on the test performed, that the damper system may leak allowing air to pass through the dampers. It is not evident how the dampers were designed to perform so we cannot comment on this intended performance. We do suggest however, the buyer contact an HVAC company to thoroughly inspect the damper system and test the damper system to ensure that the system is completely functional and operating in an energy efficient manner.

193: - The ducts include thermostatically controlled dampers. The dampers were tested (via thermostats) and found that there were in fact differences in temperature between the lower ambient temperature and the registers of the upstairs area while the downstairs was "on". It should be noted that when this test was performed, the lower system was off. We also feel it prudent to mention that the same test was performed for the upper level and there were no such differences in temperature. It is therefore our opinion based on the test performed, that the damper system may leak allowing air to pass through the dampers. It is not evident how the dampers were designed to perform so we cannot comment on this intended performance. We do suggest however, the buyer contact an HVAC company to thoroughly inspect the damper system and test the damper system to ensure that the system is completely functional and operating in an energy efficient manner.

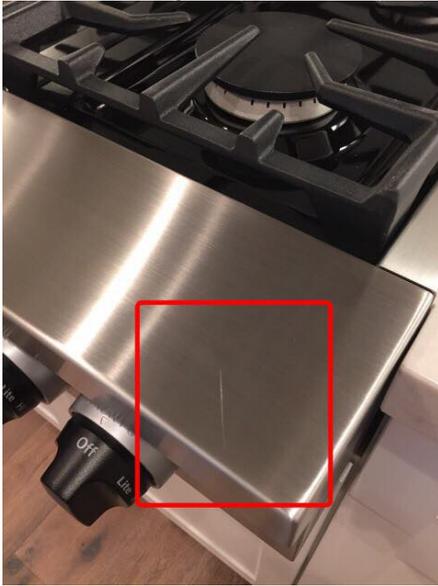
30: - The range shows evidence of cosmetic damage as pictured.

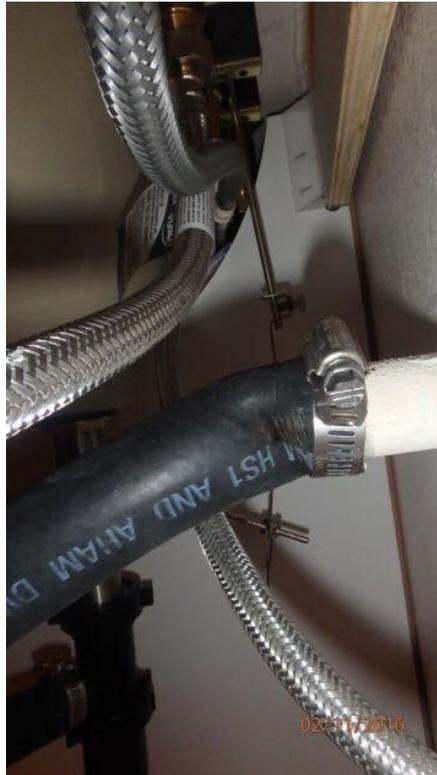
46: - The condensate drain for the furnace located under the sink is kinked and suggested to be serviced.
