# Property Inspection Report

Tuesday, March 24, 2015

Inspector, Marc Mazza  
Mazza Inspection Group  
(866) 996-2992  
[info@mazzainspections.com](mailto:info@mazzainspections.com)

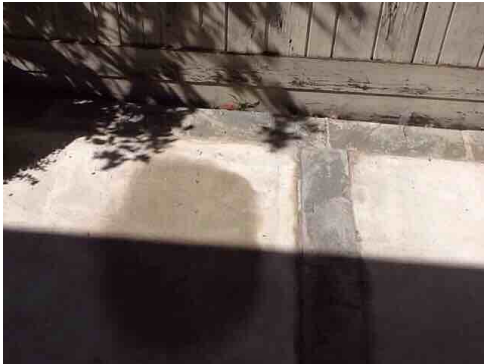
**16:** - The driveway has moisture staining, which may indicate ponding or poor drainage. In time, this condition can accelerate the wear and deterioration of the concrete. Moisture should always run away from the structure.

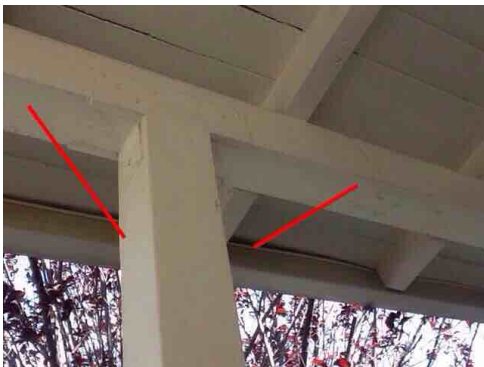
**27:** - We suggest improving the porch cover by adding knee bracing as well as metal straps and ties at all of the connections to the structure and slab.

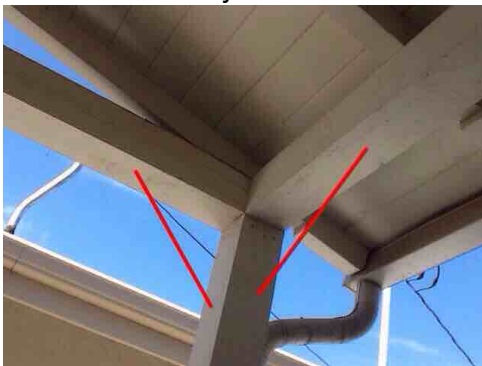
**34:** - The installation of "knee" bracing is recommended at the structure between the beams and the posts for additional stability.

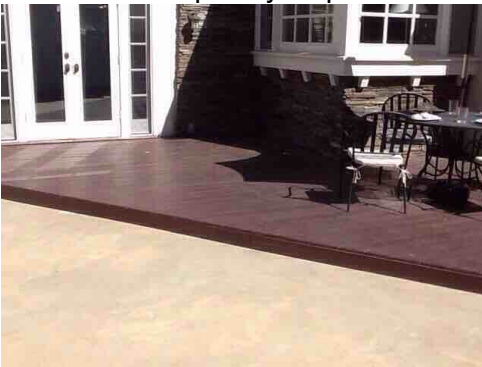
**43:** - The wood deck has been built at grade level. This configuration is prone to rot and insect activity and cannot be completely inspected.

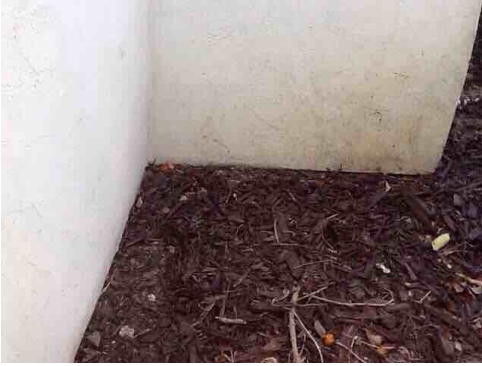
**53:** - There is concrete and soil that is high at the foundation at the time of the inspection. The soil level is up to or above the weep screed. These materials at this level may allow moisture penetration in the interior wood framing members or insect infestation. There should be at least 4 inches between the weep screed (if present) and the soil level and 6 inches between siding and the soil level. There is a recommended space of 2 inches between the weep screed and a solid surface such as concrete. It is recommended that this condition be referred to a qualified termite inspector for further evaluation - IRC 2012 §703.6.2.1.

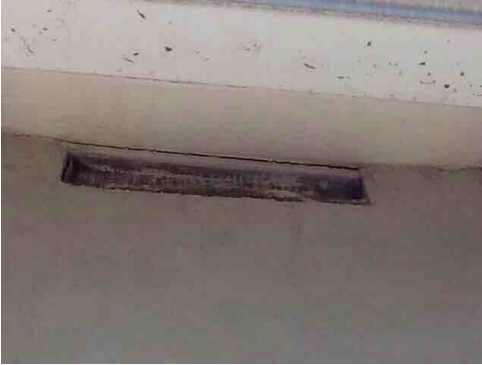
**64:** - Clogged soffit vents (the underside of the eave) were observed. Having the soffits closed may inhibit proper ventilation of the attic space. Additional ventilation, be it, soffits, vents, turbine or dormer ventilation may be needed. Further assessment is advised.

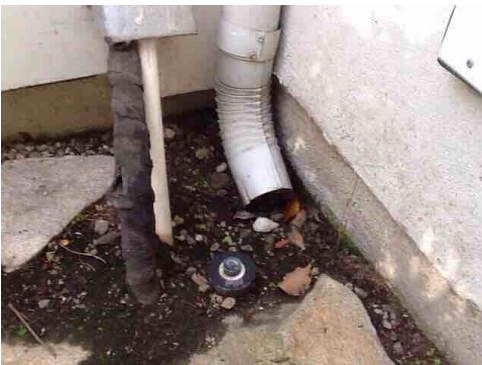
**66:** - We recommend routing all of the downspout(s) away from the structure, or installing the downspout directly into the subsurface drainage, if present. The downspout(s) should discharge water at least five (5) feet from the house or drain into existing sub surface drainage. Storm water should be encouraged to flow away from the building at the point of discharge.

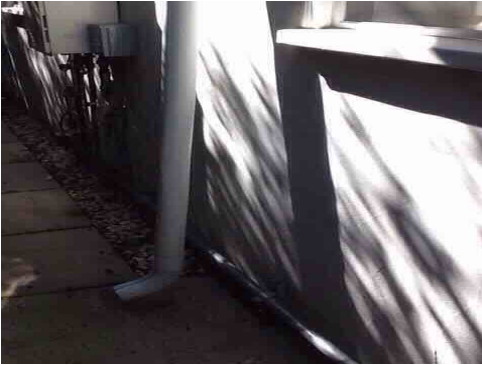
**68:** - The gutter system downspout is recommended to be better secured to the walls.

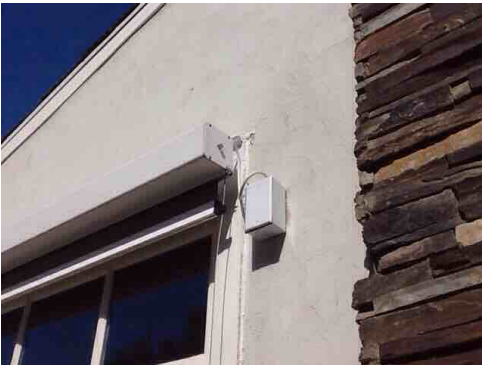
**75:** - Exposed conductors were observed within reach and in harms way at the west side of the structure. This material is recommended to be installed into exterior rated conduit for protection.

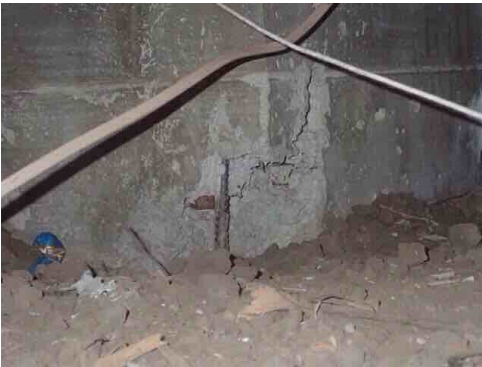
**96:** - We observed a portion of the stem wall that appears to be damaged. The damage may date back to when the addition was built, however, we are unable to determine the exact cause. Repairs are recommended.

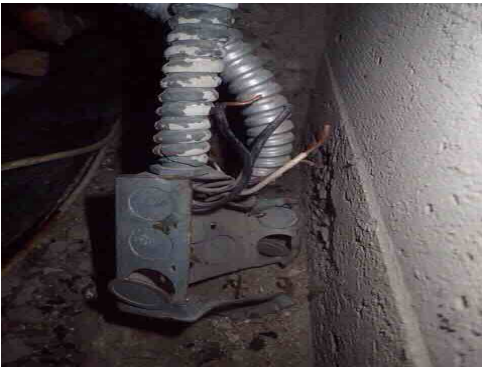
**s-1:** - There is an open/damaged electrical junction box that has exposed conductors within the crawlspace. The box may need replacement because of the damage. Properly terminating the wires and covering the box is recommended.

**100:** - There is an open/damaged electrical junction box that has exposed conductors within the crawlspace. The box may need replacement because of the damage. Properly terminating the wires and covering the box is recommended.

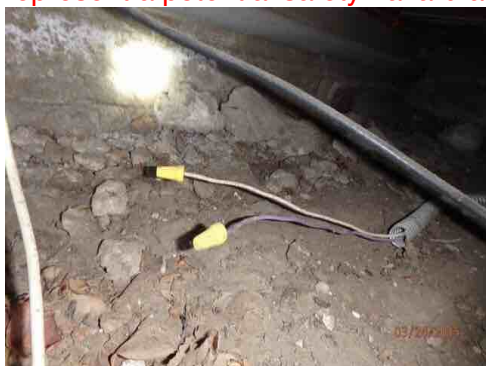
**s-4:** - Electrical conductors exposed and loose were observed under the structure. These conductors represent a potential safety hazard and are suggested to be improved.

**113:** - Electrical conductors exposed and loose were observed under the structure. These conductors represent a potential safety hazard and are suggested to be improved.

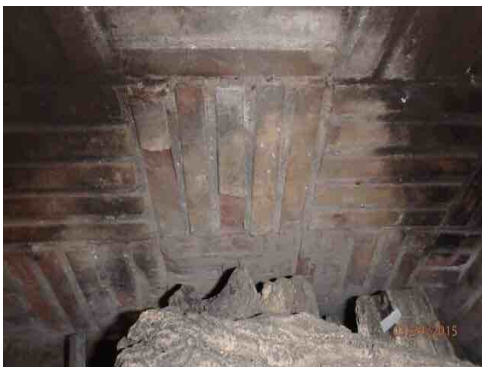
**143:** - Portions of the firebox show signs of deterioration. The cause of the damage is likely attributed to the burning of solid fuel in a firebox and / or moisture. Re-pointing of this/these area(s) with additional mortar is recommended.

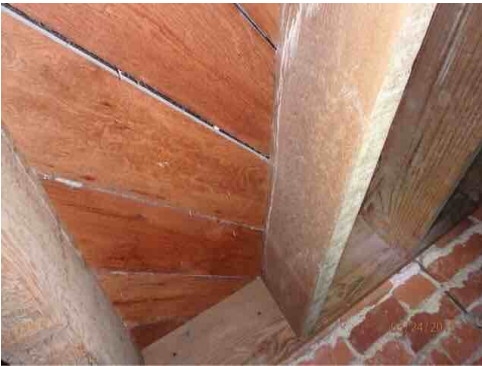
**149:** - When the area below, where we believe the hearth extension to be was viewed, we observed wood materials. We were unable to confirm the hearth thickness and we also noted that the wood was installed directly underneath the area which appears to be the hearth extension. According to NFPA 211, which is a standard for chimneys fireplaces and vents states: clearance shall be maintained directly below the underside of the hearth extension. Which is to say, no combustible materials are allowed in this area.

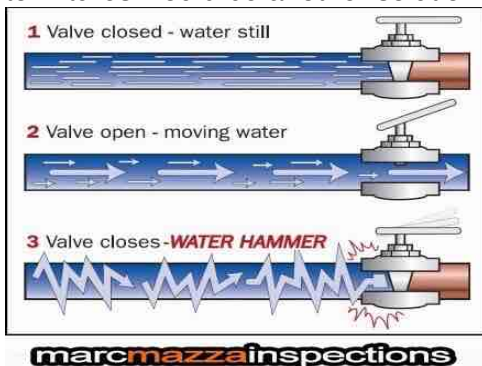
**163:** - Water hammer, or noisy piping, was observed when one or more fixtures were tested. Over time, and with severe water hammering, this condition may influence the integrity of pipe connections. Water hammering is a condition occasioned by the sudden stopping of water flow in a pipe resulting in a pressure wave that impacts upon closed valves. Closing valves and faucets slowly is one approach to avoiding water hammering. Better securing pipes (where possible) and installing air chambers (shock absorber) at the risers to fixtures would be another solution.

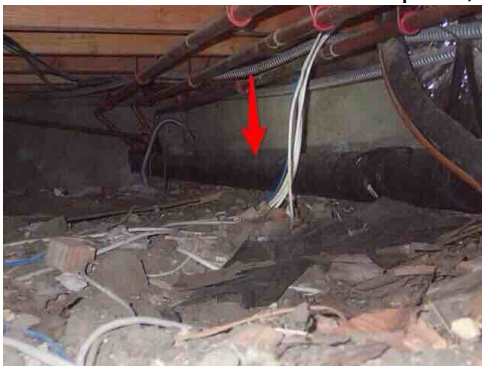
**169:** - There is waste piping that was found to have a substandard slope for proper drainage. This was observed from the west crawlspace, which is underneath the structure. Further assessment is advised.

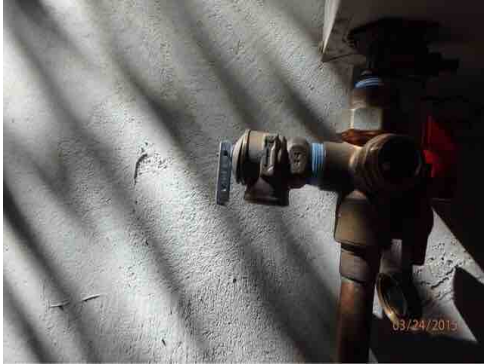
**183:** - The water heater is equipped with a mandated pressure-temperature relief valve but is lacking a drain pipe. One should be installed that extends to the exterior and terminates no more than twenty-four inches above grade and no closer than six inches to it.

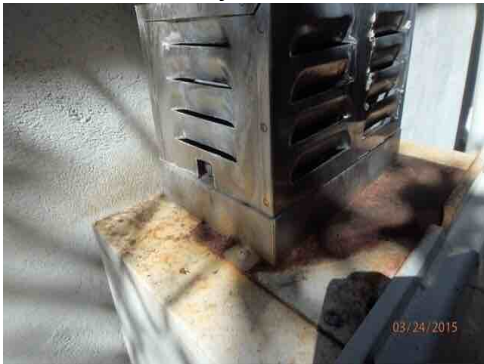
**184:** - Rust and corrosion was observed at the top of the water heater. This condition was likely the result of corrosive material within the exhaust collecting at the top of the unit. This condition is suggested to be monitored for any further deterioration in which case, repairs are likely necessary.

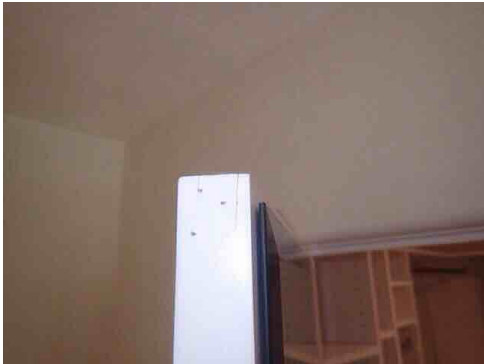
**231:** - The master bedroom closet door is split and should be improved for aesthetic purposes.

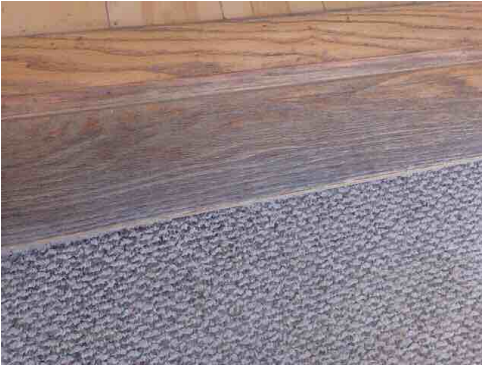
**236:** - The wood sills on the French doors are weathered and may require attention.

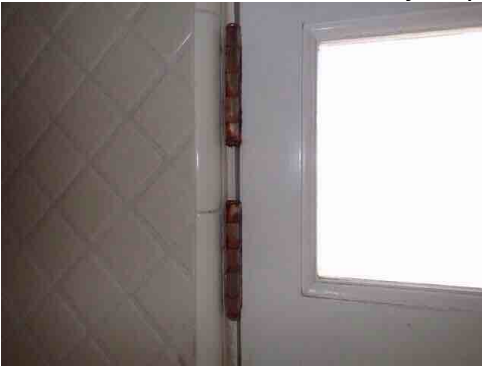
**248:** - There are rusted hinges on the window in the master bathroom shower. This may, in time cause the window to not function smoothly. Improvements are recommended.

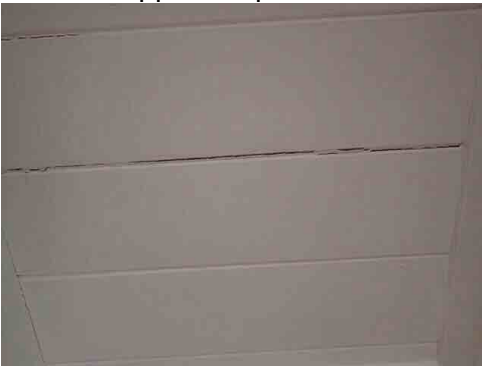
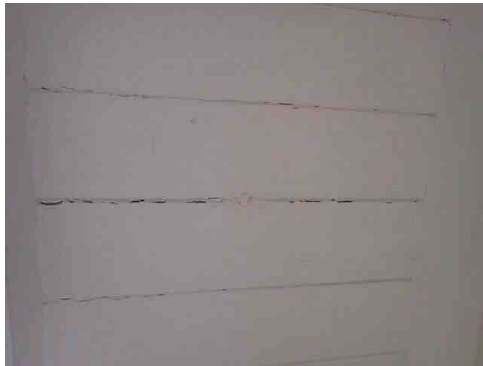
**257:** - The ceiling in the living room appears to be separating, possibly from movement or settlement. This does not appear to pose a structural concern.

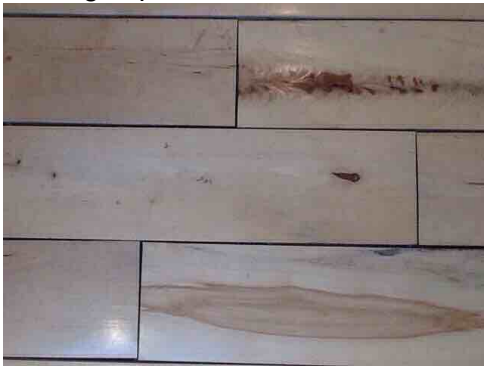
**263:** - We observed various open seams or connections at various connections within the wood flooring. This may be the result of the flooring having not been secured into one another tightly during the installation or excessive expansion / contraction. We recommend the further review, advice and services of a professional flooring expert.

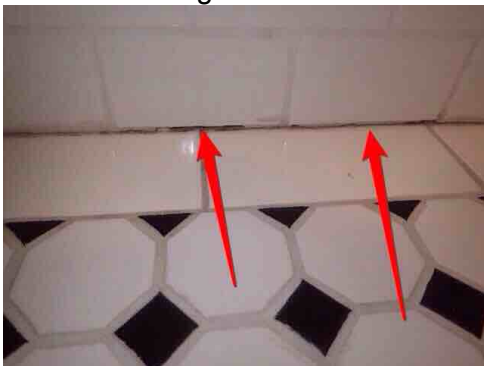
**265:** - Sealant/grout is recommended at the floor to base connection in the common bathroom.

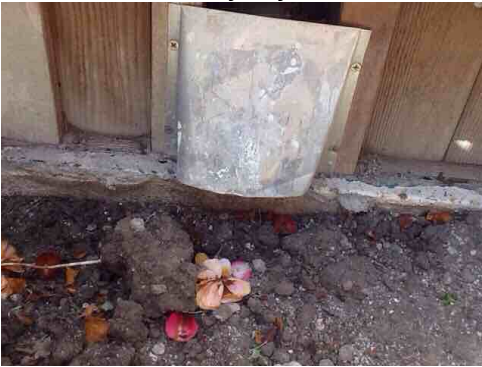
**271:** - The laundry dryer vent exhausts close to grade, which may hinder the ventilation process.

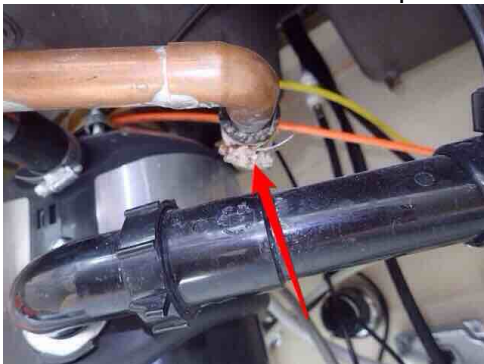
**294:** - The dishwasher drain line is stained/corroded, which may suggest a past leak. There was no leaking observed at the time of the inspection.

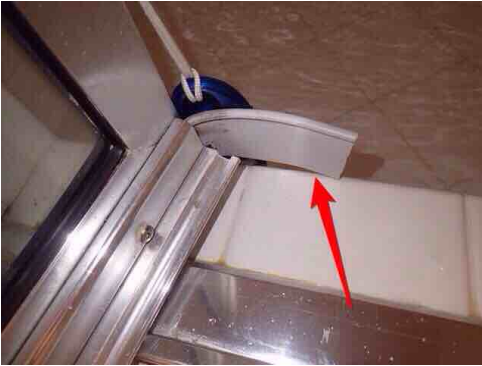
**326:** - The seal on the bottom of the shower door is out of place and should be improved.

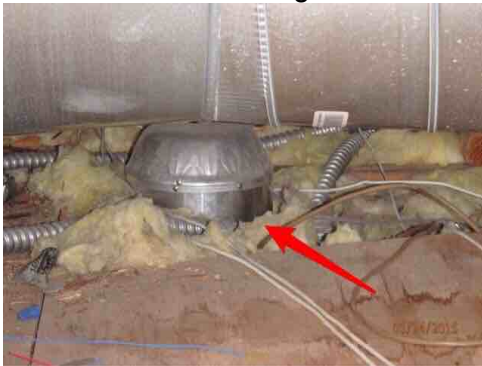
**335:** - Recessed lights can create hazardous conditions if they are not specifically designed for the installation in an insulated ceiling. These lights specifically; we were unable to identify whether or not the cans are IC or non IC type. Proof of their type is suggested to be disclosed if possible. If not, it is recommended that a licensed electrician be contacted to further evaluate these light fixtures and their specific specifications with respect to clearances from insulation. It is suggested that the insulation be removed up to 12" from around the recessed light cans in the attic as a precautionary measure.

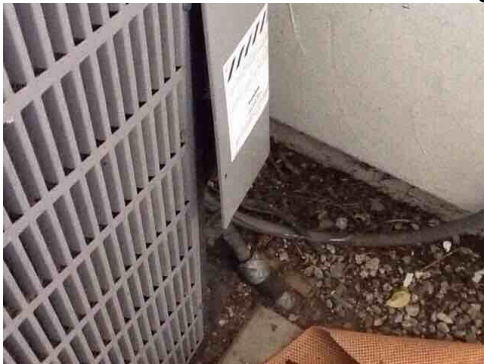
**359:** - The cabinet for the condensing coil is damaged/loose and is suggested to be improved.

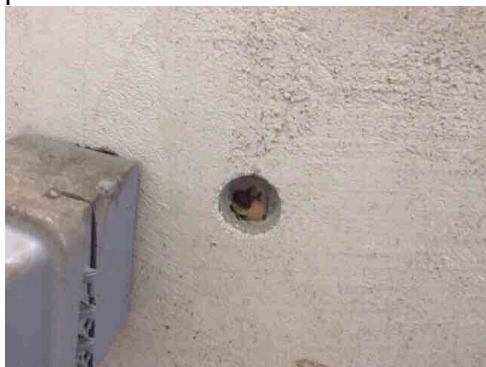
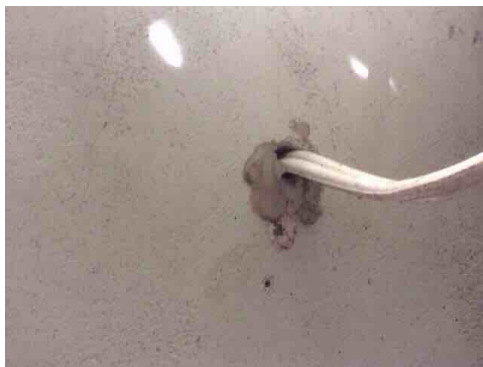
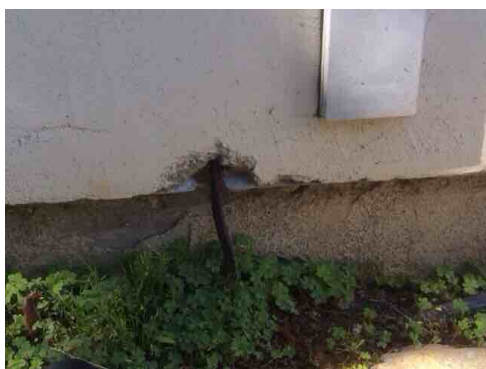
**8:** - There is missing stucco (holes, openings, missing covers, chips) noted at the exterior wall of the house. These openings may allow moisture to enter into the structure resulting in possible damage to interior wood framing members. In addition, openings in the stucco may also allow pests to enter and should be sealed as preventative maintenance.

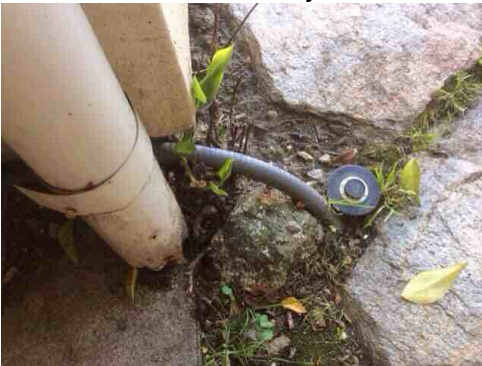
**21:** - There is conduit sticking up at the south side which poses a potential tripping hazard. Improvements are recommended for safety.

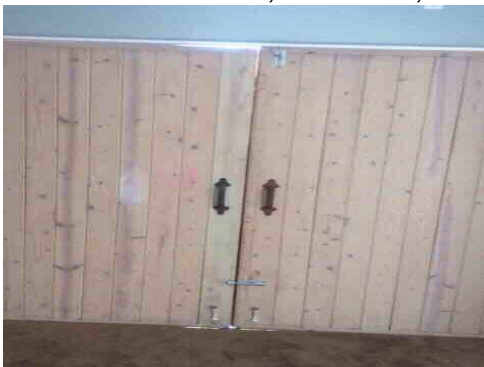
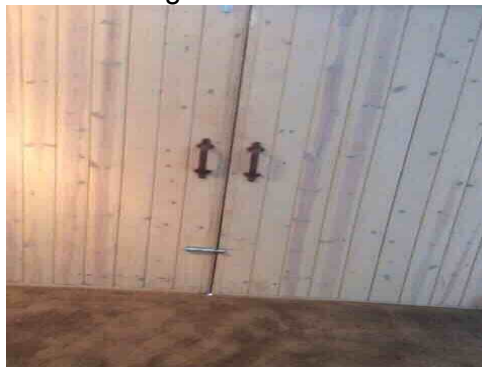
**26:** - As a suggestion, we recommend having the weather stripping improved on the exterior doors present. This includes the sill, door shoe, and weather beading.

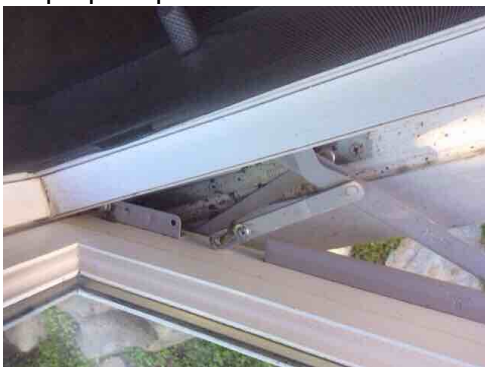
**30:** - The arm on the casement window in the south wall is disconnected and is suggested to be re connected for proper operation. The window was not tested.

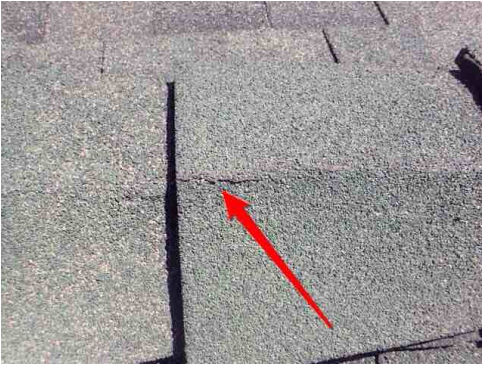
**21:** - Split ridge caps of the roofing will require repair in the very near future. Repairs should be performed by a licensed roofing contractor.

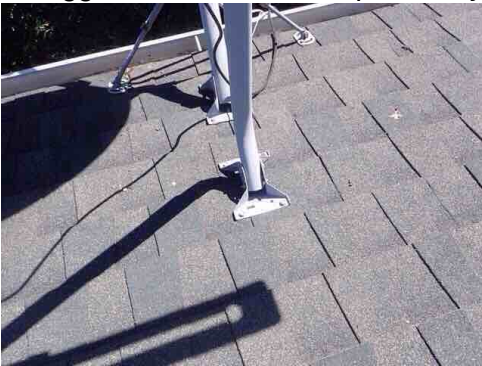
**22:** - The satellite dish has been installed onto the roof deck and the bolts were not sealed. Sealing the bolts is suggested to reduce the possibility of leakage.

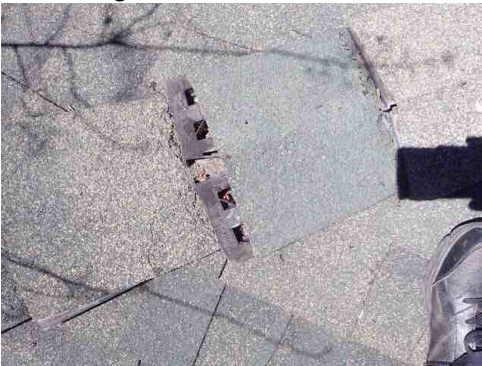
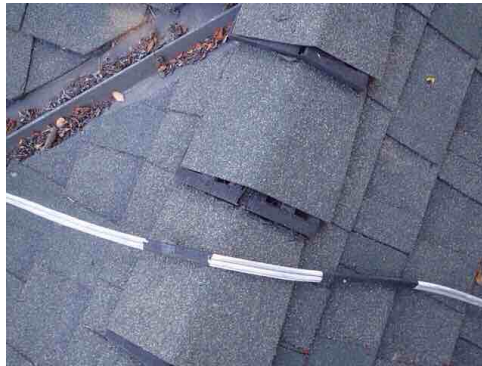
**23:** - There are ridge caps that appear to have moved or become loose from the ridge vent. Re-securing the loose ridge is recommended.

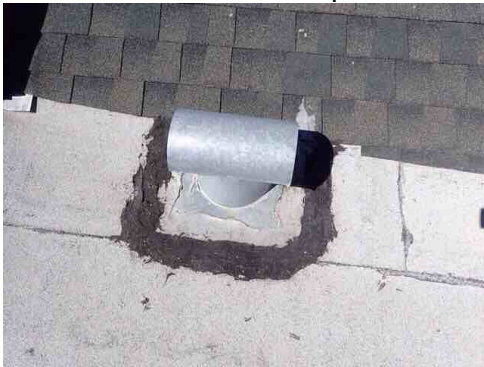
**26: -** The flashing in the cricket is installed on top of the material rather than under it, which is not the proper method of installation. Improvements are recommended.

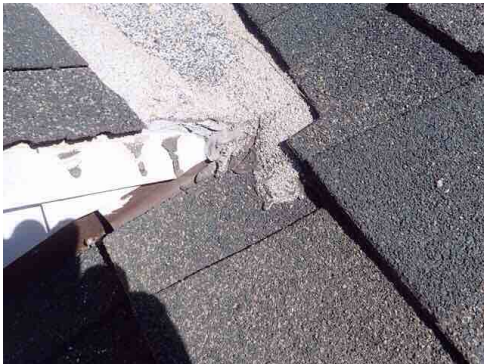
**27: -** Sealant is recommended at the ends of the cricket where it drains onto the shingle portion of the roof.
