Roof Inspection Report

LOCATED AT:

Friday, April 10, 2015

Mazza Inspection Group

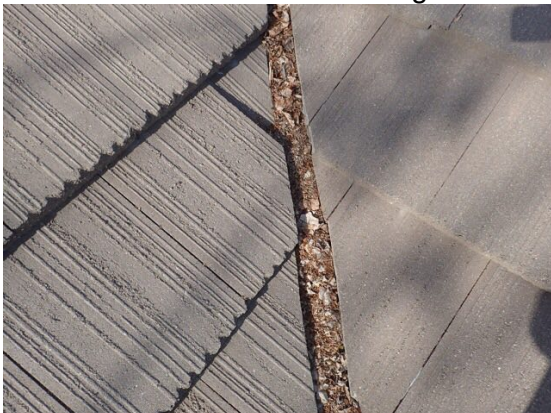
9: - We observed debris building in the valleys. Debris is suggested to be removed and the valleys monitored.

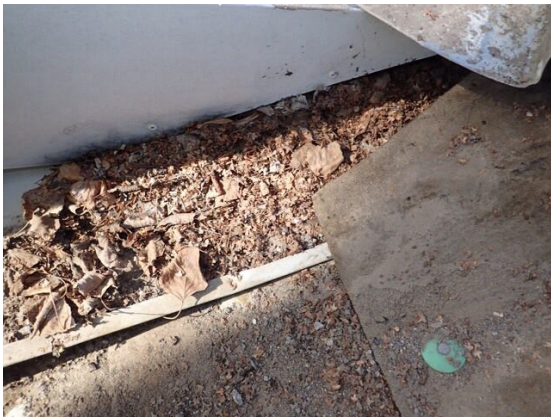
10: - There are flashings that are filled with dirt and debris. This material in the flashing pose a potential issue with respect to drainage. The flashing may cause a back up in water run off which may result in a potential leak.

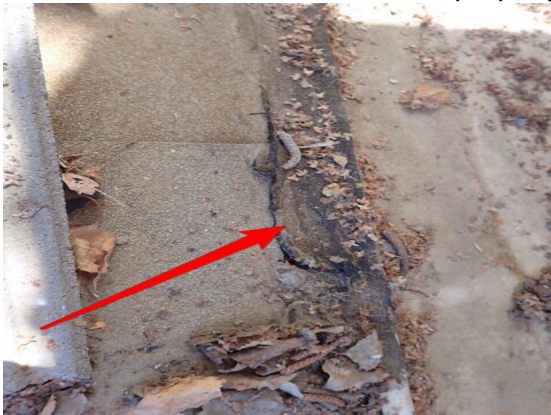
11: - We observed the use of roof cement against the side of the pan metal. This installation may trap water under the metal and not allow it to properly drain. Removing the roof cement is recommended.

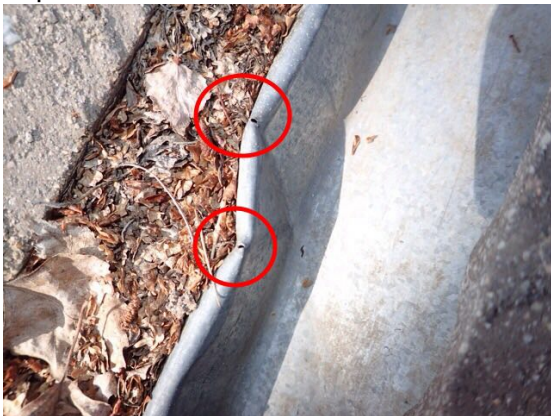
12: - There are two small holes that we observed in the valley metal. These holes are suggested to be sealed to prevent moisture intrusion.

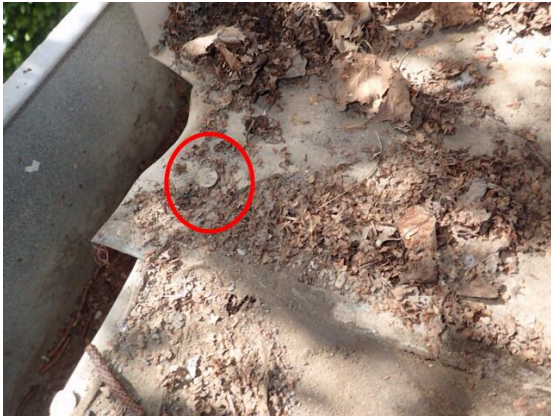
13: - There is a nail at the bottom of the pan flashing that is suggested to be sealed.

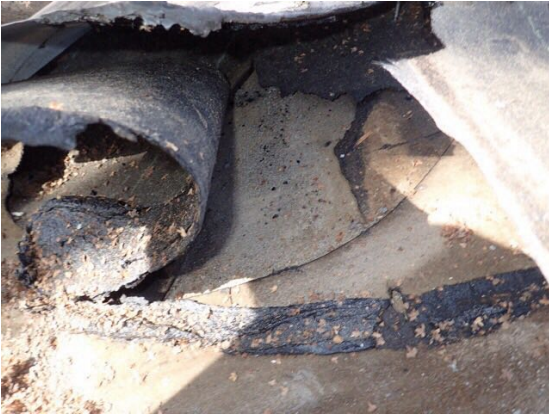
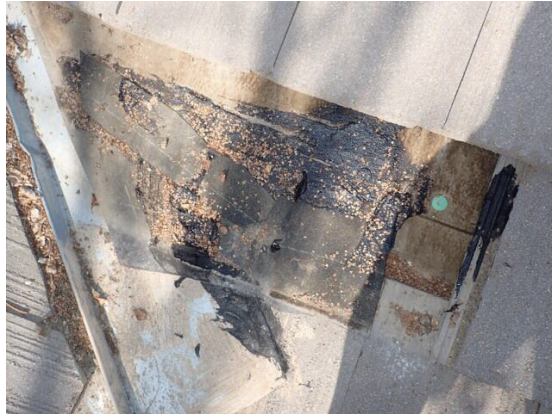
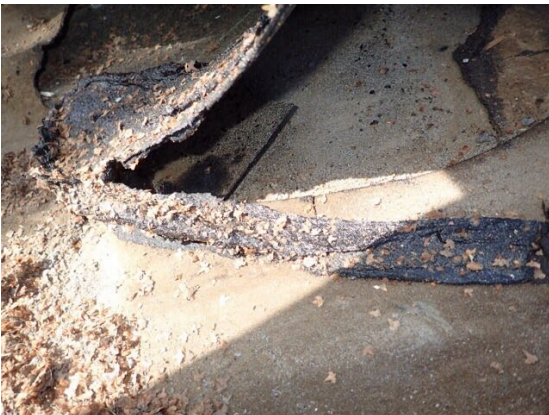
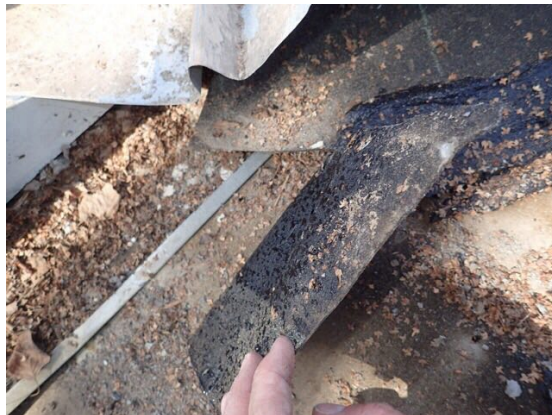
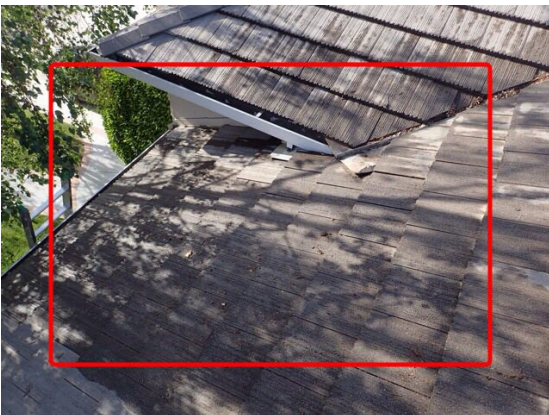
16: - The area on the roof that is believed to be leaking appears to have previously been repaired in an amateurish manner. There is membrane that is installed and not properly terminated under the membrane above. There are splits in the membrane which appears to be allowing water under the material. We observed the use of roof cement as a way to keep water out from under the improperly installed membrane. Installing new membrane in this area (pictured) that is properly terminated is recommended to prevent further issues.

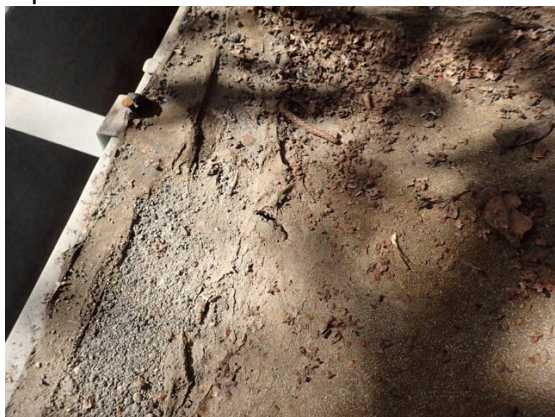
17: - The membrane at the bottom edge of the roof appears to be deteriorated and is suggested to be repaired.

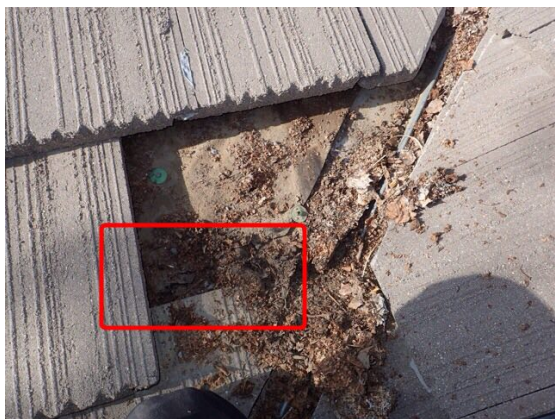
18: - Water appears to be backing off of the valley metal and deteriorating the membrane due to the debris in the valleys which may be keeping the water from properly draining. Cleaning the valleys and replacing the membrane is recommended.

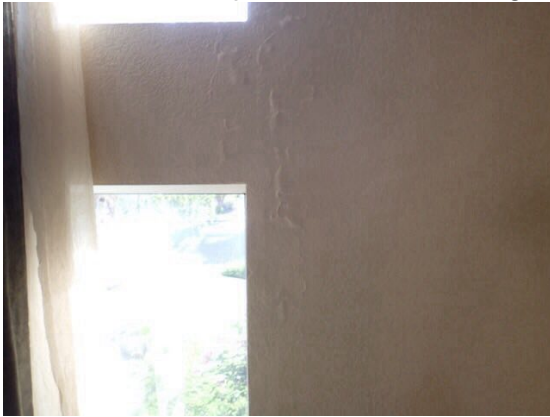
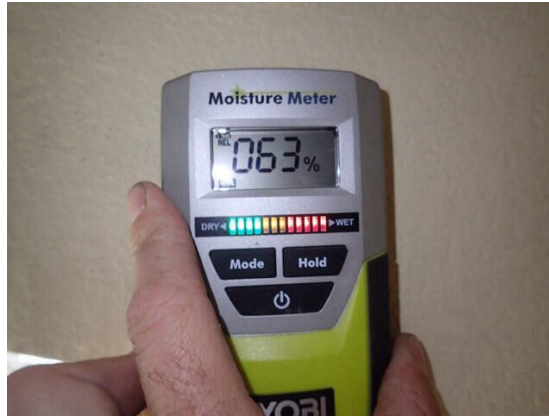
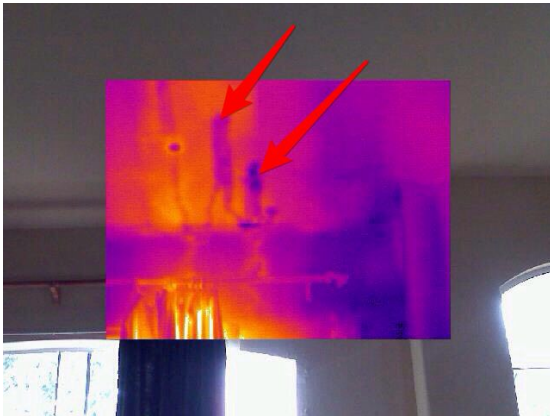
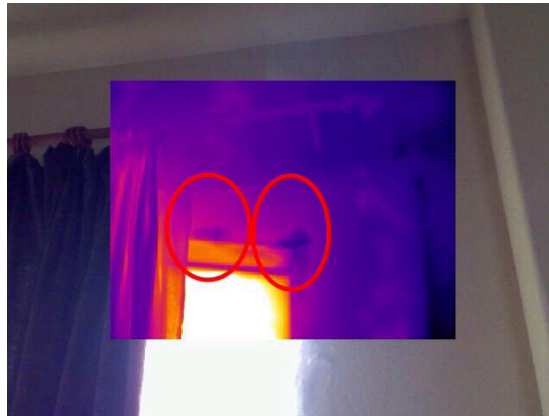
19: - The damage to the wall in the family room appears to be caused by the roof. Upon water testing the suspect area on the roof, we received elevated levels of moisture on our moisture meter. Furthermore, upon scanning with an infrared camera, we noticed readings that suggest moisture intrusion. Repairing the roof is recommended to prevent further damage to the walls.
