Chimney and Fireplace Inspection Report

1234 Inspection Way, City, CA 91406
Inspection prepared for: Mr. and Mrs. Client

Inspector: Greg Butler
27943 Seco Canyon Road, 560, Santa Clarita , CA 91350

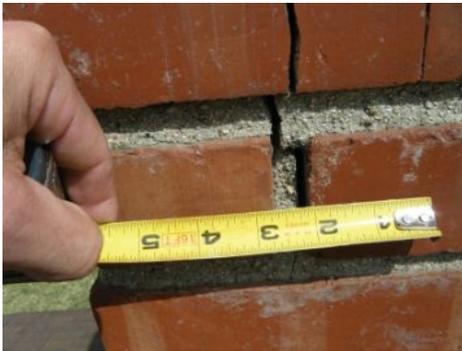
4.1. There are larger than typical cracks in the chimney bricks and grout joints. They can result from shrinkage, seismic activity, common settling, thermal extremes, moisture contamination, and the expansion and contraction associated with freezing and thawing.

large cracks noted

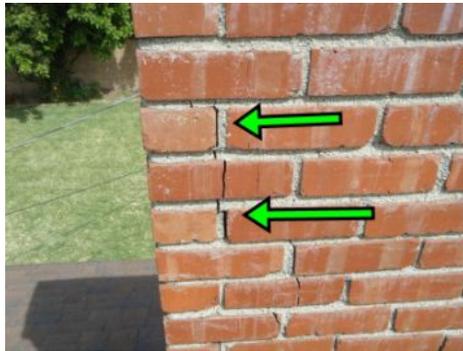
large cracks

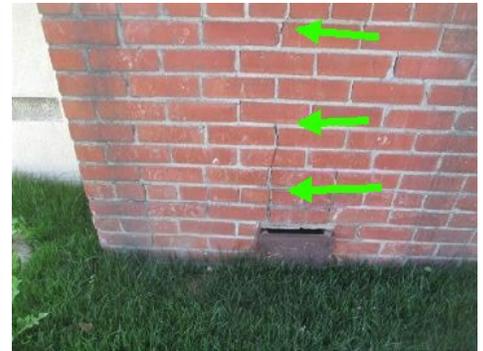
vertical cracking in brick

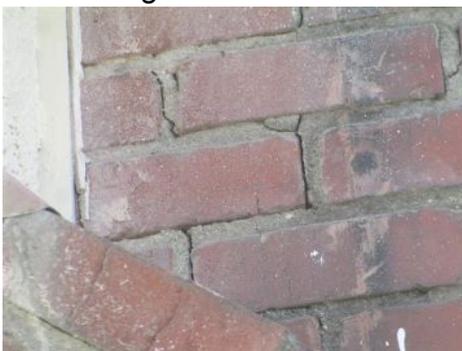
vertical cracking noted

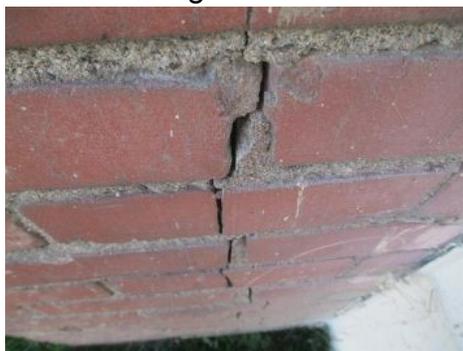
vertical cracking noted

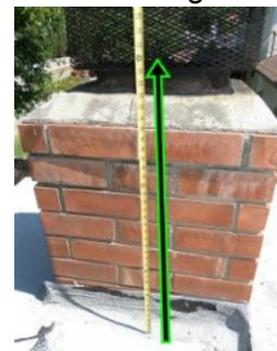
4.2. This chimney may not meet basic drafting standards, which require a chimney to extend three feet above the roof line, and two feet above any point measured in a tenfoot radius. Proof that the fireplace was built by a professional contractor with permits is recommended, or have a specialist evaluate.

R1003.9 Termination. Chimneys shall extend at least 2 feet (610 mm) higher than any portion of a building within 10 feet (3048 mm), but shall not be less than 3 feet (914 mm) above the highest point where the chimney passes through the roof.

chimney is too short

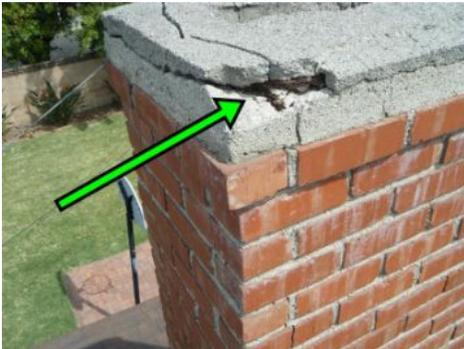
7.1. The chimney crown, which is designed to seal the chimney and shed rainwater, is cracked and damaged exposing the rebar. This should be repaired to reduce the possibility of further damage as a result of moisture penetration into this opening.

damaged crown

10. Seal the transition between the chamber and new flue.
-
11. Install rain cap/spark arrester at the top of the chimney.
-
12. Resurface the chimney crown and repairing any cracks within this component.
-

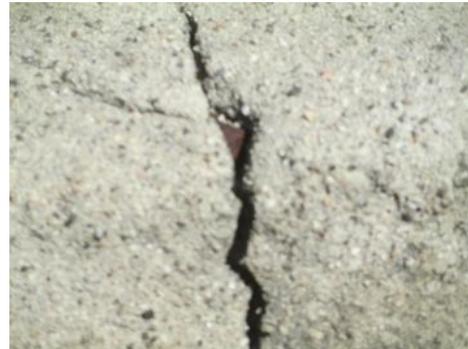
cracks noted in cap

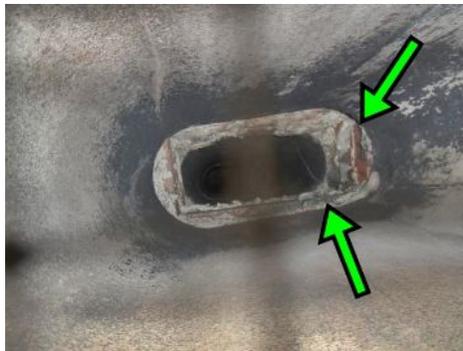
8.1. The flue liner is missing within the upper 1/3 portion of the chimney. The location of this missing material is within the attic space and therefore, possess a real and present hazard. It is our suggestion that this condition be repaired prior to use.

missing flue liner

7. Install the stainlesssteel liner in the flue.
-
8. Wrap the stainlesssteel liner with the proper insulation wrap.
-
9. Attach the top plate to the top of the liner.
-

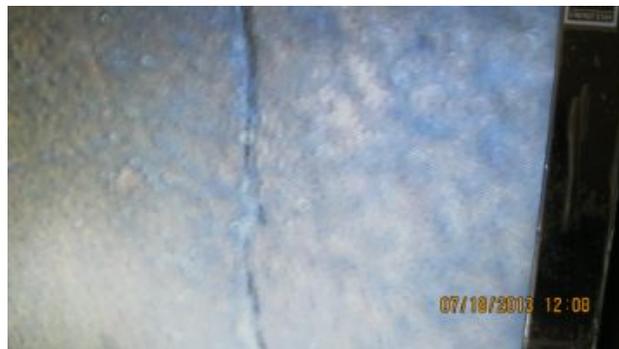
5.1. The flue was viewed using a video camera. There are visible cracks in the liners that should be evaluated by a specialist before the chimney is used. The smallest cracks can expand under thermal pressure to create a serious safety threat.

5.2. There are offsets in the flue liners when viewed through the damper does not provide a completely smooth transition for the biproducts of combustion. The liners were so severely offset, they may allow stalling of the bi products during normal drafting and they may also allow gases to deteriorate the grout and the area where the chimney passes through the attic, represents a serious issue.

cracks in flue

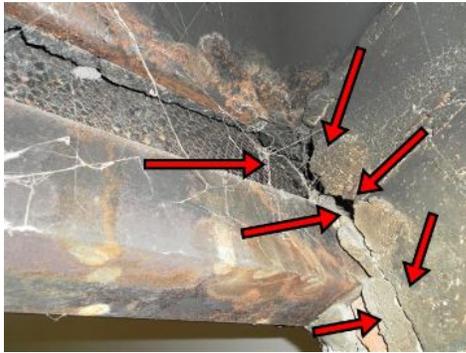
- 12.3. There appears to be missing mortar within /below the throat area of the firebox. This condition may be considered typical for a masonry fireplace as it is used, the mortar becomes brittle, and overtime deteriorates and falls out. Replacement of this mortar is considered normal maintenance, however, it is suggested that this area be inspected Periodically and material replaced as necessary. This material is further suggested to be replaced in order to reduce the potential for further deterioration or flame infiltration into cavities beyond the mortar.

missing mortar

4. Clean the fireplace and chimney.
-
5. Parge / tuckpoint all areas where mortar is missing, deteriorated and /or damaged.
-
6. Coat the smoke chamber / throat with 2000 degree rated high temperature cement to seal penetrations.
-

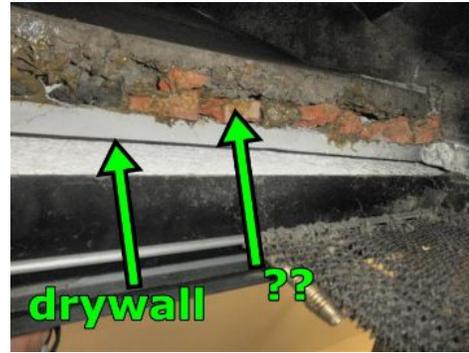
- 12.4. Combustible materials were observed within the firebox. This material consisted of drywall and wood. Removal is suggested prior to use.

combustible material

15. Install a proper ashdump door.
-
16. Remove combustible materials from inside the fire box requires removing the drywall at the front of the firebox and re constructing this area in order to maintain minimum clearances to combustible in accordance to NFPA 211.
-

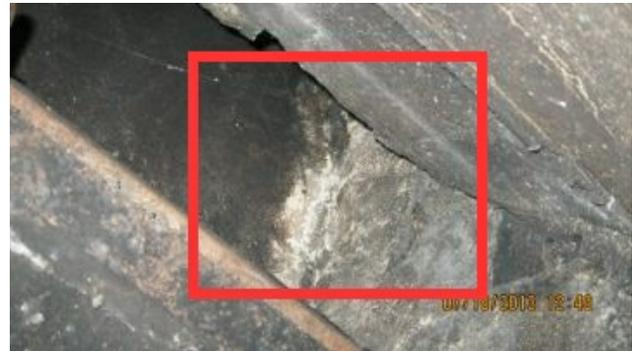
13.1. This area of the throat was viewed with a video camera. There appears to be missing mortar within /below the throat area of the firebox. This material is suggested to be replaced in order to reduce the potential for further deterioration or flame infiltration into cavities beyond the mortar.

missing mortar

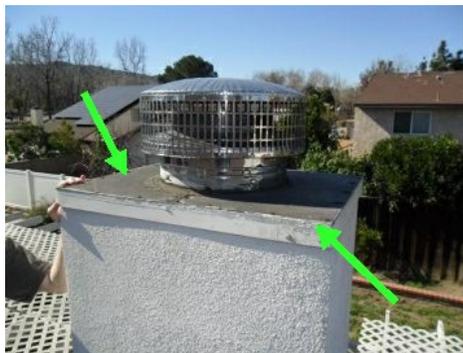
5.1. The chase cover appears to be field modified or repaired. We are unable to determine if this specific fireplace requires a "listed" chase cover. This condition required attention as there are openings in the cover which will allow moisture to enter. We further observed a large opening under the chase cover to the top of the chase. In some cases, the chase cover is suggested to be somewhat oversized in order to allow the chase to cool, or ventilate. Otherwise, the openings may need to be sealed.

chase cover is field modified in substandard manner

-
1. Remove existing chase cover and manufacture a new cover in accordance to OEM specifications.
-
2. At some point the flue was damaged, repaired, modified or never penetrated the roof chase. Install the appropriate number of listed liners / extender to exit the top of the chase.
-
3. Seal refractory panel where fuel line penetrates
-

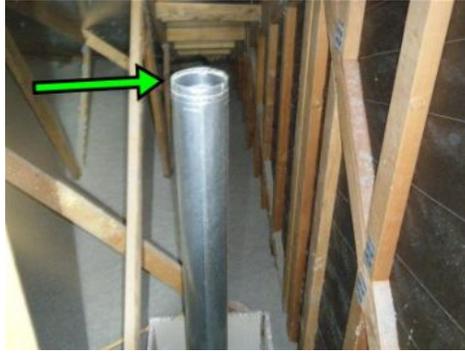
6.1. The fireplace flue does not penetrate the roof. This fireplace represents a real and present hazard and is NOT suggested to be used until this condition can be repaired.

fireplace flue does not penetrate roof

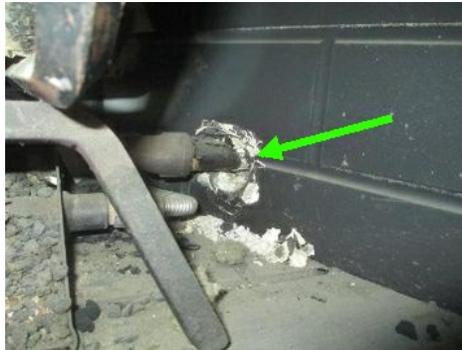
5.1. The void / separation around the gas pipe in the sidewall of the fireplace should be sealed with refractory caulk to prevent any possibility of backdrafting a flame beyond the combustion chamber, where it could come into contact with combustible material. For this condition, we suggest a more indepth examination, including any potential repairs. We suggest further assessment and advice by a qualified fireplace specialist.

log starter is suggested to be sealed here

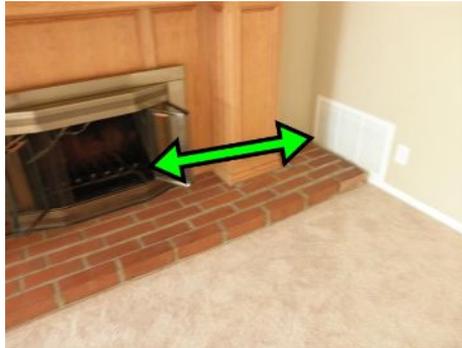
10.1. The return air vent is too close to the fireplace. Ten feet is the minimum distance which should be maintained between the air return and the opening of the firebox. An HVAC contractor is suggested to be employed to remedy this condition.

fireplace clearance to return air vent substandard
