COMMERCIAL BUILDING INSPECTION REPORT

SAMPLE REPORT

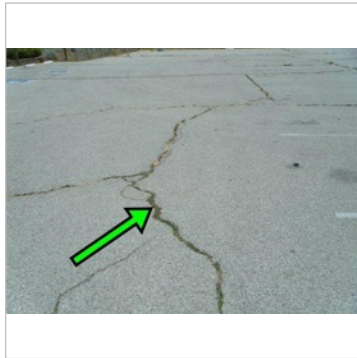
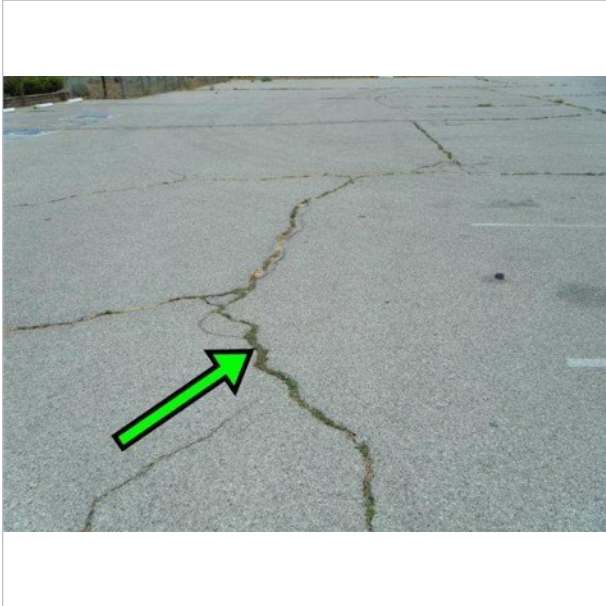
- 1.1.16 Asphalt driveways are not as durable as concrete ones, and typically develop cracks. They are expected to last approximately fifteen to twenty years, and typically need maintenance service.
- 1.1.17 There are predictable cracks in the driveway that would not necessarily need to be serviced.

Figure 1A - Asphalt cracking

Ref: 1.1.17 - There are predictable cracks in the driveway

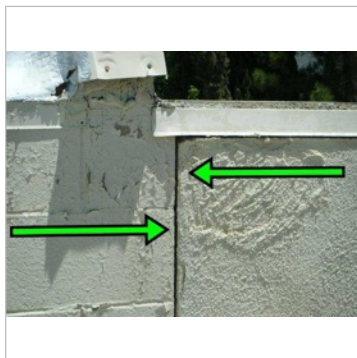
- 1.1.43 There was what appeared to be in addition constructed on the southwest side of the building to house the FAU. The structure does not appear to have been properly secured to the Main structure and as a result, may leak at the very least, or separate and become subject to structural damage, at the worst.

Figure 5A - Addition connection to main structure

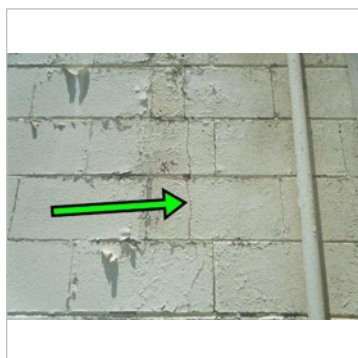
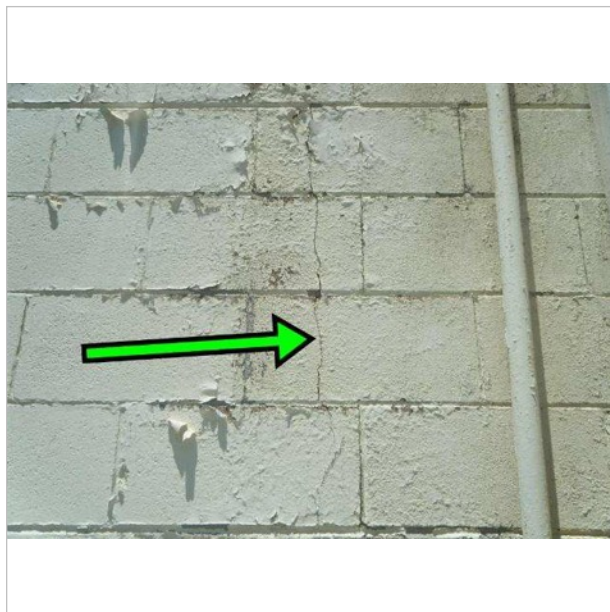
- 1.1.50 There are some obvious settling cracks that it would be prudent to seal, to forestall any possibility of moisture intrusion.

Figure 7A - CMU cracking

Ref: 1.1.50 - There are some obvious settling cracks

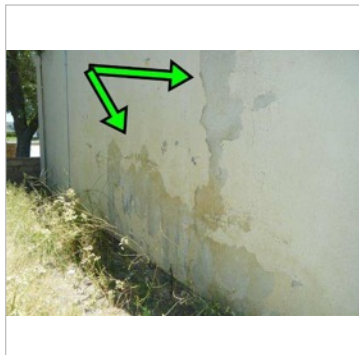
- 1.1.53 The stucco and paint, which is peeling in areas, as a result of an inadequate bond or poor preparation, and should be serviced.

Figure 8A - Stucco/paint peeling

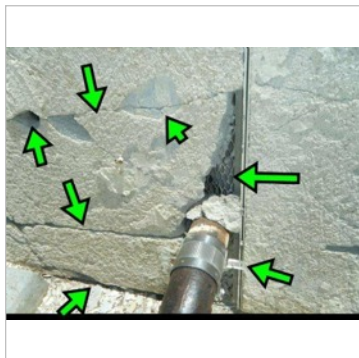
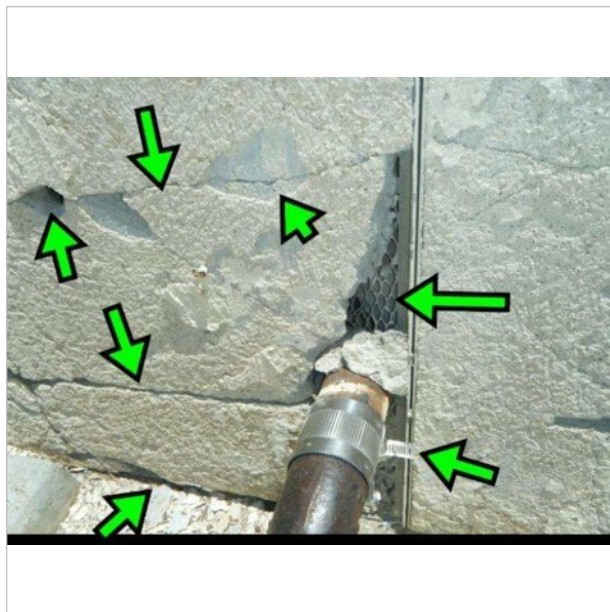
- 1.1.54 We observed stucco, which appears to have been installed in a substandard manner. On the west side of the building, we observed substantial cracking and missing material, which are consistent with substandard preparation prior/during to the installation of stucco. We, therefore, suggest this material in its entirety, be removed and replaced by professional Mason. Additionally, we observed paper backing, which is a moisture barrier, was damaged and, therefore, in need of replacement.

Figure 9A - Substandard stucco condition

Ref: 1.1.54 - Damaged stucco

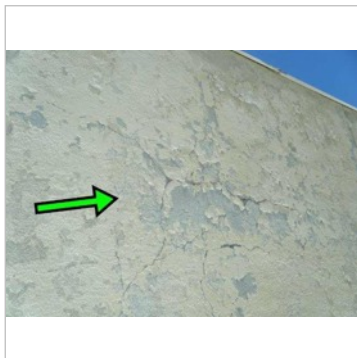
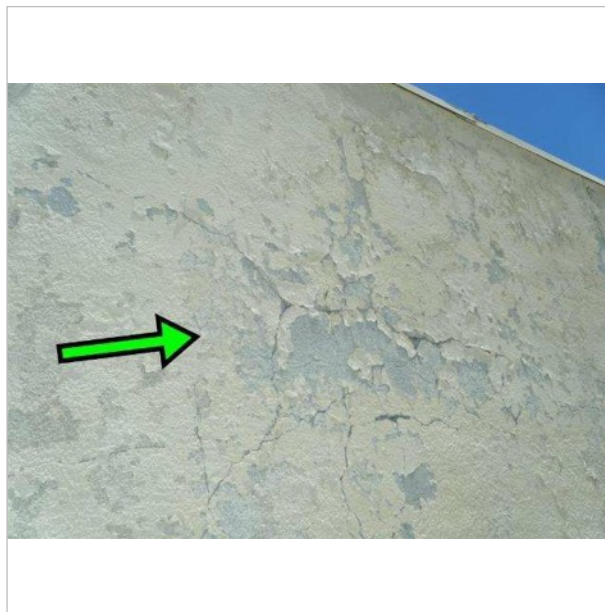
Figure 9B - Substandard stucco condition 2

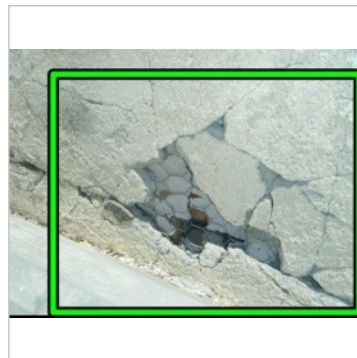
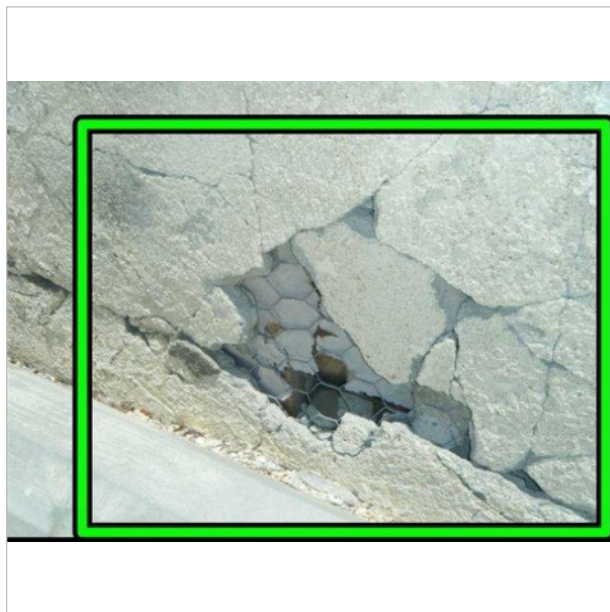
Figure 9C - Substandard stucco condition 3

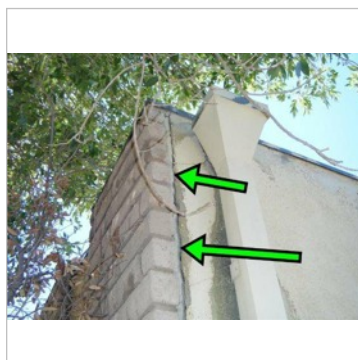
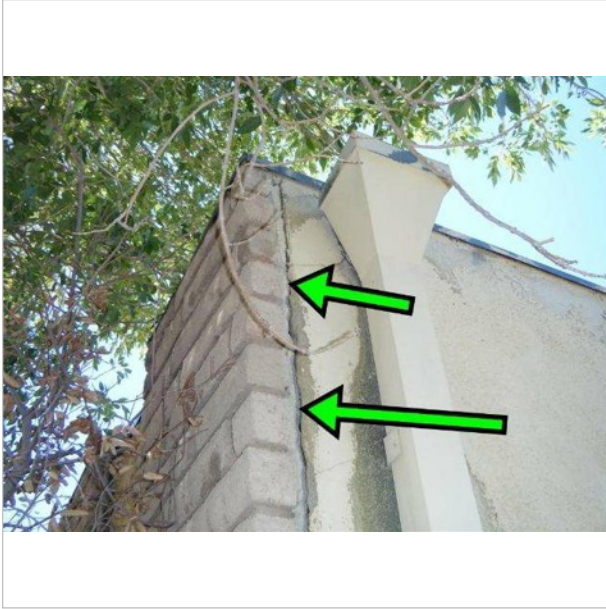
- 1.1.57 The front east CMU siding appears to have separated from the main structure, which is subject to moisture penetration and needs to be repaired. Additionally, there are some missing blocks in this area, which are also subject to moisture penetration and need to be repaired.

Figure 10A - CMU separation

Ref: 1.1.57 - loose CMU

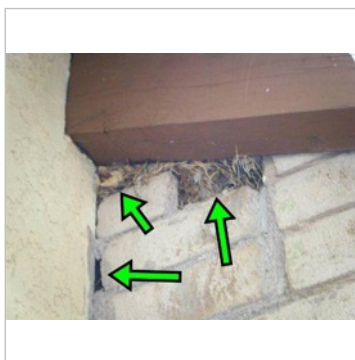
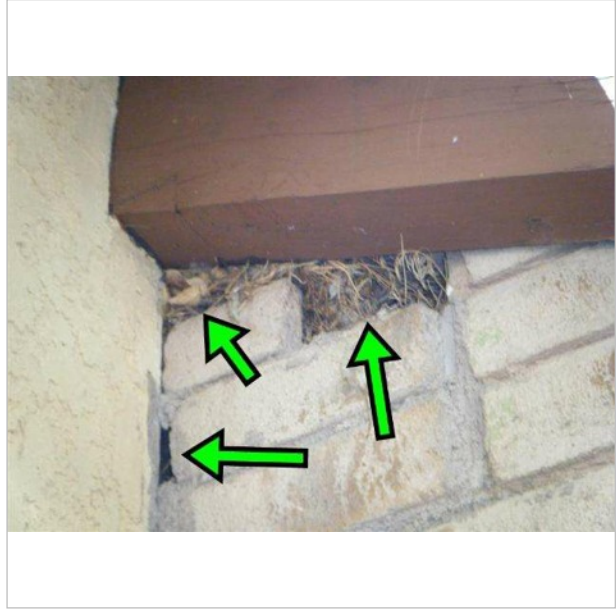
Figure 10B - Missing CMU

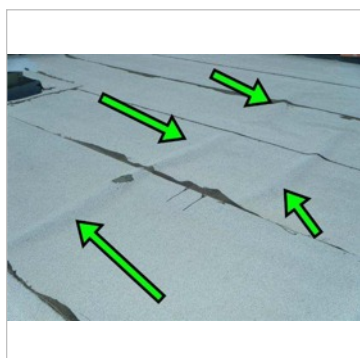
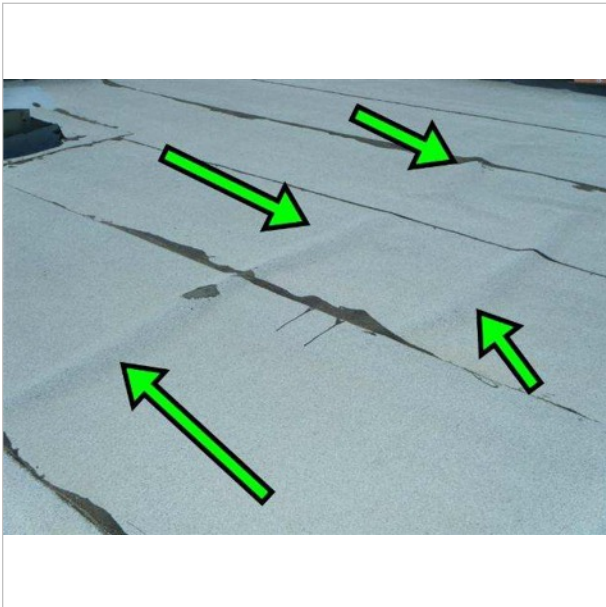
- 1.1.78 The roof is old, deteriorated, loose and ready to be replaced. Regardless, it should be evaluated by a roofing contractor within the contingency period, because the cost of replacing it may effect your evaluation of the property.

Figure 11A - Loose portion of flat roof/BUR

Ref: 1.1.78 - The roof is old and deteriorated and ready to be replaced

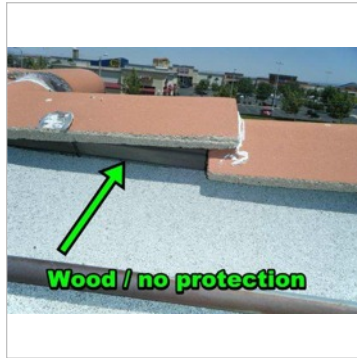
- 1.1.81 The tops of the parapet walls are not adequately sealed, which could allow moisture to penetrate. We did not observe any parapet cap flashing under the concrete rake tiles. This flashing protects the top of the parapet wall from any moisture intrusion.

Figure 12A - Exposed wood at parapet wall

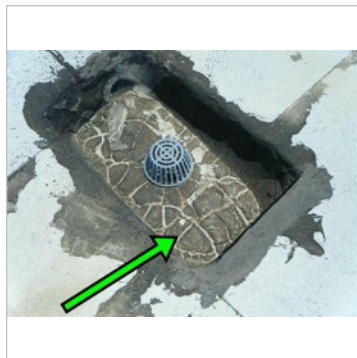
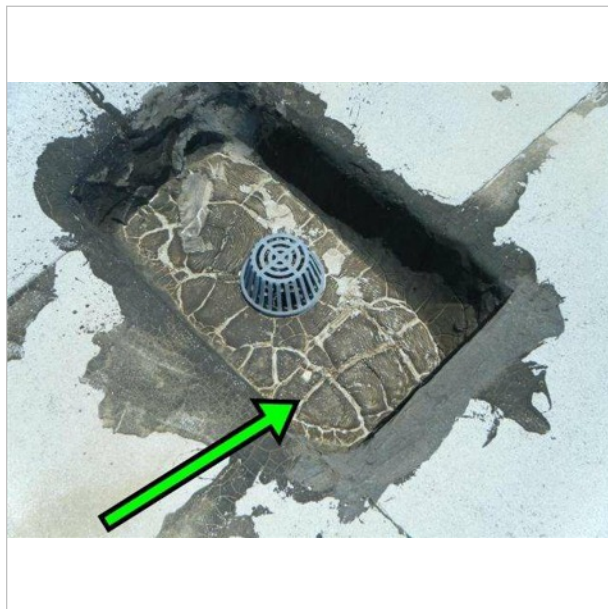
- 1.1.82 Roofing mastic was observed cracked and in need of repair or replacement around the scupper drain.

Figure 13A - Cracking within scupper

Ref: 1.1.82 - Damage within scupper

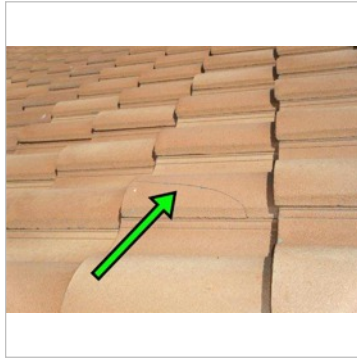
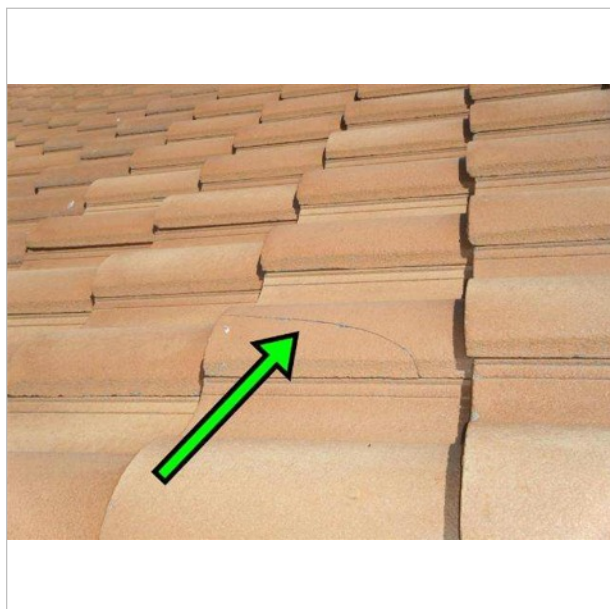
- 1.1.89 The field tiles are cracked and chipped and need maintenance service.

Figure 15A - Cracked tiles

Ref: 1.1.89 - The field tiles are cracked and chipped and need maintenance service

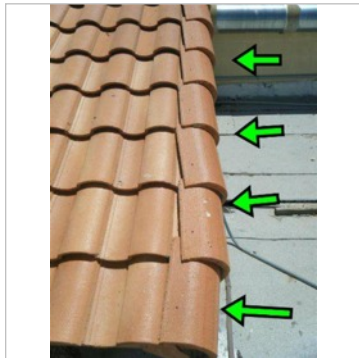
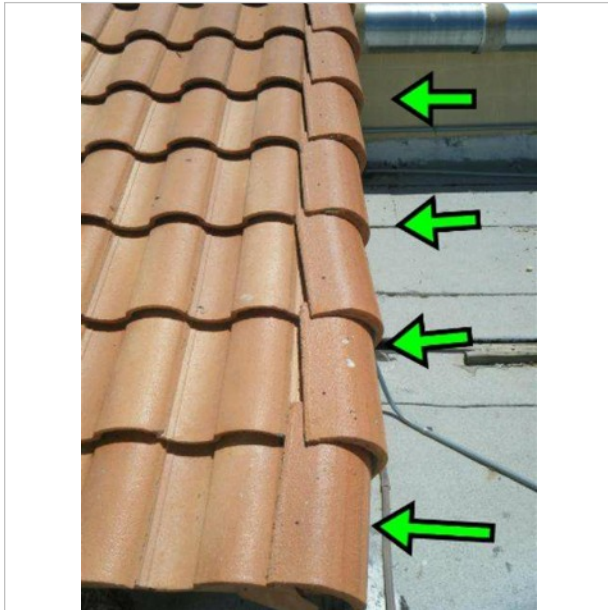
- 1.1.92 There were rake tiles, which were loose and, therefore, represent a safety hazard. These tiles are suggested to be secured by a professional.

Figure 16A - Loose rake tiles

Ref: 1.1.92 - Rake tile loose

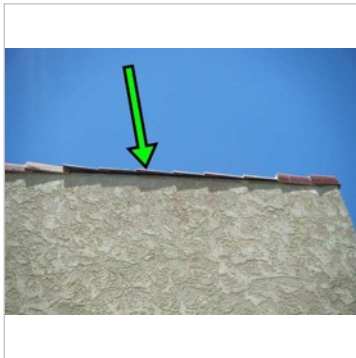
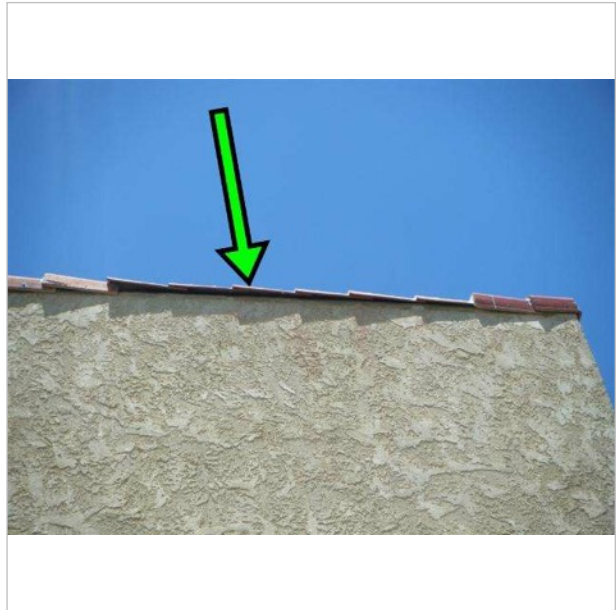
Figure 16B - Loose rake tiles 2

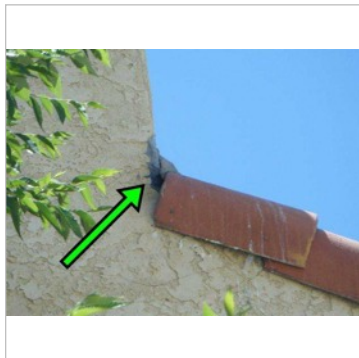
- 1.1.93 The flashings need to be sealed or serviced. They are comprised of metal that seals valleys and vents and other roof penetrations, and are the most common point of leaks. This is particularly true of the flashings on a layered roof, which are covered by the roofing material and which are even more susceptible to leaks.

Figure 17A - Sealant is needed here

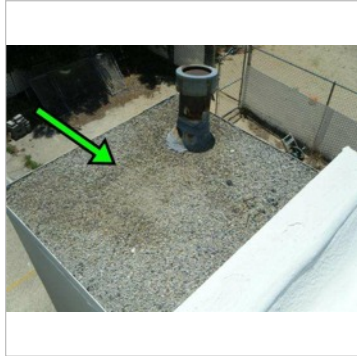
- 1.1.101 Water appears to pond on the roof membrane. Ponding shortens roof life and increases the potential for damage if leaks occur. When re-roofing the roof should be appropriately sloped, or drains should be provided.

Figure 18A - Ponding water

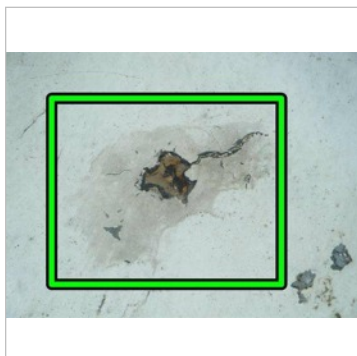
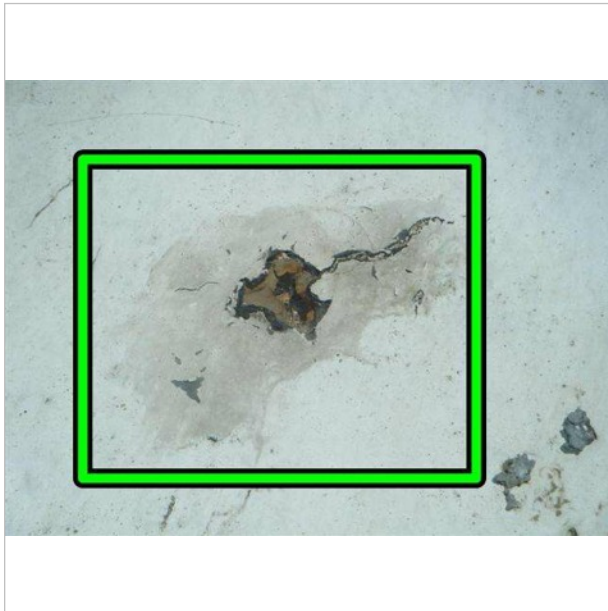
Figure 20G - Cracking/peeling

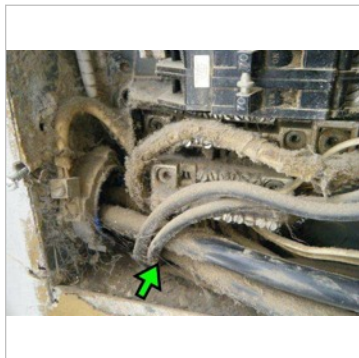
- 1.1.119 We, along with the electrical contractor, observed multiple exceptions within the Main service equipment panel. Aside from the main panel utilizing breakers, which are known to be defective, we also observed conductors which were not terminated properly, corrosion among the breakers/conductors, excessive dirt among the breakers, conductors which enter the panel in a substandard manner, open knockouts, and a double pole breaker, which appears to be operating/wired in a substandard manner.

Figure 22A - Debris in excess

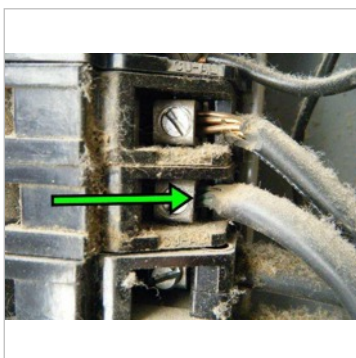
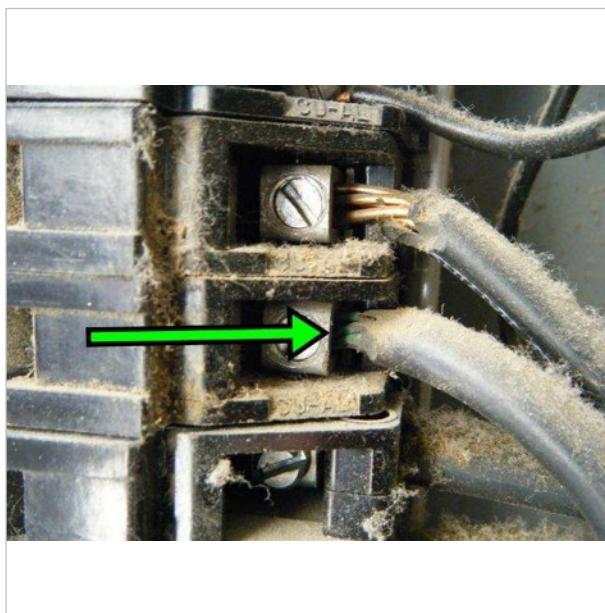
Figure 22H - Corrosion noted

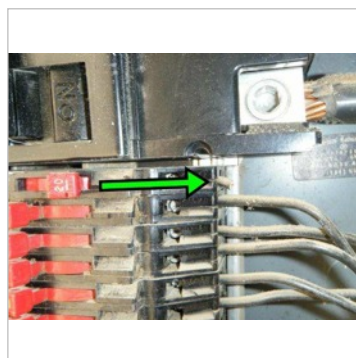
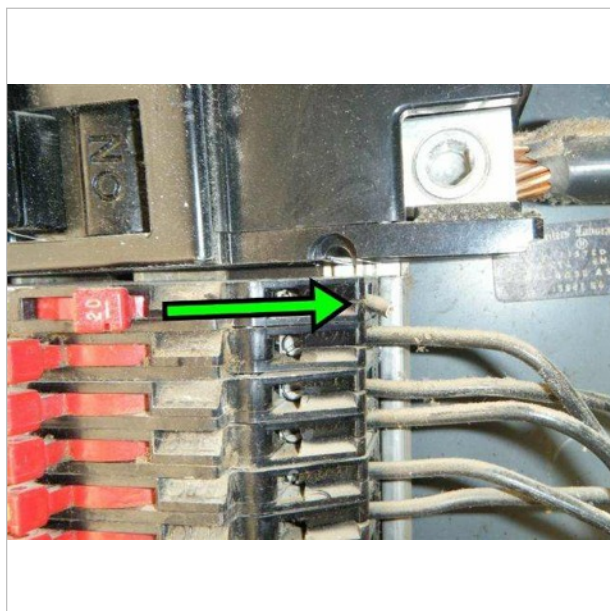
Figure 22I - Terminated conductor - hazard

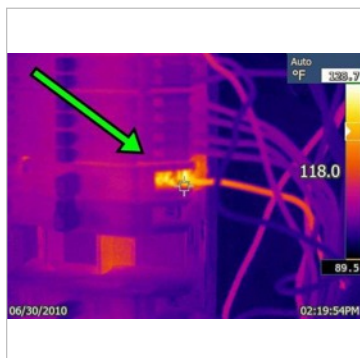
- 1.1.120 Two of the circuits/conductors in the service panel appears to be somewhat warm, or at the very least, warmer than the others around it when tested via infrared. This warmer temperature may not be indicative of an electrical issue as this circuit / conductor may be under normal operating conditions. However, in some cases such as overloading, over fusing, or loose conductor/breaker/terminal connections for example, this increase in temperature is considered atypical. Only with the use of specialized training and equipment, can this condition be investigated and we, therefore, suggest, at the very least, that the buyer have an electrician perform such an inspection of these circuits to rule out any possibility of defect. Note: At no time are breakers removed for inspection or testing.

Figure 23A - Hot circuit/wire connection

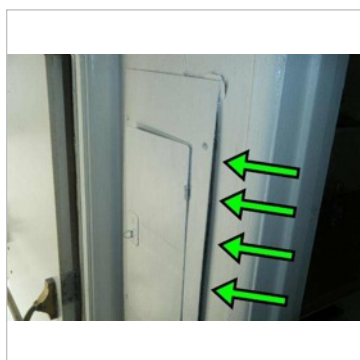
- 1.1.121 The main electrical panel does not fit properly and is suggested to be repaired.

Figure 24A - Panel did not fit properly

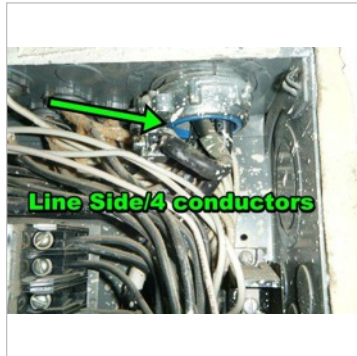
- 1.1.127 Within the sub panel, we observed four service entrance conductors on the line side of the panel. However, we only observed three conductors leaving the Main service equipment panel. The discrepancy between the two panels and a number of conductors between the two panels requires further investigation should be conducted by electrician.

**Figure 26A - Four conductors
line side here / three at the SEP**

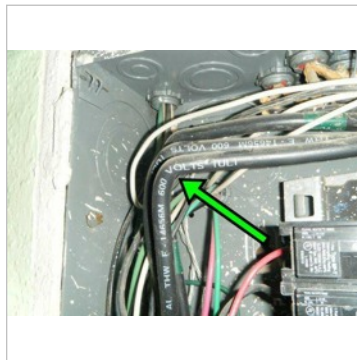
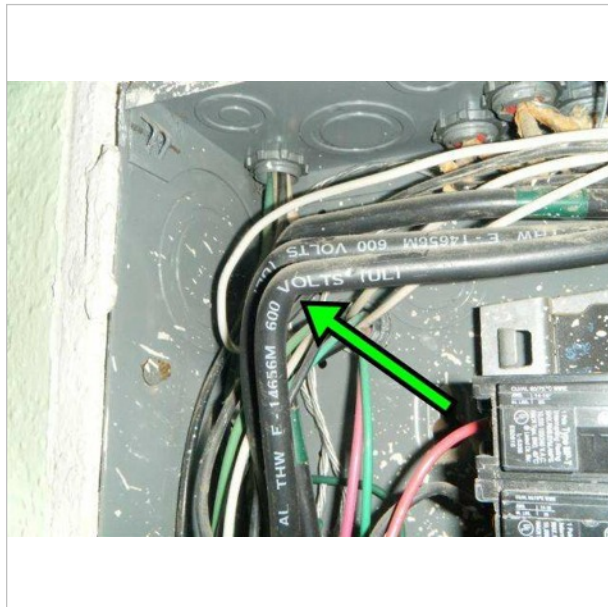
- 1.1.128 The service entrance conductors were installed within the panel in a substandard manner, as they possess a bend, which is considered substandard.

Figure 27A - Improper bend

Ref: 1.1.128 - improper bend

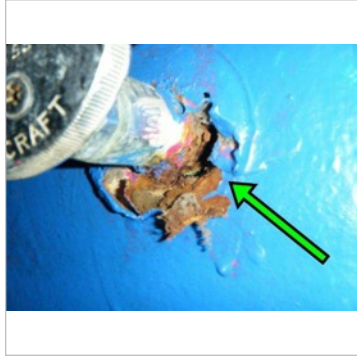
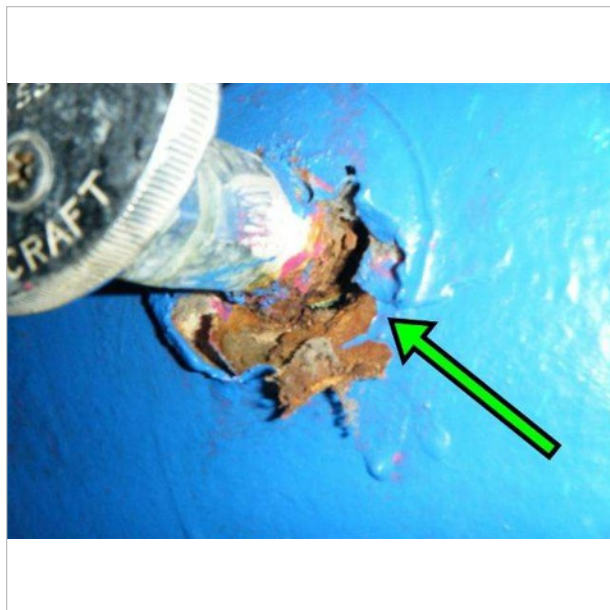
- 1.1.143 The water pipes / stubouts within the bathroom are corroded and should be evaluated by a plumber.

Figure 29A - Rust / corrosion

Ref: 1.1.143 - The galvanized pipes in the attic are blistered or corroded

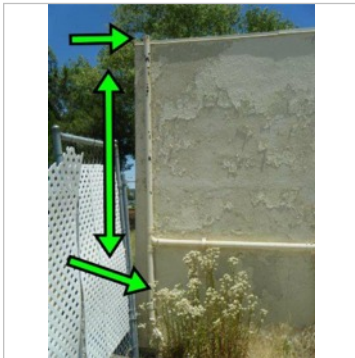
- 1.1.153 The vent stack installation has been performed in a substandard manner, without regard to minimum building standards at the rear west wall and is, therefore, subject to repair or replacement.

Figure 30A - Vent installed poorly

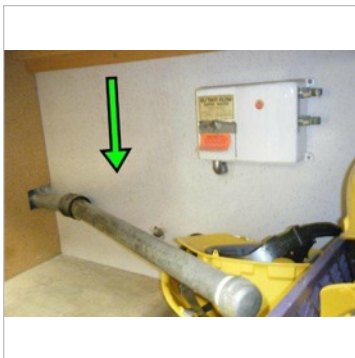
- 1.1.154 A terminated drain pipe was noted at the rear northwest office.

Figure 31A - Terminated waste pipe

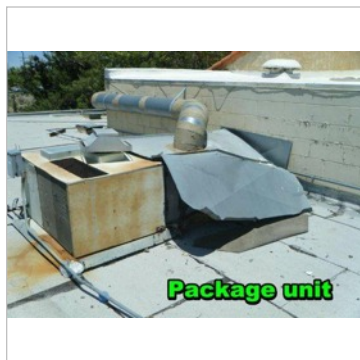
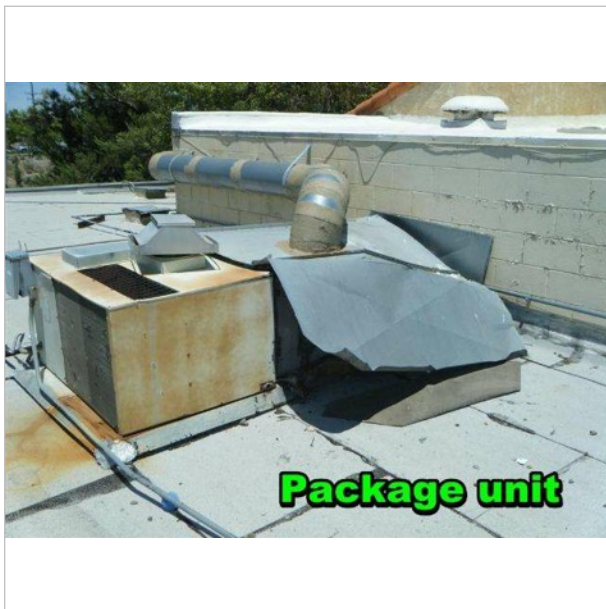
- 1.1.157 The components of the package system are in poor condition, not operational, and some may not be worth servicing.

Figure 32A - Package roof unit

Ref: 1.1.157 - The system is in poor condition and may not be worth servicing

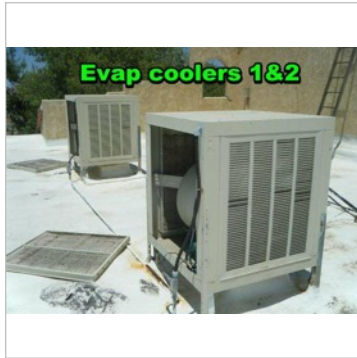
- 1.1.176 At the time of the inspection two of the three evaporative coolers were functional. They were not, however, functioning as intended, failed to cool and require significant amount of work to make them operational as they were intended.

Figure 34A - Evaporative coolers 1&2

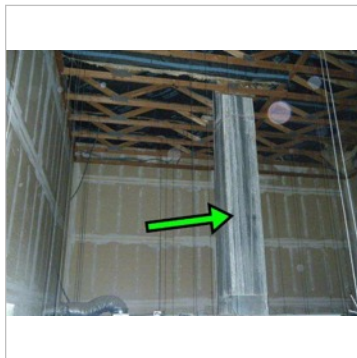
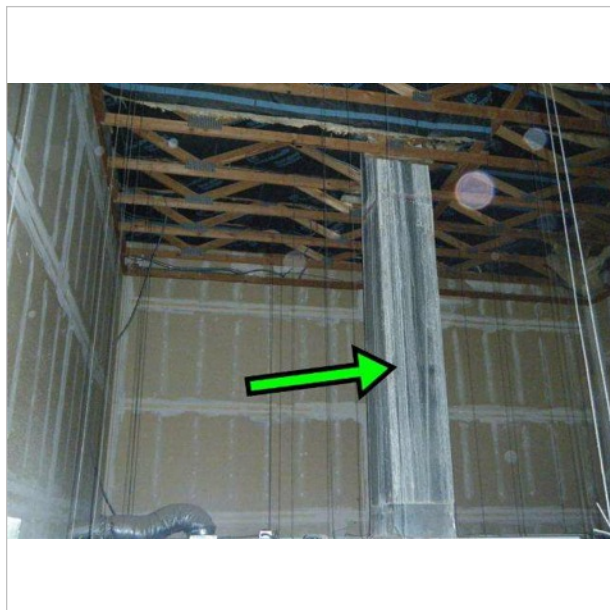
- 1.1.177 The swamp cooler ducts appear to be leaking or have leaked at some point.

Figure 35A - Stained swamp cooler ductwork

Ref: 1.1.177 - leaking

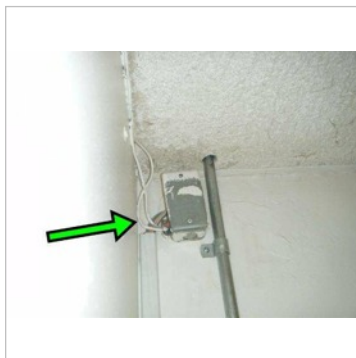
- 1.1.200 Exposed romex wiring was observed in the north corridor. This material is suggested to be contained by conduit as a safety precautionary measure.

Figure 36A - Exposed romex

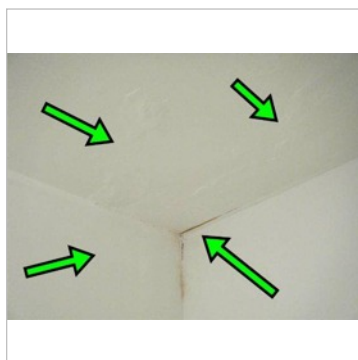
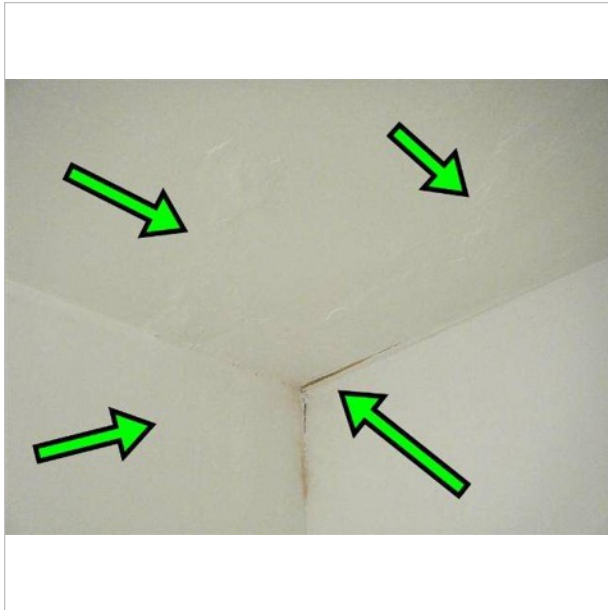
- 1.1.206 There is evidence of moisture intrusion that we will identify, but you should ask the sellers about this or have the condition evaluated by a grading and drainage contractor.

Figure 37A - Moisture intrusion - kitchen

Ref: 1.1.206 - There is evidence of moisture intrusion

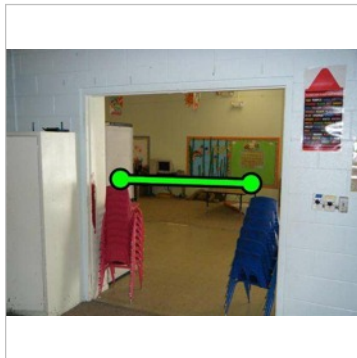
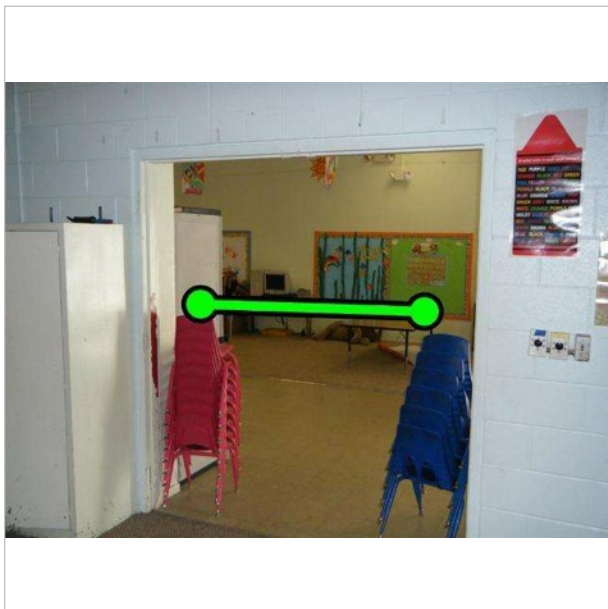
- 1.1.219 We observed double hollow metal core doors which were missing from this room.

Figure 38A - Missing hollow metal doors

Ref: 1.1.219 - Double Hollow metal core doors missing

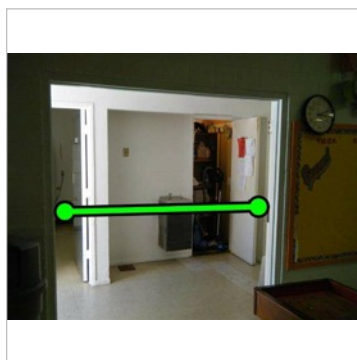
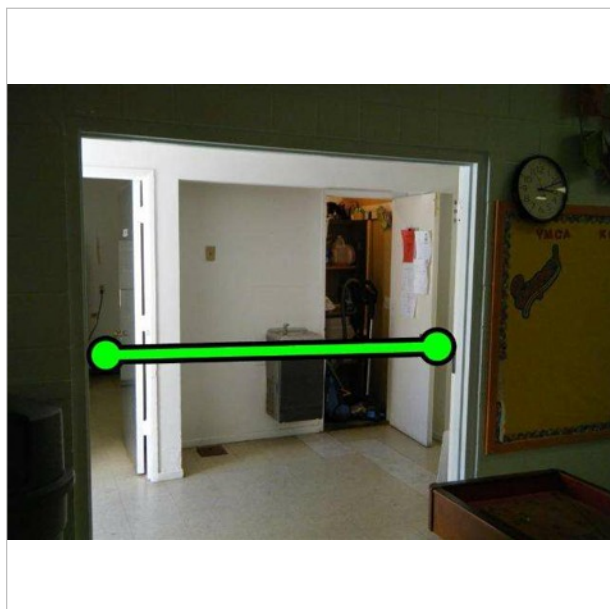
- 1.1.227 We observed double hollow metal core doors which were missing from this room.

Figure 40A - Missing hollow metal doors

Ref: 1.1.227 - Dbl doors missing

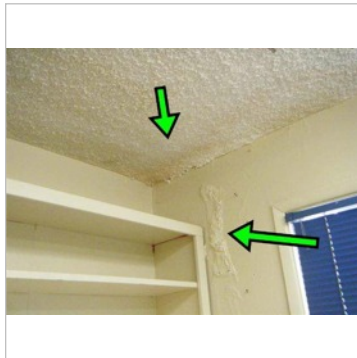
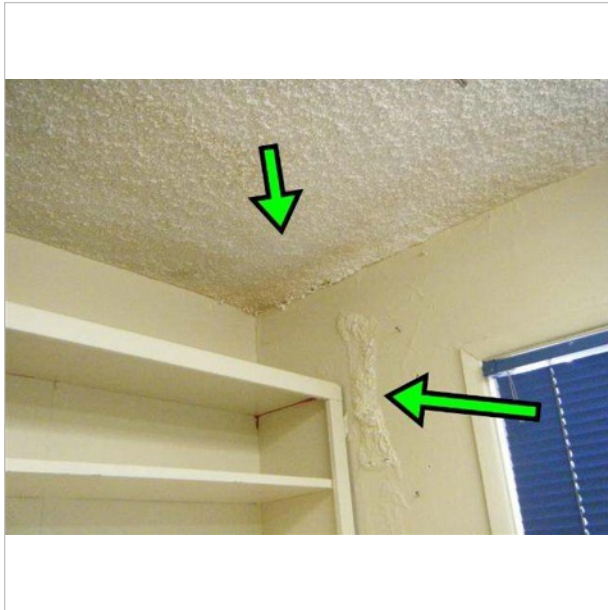
- 1.1.261 There is evidence of moisture intrusion on a wall that we will identify, but you should ask the sellers about this or have the condition evaluated by a grading and drainage contractor.

Figure 41A - Moisture intrusion noted here

Ref: 1.1.261 - There is evidence of moisture intrusion on a wall that should be further evaluated

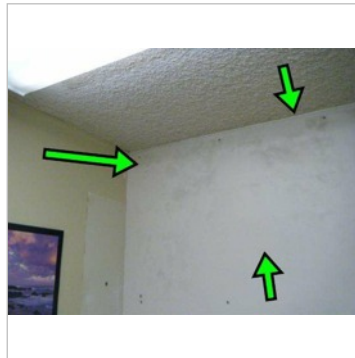
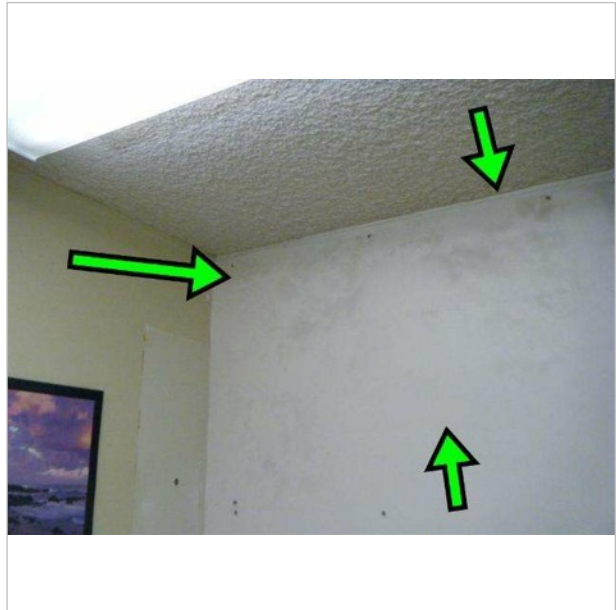
Figure 41B - Staining/discoloration

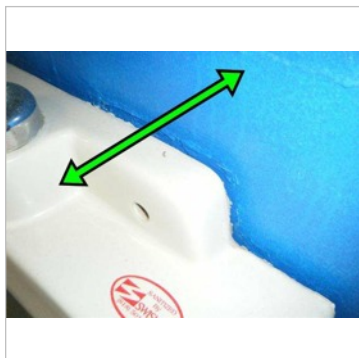
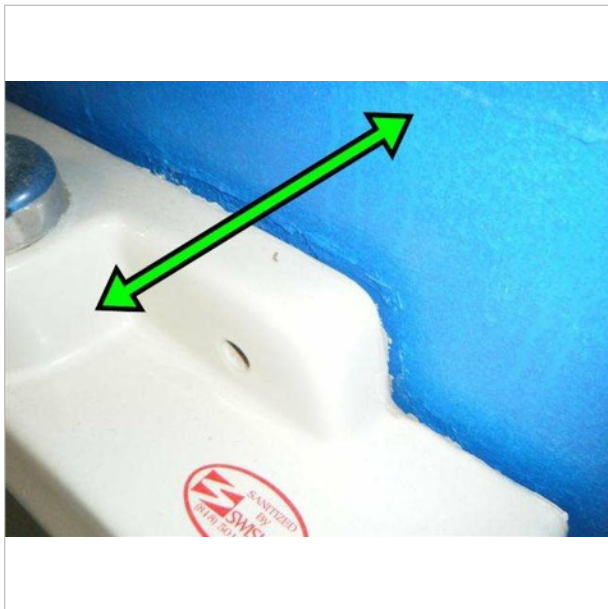
- 1.1.265 We found the general condition of the men's bathroom to be, overall, in poor condition. Collectively, we have documented many issues pertaining to the fixtures present. The urinal present was loose and not bolted to the wall, the height of the urinal does not meet ADA requirements, the toilet partition does not meet ADA minimum requirements and the entrance door to the bathroom does not meet the minimum width required by ADA.

Figure 42A - Loose urinal

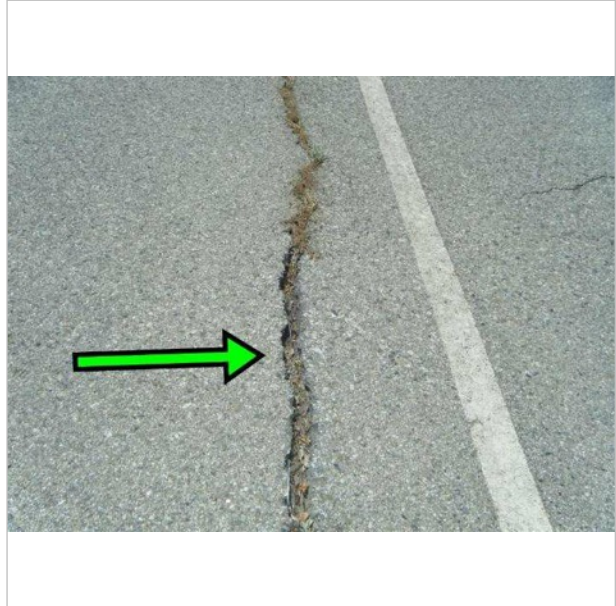
Figure 1B - Asphalt cracking 2

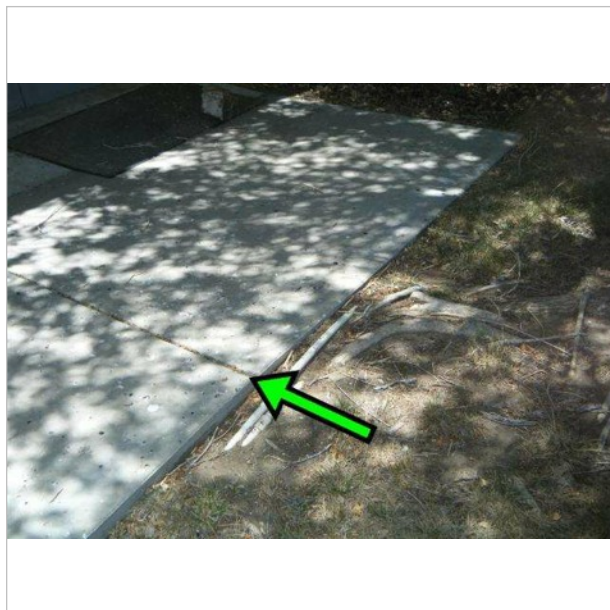
- 1.1.33 There are offsets in the walkways that could prove to be trip-hazards, which should be serviced. ADA standards reference 4.3.7, 4.3.8, 4.54, state that projections shall not exceed 1/2" minimum of 48" in width.

Ref: 1.1.33 - There are offsets in the walkways that could prove to be trip-hazards - not ADA

Figure 3A - Sidewalk raised

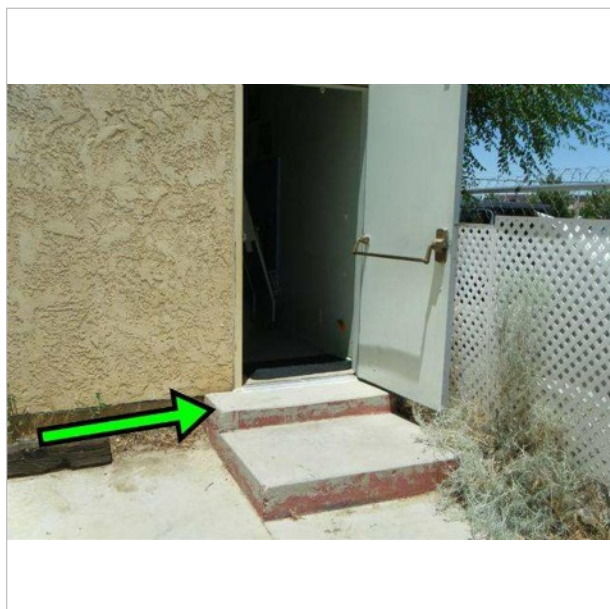
- 1.1.34 The steps located at the south side of the building are not consistent and are more than 3/8" between the two, which may cause an individual trip and is, therefore, a safety hazard. Furthermore, this exit does not possess a landing/ramp which is necessary, as this door opens outward.

Ref: 1.1.34 - Rise run improper

Figure 4A - Inconsistent step height

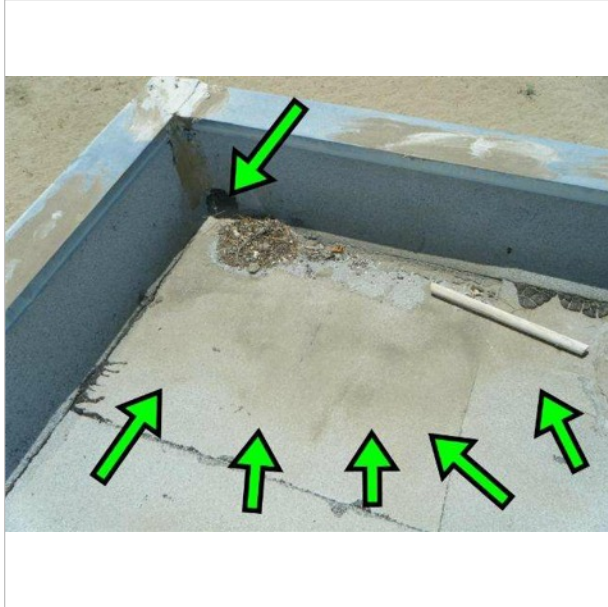
Ref: 1.1.108 - Poor condition

Figure 20A - Ponding

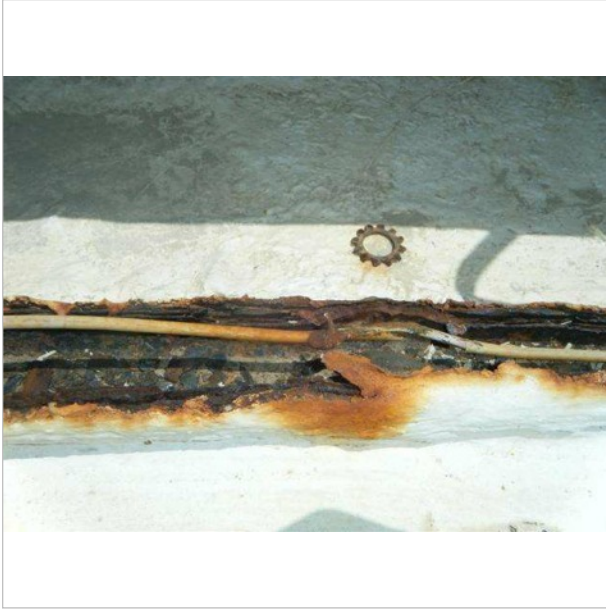
Ref: 1.1.131 - damaged conduit

Figure 28A - Deteriorated conduit

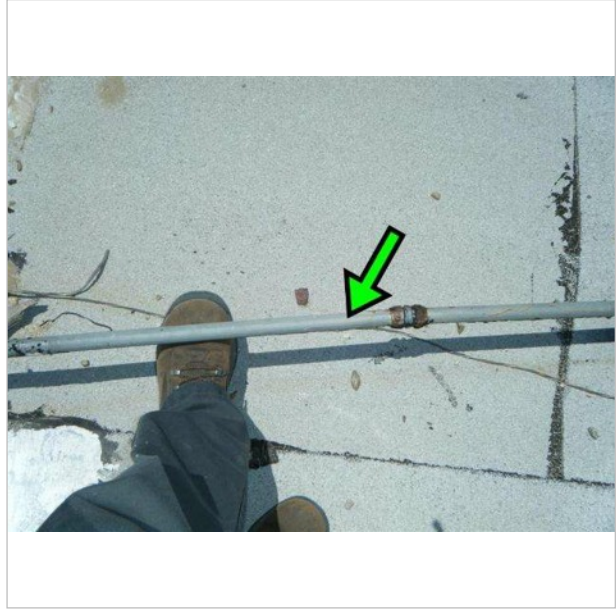
Figure 28B - Not properly secured to deck

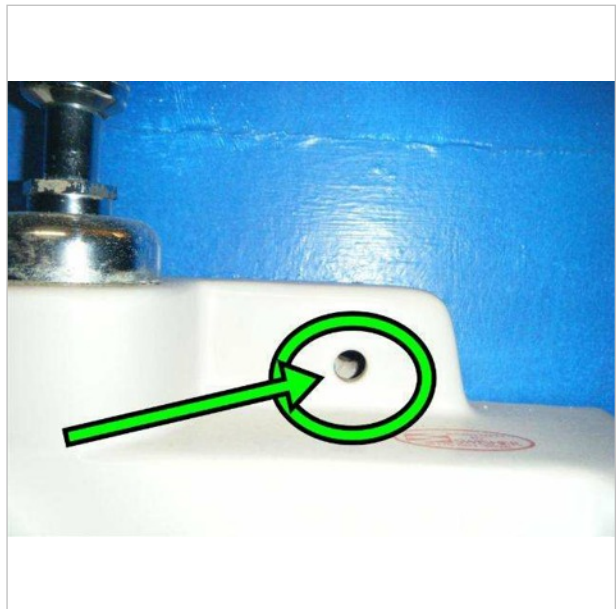
Figure 42B - Missing bolts - urinal
