General Information

The structure is three level commercial building.

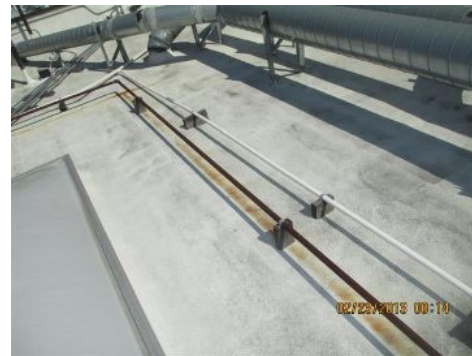
3.1. The rusted fuel lines on the roof are suggested to be painted for protection.

rusted fuel piping observed

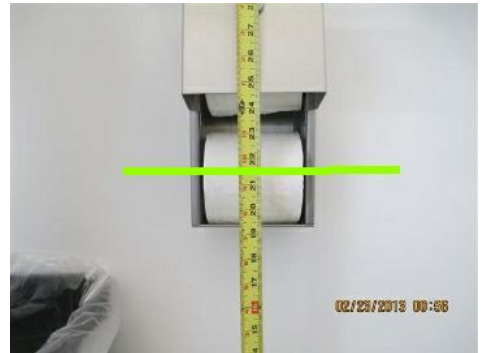
4.1. The fixtures installed in this unisex restroom do not comply with ADA standards.

toilet paper roll too high
