# COMMERCIAL BUILDING INSPECTION REPORT

## SAMPLE REPORT

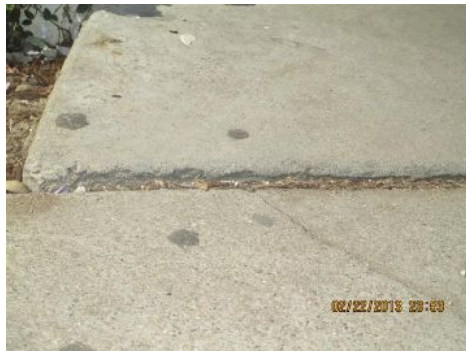
2.2. The sidewalk material was raised and may pose a possible tripping hazard. Caution is recommended in this area.

side walk has raised surface

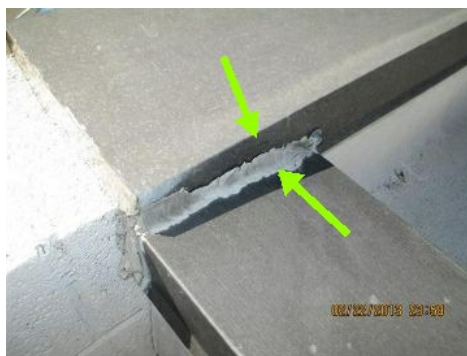
4.4. The parapet wall cap possesses areas which were in need of typical maintenance and requires a mastic or other type of sealant to forestall moisture intrusion.

sealant suggested at the parapet wall cap

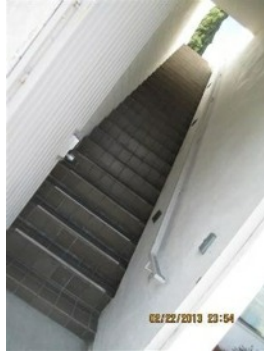
7.2. The stairs present were in generally good condition. We did, however, note that the treads are suggested to possess non skid tread material and the vertical rise of the flight of stairs is greater than 12 feet, which according to current code, is excessive without a landing.

flight of stairs without landing

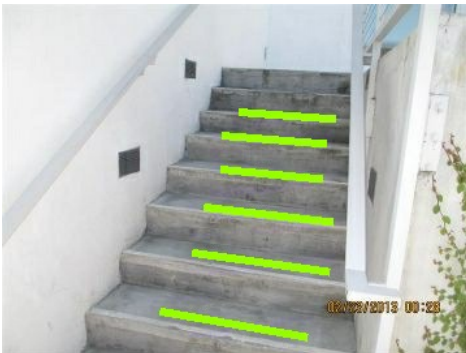
9.1. There were steps that did not have nonskid material at the tread. We recommend the addition of nonskid material as necessary.

steps suggested to possess non slip tread tape

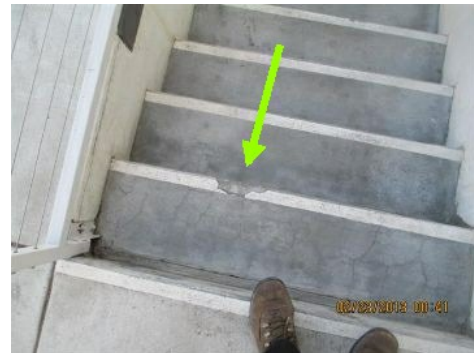
9.2. The steps located at the front of the structure were damaged and are in need of repair as a safety preventative issue. We recommend the further review, advice and services of a masonry contractor.

damaged was observed at the front patio / concrete steps

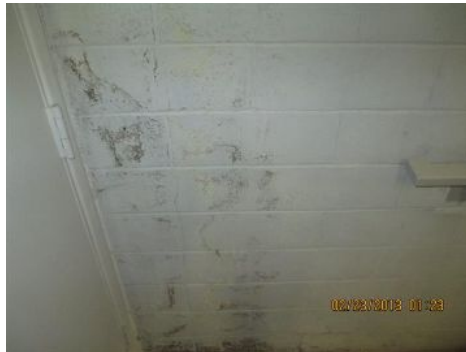
1.1. Cracks were observed in the lower hallway north block. Such cracks may be a result of the curing process, seismic activity, ordinary settling, or the presence of expansive soils. We can elaborate, but you may wish to have a structural engineer confirm this.

cracking was observed in the lower level hallway north block

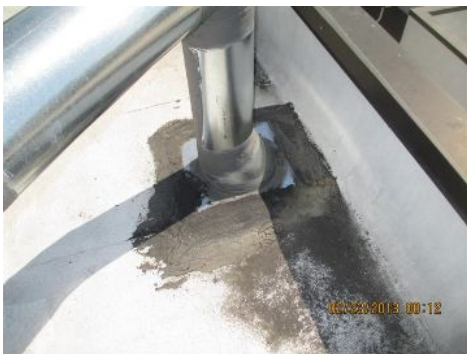
2.2. We observed quite a few duct penetrations into the existing roofing materials. These penetrations are in many cases the source of many leaks if not properly maintained. In light of this finding, we suggest consulting with the roofing contractor present, and inquire as to their recommended maintenance regiment for this condition.

flat roof penetration from ductwork

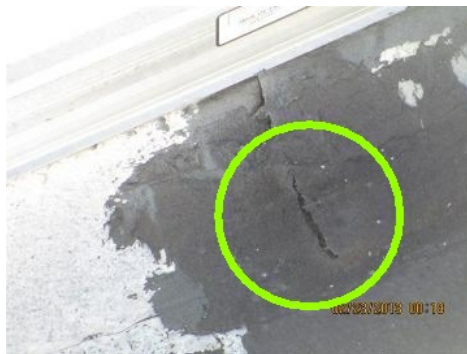
2.4. There are open seams, or splits, in the mineral cap sheet of the parapet walls that should be sealed before the close of escrow, to forestall any possibility of moisture intrusion.

loose materials observed here / sealant is suggested here

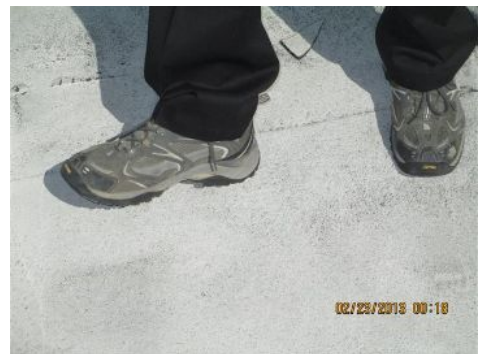
2.1. The roof deck was spongy at the northwest side of the roof. The reason for this condition is not clear as the roofing materials were intact, however, there were no visible indications of moisture damage at this location, from the interior. We cannot, however, see under the roofing material or from the attic as there is no attic at this location. Therefore, the buyer is suggested to monitor this area on a regular basis by a roofing contractor and repaired if any abnormalities is discovered. Infrared scans of the roof surface on an annual basis is recommended to detect any leaks or moisture beyond the surface.

spongy area observed in flat roof covering material

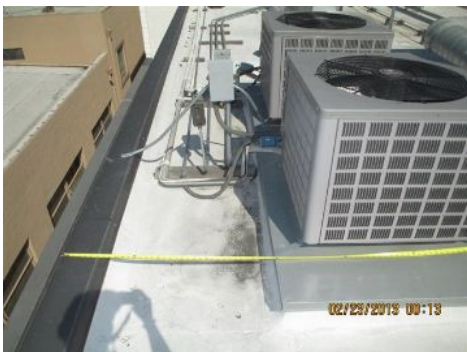
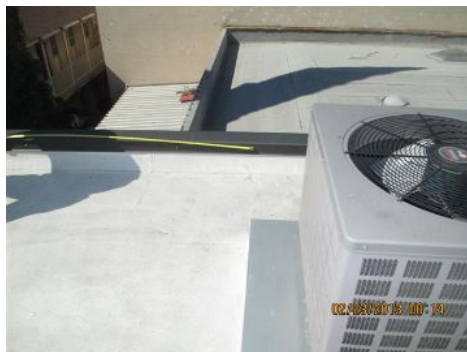
1.1. In accordance to current building standard, the mechanical components on the roof are suggested to possess railing / barriers within the current building standard setback to any / all mechanical equipment located on the roof deck.

1013.5 Mechanical equipment.  
Guards shall be provided...

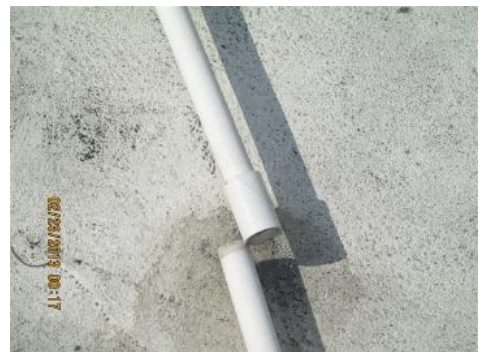
disconnected condensate drain piping

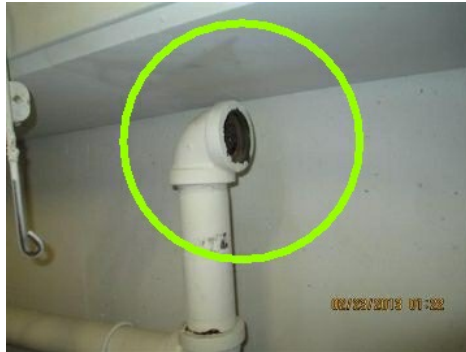
2.1. The DWV piping located in the lower level cage is missing a clean out cover.

drain or vent piping located in the low level locker missing cover

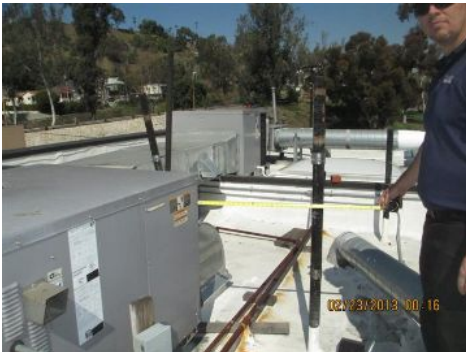
3.1. We observed DWV vent stacks at the roof level which were damaged and in some cases, too short within the listed proximity to the mechanical package forced air units.

DWV too short in close proximity to package HVAC unit

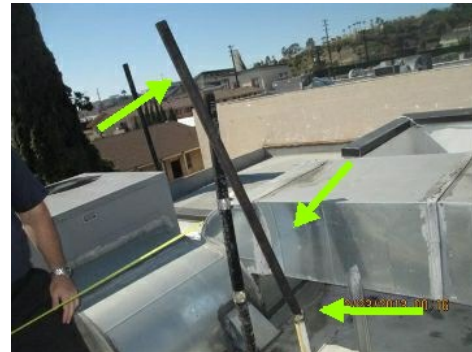
damaged and loose DWV piping

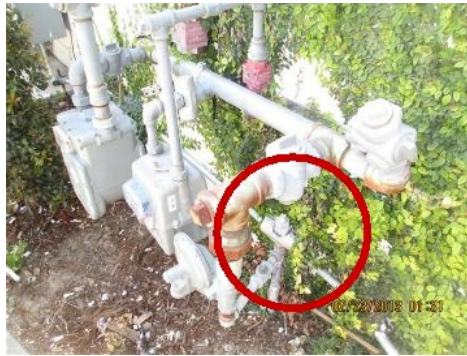
2.1. The gas is off at the main. The gas company will turn it on and safety check all of the gas appliances, but this should be scheduled within the inspection period so that you could be alerted to any potential deficiencies or recommended upgrades that could affect your evaluation of the property. At the time of the inspection, all appliances which use gas as fuel were not tested. Appliances such as water heaters, ranges, ovens, furnaces, pool heaters or barbecues.

fuel meter was terminated

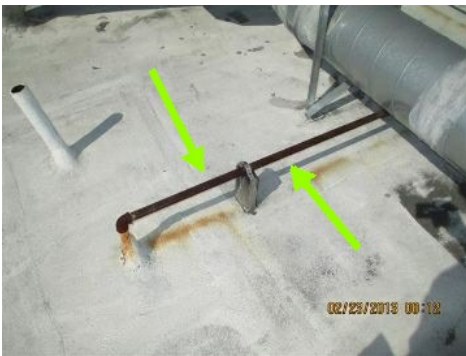
3.1. The rusted fuel lines on the roof are suggested to be painted for protection.

fuel piping is rusted suggested to be painted

rusted fuel piping observed

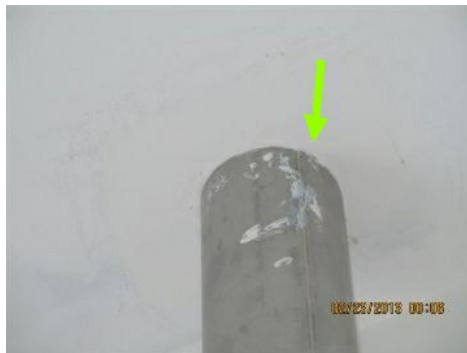
1.1. The vent pipe of the gas water heater is too close to combustible material (wood, drywall, ductwork & insulation), and should be serviced. A singlewalled vent pipe should be six inches away from any combustible material, and a doublewalled vent pipe (and transite) should be one inch away.

vent too close to combustibles

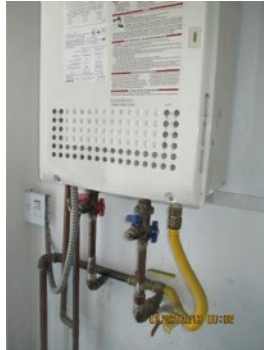
3.1. There was a tankless water heater present on site. A tankless water heater was installed. We therefore suggest that the buyer contact the local building and safety department to see if permits were obtain for the installation of this element.

this building is served by a tank less water heater

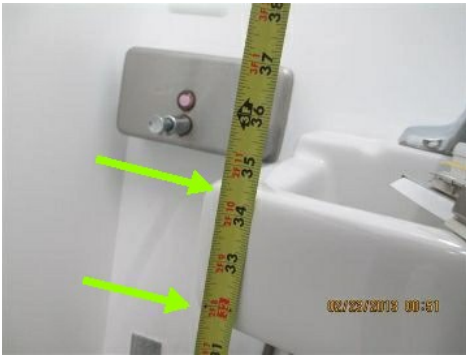
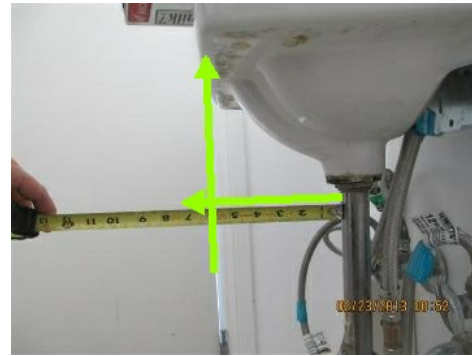
1.2. The lavatory installed, although functional, does not appear to comply with ADA requirements.

29 / 34 inch clearances are not met here

clearances of lav not met here

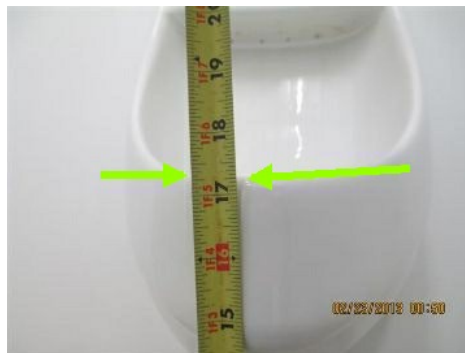
3.1. The urinal installed although functional, does not appear to comply with ADA requirements.

17" max

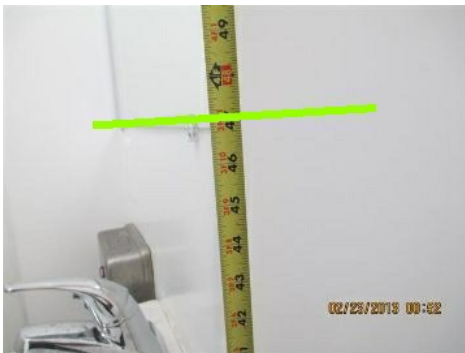
4.1. The fixtures installed in this unisex restroom do not comply with ADA standards.

mirror is too high

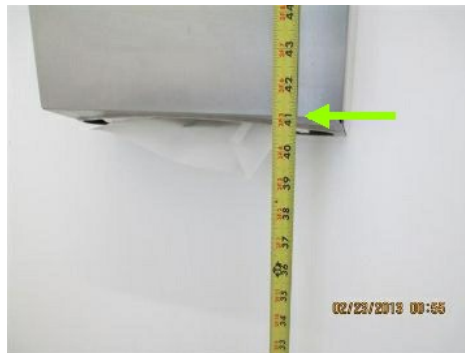
paper towel dispenser is too high

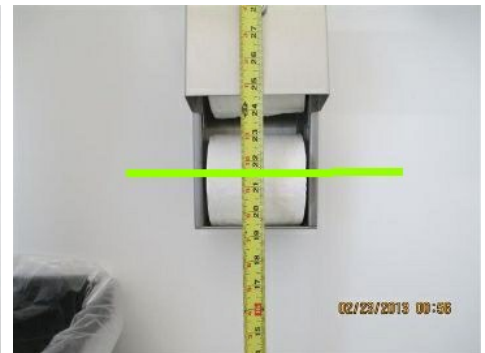
toilet paper roll too high

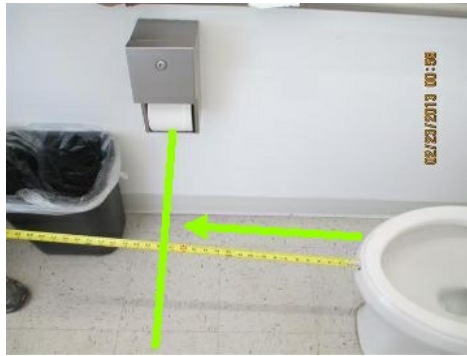
5.1. Although the toilet was functional, the toilet did not comply with ada requirements.

toilet paper roll holder to far from toilet
