COMMERCIAL BUILDING INSPECTION REPORT

SAMPLE REPORT

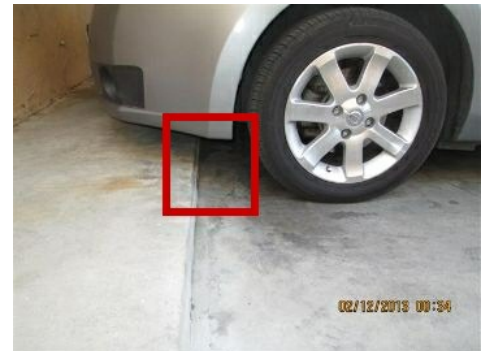
- 1.1. The asphalt driveway shows evidence of wear that includes large cracks, raised or settled surfaces, which can accelerate or hasten the life and deterioration of the driveway surface. Sealant and regular maintenance is recommended. The parking spaces may require re striping.
- 1.2. Parking blocks are recommended in various locations as a safety precautionary measure.
- 1.3. The poles which support the carport roof are suggested to be taped with reflective tape.
- 1.4. No ADA handicap compliant parking stalls were observed in the rear parking lot.

reflective tape suggested on poles

parking blocks suggested

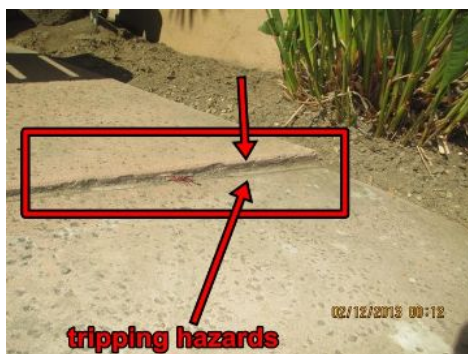
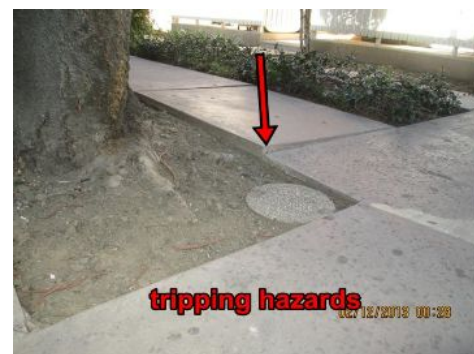
- 2.1. Cracks were noted at the walkways. This implies that movement has occurred. Sealant is recommended on the sidewalks to prevent further damage and performed on a regular basis to prevent extended wear. We recommend that this condition be monitored and further evaluated by a qualified contractor if any sign of significant movement is observed.
- 2.2. The sidewalk material was raised and may pose a possible tripping hazard. Caution is recommended in this area.

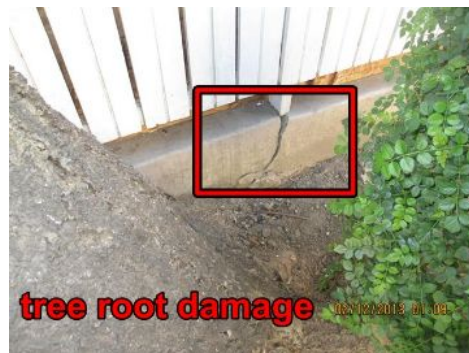
3.1. Tree roots were noted close to the patio surface material in building one. These roots appear to be causing damage to the patio which creates a possible trip hazard. Corrections for safety are recommended.

South side patio damaged from tree roots

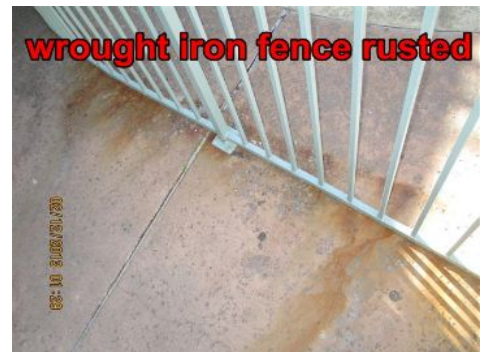
5.1. The wrought iron fence was observed to have areas of rust. Proper surface preparation and painting are necessary to prevent further / future deterioration. In some cases, wrought iron components may have to be replaced.

5.2. Loose and / or disconnected wrought iron fencing was noted where the fence is connected into the wood patio fence system. Reinforcing the area where the attachment is loose is suggested.

damaged / rusted wrought iron
fencing

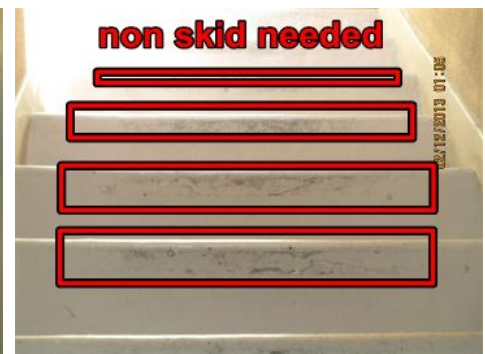
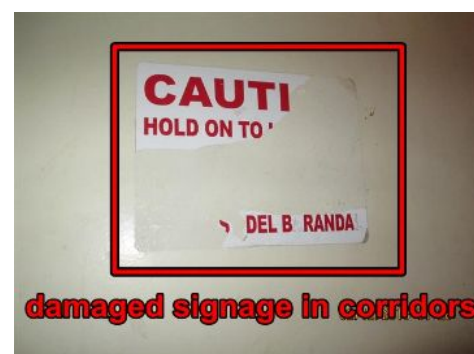
9.1. The lower landings are suggested to be re inspected for proper drainage. This area of stairwells, #1 and #4, poses a slip hazard, should it collect moisture.

9.2. Signage was observed damaged in multiple stairwells and corridors. In some corridors, signage was non existent.

9.3. The steps throughout the stairwells within all of the corridors collectively are all suggested to possess non skid tape at the foot of the tread as a safety precautionary measure.

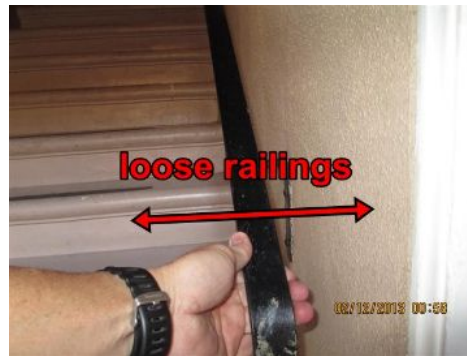
10.1. Loose handrails were observed in various stairwells. As a safety precautionary measure, the railings are suggested to be tightened firmly against the wall.

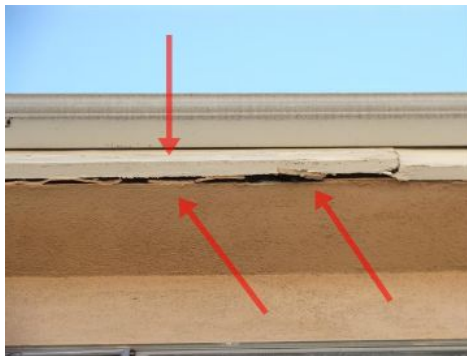
2.2. There were areas where the paint / finish was observed to be generally fair condition with signs of weathered and/or deteriorated at the exterior. Regular maintenance type service is required to decrease the possibility of premature damage.

trim requires service

2.1. Sealant is needed at various areas around the exterior trim to exterior wall connections as preventative maintenance and to prevent the possibility of moisture penetration or damage.

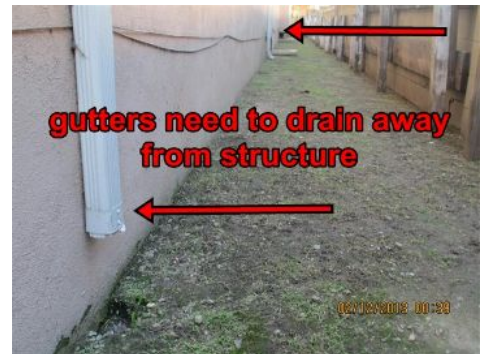
5.2. There was damage observed at the south downspout. Repair or replacement is suggested to allow for adequate drainage.

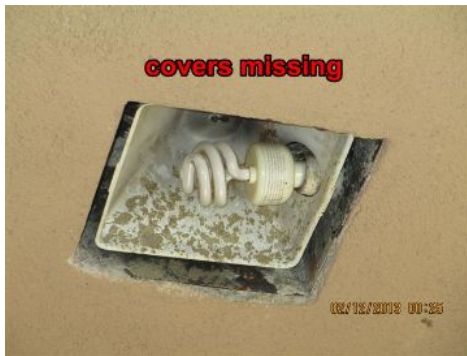
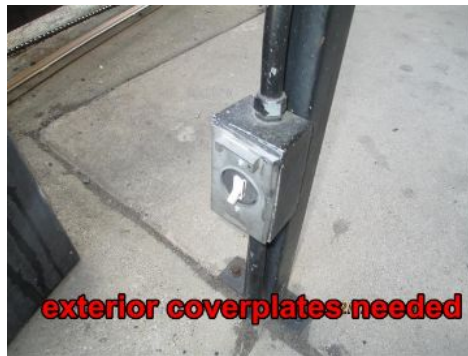
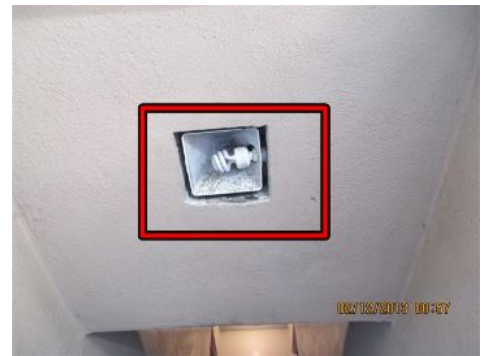
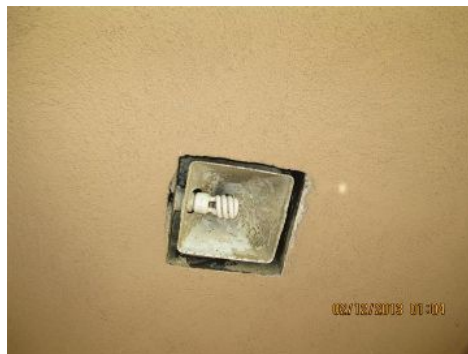
7.1. The wall switch (building #2) is not rated for the exterior and, is therefore, suggested to be replaced. For a more indepth examination of this condition, we suggest further assessment and advice by a qualified electrician prior to the close of this escrow.

7.2. The light fixtures at corridors #1 and 3 were damaged.

7.3. There were missing light globes located at the exterior of the structure. Locations include corridors #4,6,7,8.

7.4. Sealant is recommended around the exterior light fixtures to wall connection(s).

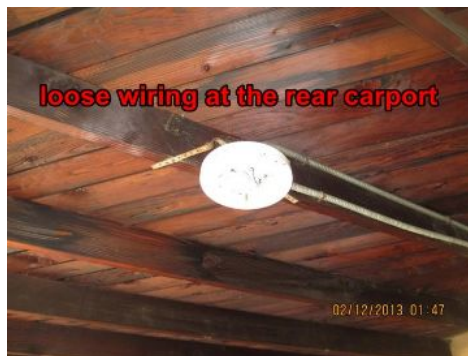
8.1. Exposed romex conductors were observed within reach and in harms way at the east of the structure, carport. This material is recommended to be installed into exterior rated conduit for protection. All work is recommended to be performed by a qualified electrical contractor.

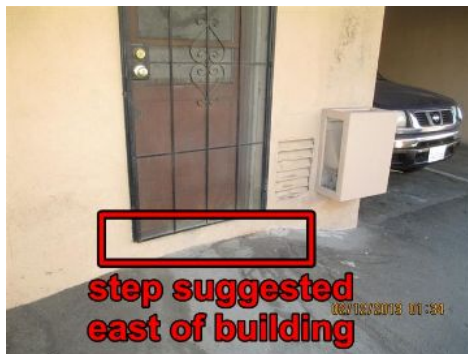
11.1. It is suggested that the door at the back of the laundry room possess a step. Currently a steel screen door is installed with a double cylinder deadbolt, which is an inherent hazard in and of itself.

east rear door / suggested step

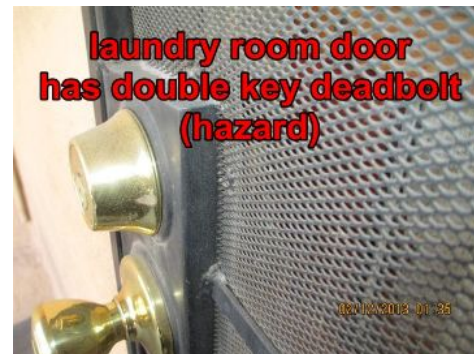
steel screen possesses a double cylinder deadbolt hazard

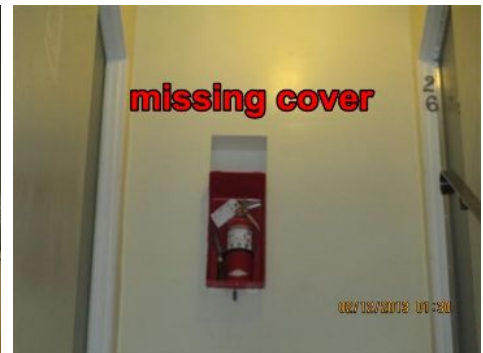
13.1. We observed fire extinguishers which were obstructed.

fire extinguisher blocked

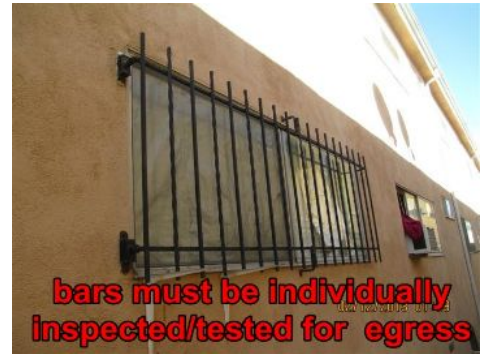
14.1. There were windows around the perimeter which possess security bars. These bars pose a potential hazardous condition if they fail to operate. In light of this condition we suggest the window bars be tested individually for correct operation and in accordance to CFC, California Fire Code section 1029.4 Operational constraints. Emergency escape and rescue openings and any exit doors shall be maintained free of any obstructions other than those allowed by this section and shall be operational from the inside of the room. Bars, grilles, grates or similar devices are permitted to be placed over emergency escape and rescue openings provided the minimum net clear opening size complies with Section 1029.2 and such devices shall be releasable or removable from the inside without the use of a key, tool, special knowledge or effort or force greater than that which is required for normal operation of the escape and rescue opening. Where such bars, grilles, grates or similar devices are installed, smoke alarms shall be installed in accordance with Sections 907.2.11 regardless of the valuation of the alteration. The release mechanism shall be maintained operable at all times. Such bars, grills, grates or any similar devices shall be equipped with an approved exterior release device for use by the fire department only when required by the authority having jurisdiction.

bars need to be functional

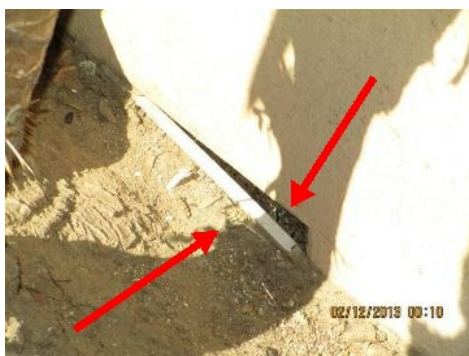
foundation vents on grade

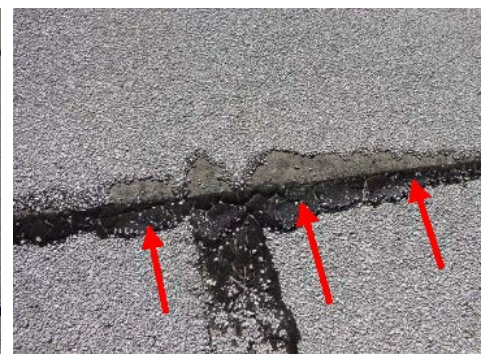
missing material at seams

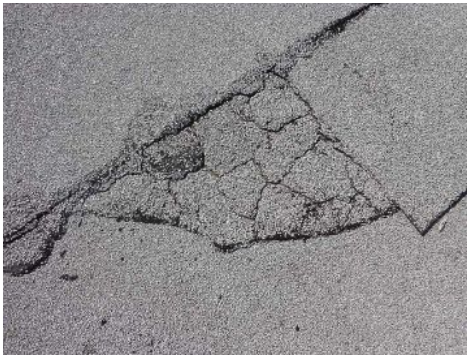
cracked/damaged material

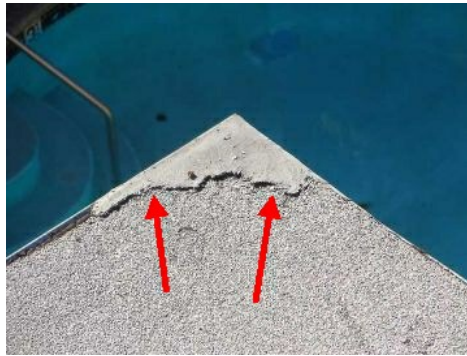
patch material at edges

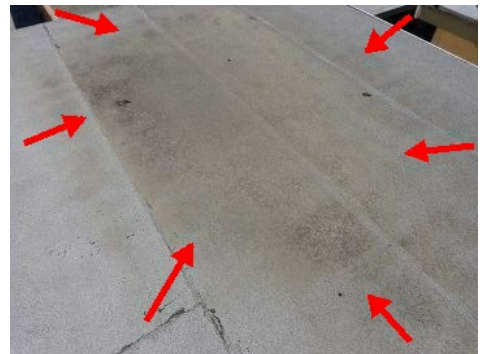
5.3. Water appears to pond on the roof membrane and in some areas, debris collects and holds moisture close to the deck. Ponding shortens roof life and increases the potential for damage if leaks occur. These areas are suggested to be monitored during the rainy season and when re roofing, the roof should be appropriately sloped. It should be noted that there were both areas that were dirty and indicated ponding and areas that actually held water and are currently ponding.

past ponding common at roof

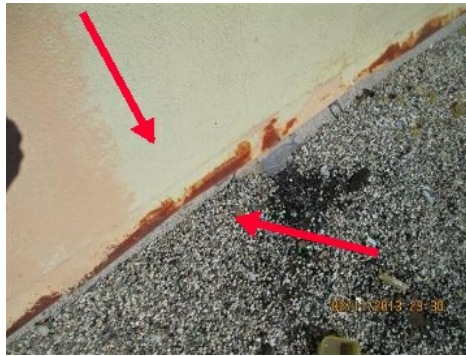
6.1. We observed rusted flashing located on the roof deck. Typically, these flashings and / or vents would have been replaced during the replacement of the roof covering materials. We suggest protecting these vents with paint.

rusted flashings

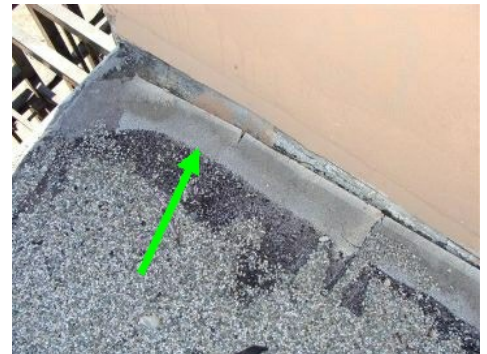
deteriorated surface missing
ballast

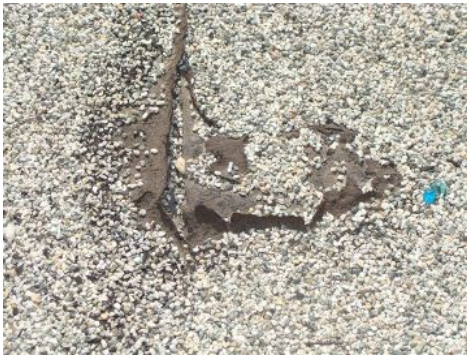
deteriorated surface missing ballast

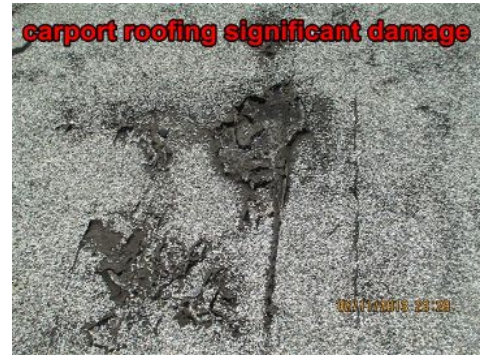
carport roofing significant damage

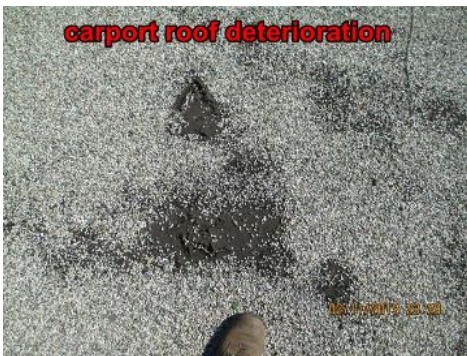
carport roof deterioration

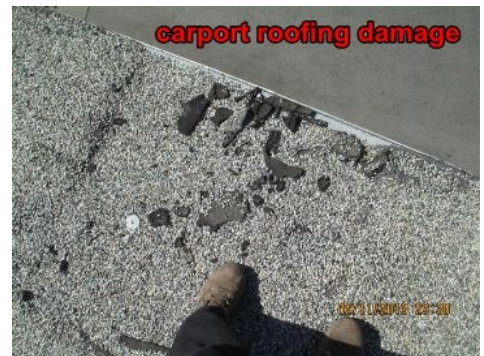
carport roofing damage

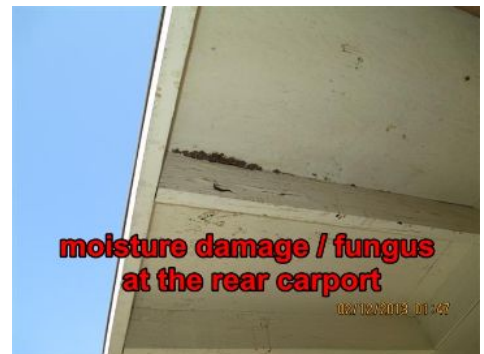
moisture damage / fungus at the rear carport

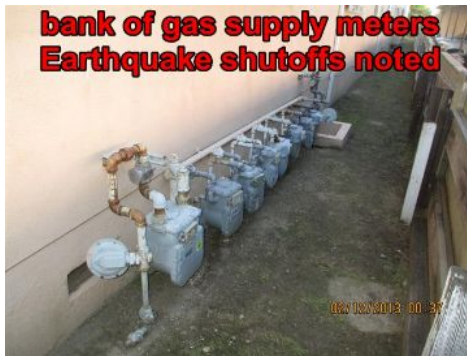
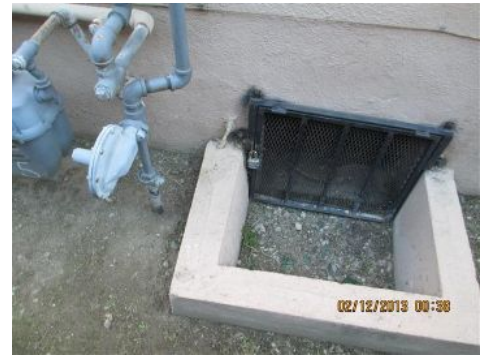
fuel meter regulator close to foundation vent/opening

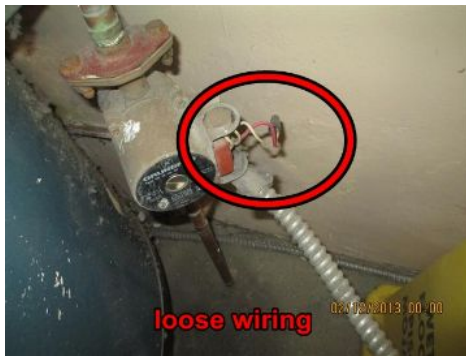
recirculator wiring loose

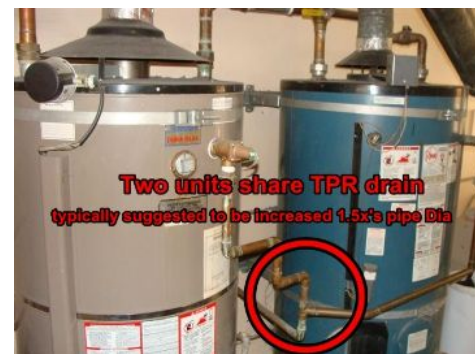
3.1. The TPR drain for unit B was damaged, thus restricting the flow when necessary. The combination of both A and B together, suggest the need to have the main drain for the TPRs to be a larger diameter in accordance to industry standards.

TPR drain suggested to be a larger DIA.

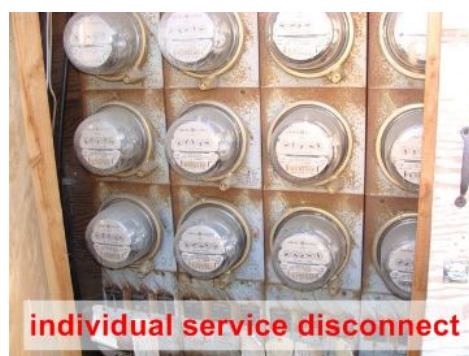
service disconnects are very easily accessible and pose a real and present danger

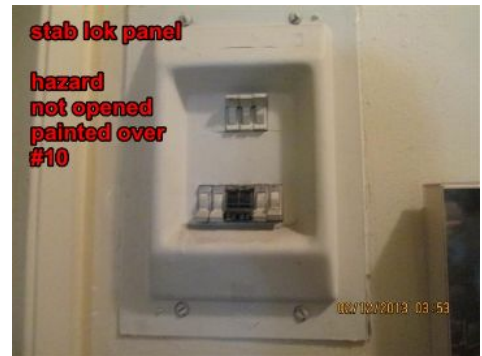
Stab lok panel inherent hazard not tested/opened

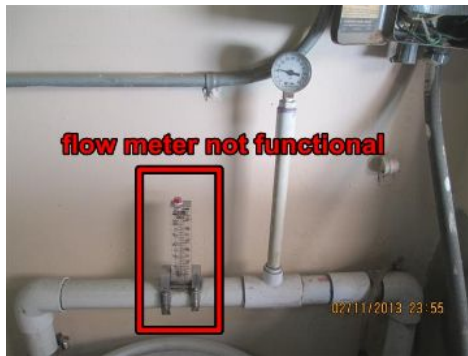
flow meter was not functional

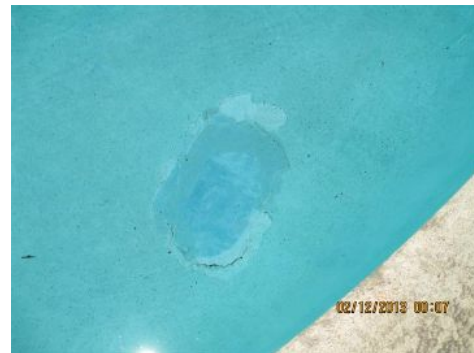
6.1. The pool interior finish is older, in poor condition and displays evidence of heavy wear consistent with age, use, chemical impregnation and etching. In general, unless there is substantial loss of material creating issues with the filtration system or holes in the plaster exposing rebar or unite, the shell can be improved when the finish becomes aesthetically intolerable.

damaged / deteriorated plaster finish

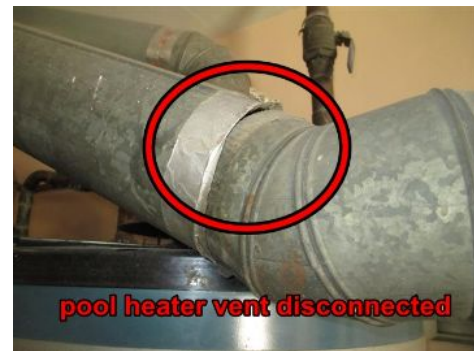
17.1. The swimming pool heater is old, obsolete and is suggested to be removed.

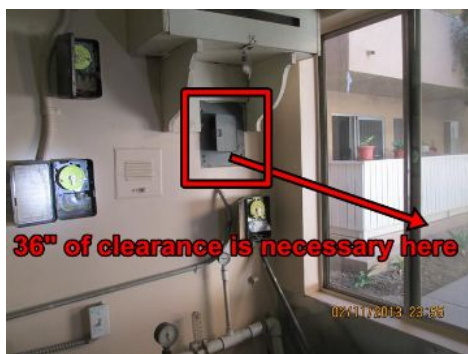
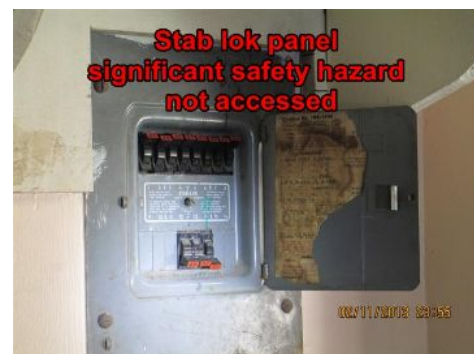
18.1. The control panel does not have thirty-six inches of clear space in front of it to facilitate an emergency disconnect, in case of an emergency. This is a condition which should be corrected. This panel is a stab lok panelboard.

stab lok panel noted inherently a hazard

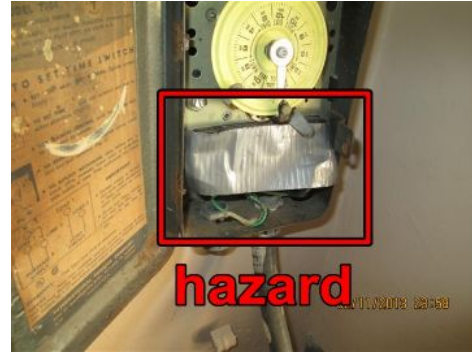
19.2. The pool timer is loose and poses a potential hazard. We recommend the further review, advice and services of an electrician.

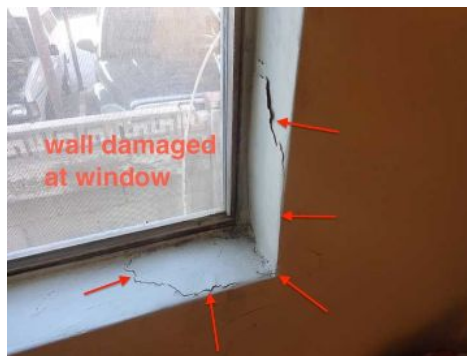
7.3. Damaged drywall was noted in the at the window in the common bedroom.

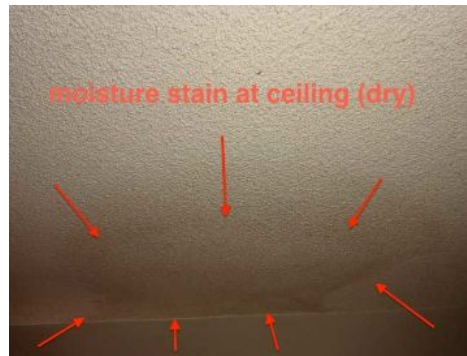
8.4. Moisture staining was observed on the master bathroom ceiling at the time of the inspection.

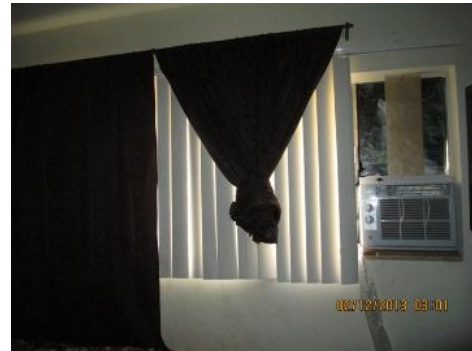
5.3. There is an A/C unit installed in the window of this unit.

ac unit in window subject to moisture intrusion

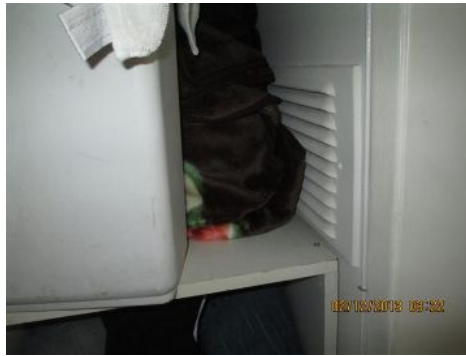
1.1. The wall mounted heater was not operational when tested by use of normal controls. The vents are blocked.

occupants belongings present a hazard

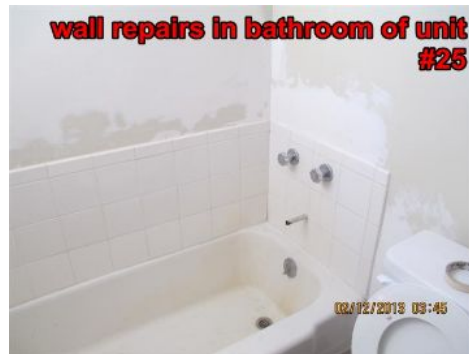
7.3. Evidence of prior repairs / patching was observed at the interior walls. Further investigation may be desirable as to the reason for the patching / repairs.
