COMMERCIAL BUILDING INSPECTION REPORT

SAMPLE REPORT

PROPERTY INSPECTION REPORT

1234 Street City, Zip

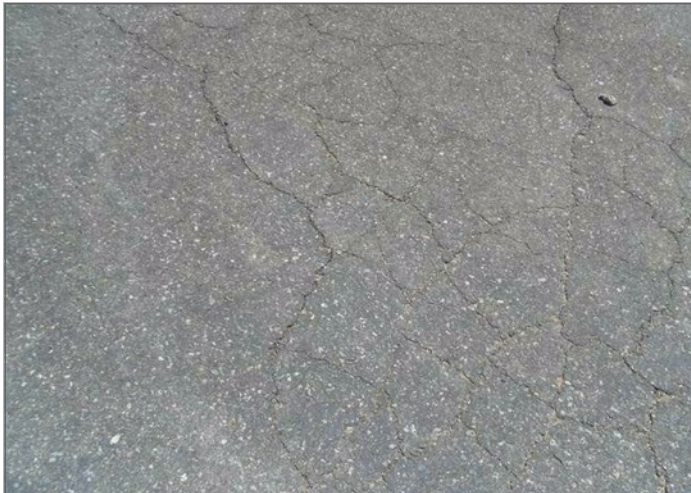
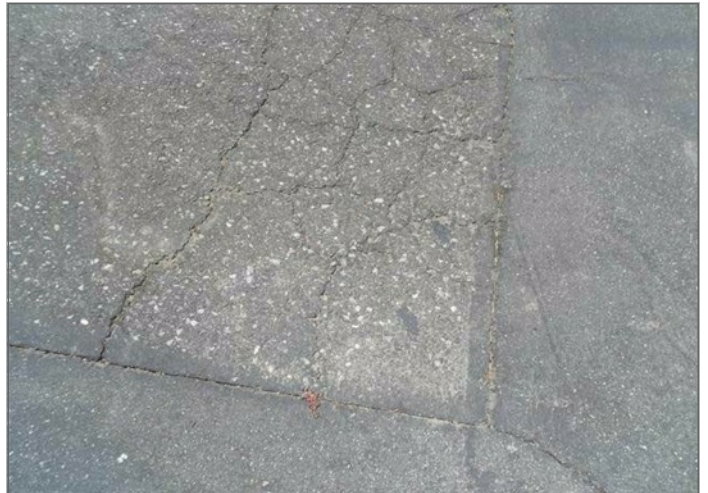
1.2 - The asphalt driveway shows evidence of excessive wear that includes large cracks, raised or settled surfaces, which can accelerate or hasten the life and deterioration of the driveway surface. Sealant or slurry re seal may be necessary to prolong the overall condition of the material and reduce deterioration.

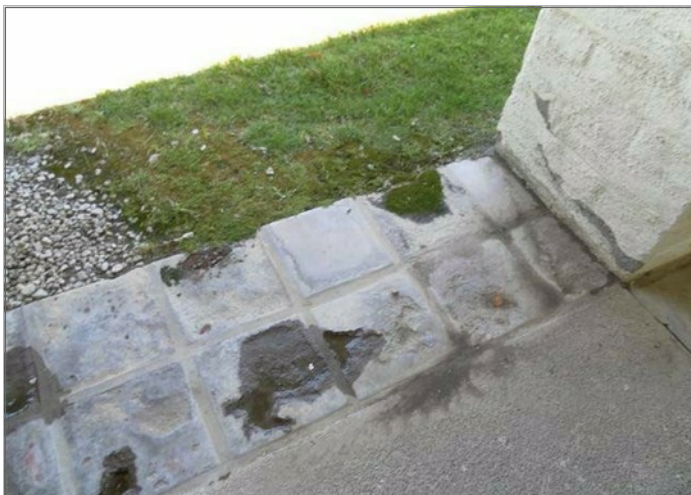
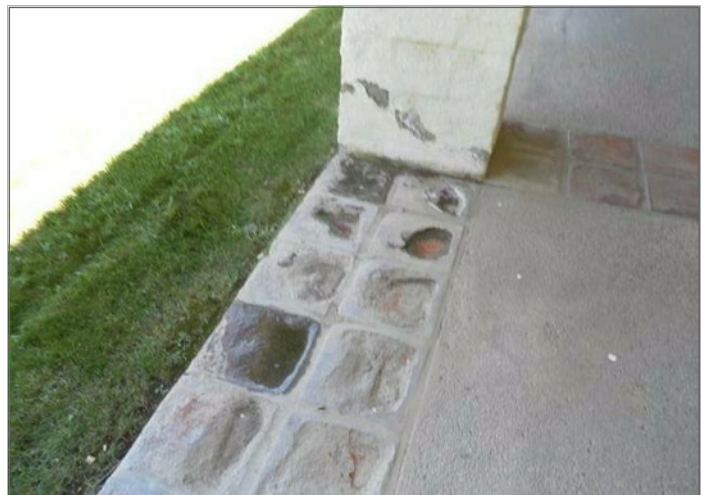
1.6 - The front clay pavers appear to be subjected to over watering, poor drainage and deterioration.

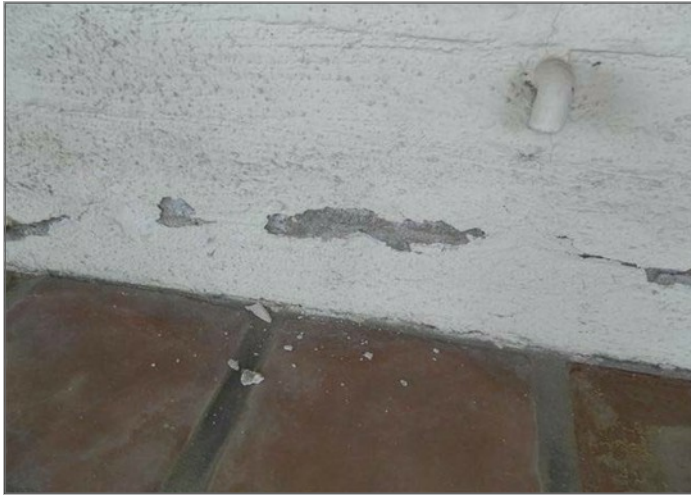
1.26 - Surface deterioration (spalling, crumbling material) was observed at the exterior walls. This condition is common in many old homes and does not usually represent a serious structural concern unless there is substantial loss of material. In an effort to prevent long term deterioration, it would be wise to consider parging (a concrete stucco-like coating) over deteriorated areas. Sprinkler and lot drainage improvements and elimination of water or roof runoff splashing against foundation walls can reduce possibility of damage deterioration.

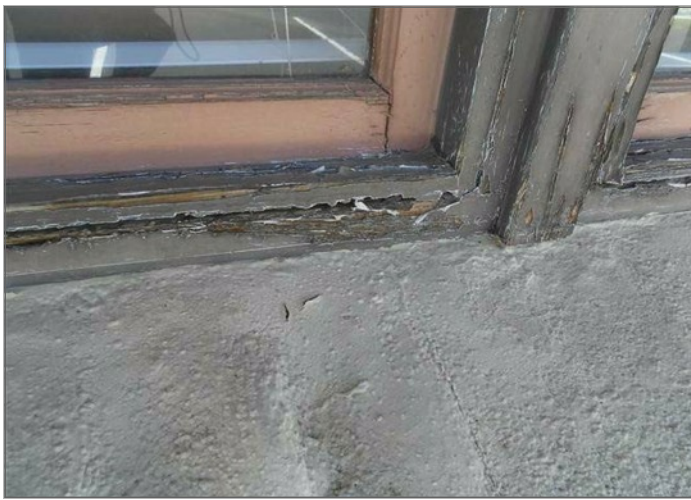
1.33 - There were areas where the paint / finish was observed to be generally fair condition with signs of weathered and/or deteriorated at the exterior. Regular maintenance type service is required to decrease the possibility of premature damage.

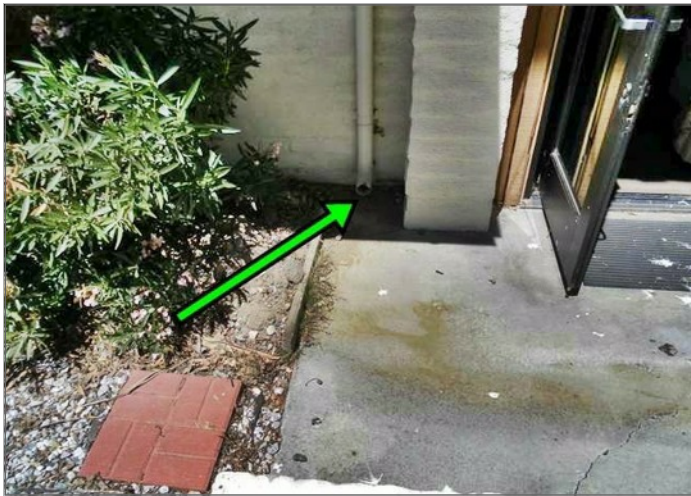
1.40 - Note: We recommend routing all of the downspout(s) away from the structure, or installing the downspout directly into the subsurface drainage if present. The downspout(s) should discharge water at least five (5) feet from the house or drain into existing sub surface drainage. Storm water should be encouraged to flow away from the building at the point of discharge.

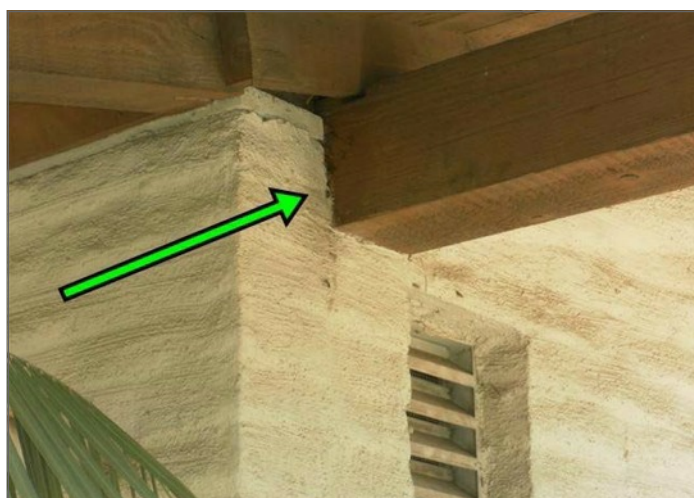
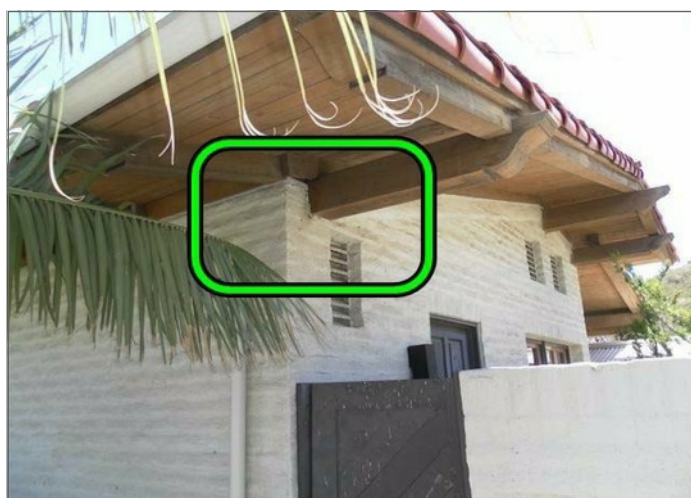
1.45 - A bee hive was observed at the northwest side of the structure. The inspection in this location is limited as a result.

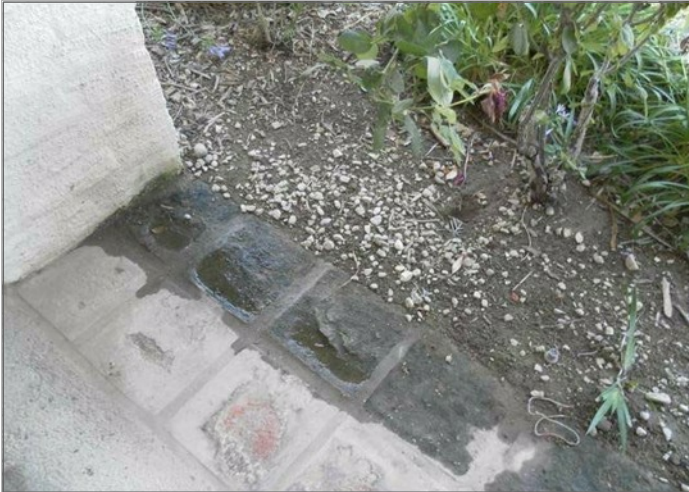
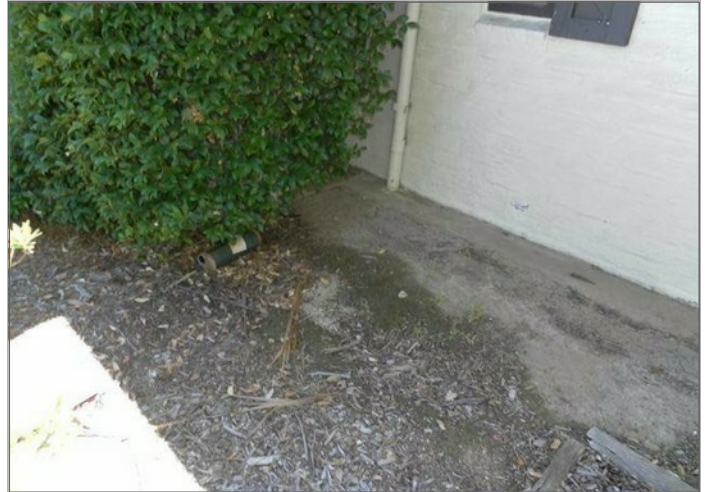
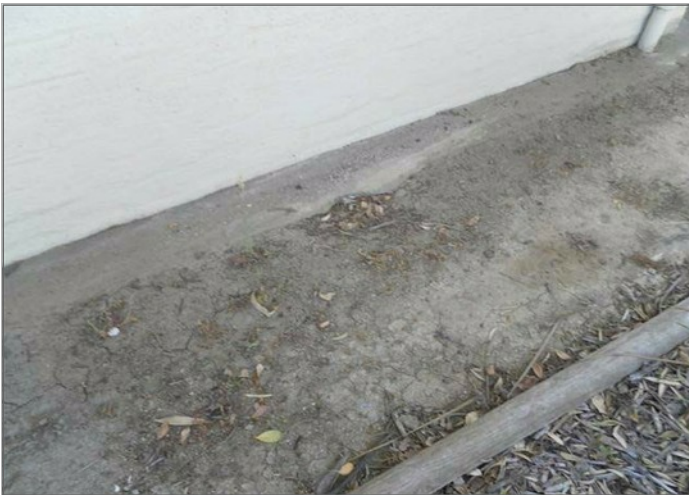
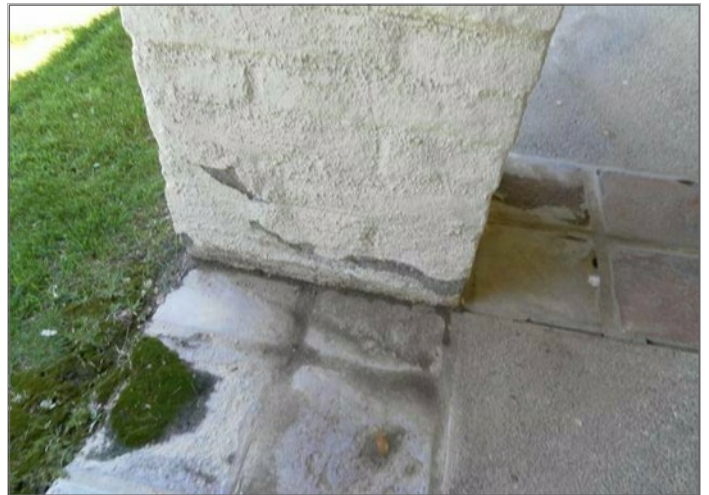
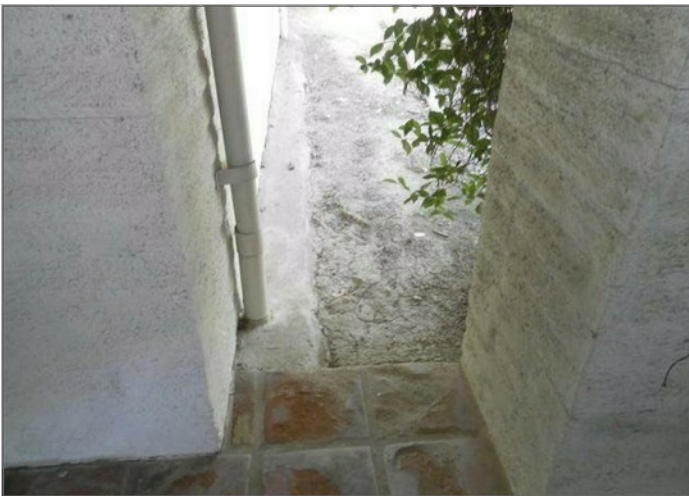
2.4 - Just as the roof is sloped to shed water, the ground around your home should be sloped too. This house possesses areas which are either negatively sloped or evenly sloped from the foundation. A slope away from the house of about 1/4 inch per foot near the walls is usually adequate. Slope the ground to carry water away from the downspout discharge, as well, and make sure the soil on the surface next to the house has low permeability to reduce infiltration.

2.5 - Grading and drainage plays a crucial role in the longevity and performance of the foundation. This grading in some areas is neither negative nor neutral adjacent to the residence, and moisture intrusion will remain a possibility. The soil or the hard surfaces should slope away from the residence to a distance of at least 10 feet, to keep moisture away from the footings. We could elaborate on this issue further, but you should seek a second opinion from a grading and drainage contractor to understand the potential risks involved with having a house on a slope combined with poor drainage.

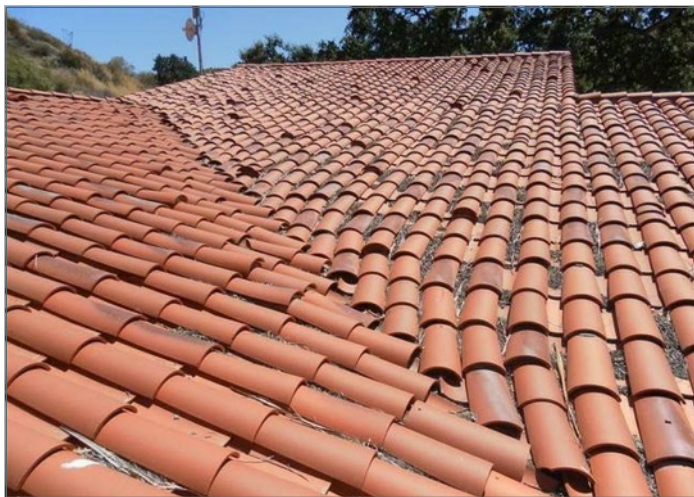
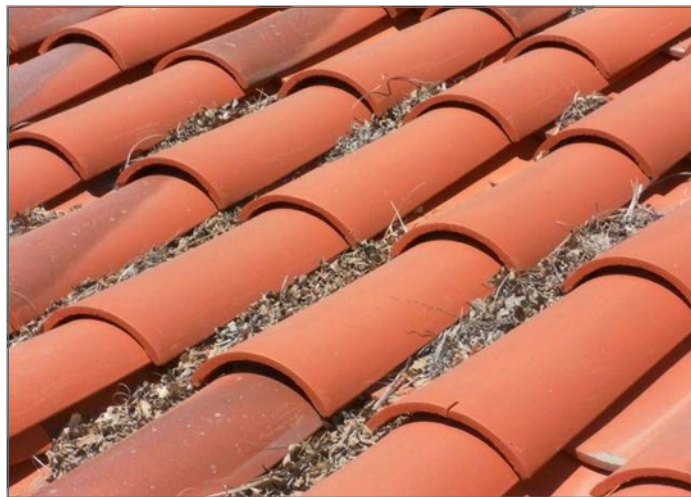
3.4 - Debris was observed on the roof deck, which should be removed to reduce the possibility of premature deterioration of the roofing materials.

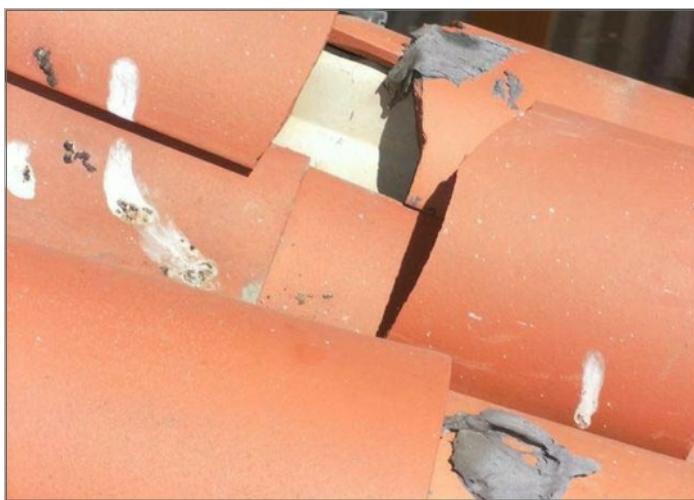
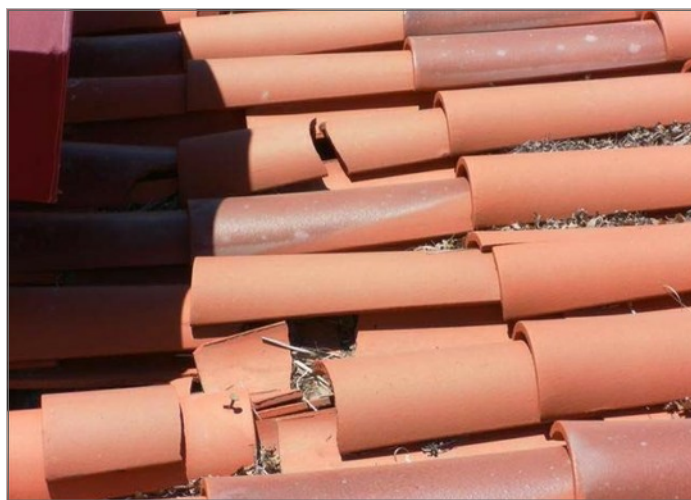
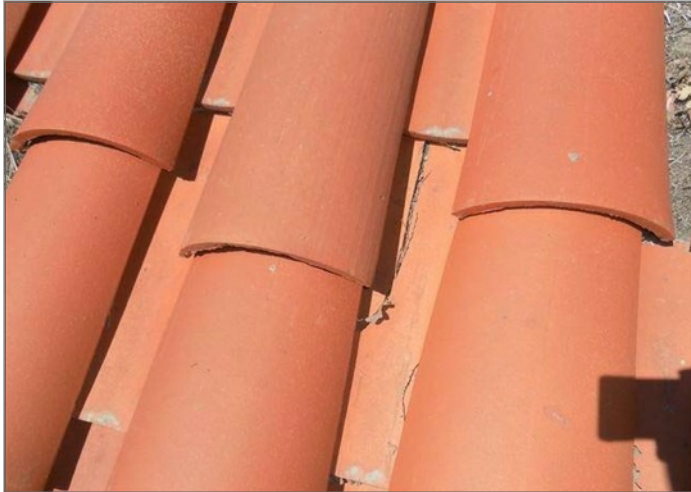
3.5 - There are a number of cracked or broken tiles that should be serviced. The entire roof is suggested to be inspected and improved, as necessary, by a professional roofing contractor prior to occupancy.

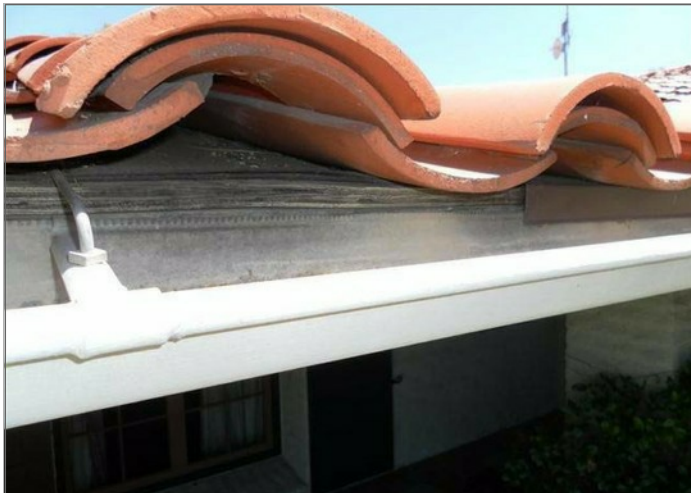
3.6 - There was no bird stop flashing observed around the perimeter of the roof structure. Due to the year of the structure, bird stop flashing may not have been commonly used but is suggested as an improvement.

3.7 - There was no drip edge flashing observed around the perimeter of the roof structure. Due to the year of the structure, drip edge flashing may not have been commonly used but is, however, suggested as an improvement. There was, however, moisture damage observed at various locations of the lower roof sheathing where unprotected.

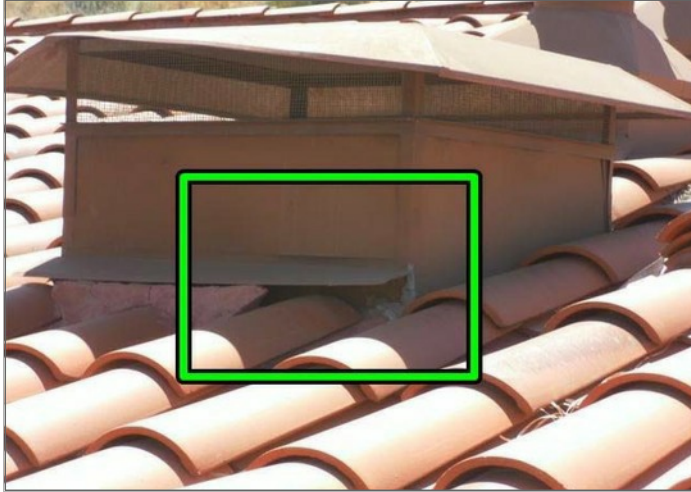
3.9 - Parging, the replacement or installation of masonry material as a protectant is suggested where missing below the front apron flashing. This material is suggested to maintain the water tight integrity of the roof structure.

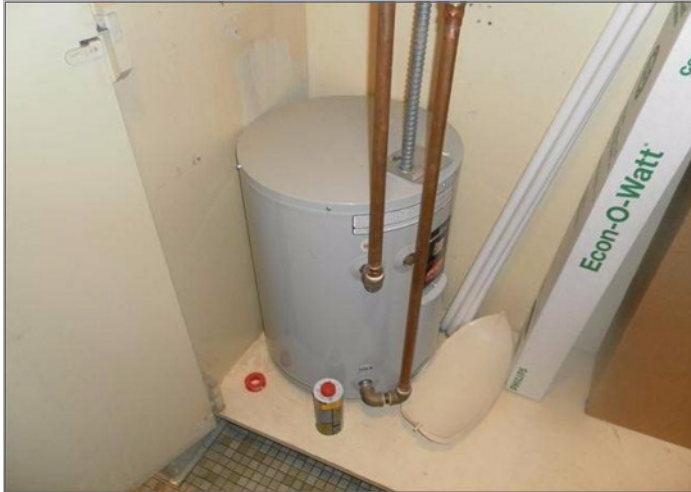
5.17 - Seismic straps were not installed at this water heater. Water heaters in seismic zones should be anchored or strapped at the upper and lower 1/3 portions of the unit with proper straps to resist movement during earthquake conditions.

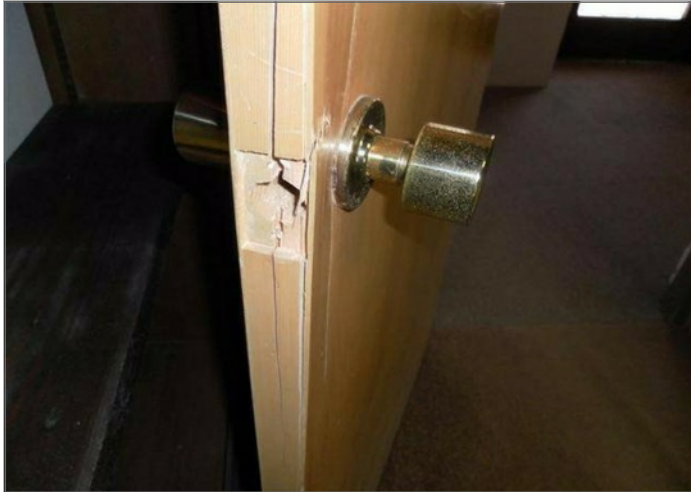
7.3 - The interior doors were functional with signs of moderate wear and tear common for the age of this structure. Such wear and tear may include, but not limited to discoloration, loose and missing hardware, repairs or patches, holes/cracks in doors, difficulty latching and rubbing at the floor or frame. Many of the passive vents installed into the doors were covered. These vents allow for ventilation as well as allowing conditioned air to move throughout the structure.

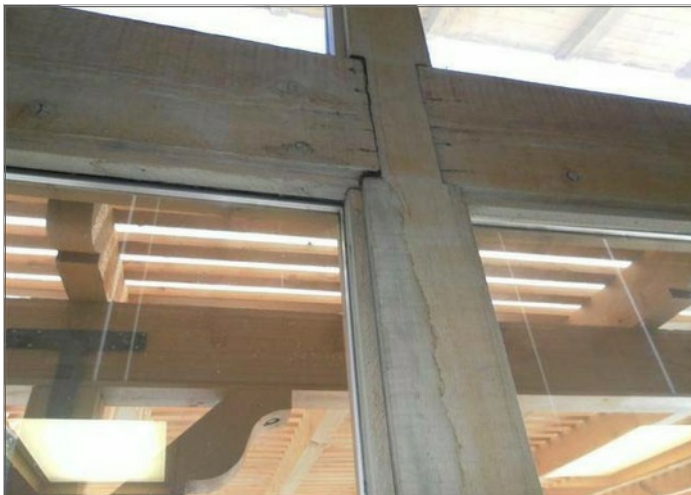
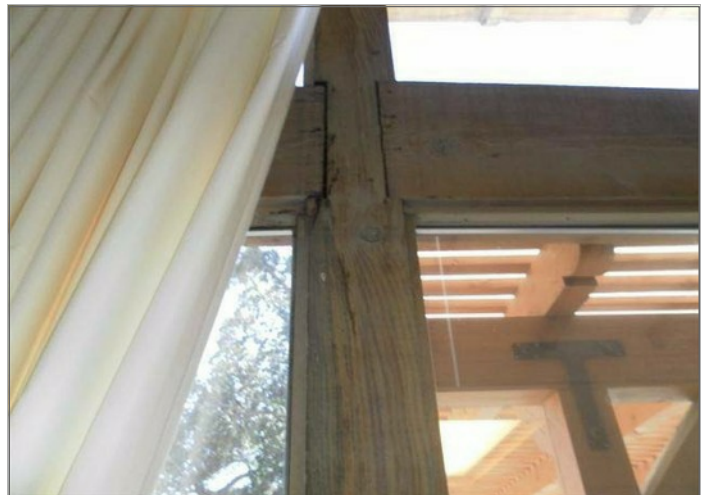
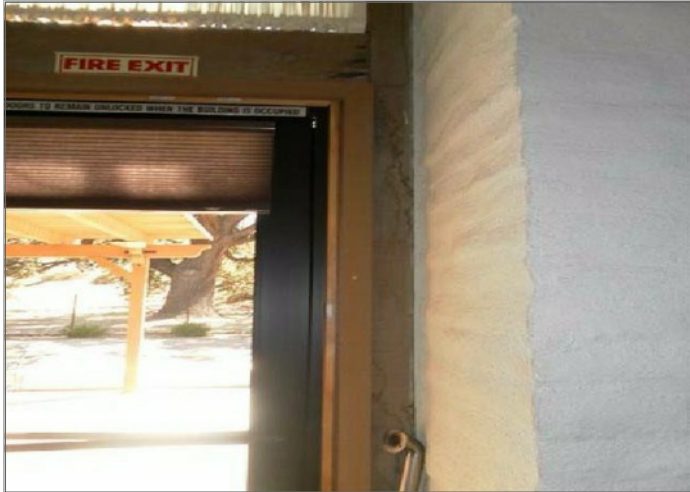
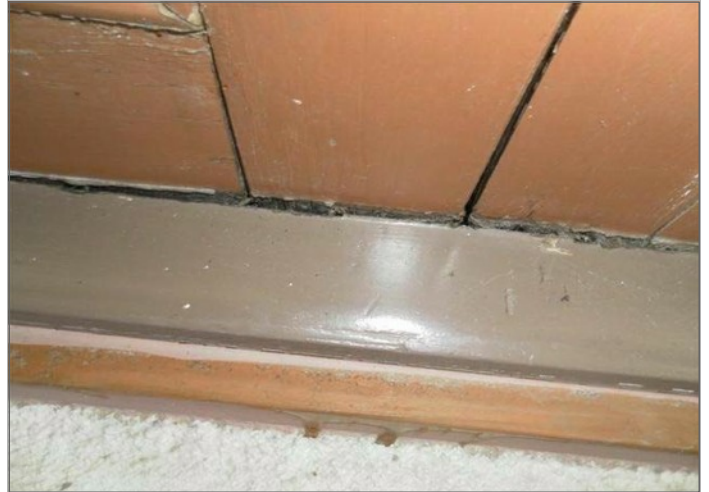
7.7 - The windows present were fixed and non operational. We did observed what appears to be moisture staining and possible intrusion at various window sills and frames.

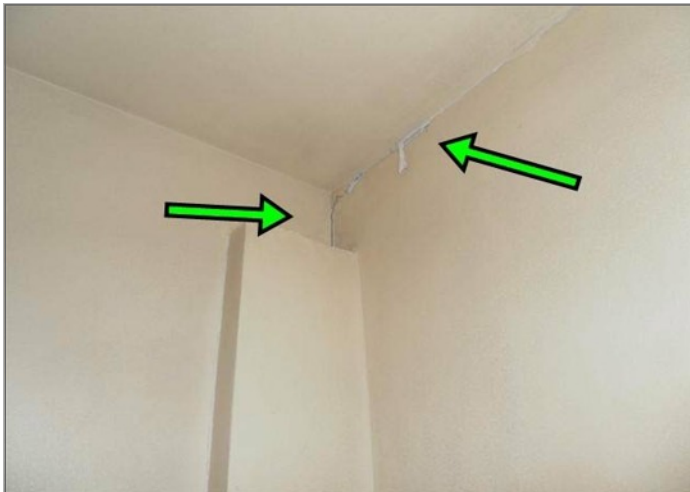
7.8 - Cracks were noted at the interior walls. These cracks suggest that some type of movement within the structure has occurred. It is well beyond our scope as well as our expertise to attempt to draw a definitive conclusion as to the cause of these cracks without additional investigations which may include destructive testing. In light of these findings, we must suggest the buyer employ the services of a contractor who is familiar with structural movement and cracking. At the very least, the buyer should monitor the cracks for further movement.

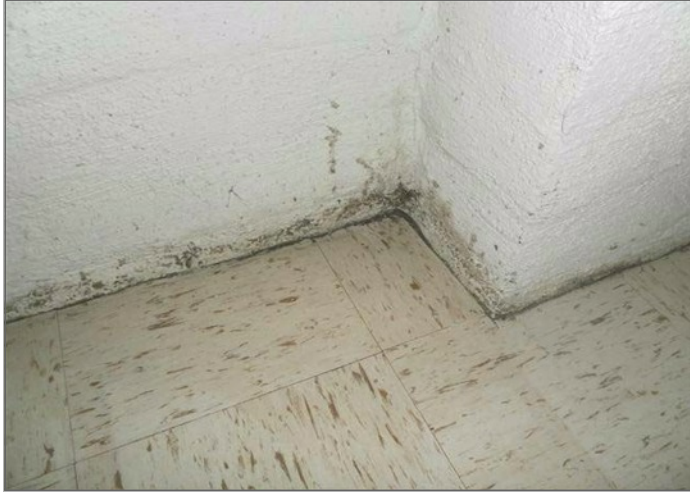
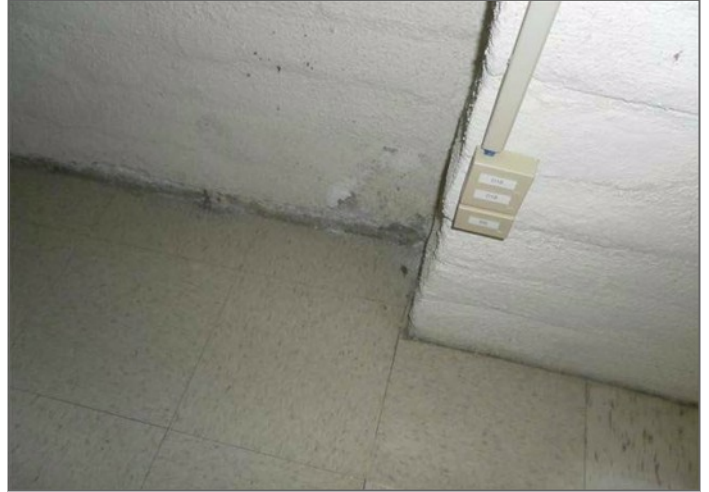
7.9 - There is efflorescence, or salt-crystal formations, at the north east office on the walls. Such efflorescence is relatively common and is activated by moisture, possibly from the exterior side, but usually has only a cosmetic significance. Stains at floor level were also noted in these areas, which may also suggest the presence of moisture, possibly from the exterior side. For this condition, we suggest a more in-depth examination, including any potential repairs. We suggest further assessment and advice by a qualified general contractor prior to the close of this escrow.

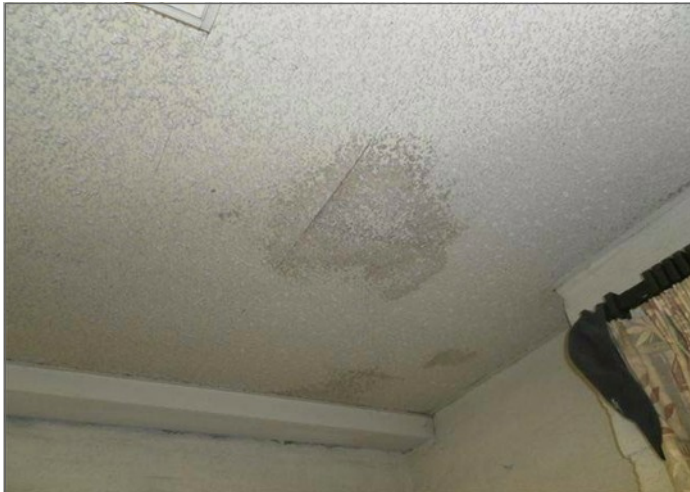
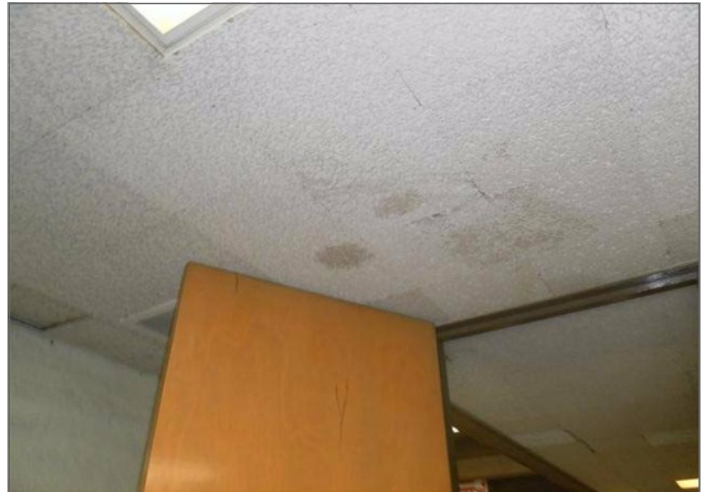
7.12 - Moisture staining was observed on the ceiling in the rear southeast office at the time of the inspection. This may suggest a prior/current leak - further investigation may be desirable. We recommend the further review, advice and services of a general contractor. No leaking noted at the time of the inspection.

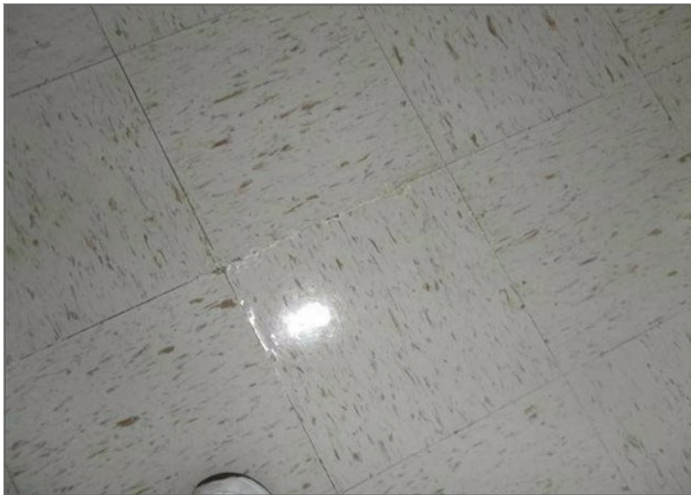
7.14 - The VCT flooring located in the front north room showed signs of possible wear as a result of efflorescence or moisture from below the tiles.

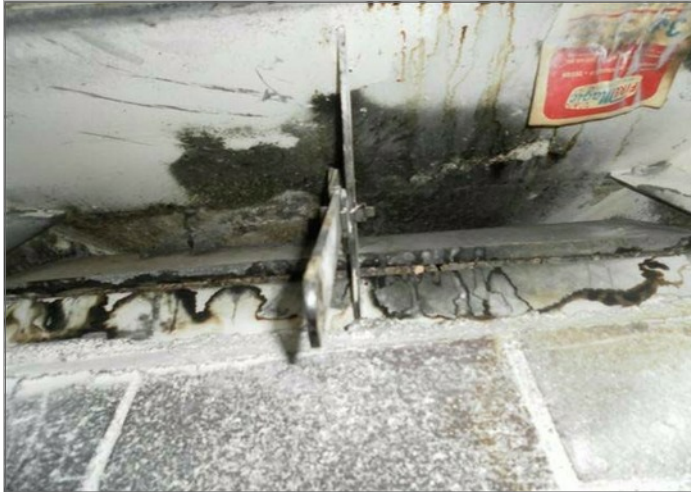
8.4 - The damper in the chimney flue appears to be restricted by debris that has fallen behind it or otherwise, and should be serviced.

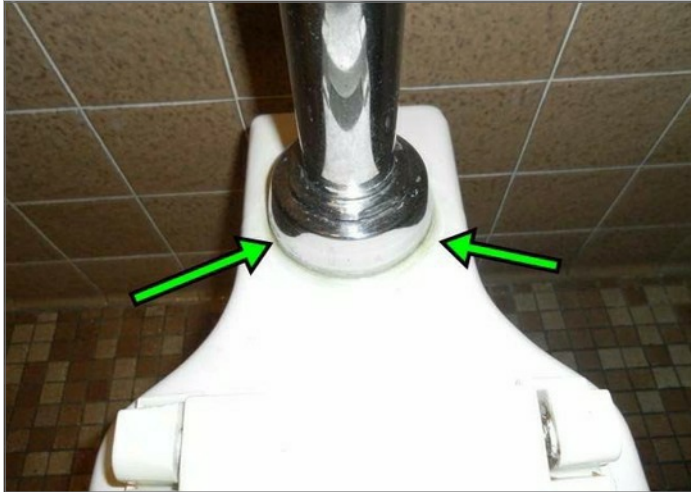
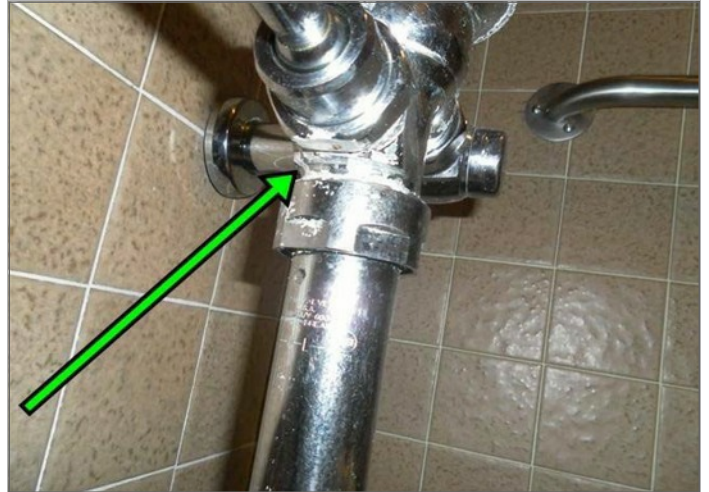
10.7 - The men's toilet was functional however, the flush valve leaked when tested.

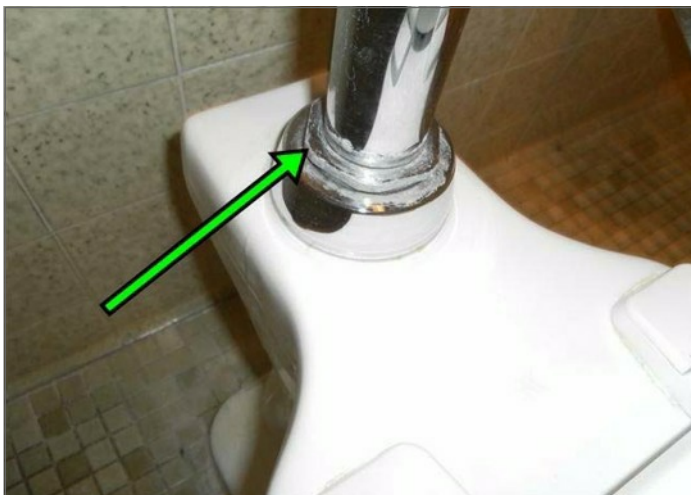
10.11 - The women's toilets were functional (2), however, the flush valve leaked on the west side unit when tested.
