[www.sewerinspectionpros.com](http://www.sewerinspectionpros.com)

Date of inspection : April 07 , 2014 - Time : 11:00 a.m. Technician : Charles Brunsmann.

This is a video inspection of the main sewer line. This is the portion of the waste pipe system that carries the waste from the structure to the city sewer connection. This report is based on the video inspection of the sewer line only. Any other parts of the water supply system are not included. The report is not intended as a code inspection or to list each flaw noted. It gives an overall picture of the condition of the main line and the opinion of the technician at the time of inspection.

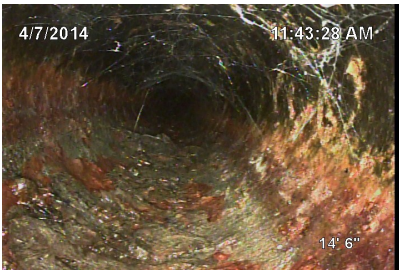
14' 6"

4/7/2014 11:43:29 AM  
Scale and corrosion in main line of home

**RECOMENDATONS :** Hire a licensed Plumber to Clear 4 inch main line of root intrusions by means of 1/2 inch snake cable and cutting tip. Cost is estimated at \$300.00. Also have main line sewer jetted with high pressure water jetter to remove all debris from root intrusions and scale buildup off inner walls of pipe. Cost is estimated at \$400.00. Due to potential broken or collapsed pipe it is also recommended to have a plumber inspect area of root intrusion for damage to pipe and estimate price to repair pipe. Recommendation costs are only estimates as there are a wide range of contractors that charge various prices for their work.
