SEWER INSPECTION REPORT

SAMPLE REPORT

Date of inspection : April 07 , 2014 - Time : 11:00 a.m. Technician : Charles Brunsmann.

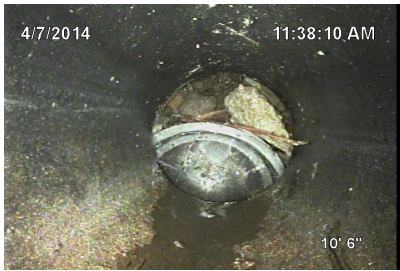
10' 6"

4/7/2014 11:38:11 AM
Sewer line not connected at guest house

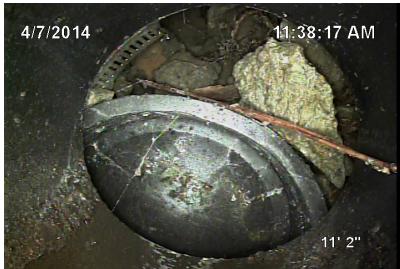
11' 2"

4/7/2014 11:38:18 AM
Sewer line not connected at guest house

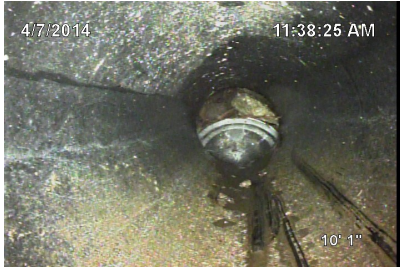
10' 1"

4/7/2014 11:38:25 AM
Sewer line not connected at guest house

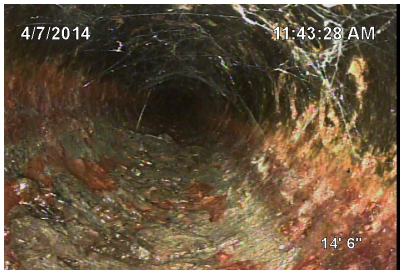
14' 6"

4/7/2014 11:43:29 AM
Scale and corrosion in main line of home

RECOMENDATONS : Hire a licensed Plumber to Clear 4 inch main line of root intrusions by means of 1/2 inch snake cable and cutting tip. Cost is estimated at \$300.00. Also have main line sewer jetted with high pressure water jetter to remove all debris from root intrusions and scale buildup off inner walls of pipe. Cost is estimated at \$400.00. Due to potential broken or collapsed pipe it is also recommended to have a plumber inspect area of root intrusion for damage to pipe and estimate price to repair pipe. Recommendation costs are only estimates as there are a wide range of contractors that charge various prices for their work.

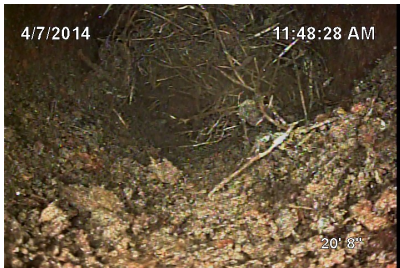
20' 8"

SEWER LINE OBSERVATIONS : After running camera through a total of 41 feet of 4 inch Cast iron and A.B.S. plastic sewer line from house connection, the conclusion was there was an obstruction 29 feet into the main line of the home after going into 4 inch sewer main line at 3 inch cleanout in primary garage of home. Large root intrusions and dirt appear to be obstructing flow of waste after cleanout transition before or near kitchen sink. Pipe is potentially broken or collapsed when high amounts of dirt are in sewer system. Although water is draining, it is at an unsufficient flow. Inner walls of pipe have a moderate buildup of corrosion and scale due to age of pipe. Camera could not go beyond root intrusion to view pipe in front yard that connects to city sewer. Repairs must be completed before front of home can be viewed. It was also noted that 4 inch A.B.S. plastic sewer pipe for guest house above secondary garage was not tied into the main line sewer. Pipe appears to have a 4 inch rubber jim cap that is partially on. The pipe has also been burried in the ground before connection to live sewer was performed. It is important that sewer line on this portion of the home is not used until the line is connected by a licensed plumber to prevent debris from the ground entering the system causing potential back ups.

4/7/2014 11:48:28 AM
Root intrusion and possible collapsed pipe

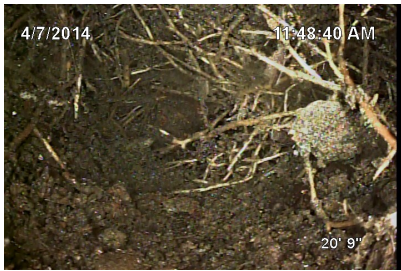
20' 9"

4/7/2014 11:48:40 AM
Root intrusion and possible collapsed pipe
