## Property Inspection Report

Saturday, April 4, 2015

Inspector, Marc Mazza  
Mazza Inspection Group  
(866) 996-2992

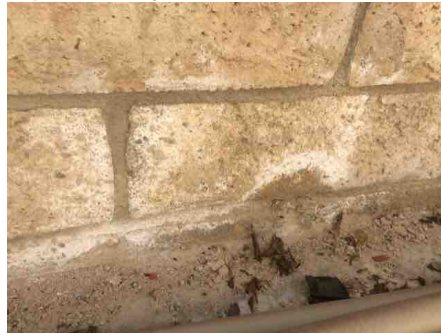
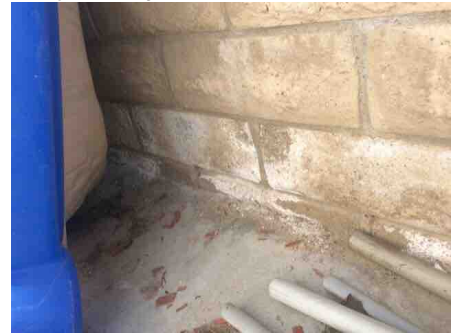
**38:** - Deterioration of the blocks in the block wall was noted at the time of the inspection. The wear may have been the result of over spray from the sprinkler system or moisture from the adjacent yard.

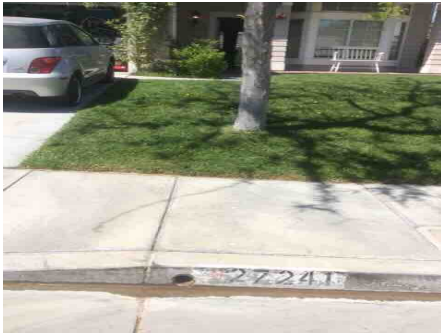
**45:** - A tree or trees, are located in an area that is considered close to the subsurface drains. There is no way to determine whether or not the trees have had any affect on the drains without the use of a sewer scope/ camera.

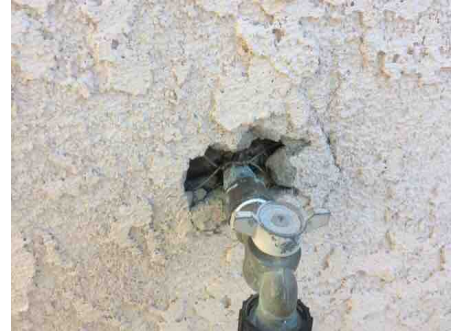
**50:** - There is missing stucco (holes, openings, missing covers, chips) noted at the exterior wall of the house. These openings may allow moisture to enter into the structure resulting in possible damage to interior wood framing members. In addition, openings in the stucco may also allow pests to enter and should be sealed as preventative maintenance.

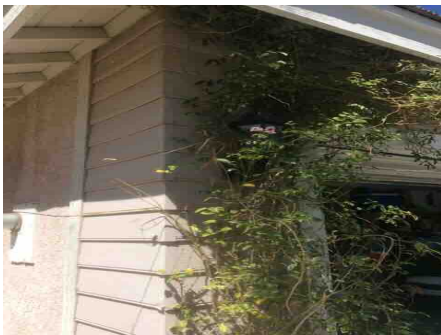
**53:** - Vegetation was noted in contact with the siding wall material at various locations around the structure and should not be on or near the house. Vegetation can encourage mold / mildew, interior rot, termites and other undesirable guests. The weight of the vegetation can dislodge siding and the tendrils from some vines can actually dissolve mortar joints in masonry walls. Vegetation limits the inspection of the exterior walls and foundation.

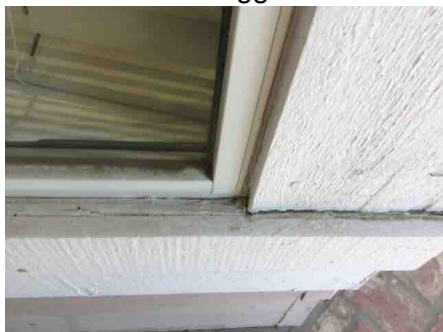
**59:** - There are windows and or door which appeared to have been replaced. The new trim overlaps the exterior wall covering material, leaving a small area exposed to moisture intrusion. Sealant is suggested around the exterior window trim to wall connection to decrease the possibility of moisture entry into the structure. Sealing the connection with an exterior approved material with a 25 / 50 guarantee against deterioration is suggested.

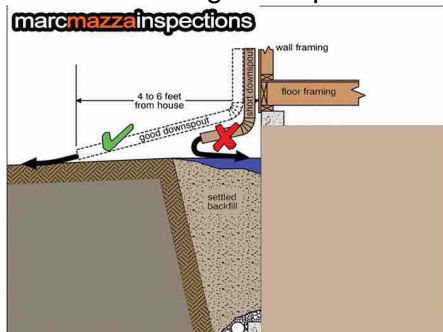
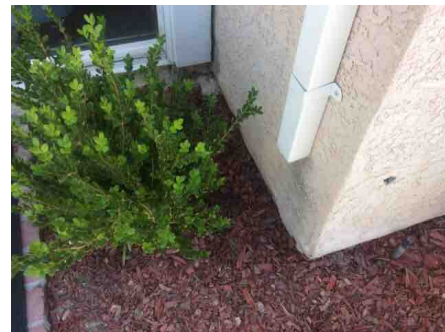
**61:** - We recommend routing all of the downspout(s) away from the structure, or installing the downspout directly into the subsurface drainage, if present. The downspout(s) should discharge water at least five (5) feet from the house or drain into existing sub surface drainage. Storm water should be encouraged to flow away from the building at the point of discharge.

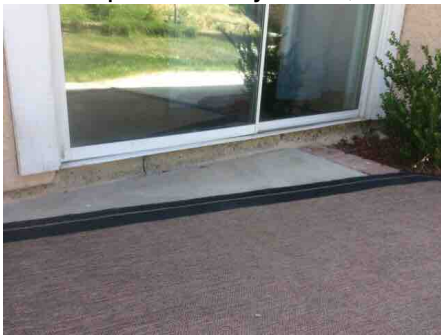
**82:** - We observed what appears to be deterioration and exposed rebar at the rear stem wall of the back exterior side of the house. We are unable to determine if the rebar pictured is / was necessary to secure a sole/sill plate. In any event, the exposure will ensure the rebar deteriorates prematurely.

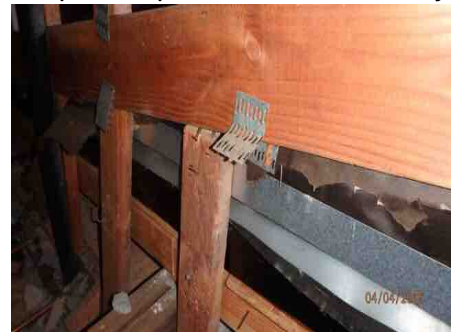
**84:** - Portions of the framing system (cripples) system have been modified, damaged, sub standardly modified or re-installed. We have no way to determine if this framing was modified and re-supported with the adjacent ledger from the addition. In light of this, further assessment is advised. We recommend the advice and services of a licensed general contractor who can inspect this condition and improve upon it as / if necessary.

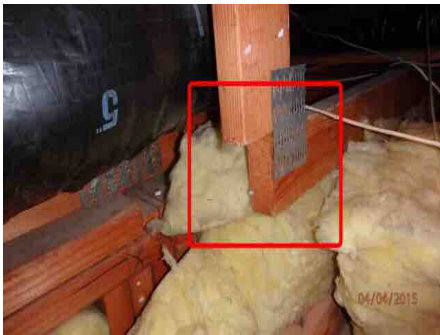
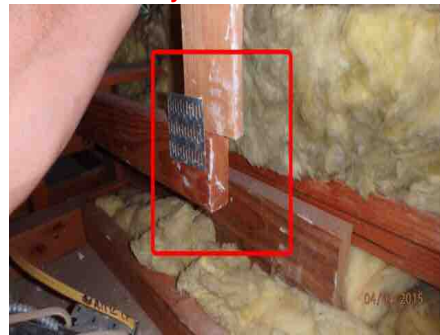
**s-3:** - We observed a cut or otherwise damaged truss within the attic. These trusses are structural components and as such will require building permits for repair. Prior to that, however, an engineer should evaluate the condition in order to determine how to best remedy this condition.

**85: -** We observed a cut or otherwise damaged truss within the attic. These trusses are structural components and as such will require building permits for repair. Prior to that, however, an engineer should evaluate the condition in order to determine how to best remedy this condition.

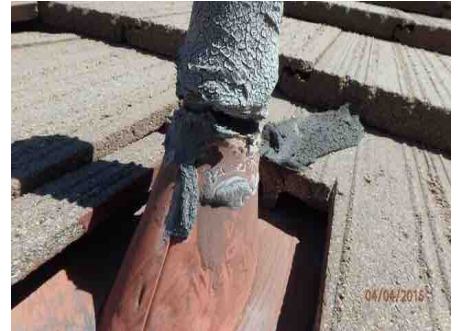
**93:** - The roof flashings that are visible, are suggested to be sealed as part of typical service. They are comprised of metal that seals valleys, plastic or metal vents and other roof / wall penetrations, and are the most common point of leaks. This is particularly true of the flashings on a layered roof, which are covered by the roofing material and are even more susceptible to leaks - Reference Building Code IRC-P3103.3.

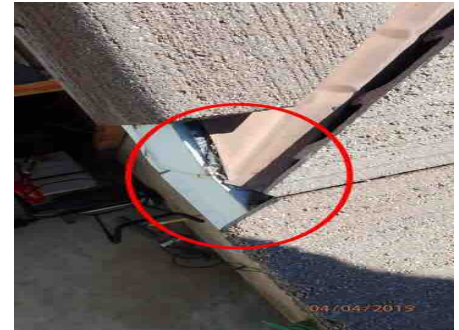
**95: -** We observed an under-cut valley flashing. This single crown valley flashing appears to be cut short prior to extending over the eave and drip edge flashing.

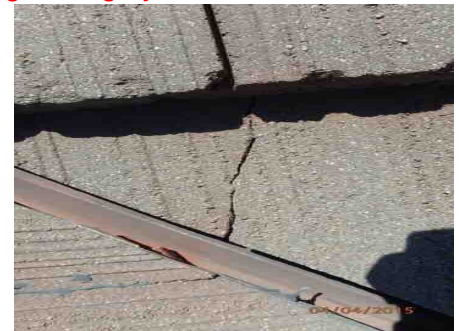
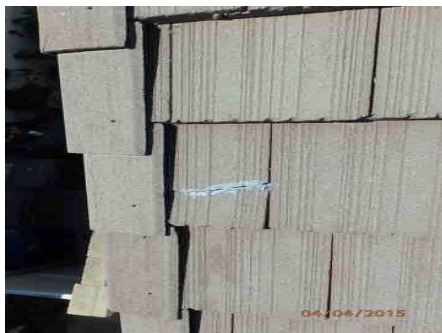
**96: -** There are cracked roof tiles that were observed at the main roof. This should be expected as regular wear and tear, however, the tile should be serviced to maintain the water tight integrity of the roof.

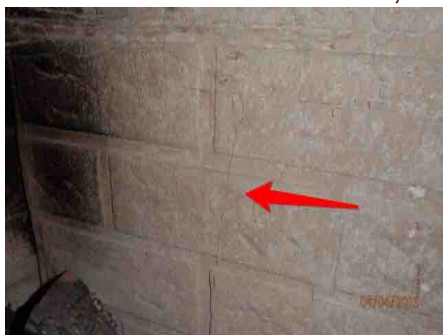
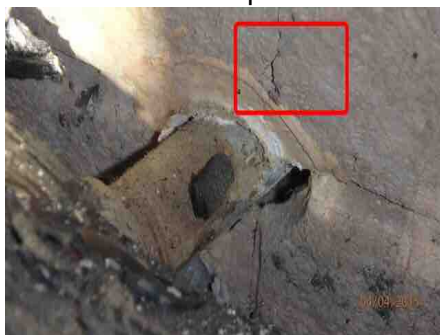
**113:** - There are cracks in the refractory (firebricks) in the fireplace. These cracks warrant attention and necessary repairs (which may include replacement) to reduce possible future damage or deterioration. We recommend the further review, advice and services of a professional contractor.

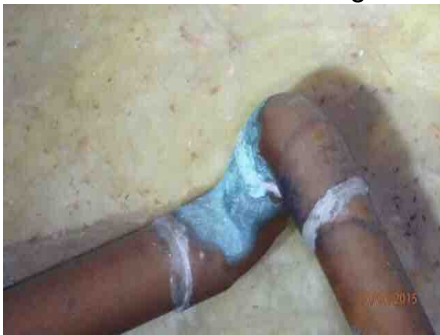
**130:** - Surface corrosion was observed at the copper piping. This is a condition that should be monitored for further corrosion and possible leakage. Future repairs may ultimately be necessary if leaking is discovered. There was no active leaking at the time of the inspection.

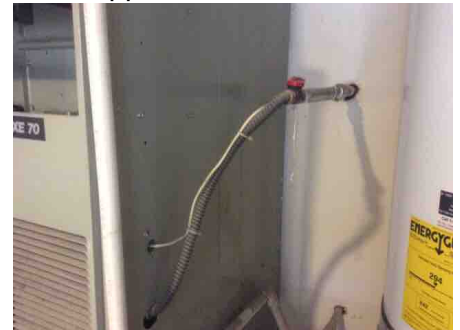
**141:** - There are missing sediment traps at all or some of the fuel piping installed prior to fuel burning appliances e.g. furnace, water heater. A drip leg, also known as a dirt leg, is there to protect the gas train and burner orifices from gas born water and dirt. In a clean piping system, with best quality gas supply, there will never be a need for this. Typically, systems develop some moisture from condensation, as well as some dirt or other contamination. Typically, the drip leg is 3-6 inches in length and prior to the appliance.

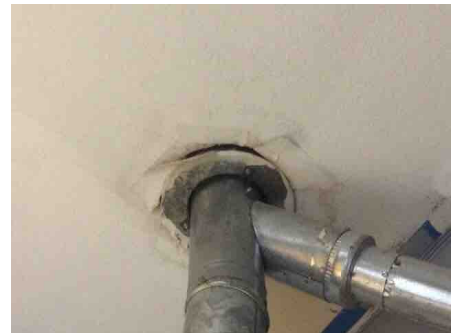
**165:** - Holes and / or missing wall separation wall covering were noted in the fire rated wall that connects the garage to the main structure. The walls and ceilings of the attached garages should be well sealed where they abut the interior of a house to maintain the integrity of the fire rated materials. Dwelling/garage opening/penetration protection. Openings and penetrations through the walls or ceilings separating the dwelling from the garage shall be in accordance with Sections R302.5.1 through R302.5.3.

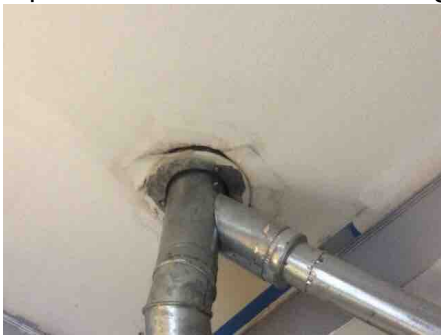
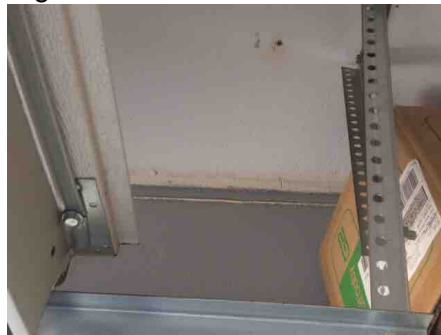
**170:** - Moisture stains, which may indicate a past or even present leak, were observed on the ceiling of the garage at the time of the inspection. We do suggest that the buyer inquire with the current owners or representatives for information regarding this condition.

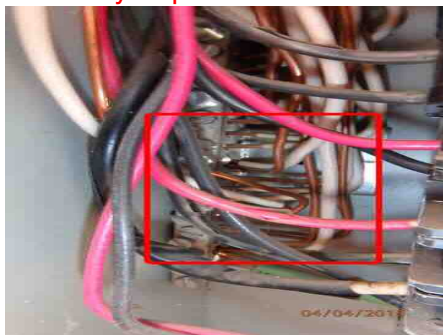
**204:** - There are mixed ground / neutral conductors within the service equipment panel, inserted under one terminal lug at the ground bus bar. Current building standard requires all grounded conductors to be inserted into individual terminals. Furthermore, neutral conductors and ground conductors should not be intertwined under one terminal. For a more in-depth examination of this condition, we suggest further assessment and advice by a qualified electrician.

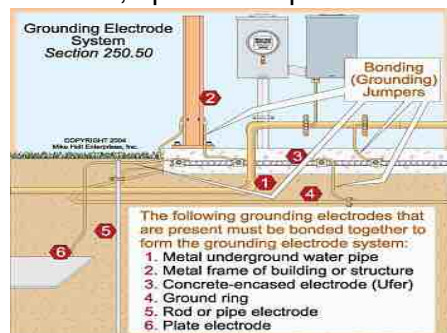
**205:** - Service equipment ground or grounding conductors may have been observed inside the service equipment panel, however, a definitive system ground (complete view of grounding conductor & electrode and / or conductor connected directly onto a grounding source i.e. water piping, rebar, grounding rod etcetera) were/was not visible for complete verification at the time of the inspection (except otherwise noted). In many cases, the ground is connected to one or more locations within the structure and bonded together. We do not, however, open cover plates or remove wall covering materials to verify bonds / grounds.

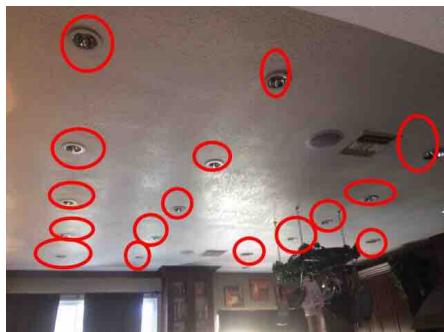
**210:** - There are recessed light fixtures which appear to have been added after the initial construction of the house. Recessed light fixtures (sometimes known as "can lights") which are installed into insulated ceilings, can represent a potential fire hazard if they are not suitably rated for this application. A licensed electrical contractor is recommended to be engaged to verify the safeness of the installation. Lights rated for this installation in insulated ceilings are marked as "direct-contact-insulated-ceilings" or "DCIC" or marked as "thermally protected". Insulation should be pulled back from the unprotected lights and proper bulbs should be installed to avoid a fire risk. Furthermore, the addition of these types of lights may require a new circuit be added to the panel as not to overload an existing circuit. This we cannot verify. Many electrical installations require building permits. Therefore, we suggest the buyer contact the local building authority to determine if the work required a building permit. Furthermore, the light buckets installed are suggested to possess insulation barriers around the newly installed fixture. this will keep insulation away from the light fixture.

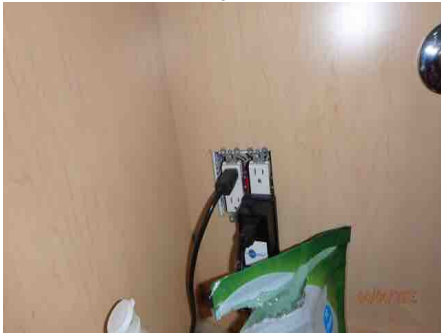
**217:** - There are light switch and / or receptacle cover plates that are damaged or missing. Replacement of the cover plates is suggested to reduce the potential of shock - NEC 2014 §406.6 & 410.22. Local jurisdictions to some extent, may offer a different version of this standard.

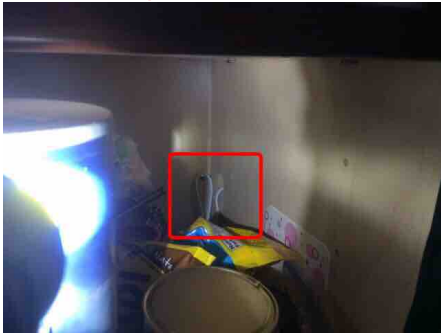
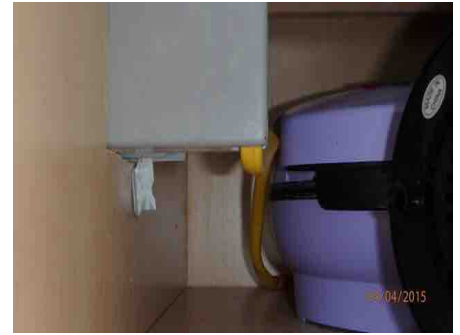
**220:** - NM cable wiring (I.E. Romex, cord etc..) exposed to physical damage or contact was observed in the kitchen which is within harms reach should be relocated or protected from damage or contact by the use of conduit. Improvements are recommended for safety.

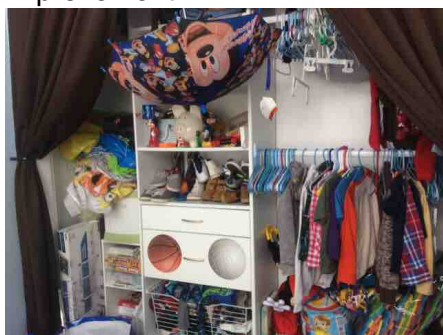
**226:** - The bedroom and hall closet doors are not installed. Replacement of the doors is primarily a cosmetic improvement.

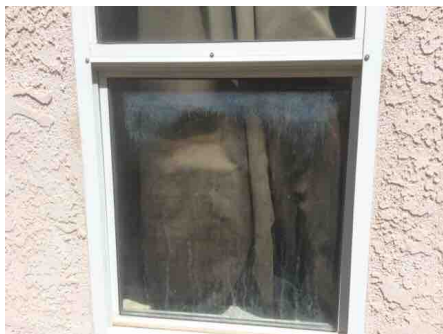
**233:** - The dual pane window(s) at the south side has lost its seal (or is very dirty) judging by the discoloration observed within the glass panes (condensation / staining developing between the panes of glass). This "fogging" of the glass is primarily a cosmetic concern, and need only be improved for cosmetic as well as energy efficiency reasons. Although double-paned windows appear to be stable, they actually experience a daily cycle of expansion and contraction caused by thermal pumping. Sunlight heats the air space between the panes and causes the gas there to heat up and pressurize. Expanding gas cannot leave the chamber between the panes, and the trapped gas causes the glass to bulge outward during the day and contract at night to accommodate the changing pressure. This motion acts like the bellows of a forge, pumping minute amounts of air in and out of the air space between the panes. Over time, the constant pressure fluctuations caused by thermal pumping will stress the seal and challenge its ability to prevent the flow of gas in and out of the window chamber. Incoming humid air has the potential to condense on the window surface, if it is cold enough. It should be known that if one window performs in this manner, more may follow in time as they may have been constructed in the same "batch".

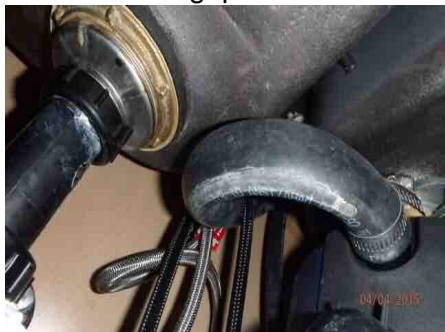
**273:** - The air gap line was kinked and is suggested to be repaired.

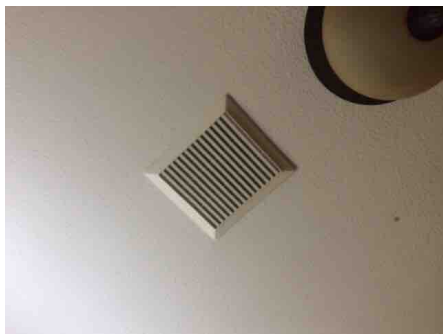
**279:** - The bathroom ventilation fan is recommended to be cleaned for adequate ventilation.

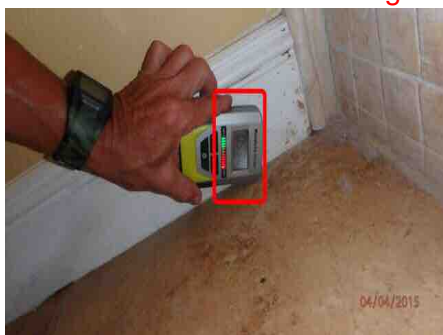
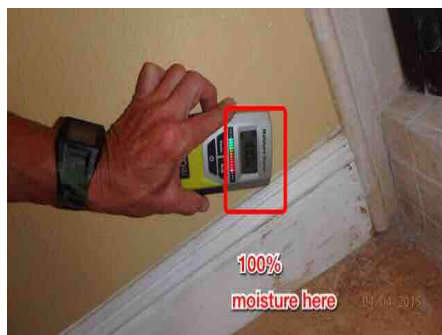
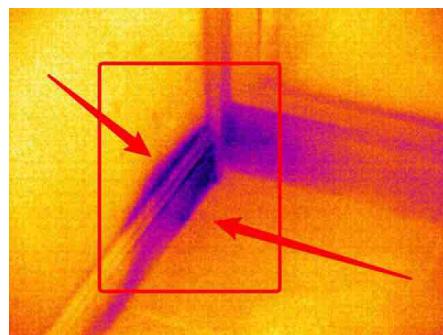
**280:** - The shower pan was tested and appears to be leaking. Repairs are suggested at the pan so the shower enclosure may function without leaking. It should be noted that shower pans should hold water for an indefinite amount of time without losing water. Further assessment is advised.

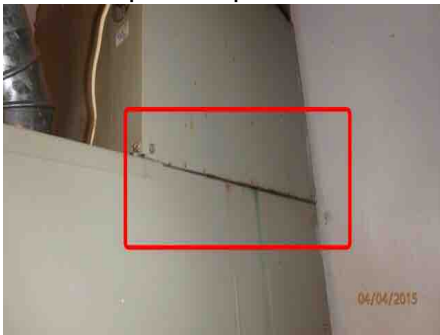
**317:** - Sealant / tape is recommended at the air handler / plenum. Conditioned air appears to be leaking from this area. Sealing this area will reduce energy loss, as well as, the infiltration of airborne contaminants within the attic space. A professional HVAC contractor is recommended to perform this task.

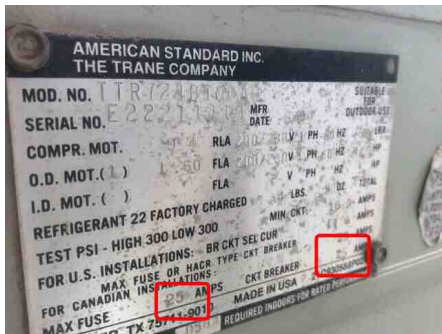
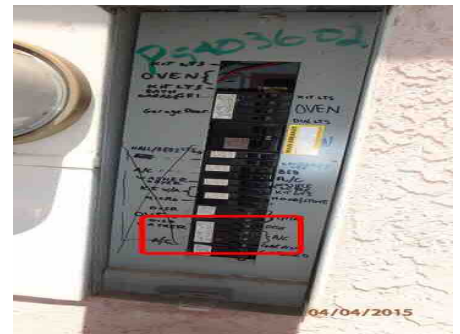
**331:** - The air condition service disconnect which possesses 30 amp fuses and breaker which are too large for this condenser.

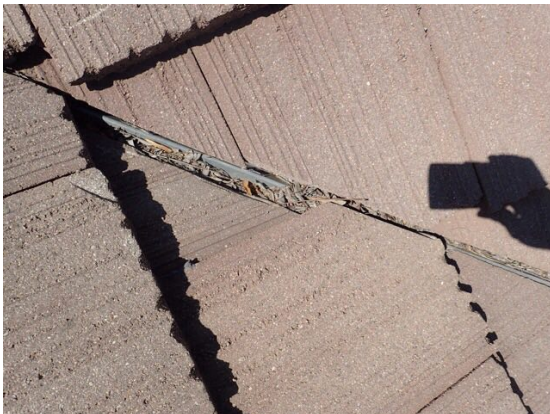
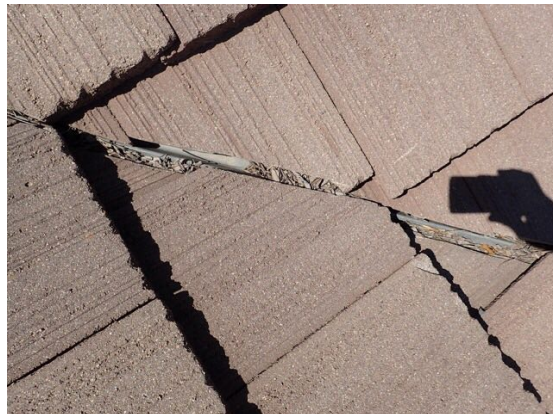
**14:** - We observed debris building in the valleys. Debris is suggested to be removed and the valleys monitored.

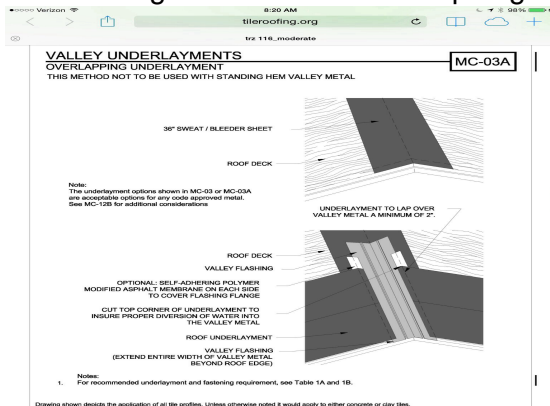
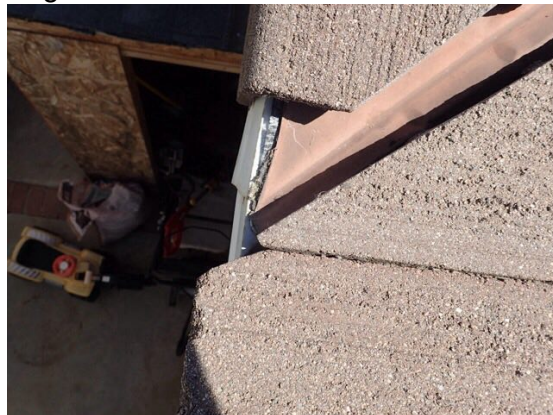
**15:** - We observed an under-cut valley flashing. This single crown valley flashing appears to be cut short prior to extending over the eave and drip edge flashing.

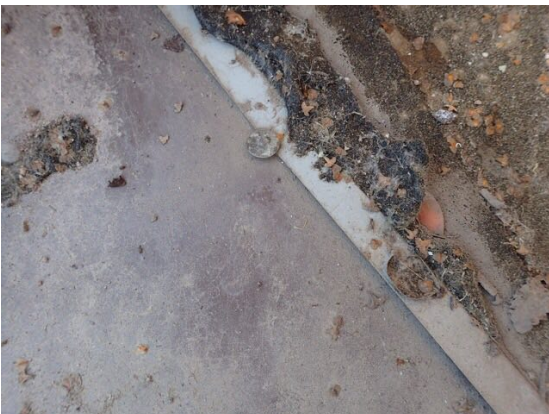
**25:** - There are nails that are driven through the metal at the flat addition portion of the roof that should be sealed.

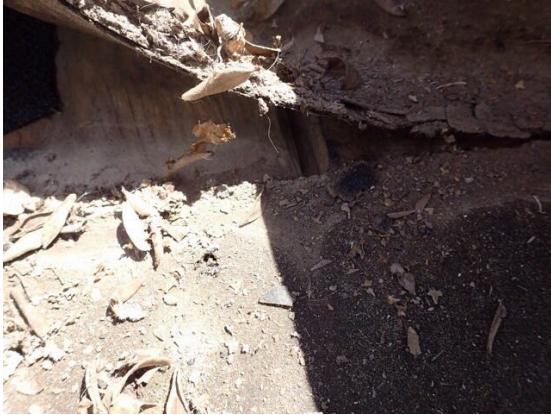
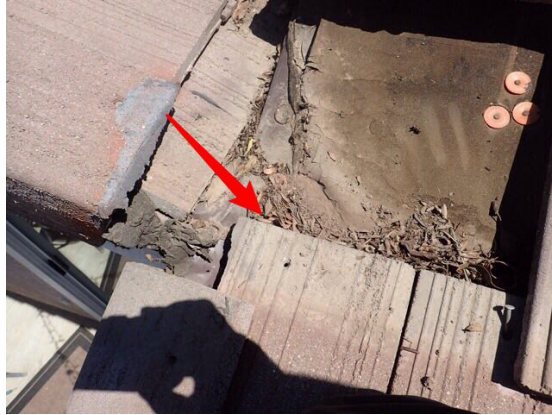
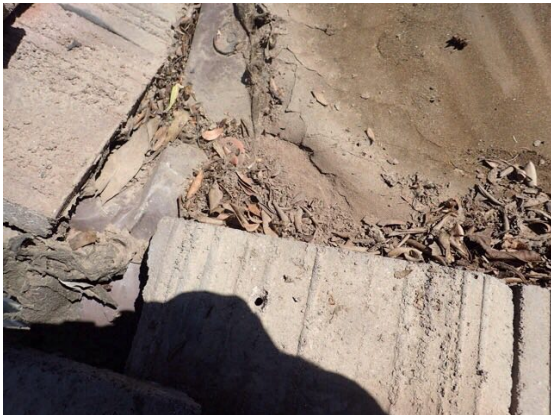
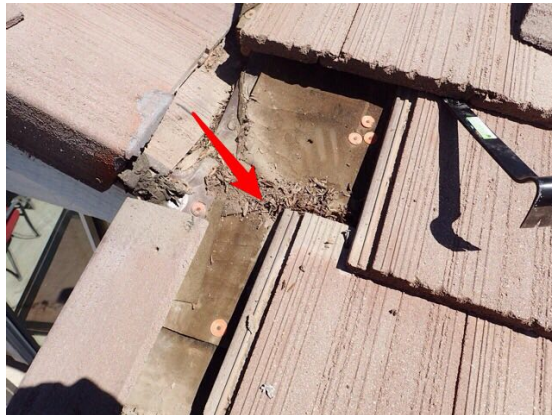
**26:** - Upon inspection of the addition portion of the roof, we noticed that water may be draining down one side of the roof and underneath the tile on the adjacent side. The membrane appears to be deteriorated in this section. This may be the reason for the damaged wood on the eaves. Pulling the tile up in this area and properly roofing/flashing the area is recommended.

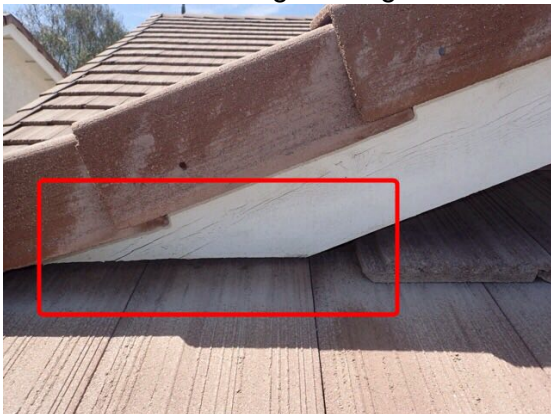
**27:** - There is flashing missing from the fascia boards where they terminate at the roof underneath them.

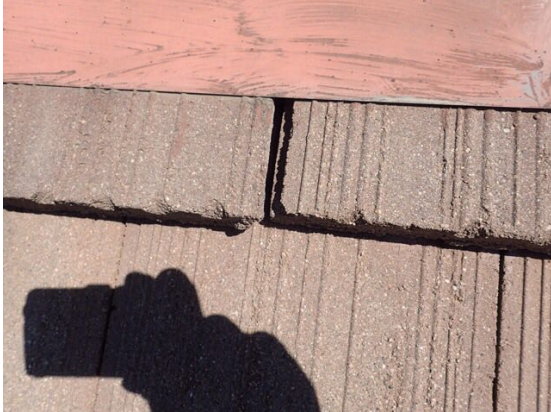
**28:** - There are tiles under the front of the skylight that have broken channels and may allow moisture to enter under the tile. Repairs are recommended.
