Property Inspection Report

xxx

Acton, California

Mazza Inspection Group

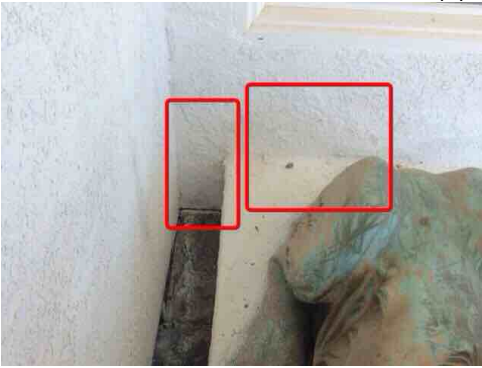
19: - The porch surface material is high at the foundation, which does not allow a complete inspection of the foundation. Furthermore, moisture may penetrate beyond the slab into the interior wood framing members via the weep screed flashing (or under a house with a crawlspace). Sealant is recommended to be installed at the slab to foundation connection(s) as preventative maintenance - IRC 2012 §703.6.2.1.

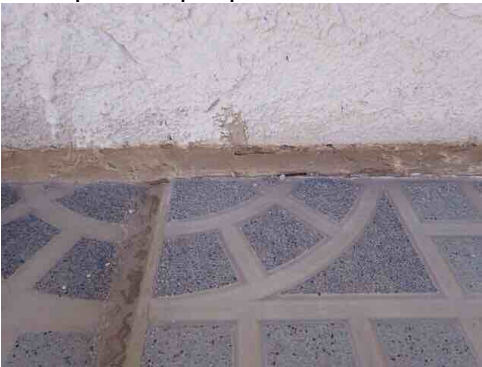
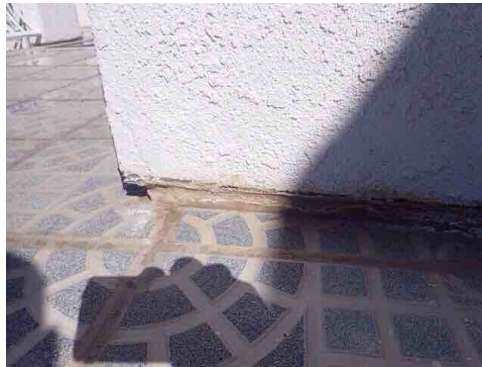
29: - Sealant was noted at the deck on the grout joints of the tile and up against the house. This may be an attempt to stop a previous leak on the deck.

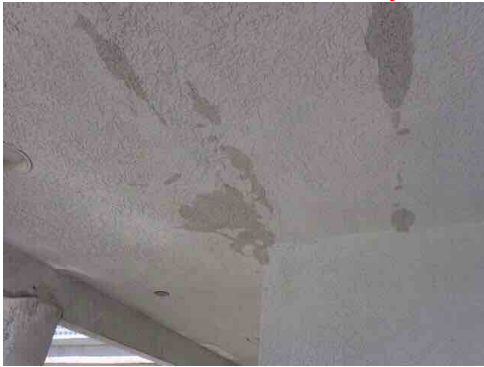
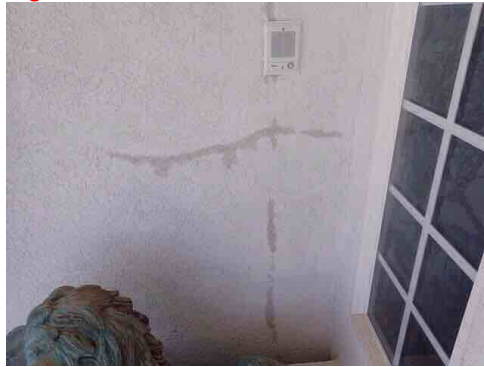
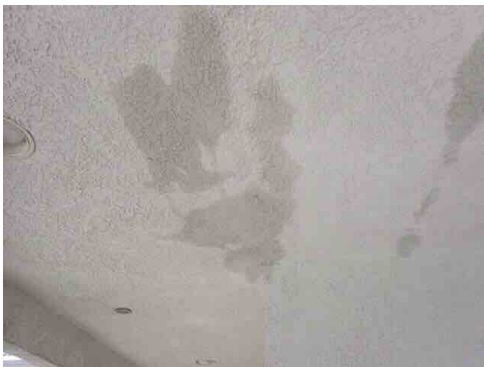
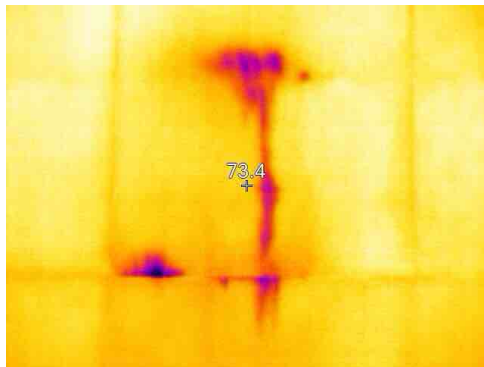
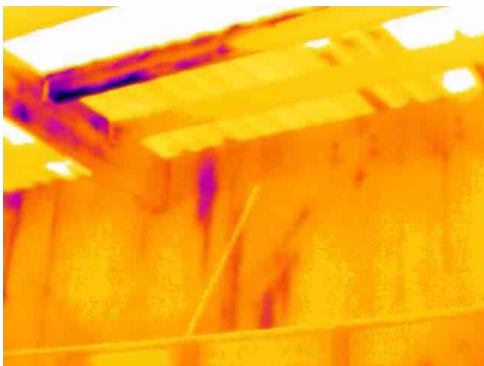
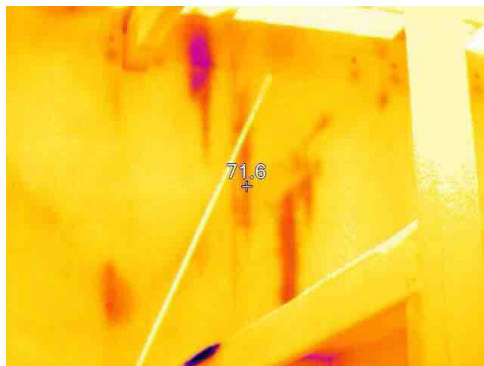
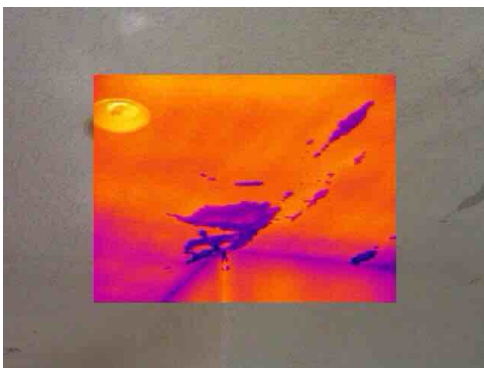
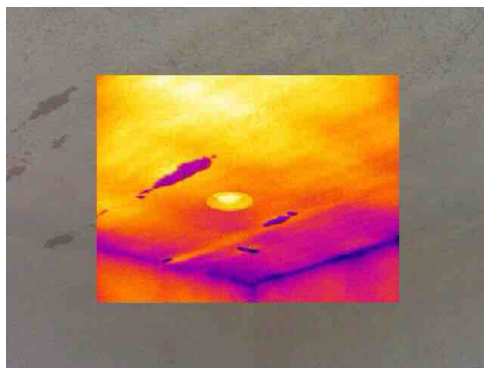
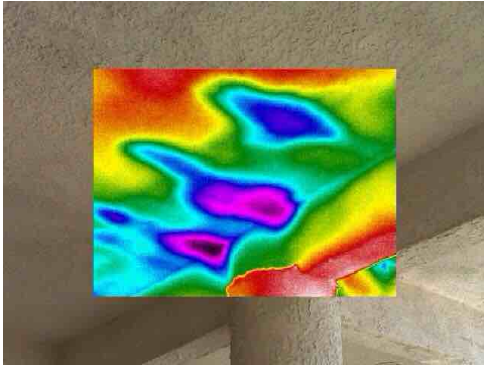
32: - Evidence of leaking was observed from underneath the deck and on the exterior walls of the house. We are unable to determine the methods in which the deck is waterproofed without destructive testing. Our fear is that the wood framing members of the deck may be damaged/rotten and in need of replacement. Further evaluation is recommended by a licensed general contractor.

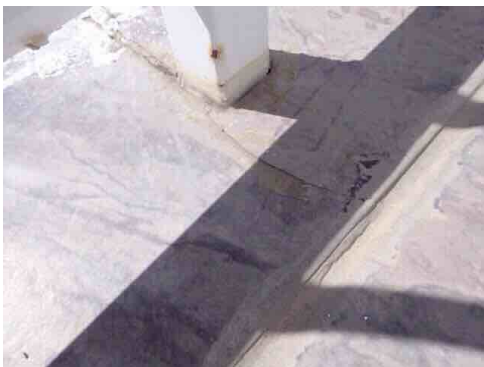
38: - There are cracked tiles on the deck.

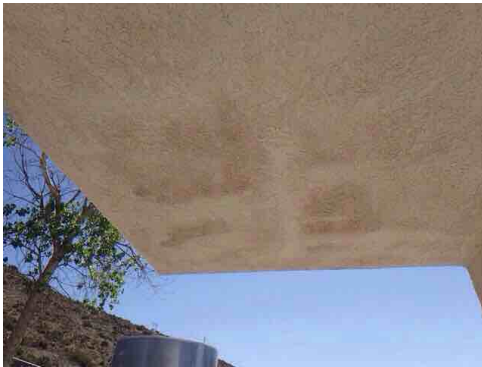
43: - Moisture staining was observed on the stucco underneath the deck, which may suggest that the deck leaks. We are unable to determine the methods in which the deck is waterproofed without destructive testing. Our fear is that the wood framing members of the deck may be damaged/rotten and in need of replacement. Further evaluation is recommended by a licensed general contractor.

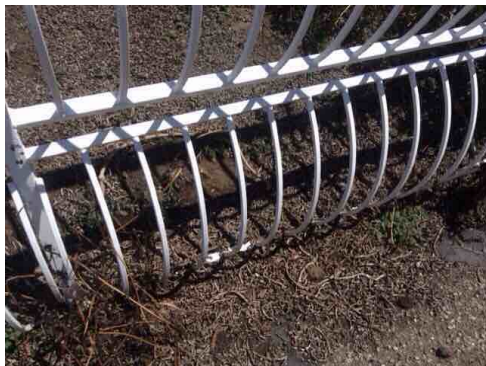
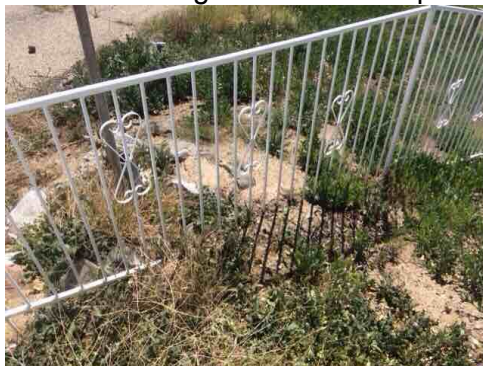
49: - There is wrought iron fencing that has been embedded in the soil. This may cause deterioration / rust. A six inch clearance is recommended between the fencing and the soil as preventative maintenance.

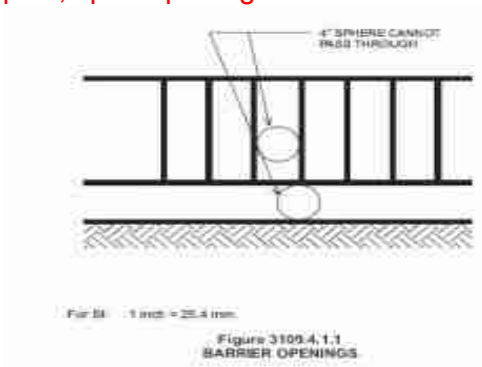
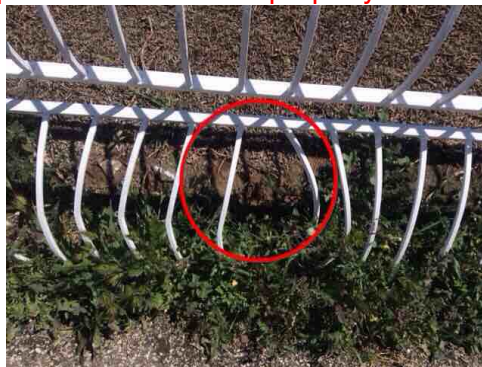
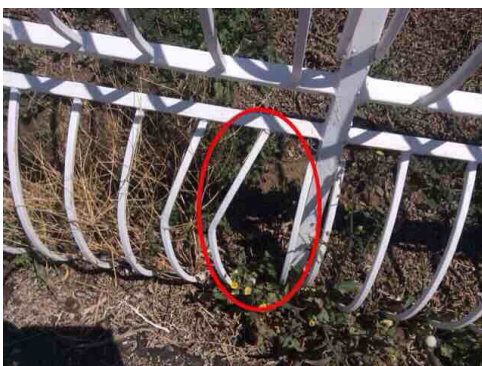
51: - The gaps or voids, in the wrought iron fencing are greater than 4 inches which is substandard when a pool, spa or pond greater than 18" in depth is located on the property. IRC 2012 §312.3.

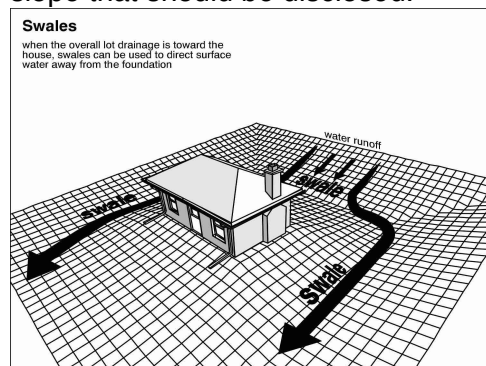
60: - We observed drainage swales located within the perimeter of this property. The buyer is recommended to inquire as to any potential issues related to these swales. There may be other swales located on the hill slope that should be disclosed.

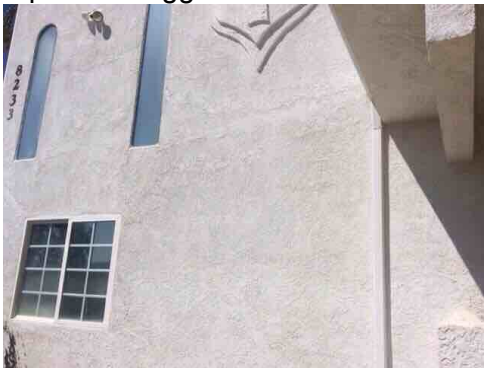
63: - Evidence of prior repairs / patching was viewed at exterior wall(s). We are unable to determine if the repairs were performed in a manner which is consistent with minimum building standards. Our concern is that the building paper is not breached or damaged. Further investigation as to the reason for the patching / repairs is suggested.

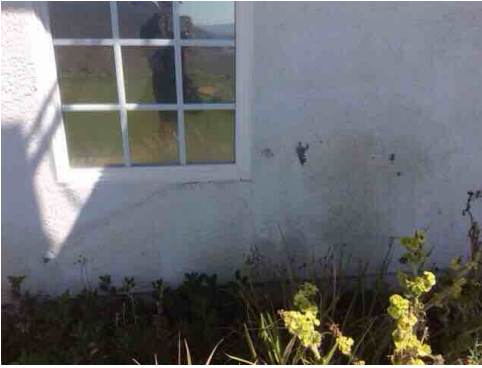
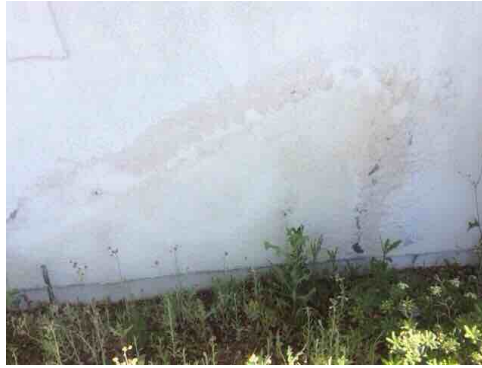
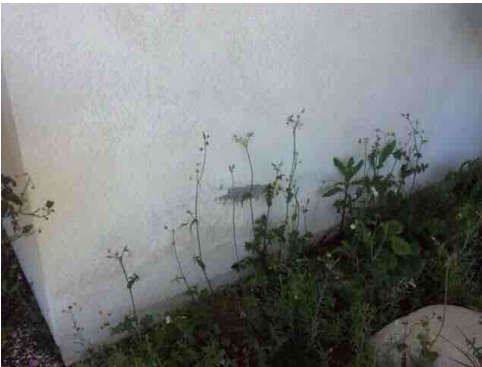
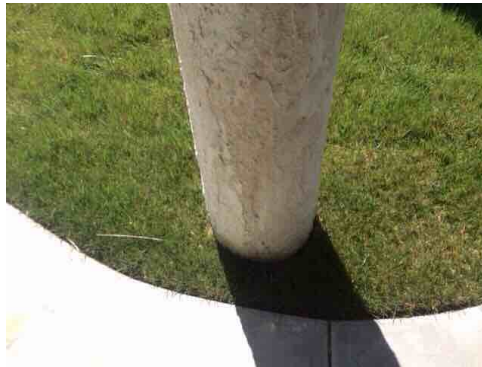
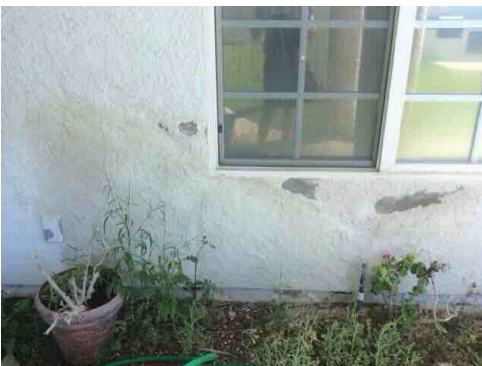
64: - Surface deterioration (spalling, crumbling material) was observed at the exterior walls. This condition is common in many old homes and does not usually represent a serious structural concern unless there is substantial loss of material. In an effort to prevent long term deterioration, it would be wise to consider parging (a concrete stucco-like coating) over deteriorated areas. Sprinkler and lot drainage improvements and elimination of water or roof runoff splashing against foundation walls can reduce possibility of damage deterioration.

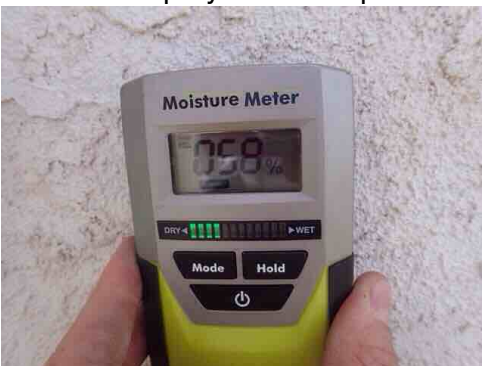
65: - Elevated levels of moisture were observed in the exterior walls at the front of the house. This may be due to overspray from the sprinklers or leaking from the decks above.

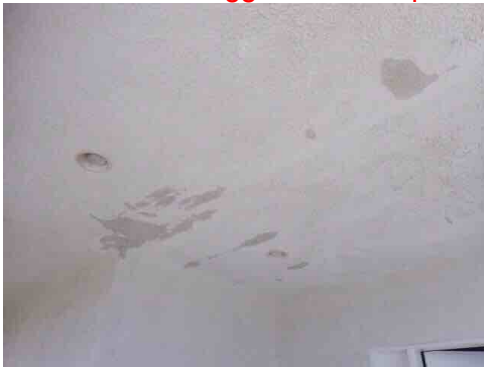
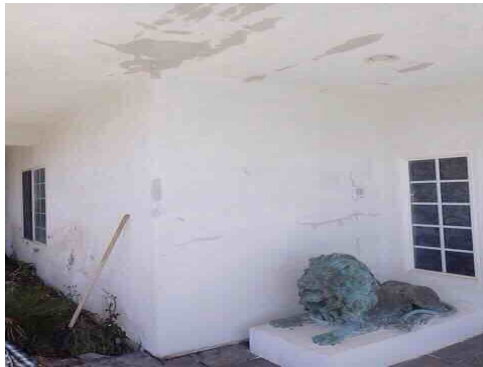
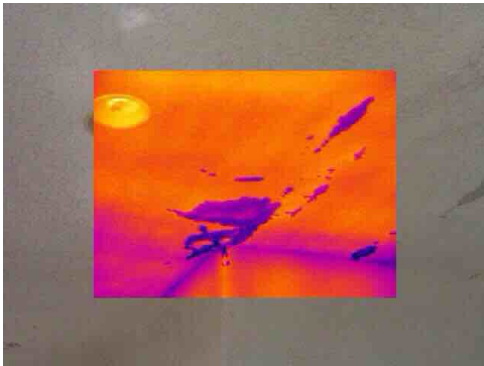
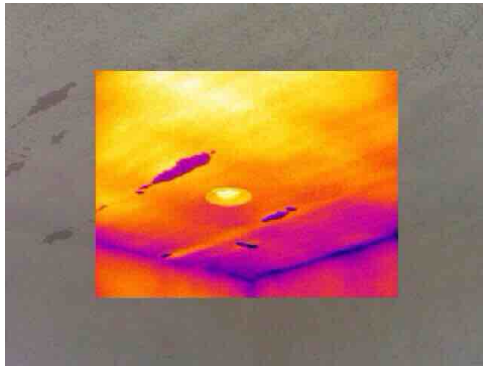
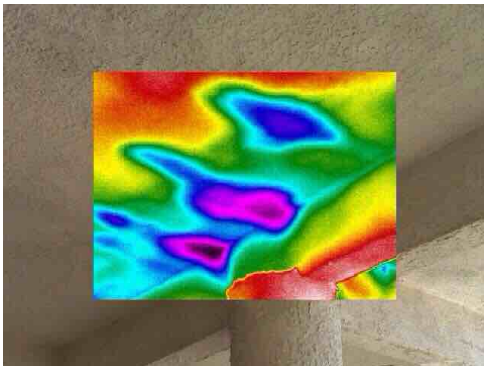
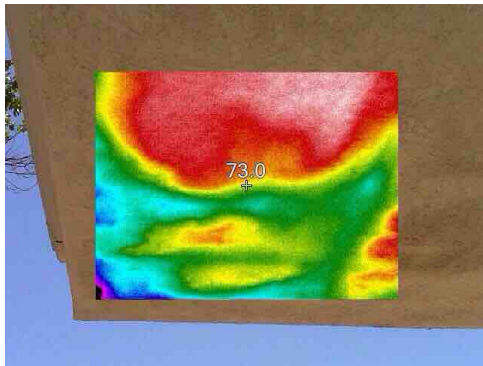
s-11: - Moisture was observed throughout the stucco covering under the south side and north side decks as well as the wall under the south side deck. The moisture appears to derive from the deck surfaces, however, a water test is suggested to be performed to confirm this.

66: - Moisture was observed throughout the stucco covering under the south side and north side decks as well as the wall under the south side deck. The moisture appears to derive from the deck surfaces, however, a water test is suggested to be performed to confirm this.

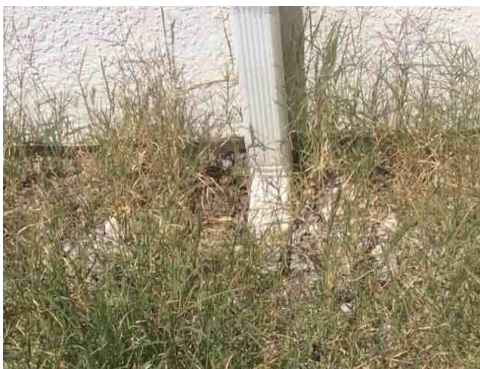
77: - There are downspouts that are too close to the ground and should be raised at least 6 inches for maximum flow.

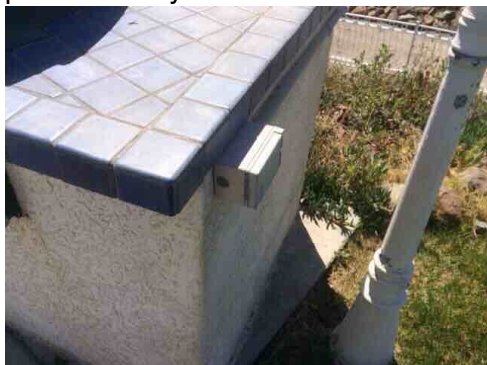
82: - We observed missing coverplates at the north side switch. Improvements are recommended as a safety precautionary measure.

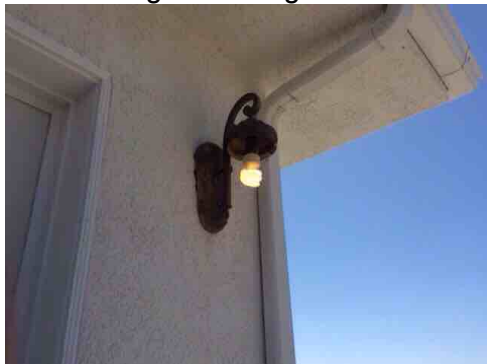
84: - The light fixture globe was damaged at the front north side.

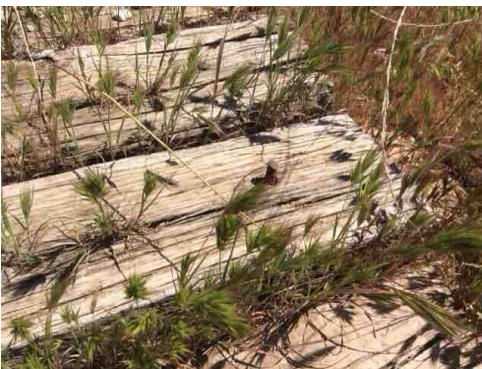
s-13: - There is steel rebar sticking up in the north and east side of the yard. Caution is suggested as this condition poses a potential safety hazard. Improvements are recommended as a safety precautionary measure.

100: - There is steel rebar sticking up in the north and east side of the yard. Caution is suggested as this condition poses a potential safety hazard. Improvements are recommended as a safety precautionary measure.

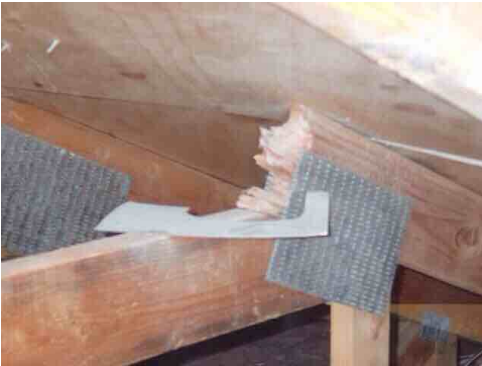
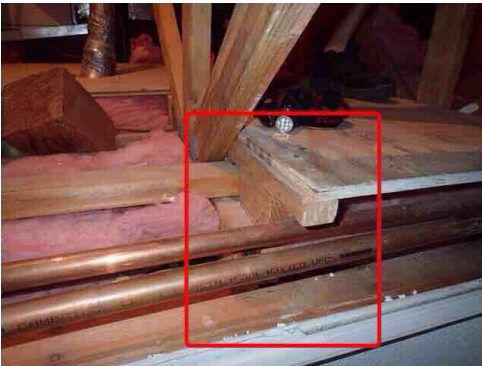
s-15: - We observed several damaged trusses within the attic. These trusses are structural components and as such will require the evaluation of an engineer to better determine what repairs are necessary to remedy this condition.

108: - We observed several damaged trusses within the attic. These trusses are structural components and as such will require the evaluation of an engineer to better determine what repairs are necessary to remedy this condition.

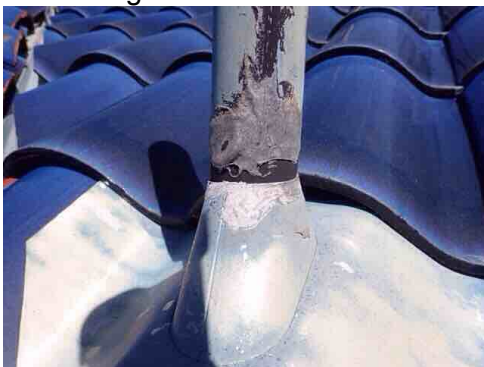
116: - The roof flashings, which were visible, are suggested to be sealed as part of typical service. They are comprised of metal that seals valleys, plastic or metal vents and other roof / wall penetrations, and are the most common point of leaks. This is particularly true of the flashings on a layered roof, which are covered by the roofing material and are even more susceptible to leaks.

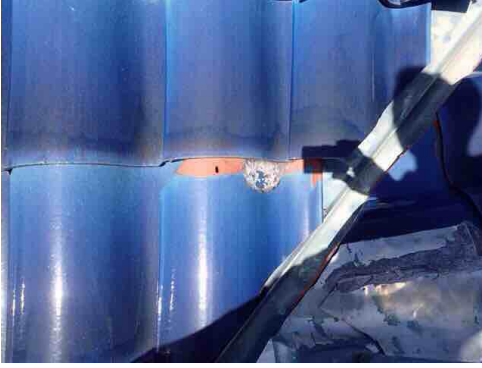
117: - There were flashings which were filled with dirt and debris. This material in the flashing poses a potential issue with respect to drainage. The flashing may cause a back up in water run off which may result in a potential leak.

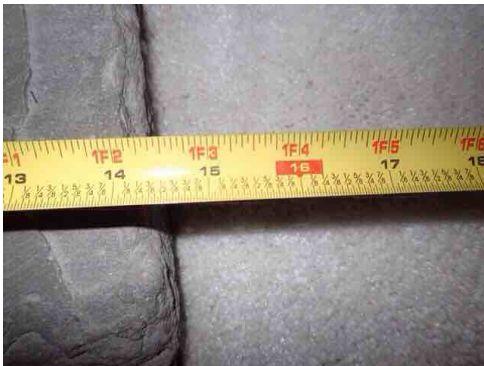
160: - The hearth does not have standard dimensions, which would require it to extend at least 16 inches from the front of the opening (should carpet or a rug be added) and 8 inches on either side. When the fireplace opening is more than 6 square feet, the hearth should extend at least 20 inches from the front and at least 12 inches on either side.

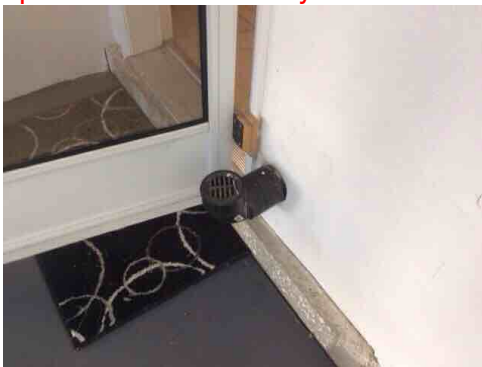
s-22: - We observed an exposed DWV in the garage which does not terminate through to the exterior. We recommend the advice and services of a licensed contractor who can inspect this condition and improve upon it as / if necessary.

190: - We observed an exposed DWV in the garage which does not terminate through to the exterior. We recommend the advice and services of a licensed contractor who can inspect this condition and improve upon it as / if necessary.

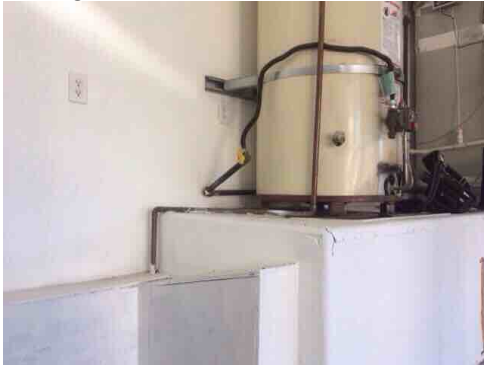
200: - The end of the TPR drain is suggested to terminate downward, no less than 6" and no more than 24" from grade.

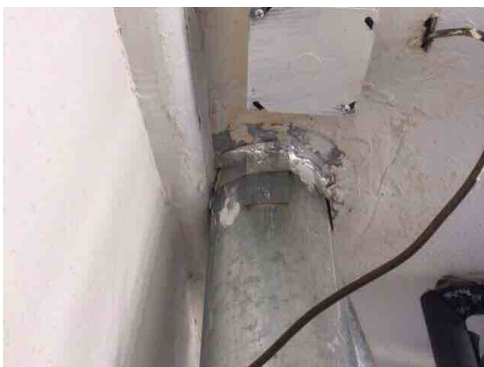
203: - The vent pipe of the gas water heater is too close to combustible material (wood, drywall, ductwork & insulation), and should be serviced. A single-walled vent pipe should be six inches away from any combustible material, and a double-walled vent pipe (and transite) should be one inch away - Code Reference CPC 510.

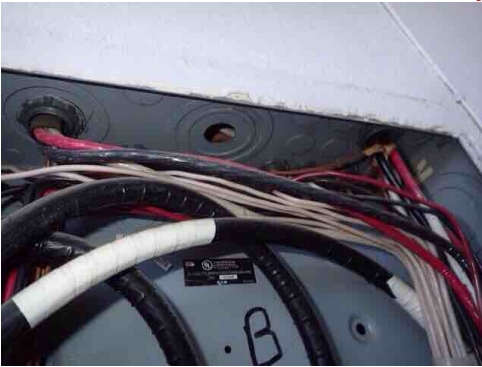
255: - We observed openings within the service equipment panel. Openings in the panel are not suggested and should be closed or sealed off by a professional contractor.

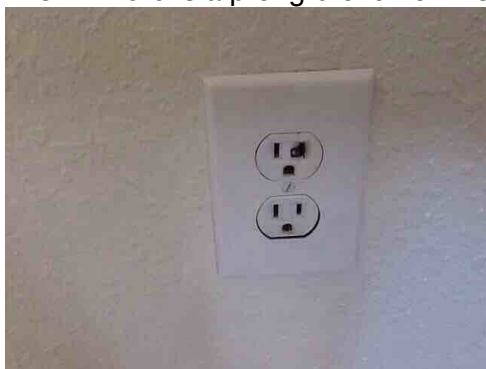
273: - There is a prong broken off inside the receptacle at the top of the north stairwell.

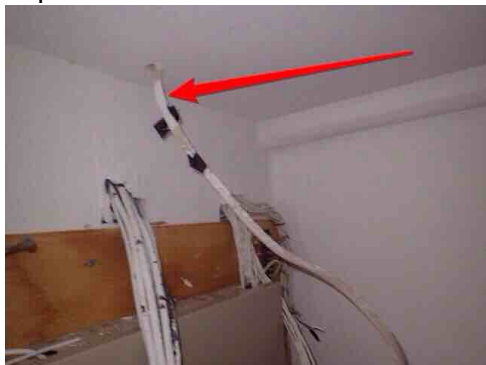
274: - NM cable wiring (romex) exposed to physical damage or contact was observed in the downstairs closet. The wiring should be relocated or protected from damage or contact by the use of conduit. Improvements are recommended for safety.

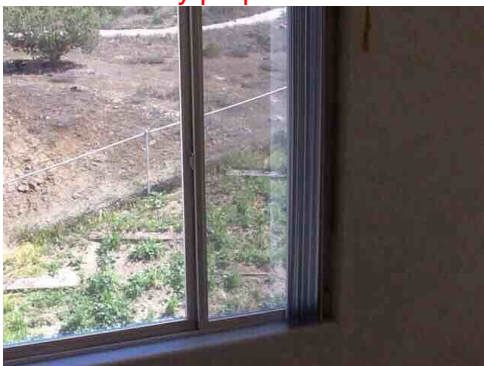
s-36: - The window located in master bedroom is cracked / broken. Improvements are recommended for obvious safety purposes.

311: - **The window located in master bedroom is cracked / broken. Improvements are recommended for obvious safety purposes.**

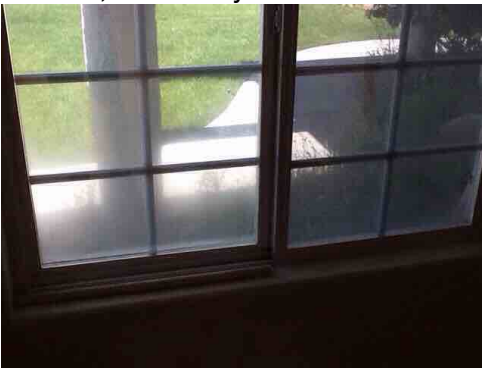
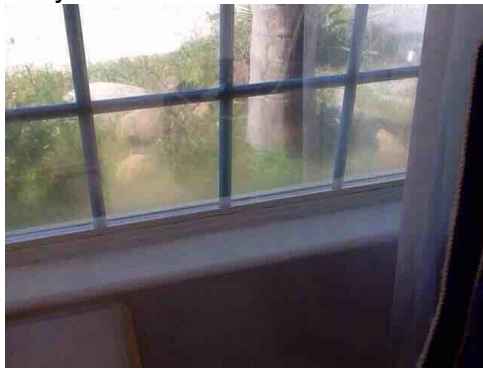
313: - The dual pane windows in the downstairs bedroom and the living room have lost their seal (or are very dirty) judging by the discoloration observed within the glass panes (condensation / staining developing between the panes of glass). This "fogging" of the glass is primarily a cosmetic concern, and need only be improved for cosmetic as well as energy efficiency reasons. Although double-paned windows appear to be stable, they actually experience a daily cycle of expansion and contraction caused by thermal pumping. Sunlight heats the air space between the panes and causes the gas there to heat up and pressurize. Expanding gas cannot leave the chamber between the panes, and the trapped gas causes the glass to bulge outward during the day and contract at night to accommodate the changing pressure. This motion acts like the bellows of a forge, pumping minute amounts of air in and out of the air space between the panes. Over time, the constant pressure fluctuations caused by thermal pumping will stress the seal and challenge its ability to prevent the flow of gas in and out of the window chamber. Incoming humid air has the potential to condense on the window surface, if it is cold enough. It should be known that if one window performs in this manner, more may follow in time as they may have been constructed in the same "batch".

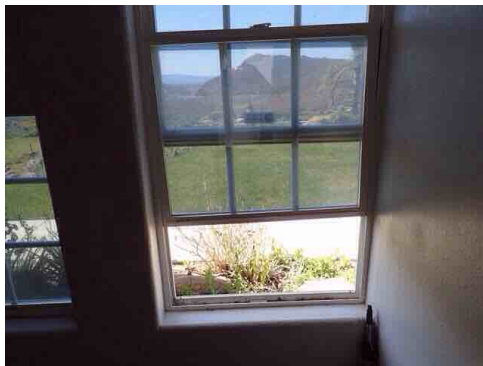
s-37: - Sash cords / balancers (the ropes that hold up the windows) are inoperable on the window(s) in the garage. Repairs are suggested for proper operation of single and double hung windows and should be performed by a professional contractor. All of the inaccessible single hung windows are suggested to be tested once they are made accessible and prior to the close of escrow.

314: - Sash cords / balancers (the ropes that hold up the windows) are inoperable on the window(s) in the garage. Repairs are suggested for proper operation of single and double hung windows and should be performed by a professional contractor. All of the inaccessible single hung windows are suggested to be tested once they are made accessible and prior to the close of escrow.

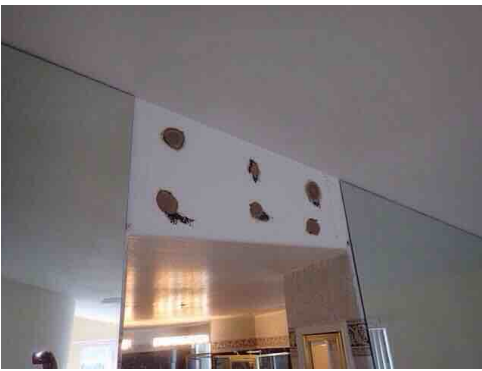
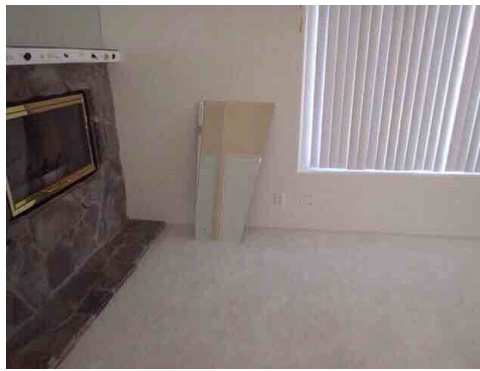
324: - One of the mirrored wall covering materials in the master bedroom is detached from the wall.

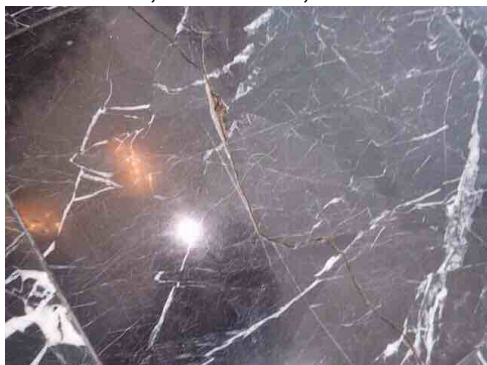
331: - There were cracked floor tile observed at the interior flooring in the front entry. We cannot view under the tile and, as a result, we are unable to determine the reason for the cracking (e.g. cracked concrete slab).

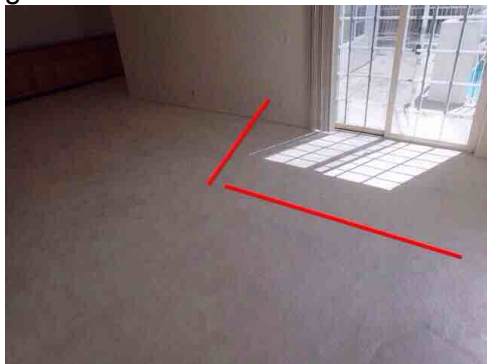
333: - There is an area in the loft where we noted uneven flooring. Upon lifting the carpet, we noticed the subfloor is uneven and is not level with the adjacent piece. Further evaluation is recommended by a licensed general contractor who can determine the cause for this and make recommendations for repairs.

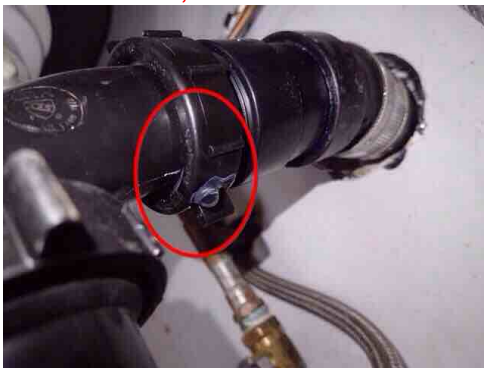
s-42: - There is a leak at the trap-arm below the kitchen sink, which should be repaired. We recommend the further review, advice and services of a plumbing contractor.

368: - There is a leak at the trap-arm below the kitchen sink, which should be repaired. We recommend the further review, advice and services of a plumbing contractor.

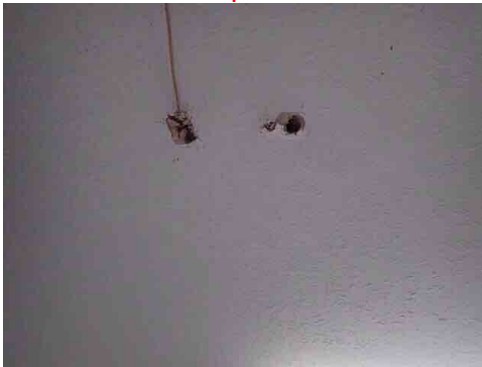
s-45: - The bathtub drain pipe was leaking at the time of the inspection. The leaking noted appears to be from under the tub. Repairs are recommended.

422: - The bathtub drain pipe was leaking at the time of the inspection. The leaking noted appears to be from under the tub. Repairs are recommended.

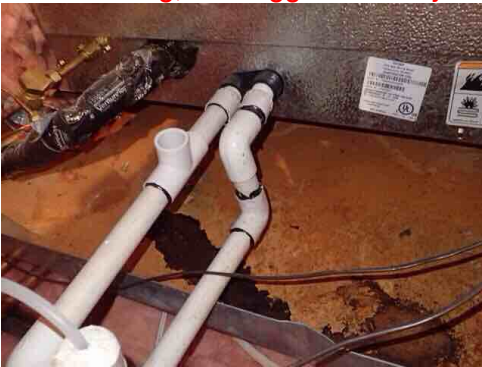
482: - The condensation pan appears to be severely rusted and deteriorated. A rusted pan may suggest a leaking secondary condensate drain, leaking primary, switched condensate drains or leaking "A" coil. In light of this finding, we suggest the buyer have an HVAC contractor evaluate the pan.

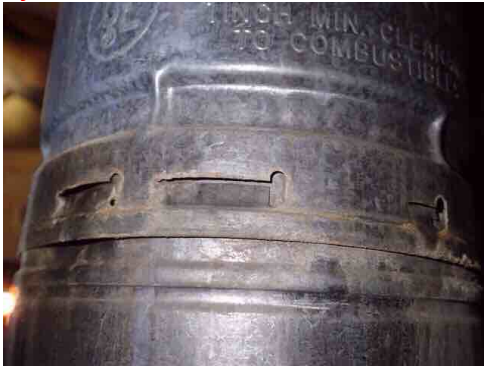
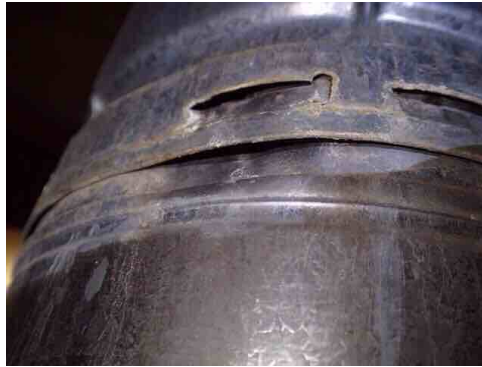
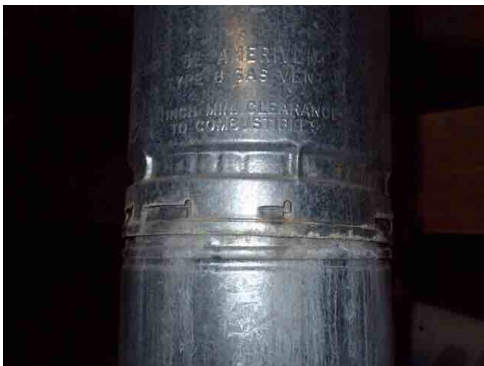
491: - The vent pipe which serves both the water heater and the furnace appears to be separated in the attic as pictured, which will allow the bi-products of combustion to contaminate the residence. It should be repaired by an HVAC contractor before the furnace is used.

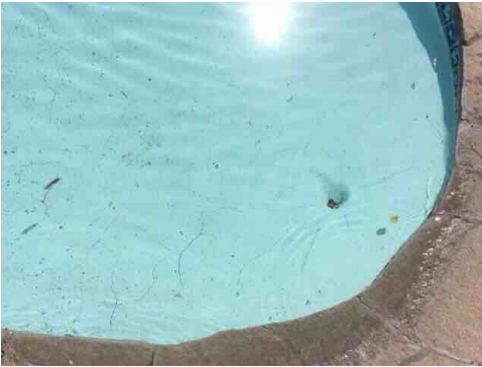
528: - Cracks were observed in the pool plaster. In many cases spider cracking is a result of aged plaster, however, the depth or degree of damage if any cannot be determined during this one time limited inspection. For this evaluation or leak test, a professional contractor is suggested to be contacted prior to the close of escrow.
