Property Inspection Report

XXX

Thursday, February 26, 2015

Inspector, Marc Mazza
Mazza Inspection Group
(866) 996-2992
info@mazzainspections.com

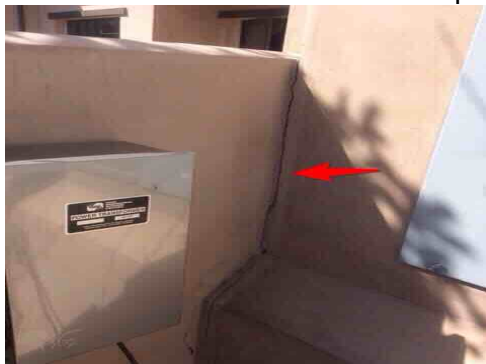
38: - The block wall located at the pool equipment is cracked where attached to the structure.

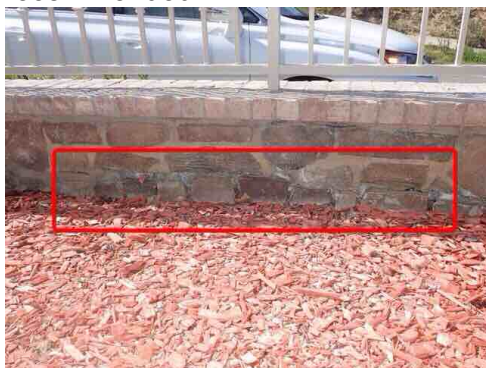
39: - There is grout missing from in between the stone facing located at the front wall. Improvements are recommended.

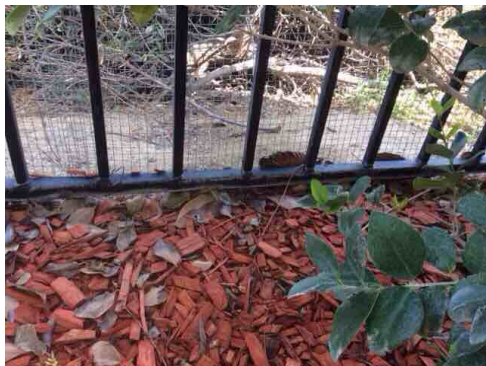
40: - There is wrought iron fencing that has been embedded in the soil. This may cause deterioration / rust. A six inch clearance is recommended between the fencing and the soil as preventative maintenance.

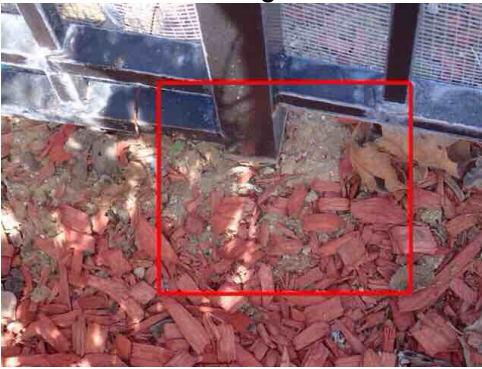
42: - The front wrought iron fence is loose at the footing when pressed upon. Additional stability is suggested.

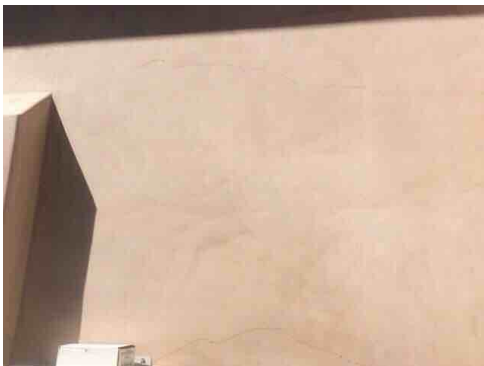
43: - The walls are clad with stucco or plaster in a smooth finish. We further noted that the finish was cracked in multiple areas around the perimeter of the structure as well as having "Pitts". The cracking may be the result of many things but commonly is related to the manner in which the materials were applied, the conditions under which the materials were applied or the lack of proper preparation of the materials. A professional masonry contractor is, however, the individual who may offer a definitive explanation as to the reason for this cracking.

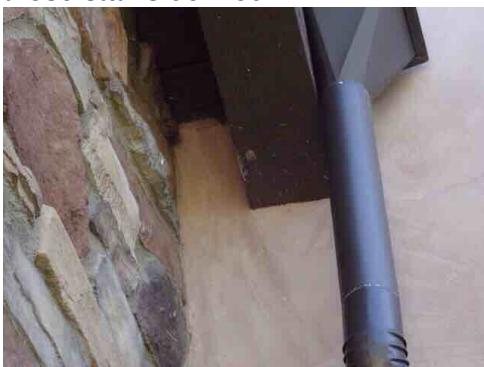
44: - Moisture staining was observed on the exterior stucco walls under the eave. It is possible that the water is passing behind the fascia, under the gutter (if installed) or eave board, however, this is merely speculation. It may also be runoff from the roof. Without a calibrated water test there is no way to determine from where these stains derived.

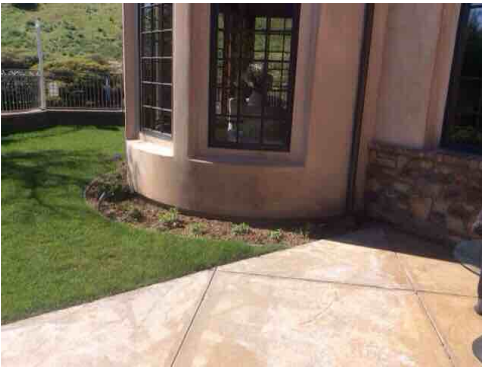
45: - The exterior stucco walls appear to show signs of wear which appear to be caused by sprinkler spray. It is recommended that the sprinklers be pointed away from the structure to reduce damage to the structure as a result.

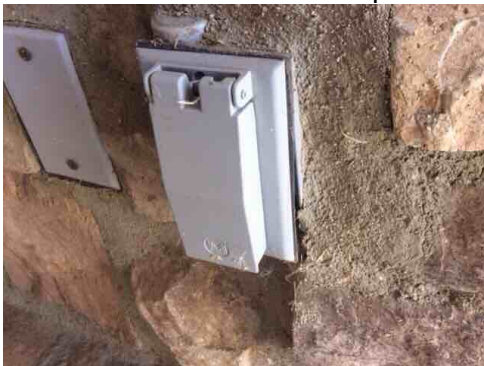
55: - There are exterior receptacles that are loose where attached to the wall.

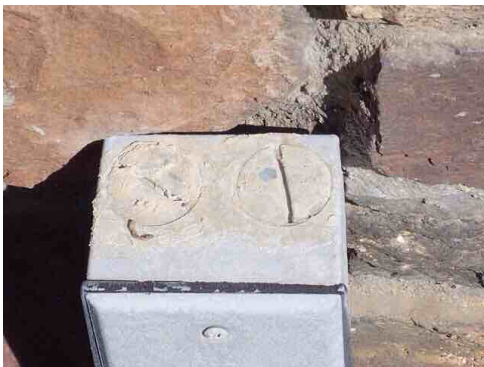
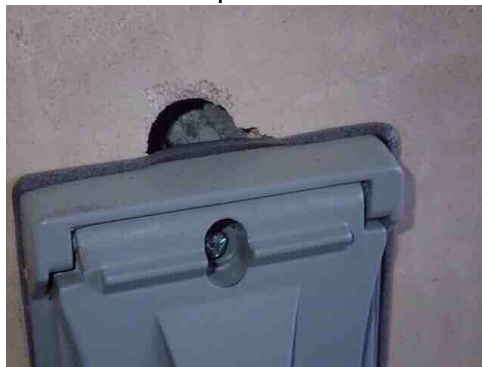
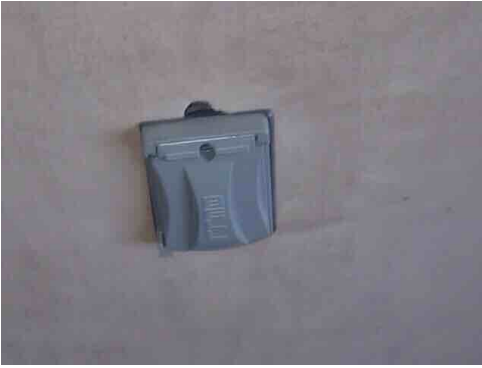
56: - Sealant is recommended around the exterior cover plates to wall connections.

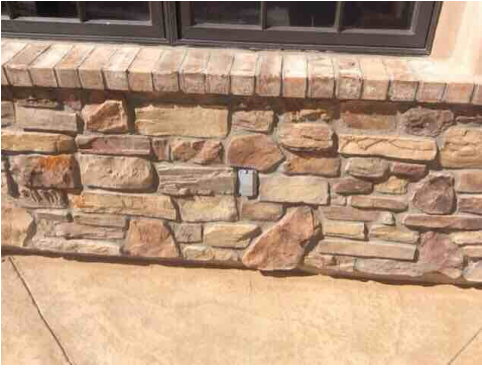
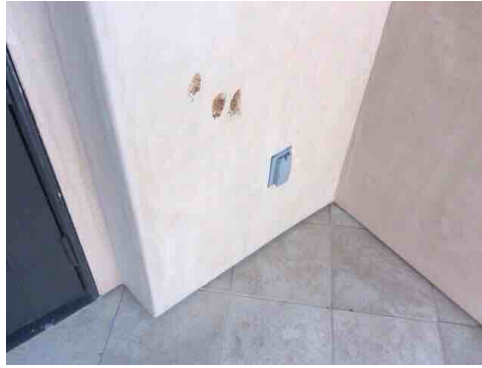
s-1: - The front porch, north side, east side rear, south side, upper deck ground-fault protected outlets did not trip or are not protected upon test. The receptacles are suggested to be repaired or replaced as necessary.

58: - The front porch, north side, east side rear, south side, upper deck ground-fault protected outlets did not trip or are not protected upon test. The receptacles are suggested to be repaired or replaced as necessary.

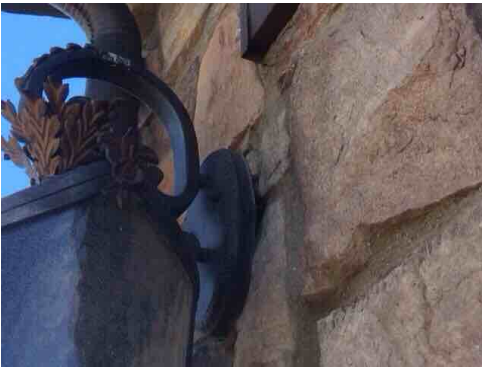
59: - Sealant is recommended around the exterior light fixture to wall connection(s).

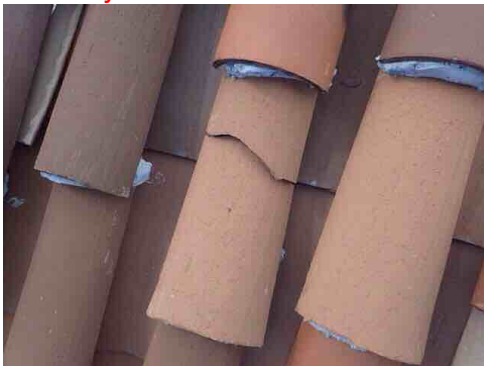
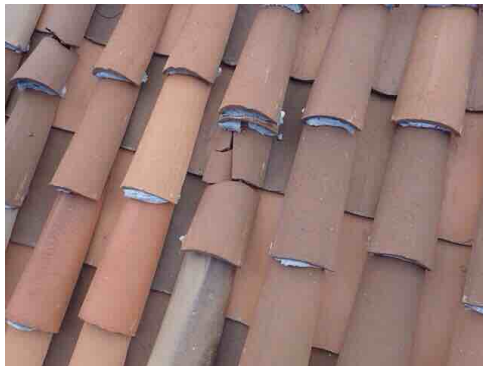
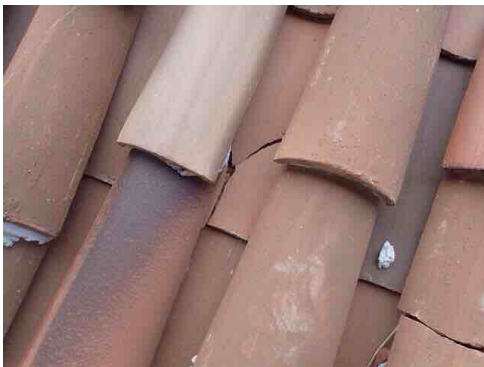
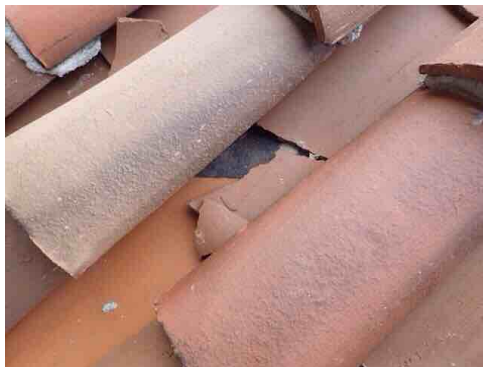
s-2: - There were cracked roof tiles which were observed at the main roof. This should be expected as regular wear and tear, however, the tile should be serviced to maintain the water tight integrity of the roof. This type of material should be replaced by a qualified roofing contractor as walking on this roof material may crack and / or break many tiles and cause more damage than necessary. Regular inspections and maintenance are recommended. This type of roof structure is recommended to be inspected every 2-3 years for any slipped, cracked or missing tiles. It is also recommended that the vents be inspected at this time and sealed as necessary. The tile roof covering material observed is a type that is typically walked on by Mazza Inspections, however, in some cases we may choose not to. For example, the seller may request that we not walk on their roof or the height or weather may represent a hazard. Other examples may be a steep pitch or the roof is a clay tile roof, where the possibility of damage to the tiles is greater. In which case, the roof is inspected from the inside of the house as well as all exterior accessible areas of the roof that are visible. There may be portions of the roof that were viewed from the ground and / or ladder using binoculars. Some sections of the roof may not be viewed at all.

90: - There were cracked roof tiles which were observed at the main roof. This should be expected as regular wear and tear, however, the tile should be serviced to maintain the water tight integrity of the roof. This type of material should be replaced by a qualified roofing contractor as walking on this roof material may crack and / or break many tiles and cause more damage than necessary. Regular inspections and maintenance are recommended. This type of roof structure is recommended to be inspected every 2-3 years for any slipped, cracked or missing tiles. It is also recommended that the vents be inspected at this time and sealed as necessary. The tile roof covering material observed is a type that is typically walked on by Mazza Inspections, however, in some cases we may choose not to. For example, the seller may request that we not walk on their roof or the height or weather may represent a hazard. Other examples may be a steep pitch or the roof is a clay tile roof, where the possibility of damage to the tiles is greater. In which case, the roof is inspected from the inside of the house as well as all exterior accessible areas of the roof that are visible. There may be portions of the roof that were viewed from the ground and / or ladder using binoculars. Some sections of the roof may not be viewed at all.

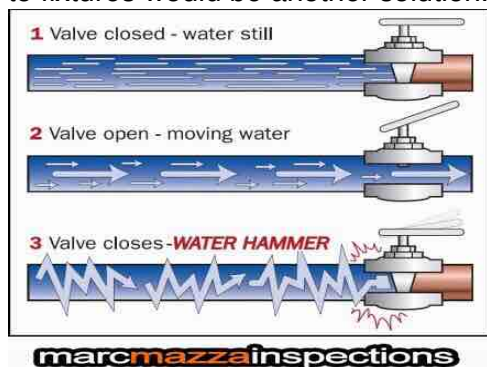
104: - Water hammer, or noisy piping, was observed when one or more fixtures were tested. Over time, and with severe water hammering, this condition may influence the integrity of pipe connections. Water hammering is a condition occasioned by the sudden stopping of water flow in a pipe resulting in a pressure wave that impacts upon closed valves. Closing valves and faucets slowly is one approach to avoiding water hammering. Better securing pipes (where possible) and installing air chambers (shock absorber) at the risers to fixtures would be another solution.

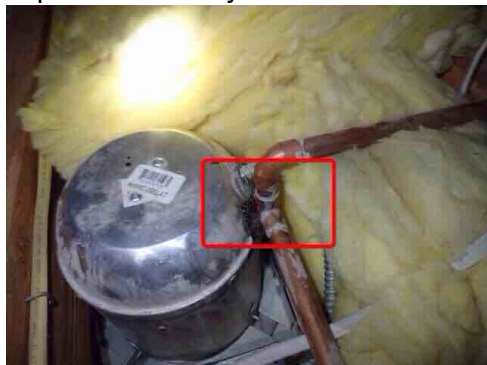
105: - There were connections of copper and dissimilar metals in the attic. The two metals should be separated as they can conduct electrolysis which corrodes the metals.

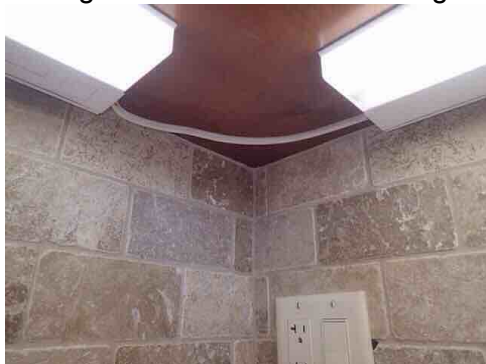
224: - There is under cabinet lighting which has been added in the kitchen. The wires are subject to physical damage and should be run through conduit for protection.

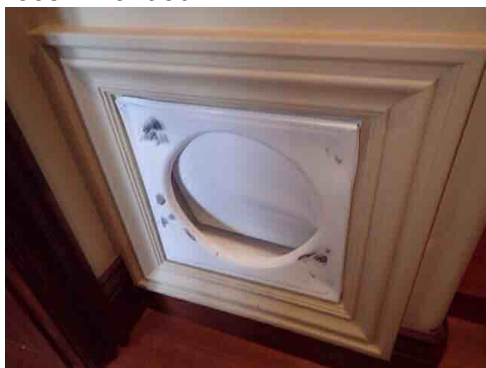
245: - The laundry chute door in the second floor north bedroom is damaged. Repair/replacement is recommended.

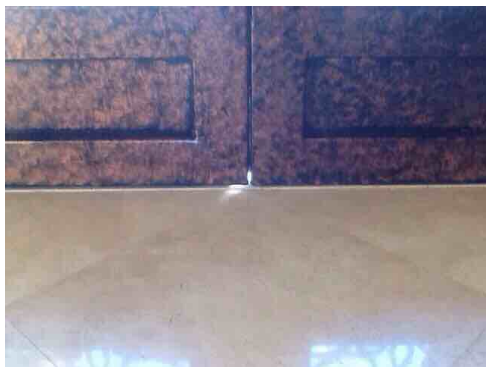
249: - The front door is functional but it is not weather sealed.

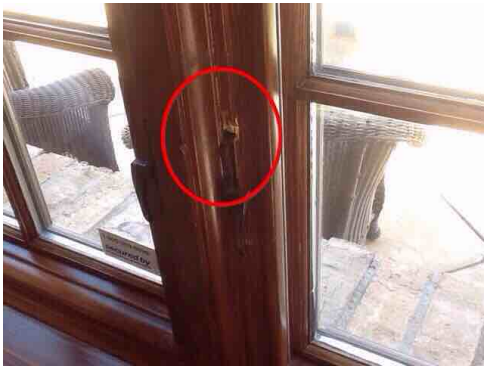
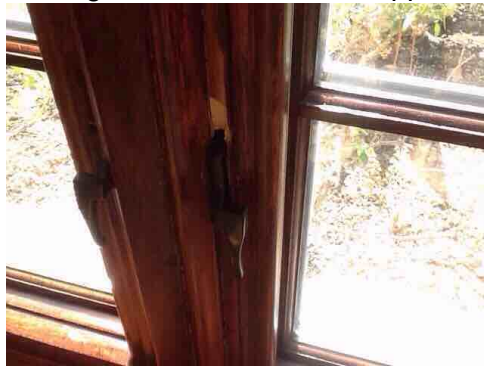
275: - There are window frames that are damaged in the office. This appears to be only of cosmetic concern.

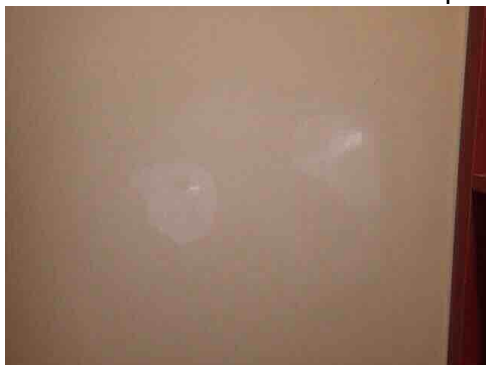
281: - Evidence of prior repairs / patching was observed at the interior walls. Further investigation may be desirable as to the reason for the patching / repairs.

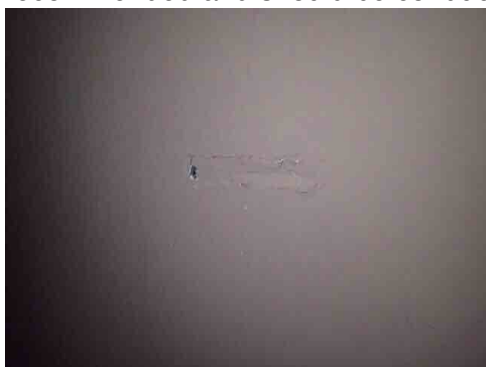
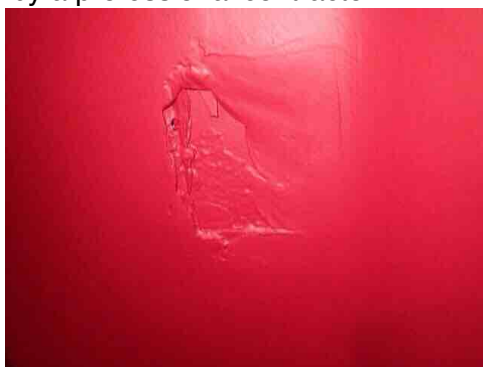
282: - Damaged drywall was noted under the basement stairwell and in the theater room. Repairs are recommended and should be conducted by a professional contractor.

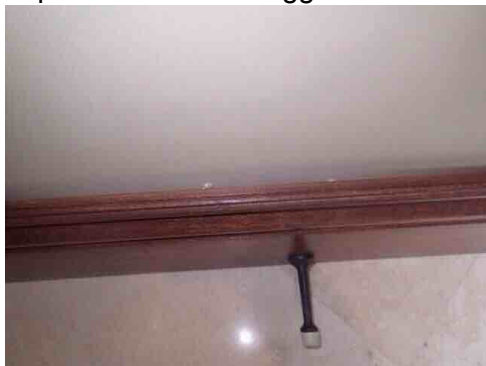
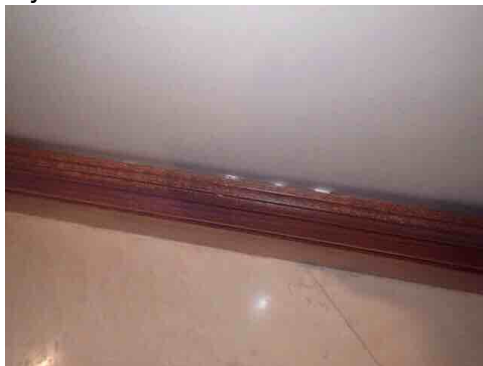
283: - We observed baseboard throughout the residence that appears to be loose/separating from the wall. Improvements are suggested as this is only a cosmetic concern.

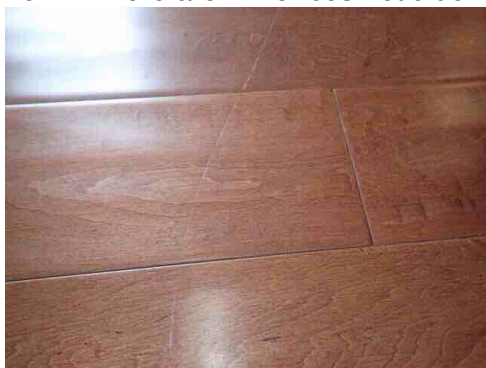
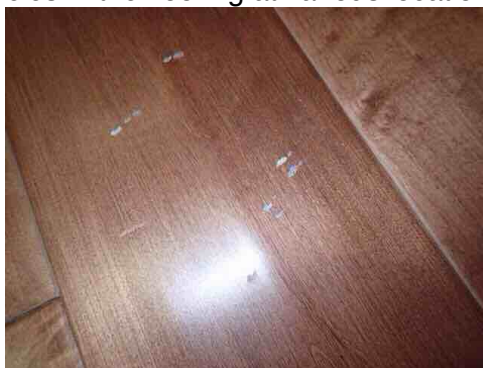
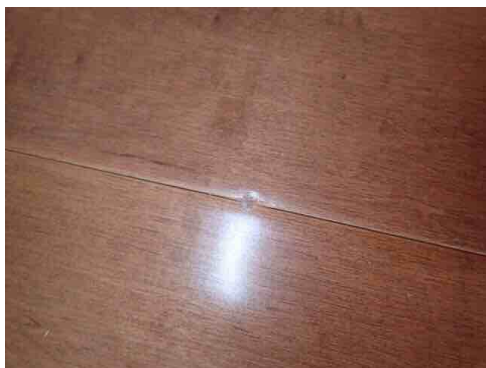
294: - There are minor cosmetic deficiencies in the flooring at various locations of the house.

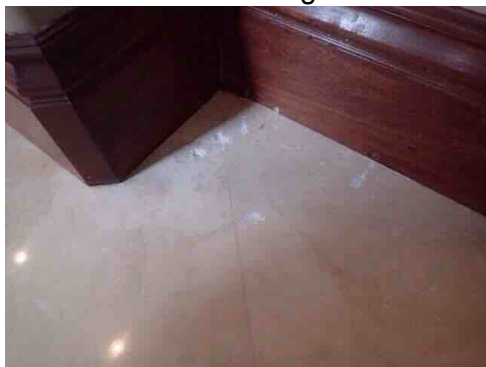
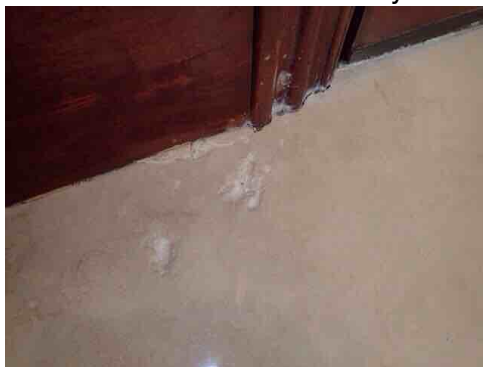
295: - There are damaged tiles in the north end of the first floor hallway.

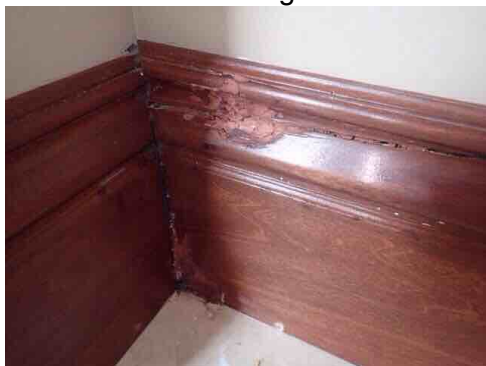
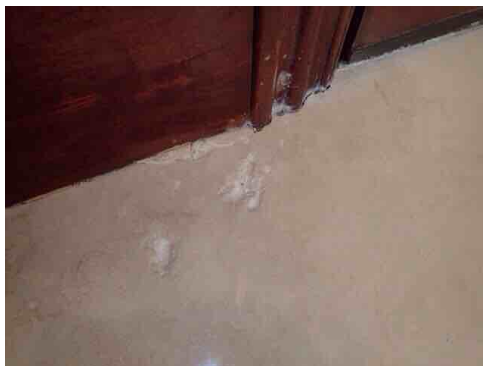
296: - There is damaged baseboard/trim in the north end of the first floor hallway.

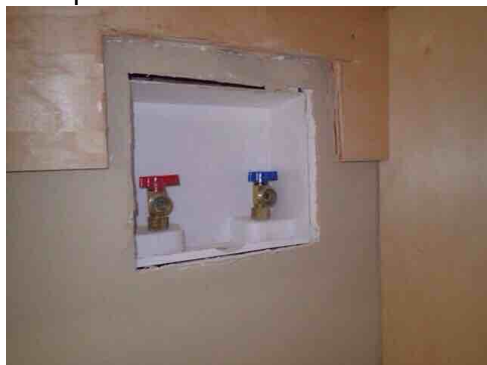
307: - The plastic covers to the plastic boxes that house the water supply lines are missing and suggested to be replaced.

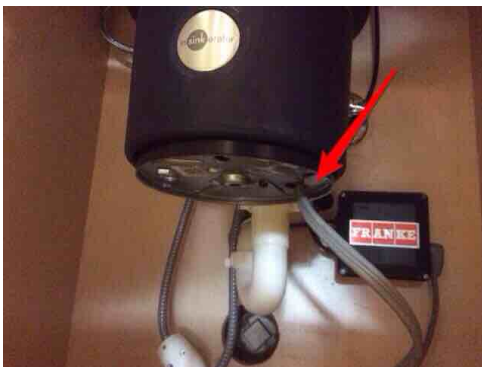
s-8: - The wire clamp is missing from the disposal unit under the secondary kitchen sink. Replacement is recommended.

339: - The wire clamp is missing from the disposal unit under the secondary kitchen sink. Replacement is recommended.

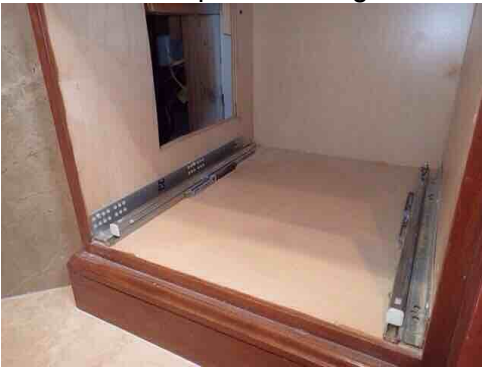
386: - We were unable to definitively say that the spa tub is on a dedicated GFI circuit due to inaccessibility inside the access panel. The tub is suggested to be on a dedicated GFI circuit. We recommend verification of this GFI circuit prior to using the tub.

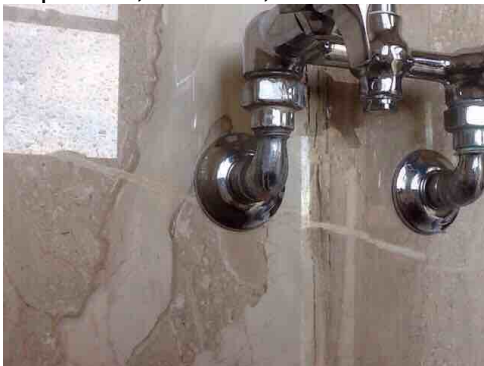
411: - Corrosion was noted on the water valve of the shower faucet. There was no leaking at the time of the inspection, however, the corrosion may suggest a past leak.

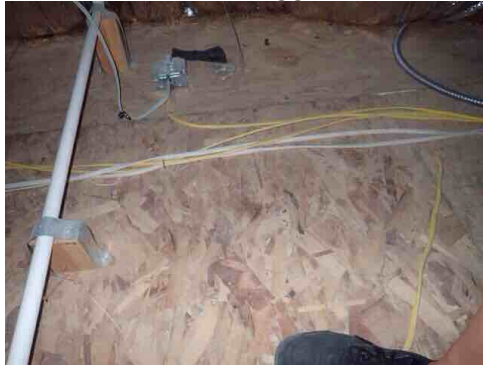
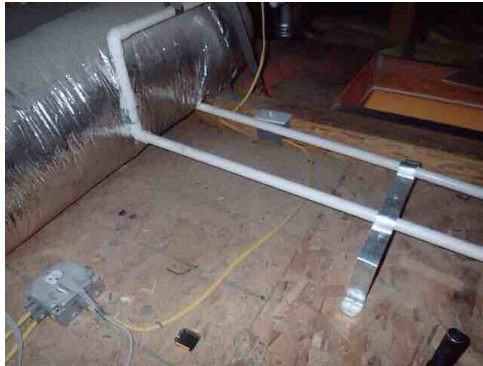
445: - Romex was observed on the platform deck which is suggested to be protected from physical damage.

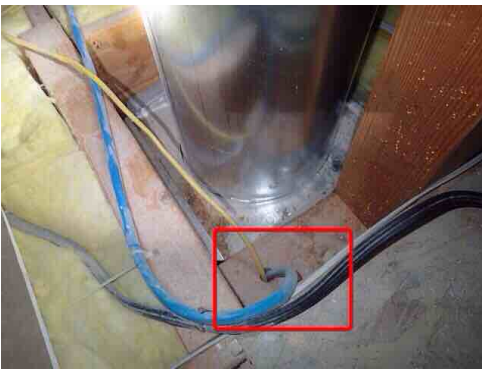
449: - The fire stop / fire blocking around the fireplace flue vent is breached by the wiring installed into the chase which is not installed in accordance to manufacturer's / building standards / specifications (and thus leaves a gap) around its perimeter, where it is suggested to be tightly sealed to the top of the ceiling "plates". Further assessment is advised.

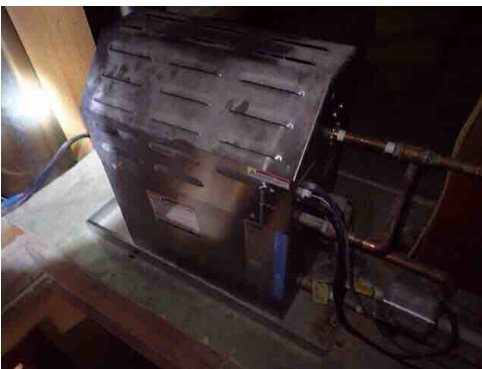
450: - We observed a steam machine located within the attic. This unit was not tested but we feel it prudent to disclose we observed stains within the pan as if to suggest a current or previous leak. There was, however, no visible leak observed.

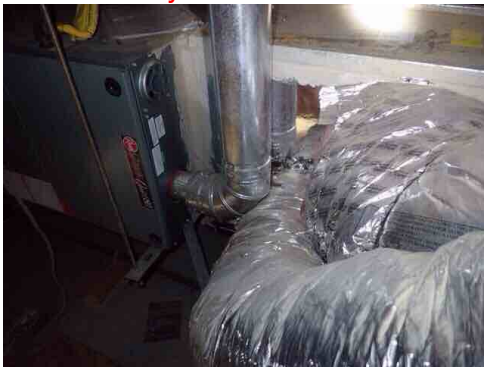
502: - The gas appliance vent pipe should be one inch away from combustible materials (wood, plastic, insulation, drywall, foam, etcetera). This vent is close to combustible materials. Moving the vent to a safer location away from the combustibles is suggested.

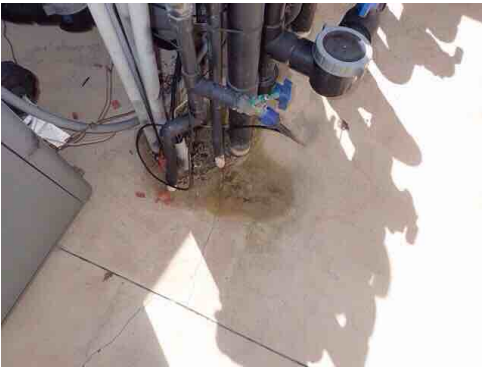
556: - Leaking was observed at a faucet located within the pool equipment area which has a hose attached to it.

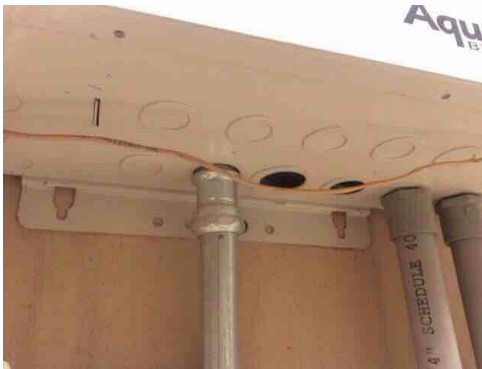
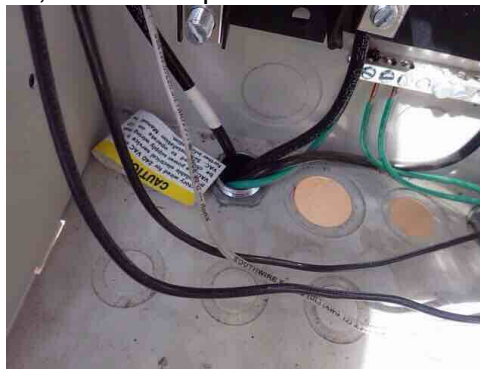
590: - An opening in the electrical panel was observed. No openings are recommended in the panel that are accessible from the exterior side of the box, as this is a potential hazard.

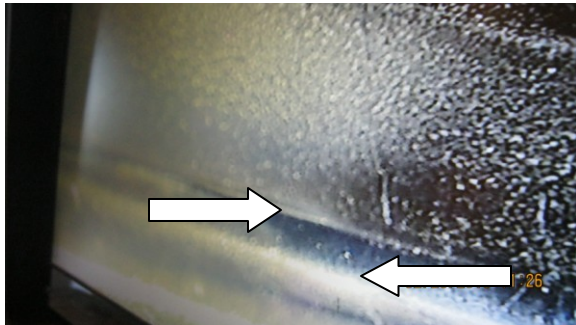
As viewed via video camera, there are several sections of pipe that are coming apart. These separations can pose a potential fire hazard as heat and sparks could get past the seams in the pipes.

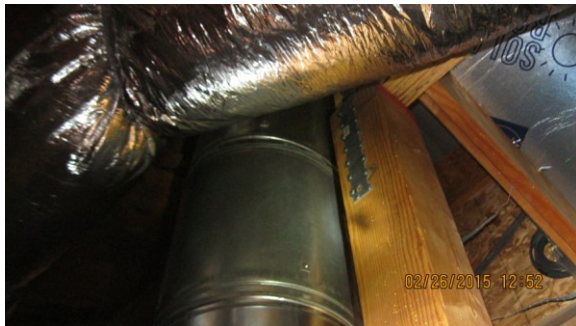
When viewed within the attic exposed pipes are visible. This pipe should not be exposed within the attic. There should be vertical firestopping closing off the pipe to prevent heat and sparks from entering into the attic space. The pipe is too close to combustible materials (wood beam). The pipe is required to be at least 2 inches away.

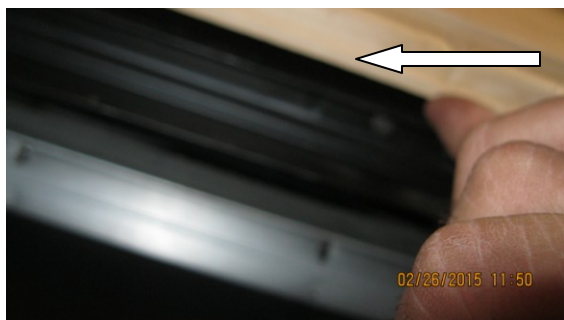
The face/surround was not sealed around the opening of the fireplace. This poses a potential fire hazard as heat can get between the tile and fireplace and enter into the interior structure.

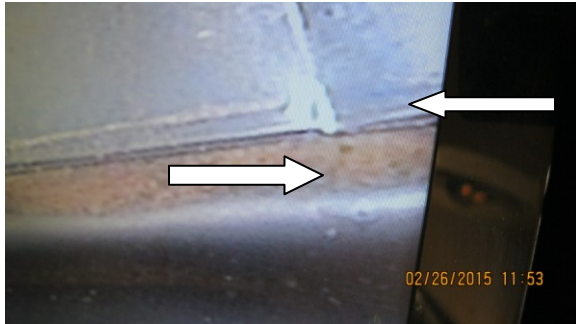
When viewed via video camera, several sections of pipe that were coming apart were viewed. These separations pose a potential fire hazard as heat and sparks could get past the seams in the pipes.

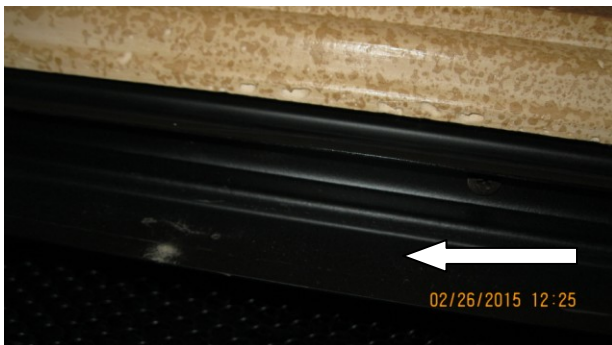
The face/surround was not sealed around the opening of the fireplace. This can be a potential fire hazard as heat can get between the tile and fireplace and enter into the structure of the house.

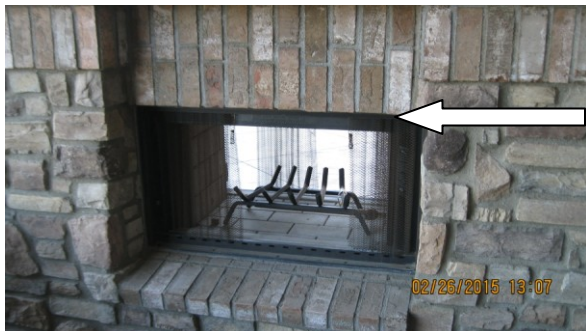
The face/surround has some rusting that is occurring around the opening. The rusting is minor but it should be repainted to help prolong the life of the fireplace.
