Pool and Spa

1. General Comments

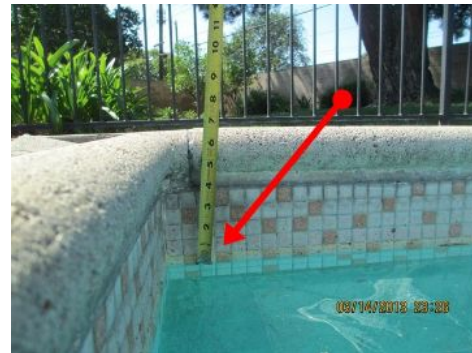
pool out of level north side of pool

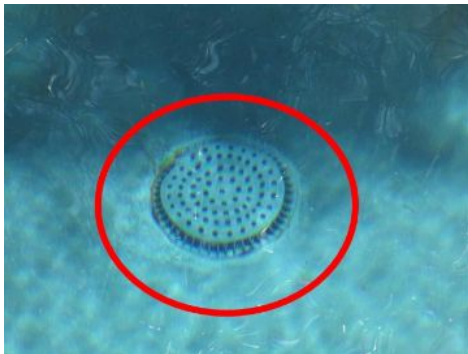
Type: The pool drain cover is a non antientrapment type.

- 10.1. These drain covers installed have been recalled by CMP Inc. Removal and replacement of these drain covers is suggested. <http://www.cmp.com/DrainCoverRecall2.htm>

"recalled" drain cover

Replace drain cover

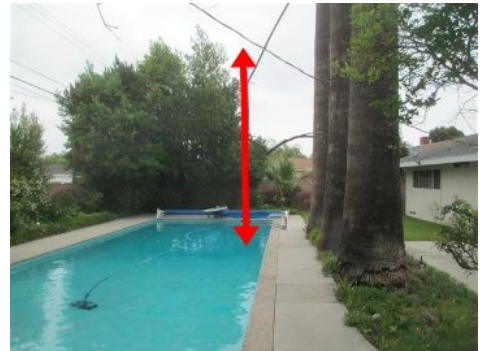
22.3. The overhead conductor lines that convey power to the house are too low over the swimming pool. However, if you do not wish to have them rerouted, they should be raised to a minimum of 22.5 feet from the waters surface, within 10 feet of the water.

electrical service conductors too close to pool surface

Service drop and pool bonding Licensed Electrical Contractor estimate recommended.

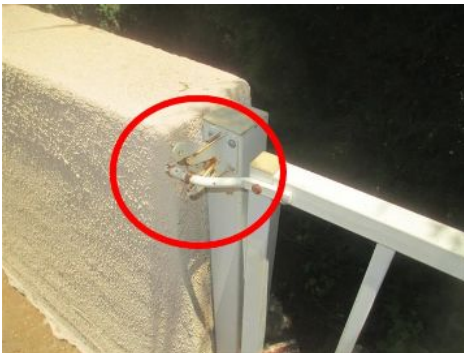
24.1. The gate(s) that lead into the rear yard where there is a pool, pond (greater than 18 inches deep) or spa, (including spas with locking covers) should be equipped with a selfclosing device that completely latches the gate when shut as per local building standards (we test at 12" away). Gates should close completely and latch and open outward away from the rear yard.

gates to pool yard do not self latch

Install selfclosers on gates
