Pool and Spa

1. General Comments

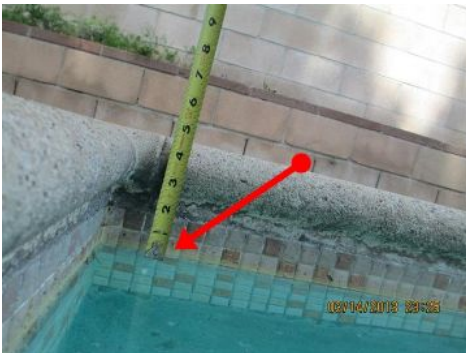
pool out of level south side of pool

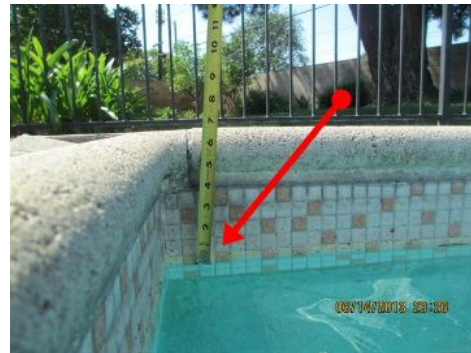
pool out of level north side of pool

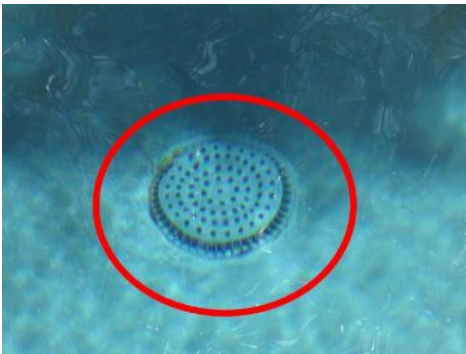
Type: The pool drain cover is a non antientrapment type.

- 10.1. These drain covers installed have been recalled by CMP Inc. Removal and replacement of these drain covers is suggested. <http://www.cmp.com/DrainCoverRecall2.htm>

"recalled" drain cover

recalled drain covers

Replace drain cover

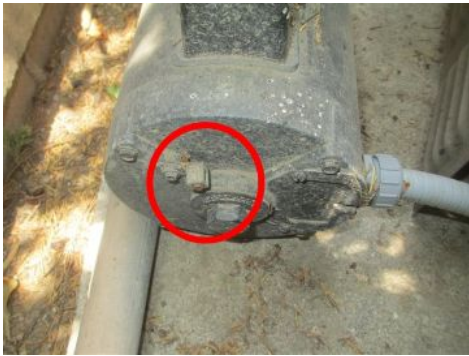
15.2. This pool circulation motor is not bonded. A bond wire is recommended to be connected to all metal components within the pool equipment then back to a ground source.

no bond observed at the pool motor

Circulation Pump Install new main seal and repair top nipple and bond

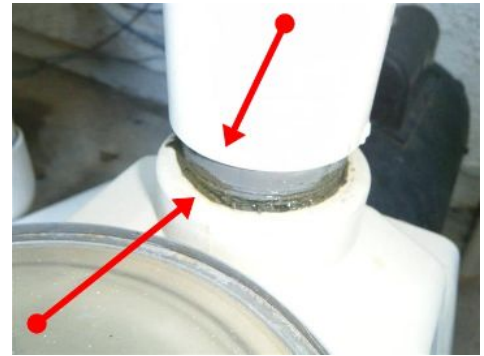
15.4. Leaking was observed at the top nipple or return side of the pump. The leaking appears to be somewhat minimal, however, as a precautionary measure we suggest a pool professional inspect the pipes and repair as necessary.

leak at the top pipe connection into pump

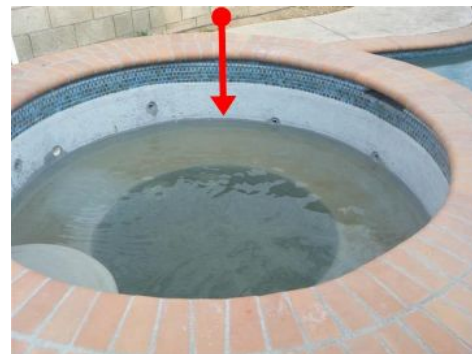
17.2. The "check" valve installed was leaking and may allow the spa to backdrain.

bad "check valve" causing the spa to drain out

Repair check valve

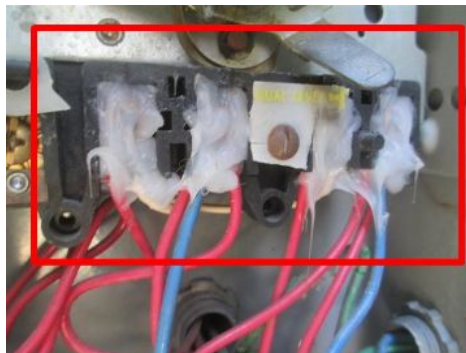
21.2. There is a material, which appears to be silicone, that has been applied to the connections / screw terminals in the timer box. This is not a suggested application and may be considered a hazard. Removal is recommended and any repairs necessary as a result of the removal.

silicone material on screw terminals

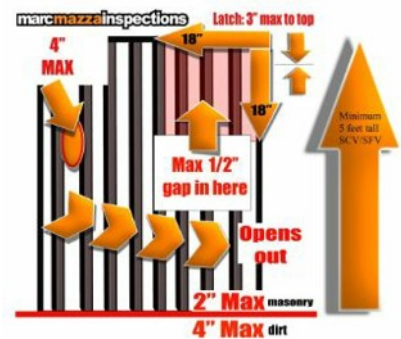
pool gate standards
