# Pool Inspection Report

123 Inspection Way, City, CA 91354  
Inspection prepared for: Mr. Client

Inspector: Marc Mazza  
27943 Seco Canyon Road, 560, Santa Clarita , CA 91350

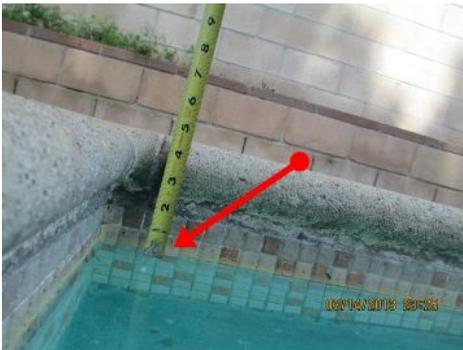
pool out of level south side of pool

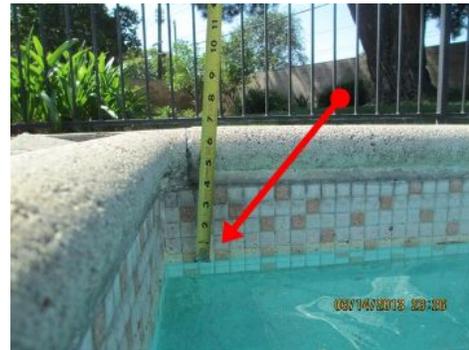
pool out of level north side of pool

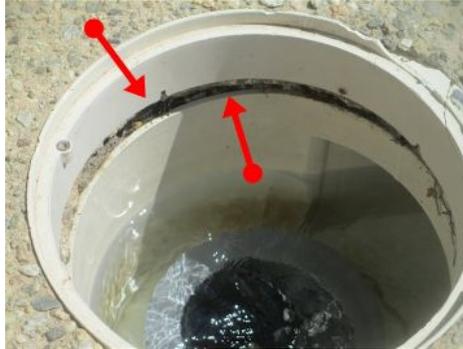
- 8.1. The skimmer box and its cover are functional.
- 8.2. The connection of the skimmer box to the concrete deck is in need of sealant.

sealant is suggested within skimmer

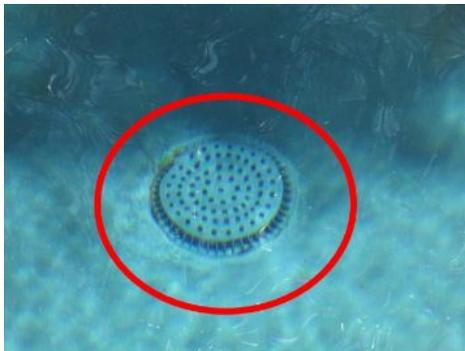
Type: The pool drain cover is a non antientrapment type.

- 10.1. These drain covers installed have been recalled by CMP Inc. Removal and replacement of these drain covers is suggested. <http://www.cmp.com/DrainCoverRecall2.htm>

"recalled" drain cover

Replace drain cover

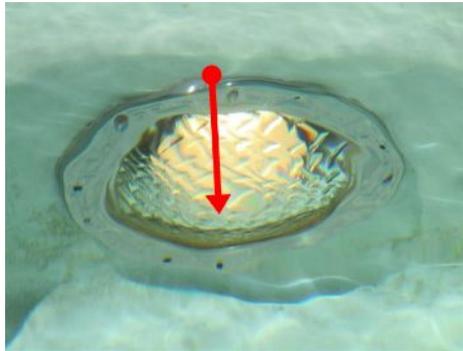
11.2. At the time of the inspection we observed stains or discoloration or, what appeared to be water within the wet niche light bucket. We suggest inspecting the light fixture for possible moisture entry and if water is in fact present, we therefore suggest removing the bucket and replacing the niche or servicing the seal if possible.

water in light niche

Install new light

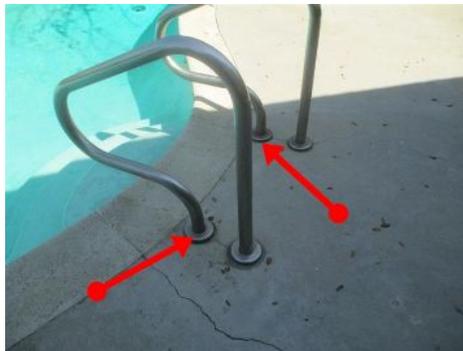
14.2. The pool ladder rails are too loose and should be more securely mounted, for safety reasons.

14.3. The ladder and or railing did not appear to be visibly "bonded" as per building standard.

loose railing / no visible equipotential bonding conductor

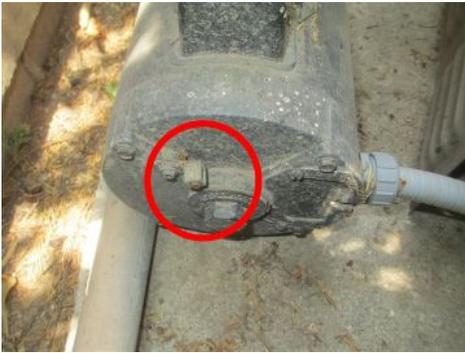
15.2. This pool circulation motor is not bonded. A bond wire is recommended to be connected to all metal components within the pool equipment then back to a ground source.

no bond observed at the pool motor

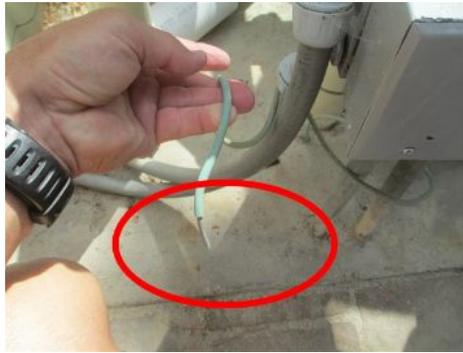
disconnected pool equipotential bonding conductor

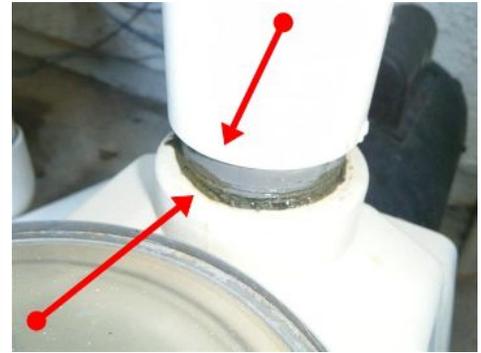
15.4. Leaking was observed at the top nipple or return side of the pump. The leaking appears to be somewhat minimal, however, as a precautionary measure we suggest a pool professional inspect the pipes and repair as necessary.

leak at the top pipe connection into pump

Circulation Pump Install new main seal and repair top nipple and bond

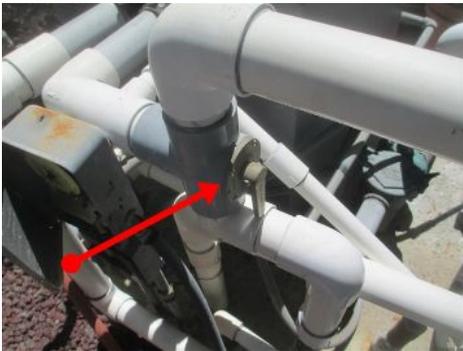
17.1. There is a leak at a valve on the return side in the equipment area, which should be repaired.

valve is leaking

Repair return valve

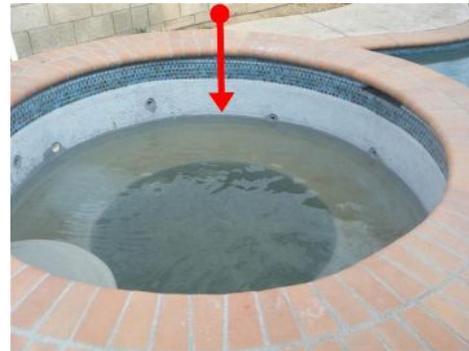
17.2. The "check" valve installed was leaking and may allow the spa to backdrain.

bad "check valve" causing the spa to drain out

Repair check valve

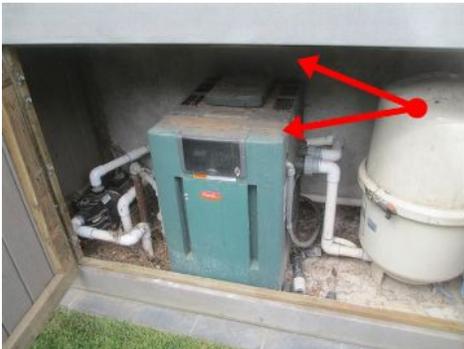
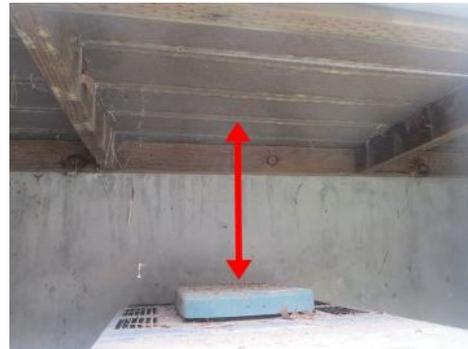
19.3. The heater has been installed in an area with insufficient clearance from combustible materials (wood) according to current building standards and is considered a fire hazard. Heaters must not be installed under an overhang of less than three (3) feet from the top of the heater. Three (3) sides must be open in the area under the overhang. Roof water drainage must be diverted away from the heaters installed under overhangs with the use of gutters.

heater clearance to wood is substandard

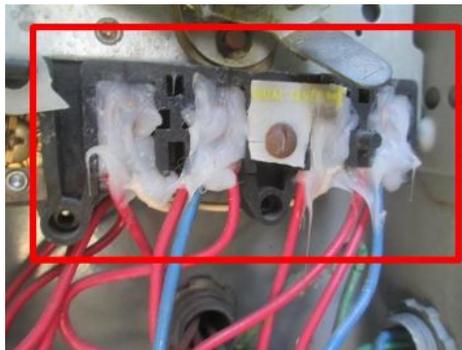
21.2. There is a material, which appears to be silicone, that has been applied to the connections / screw terminals in the timer box. This is not a suggested application and may be considered a hazard. Removal is recommended and any repairs necessary as a result of the removal.

silicone material on screw terminals

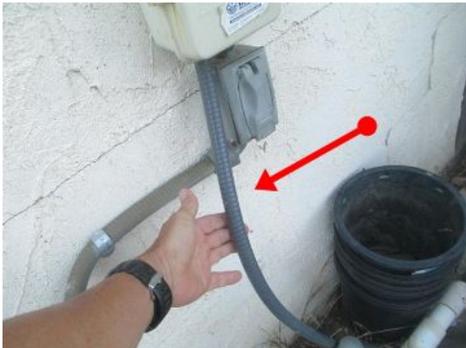
22.1. A flexible metal conduit for the pool equipment is loose and not secured properly. Securing this attachment is recommended.

conduit is not secured in accordance to building standard

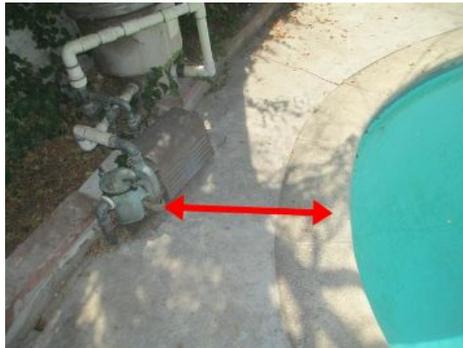
22.2. The pool equipment is too close to the pool body per current building standards.

CEC Article 680.27(B) (1)

The electric motors, controllers, and wiring shall be located at least 5 feet from the inside wall of the pool unless separated from the pool or spa by a wall, cover, or other permanent barrier.

pool equipment is too close to water

Build barrier at equipment

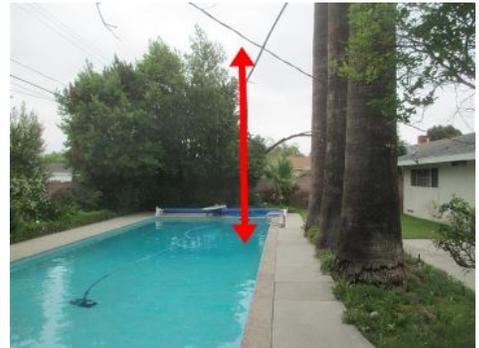
22.3. The overhead conductor lines that convey power to the house are too low over the swimming pool. However, if you do not wish to have them rerouted, they should be raised to a minimum of 22.5 feet from the waters surface, within 10 feet of the water.

electrical service conductors too close to pool surface

Service drop and pool bonding Licensed Electrical Contractor estimate recommended.

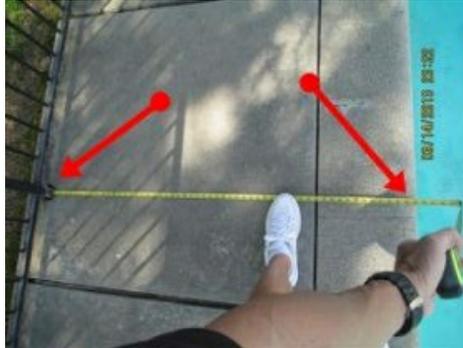
23.4. If the wrought iron fencing is closer than 5 feet to the swimming pool the fencing must then be

bonded in accordance to building code.

wrought iron fence too close to pool water

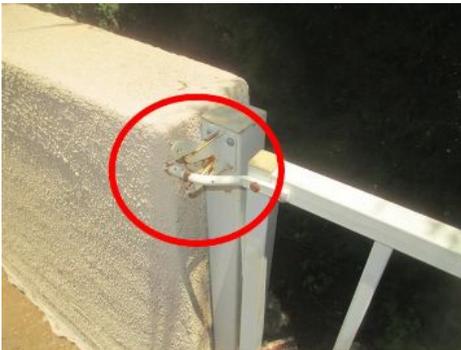
24.1. The gate(s) that lead into the rear yard where there is a pool, pond (greater than 18 inches deep) or spa, (including spas with locking covers) should be equipped with a selfclosing device that completely latches the gate when shut as per local building standards (we test at 12" away). Gates should close completely and latch and open outward away from the rear yard.

gates to pool yard do not self latch

Install selfclosers on gates

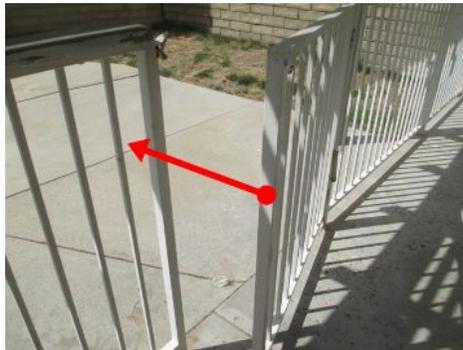
gates do not self close

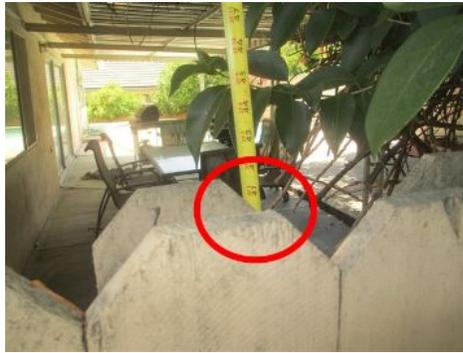
25.1. The pool barrier is short. The barrier should be maintained at the local minimum building standard height of 4860 inches (depending on code in jurisdiction) but this figure should be verified with the local building authority.

pool barrier is short

Increase height of barrier where its low General or Fencing Contractor estimate recommended.
