Pool and Spa

1. General Comments

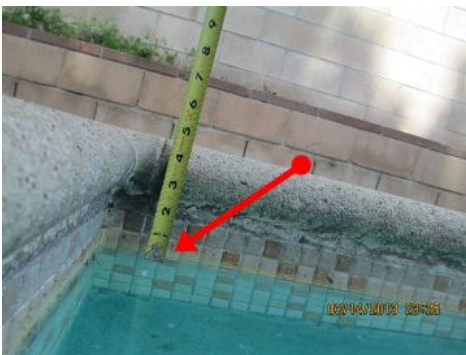
pool out of level south side of pool

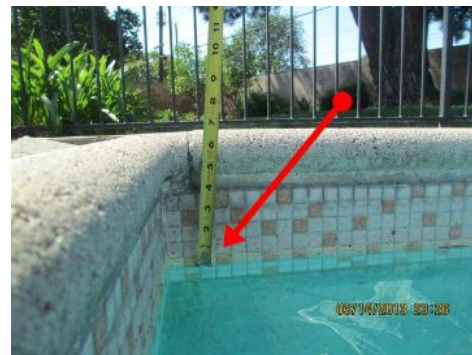
pool out of level north side of pool

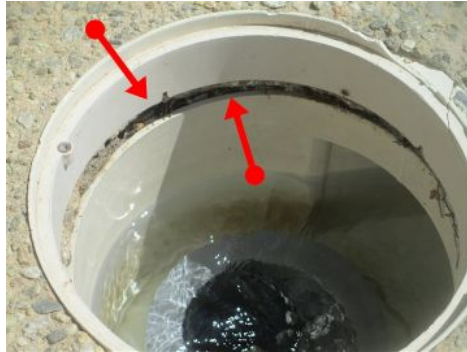
- 8.1. The skimmer box and its cover are functional.
- 8.2. The connection of the skimmer box to the concrete deck is in need of sealant.

sealant is suggested within skimmer

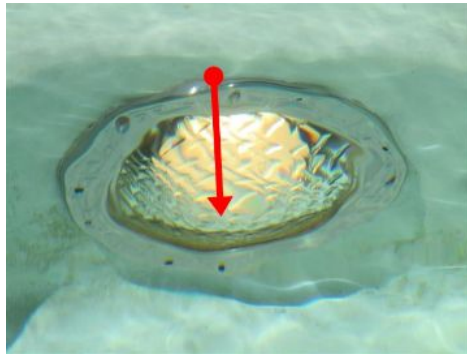
water in light niche

11.2. At the time of the inspection we observed stains or discoloration or, what appeared to be water within the wet niche light bucket. We suggest inspecting the light fixture for possible moisture entry and if water is in fact present, we therefore suggest removing the bucket and replacing the niche or servicing the seal if possible.

Install new light

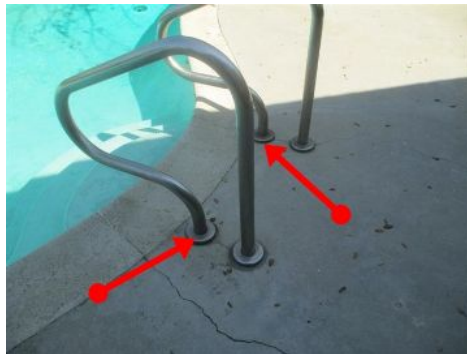
14.2. The pool ladder rails are too loose and should be more securely mounted, for safety reasons.

14.3. The ladder and or railing did not appear to be visibly "bonded" as per building standard.

loose railing / no visible equipotential bonding conductor

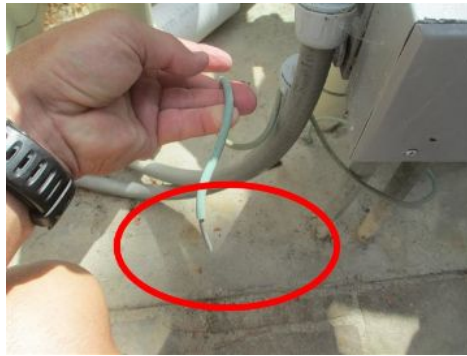
disconnected pool equipotential bonding conductor

23.5. At the time of this inspection we did not observe an equipotential bond at any metal component associated with the pool in accordance to the NEC, local building standards. In light of this condition, we suggest the buyer have an electrician familiar with bonding and the bonding grid perform repairs as necessary.

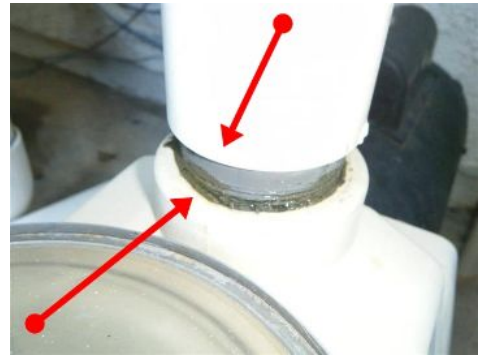
leak at the top pipe connection into pump

15.4. Leaking was observed at the top nipple or return side of the pump. The leaking appears to be somewhat minimal, however, as a precautionary measure we suggest a pool professional inspect the pipes and repair as necessary.

Circulation Pump Install new main seal and repair top nipple and bond

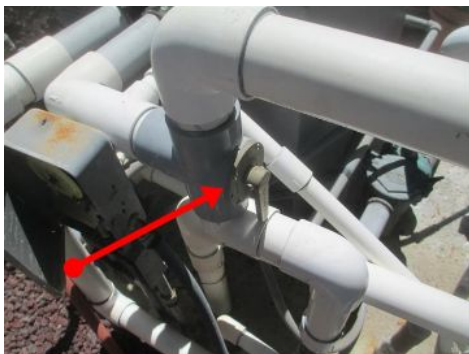
valve is leaking

17.1. There is a leak at a valve on the return side in the equipment area, which should be repaired.

Repair return valve

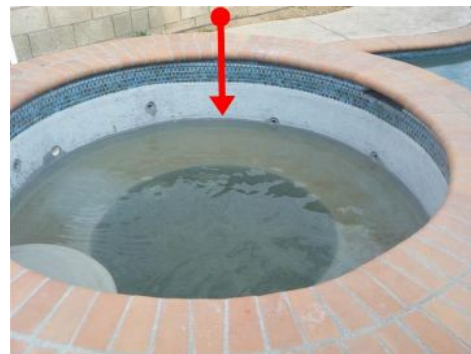
17.2. The "check" valve installed was leaking and may allow the spa to backdrain.

bad "check valve" causing the spa to drain out

Repair check valve

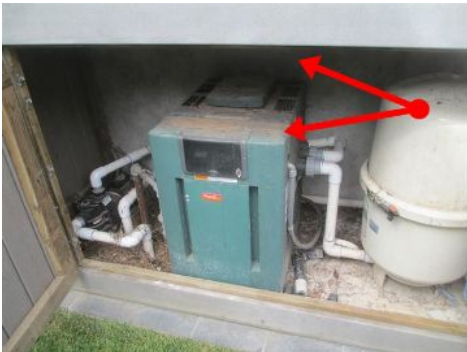
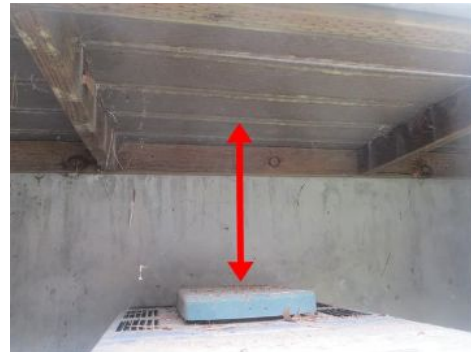
heater clearance to wood is substandard

19.3. The heater has been installed in an area with insufficient clearance from combustible materials (wood) according to current building standards and is considered a fire hazard. Heaters must not be installed under an overhang of less than three (3) feet from the top of the heater. Three (3) sides must be open in the area under the overhang. Roof water drainage must be diverted away from the heaters installed under overhangs with the use of gutters.

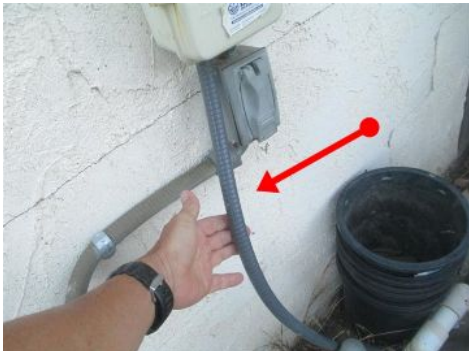
conduit is not secured in accordance to building standard

22.1. A flexible metal conduit for the pool equipment is loose and not secured properly. Securing this attachment is recommended.

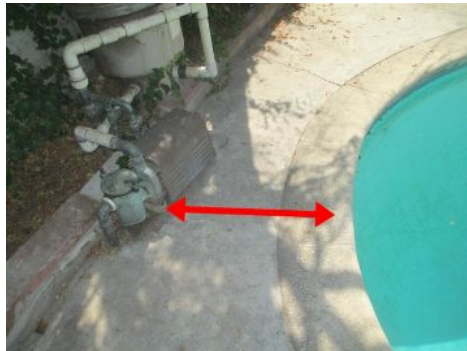
pool equipment is too close to water

22.2. The pool equipment is too close to the pool body per current building standards.

CEC Article 680.27(B) (1)

The electric motors, controllers, and wiring shall be located at least 5 feet from the inside wall of the pool unless separated from the pool or spa by a wall, cover, or other permanent barrier.

Build barrier at equipment

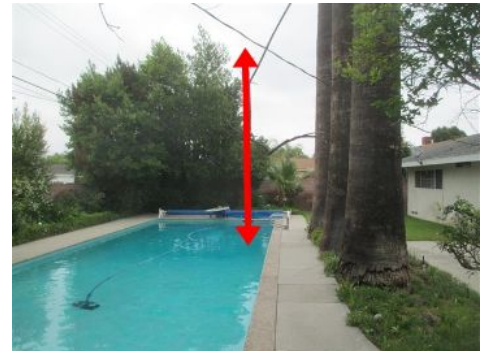
electrical service conductors too close to pool surface

22.3. The overhead conductor lines that convey power to the house are too low over the swimming pool. However, if you do not wish to have them rerouted, they should be raised to a minimum of 22.5 feet from the waters surface, within 10 feet of the water.

Service drop and pool bonding Licensed Electrical Contractor estimate recommended.

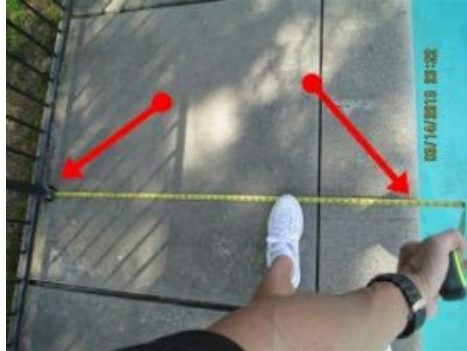
wrought iron fence too close to pool water

23.4. If the wrought iron fencing is closer than 5 feet to the swimming pool the fencing must then be

bonded in accordance to building code.

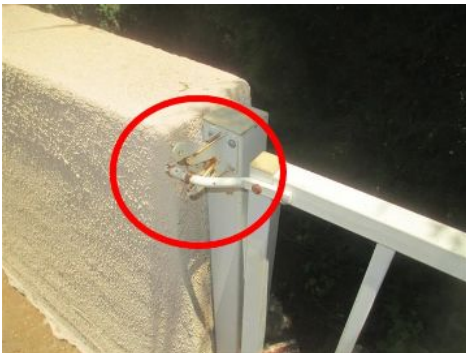
gates to pool yard do not self latch

24.1. The gate(s) that lead into the rear yard where there is a pool, pond (greater than 18 inches deep) or spa, (including spas with locking covers) should be equipped with a selfclosing device that completely latches the gate when shut as per local building standards (we test at 12" away). Gates should close completely and latch and open outward away from the rear yard.

Install selfclosers on gates

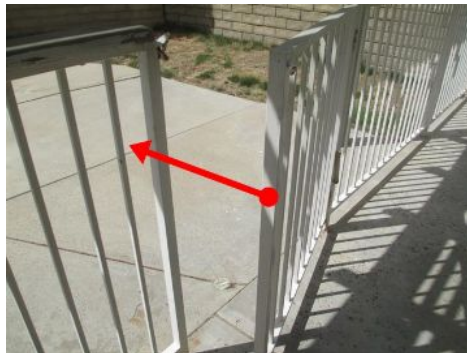
gates do not self close

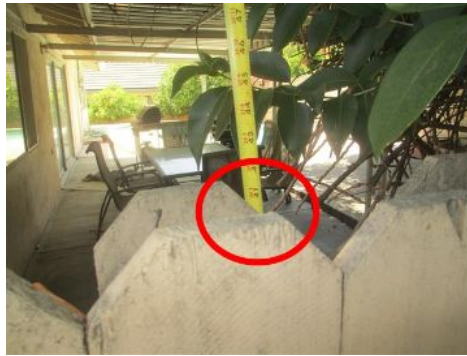
pool barrier is short

25.1. The pool barrier is short. The barrier should be maintained at the local minimum building standard height of 4860 inches (depending on code in jurisdiction) but this figure should be verified with the local building authority.

Increase height of barrier where its low General or Fencing Contractor estimate recommended.
