Property Inspection Report

Monday, February 1, 2016

Inspector, Marc Mazza
Mazza Inspection Group
(866) 996-2992
CA 776512

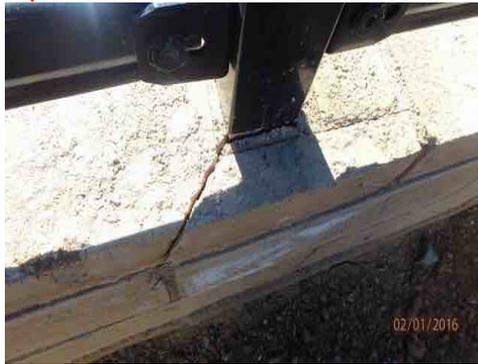
26: - Cracks were observed in the brick cap of the block fence.

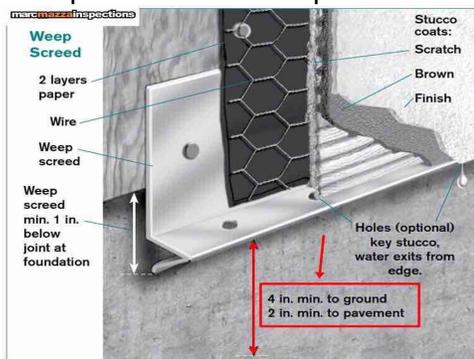
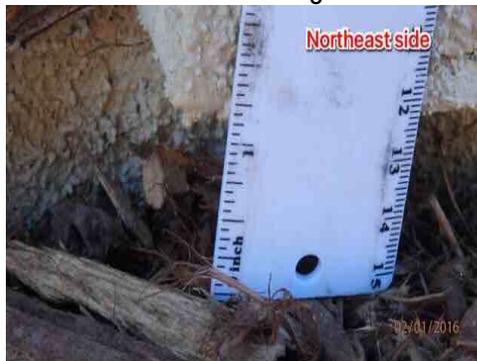
30: - There is soil that is high at the foundation at the time of the inspection which is to say the soil level is up to or above the weep screed. Soil at this level may allow moisture penetration in the interior wood framing members or insect infestation. There should be at least 4 inches between the weep screed (if present) and the soil level and 6 inches between siding and the soil level. It is recommended that this condition be referred to a qualified termite inspector for further evaluation - IRC 2012 §703.6.2.1.

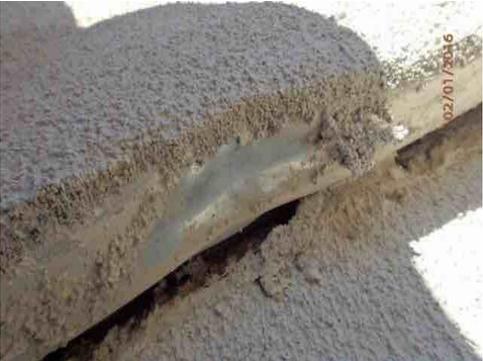
32: - Evidence of prior repairs / patching was viewed at exterior wall(s). We are unable to determine if the repairs were performed in a manner which is consistent with minimum building standards. Our concern is that the building paper is not breached or damaged. Further investigation as to the reason for the patching / repairs is suggested.

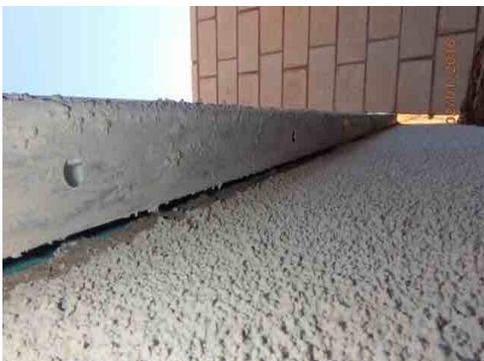
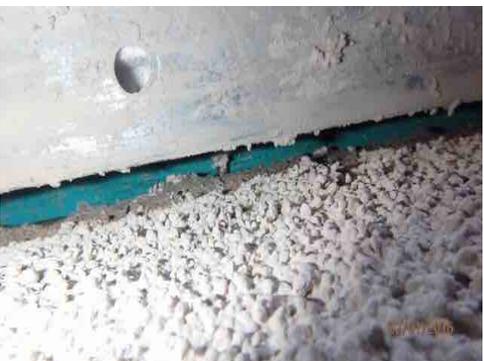
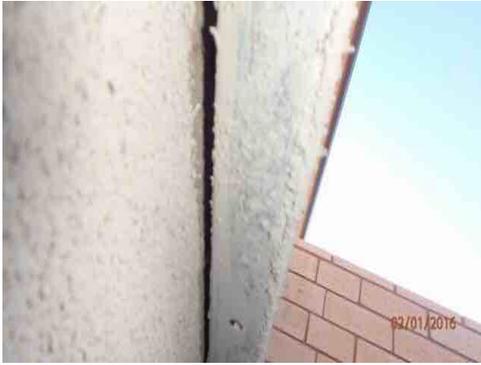
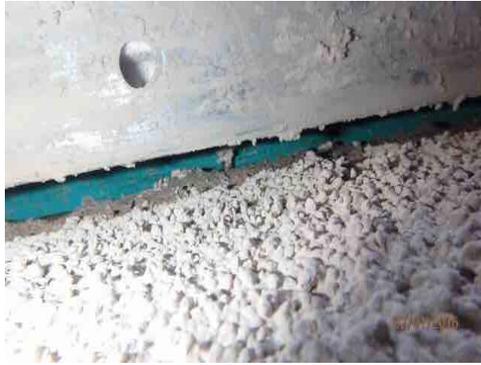
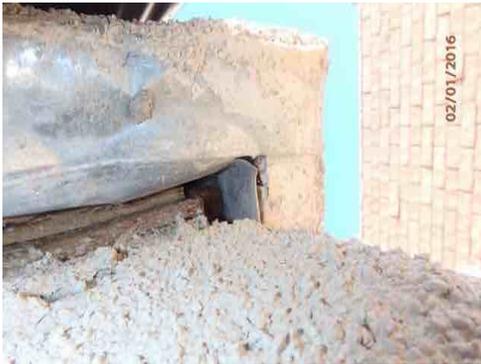
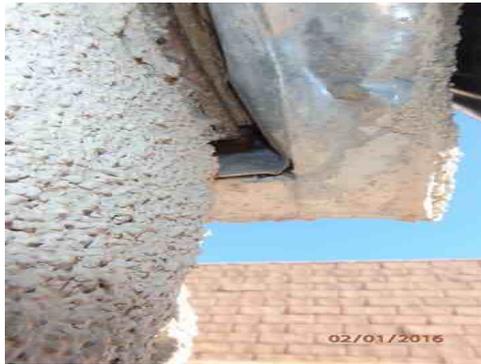
34: - We observed a significant separation between the weep screed and the exterior wall exposing the interior wall covering materials around the perimeter of the building as pictured. Without original structural drawings we won't be able to say definitively that the separation is substandard, however, conventional wisdom suggests that the interior of the buildings system should not be exposed to the elements.

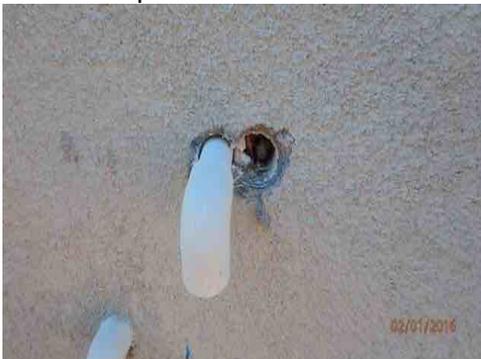
35: - There is missing stucco (holes, openings, missing covers, chips) noted within the exterior walls of the house. These openings may allow moisture to enter into the structure resulting in possible damage to interior wood framing members. In addition, openings in the stucco may also allow pests to enter and should be sealed as preventative maintenance.

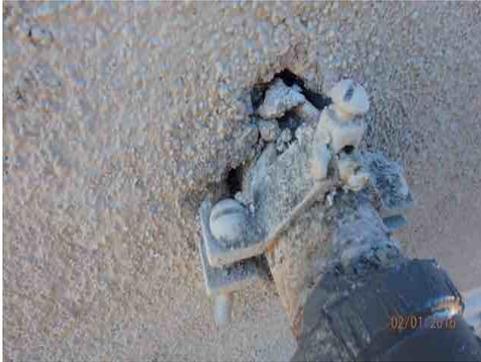
36: - Sealant is necessary around holes, cracks, A/C lines, bolts, screws, flashing connections into the stucco, pipes and other various areas which may offer an point of penetration into the exterior wall covering materials to prevent moisture intrusion.

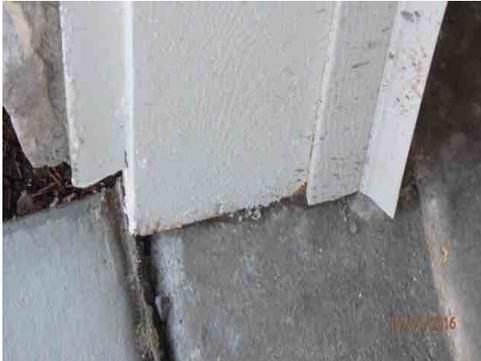
38: - Wood trim was observed in direct contact with the grade (concrete or soil). This contact may increase the wicking effect of moisture being drawn up into the wood that, in turn, creates the flaking and peeling of paint material, pest intrusion or the deterioration of wood. 2013 CRC section 317.1.2.

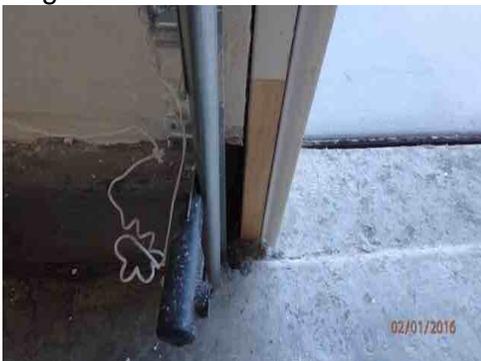
39: - Unfinished wood trim was noted at the time of the inspection. Proper finishing of these materials will lengthen the life of the material.

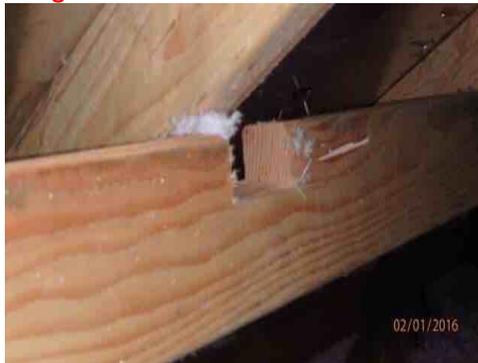
s-3: - Multiple mending plates within the truss system observed in the attic are damaged, loose or completely unattached. The mending plates are recommended to be properly attached to maintain the structural integrity of the framing components.

47: - Multiple mending plates within the truss system observed in the attic are damaged, loose or completely unattached. The mending plates are recommended to be properly attached to maintain the structural integrity of the framing components.

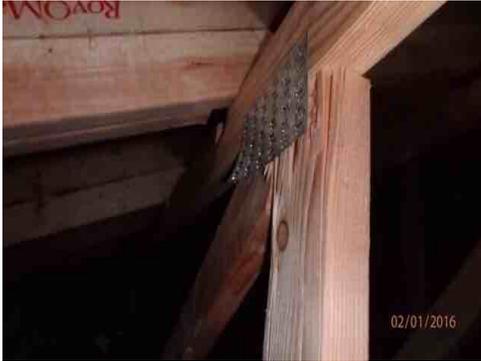
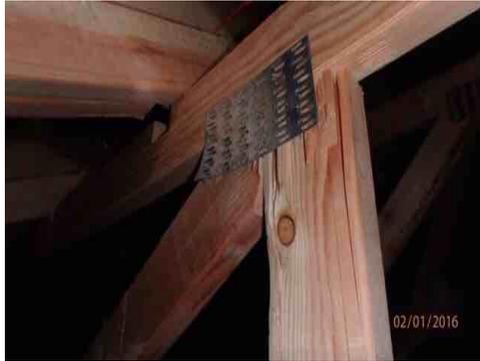
49: - Damage was noted at the truss pictured. Truss damage is suggested to be repaired under the jurisdiction of the local building authority and the work performed by a qualified contractor.

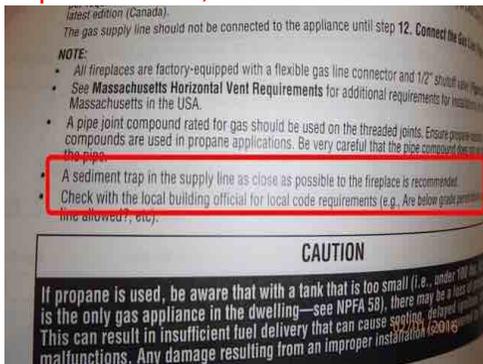
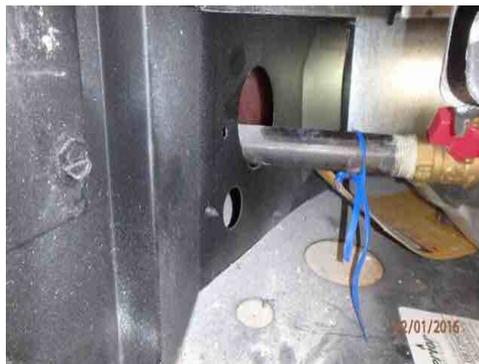
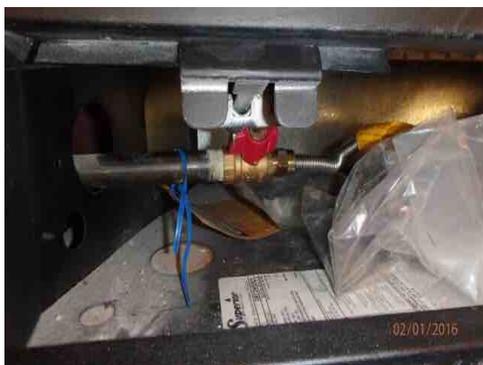
53: - In accordance with the manufacturer, the fuel line is suggested to possess a sediment trap. If such a trap is installed, it is not visible to us.

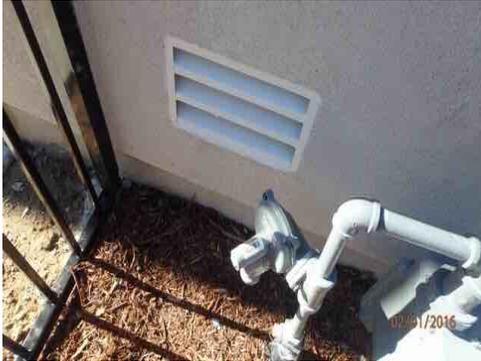
70: - The gas meter air relief vent is too close to the garage intake vent, according to building standards. A three foot clearance is suggested to be maintained as not to conflict. This meter was obviously installed by the local utility company, who with the AHJ, has complete jurisdiction over the installation of this component.

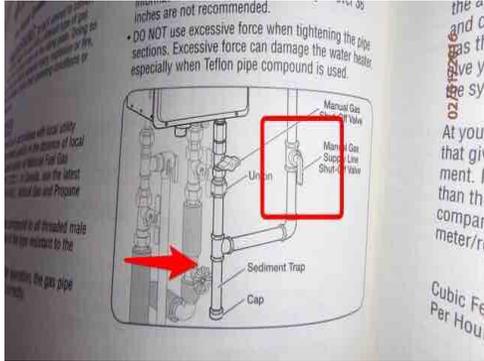
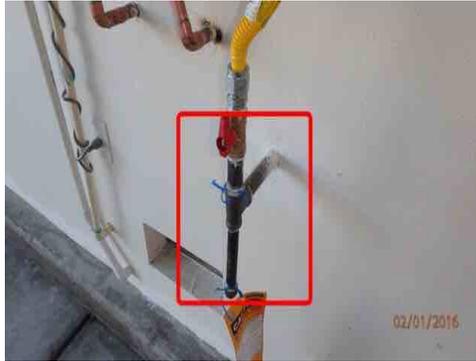
76: - In accordance with the manufacturer's installation guidelines, the sediment trap is installed incorrectly.

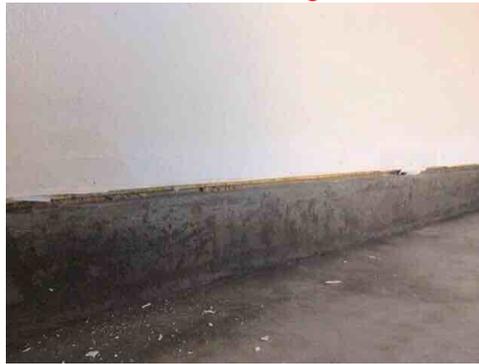
s-6: - Holes and / or missing wall separation wall covering were noted in the fire rated wall that connects the garage to the main structure. The walls and ceilings of the attached garages should be well sealed where they abut the interior of a house to maintain the integrity of the fire rated materials. Dwelling/garage opening/penetration protection. Openings and penetrations through the walls or ceilings separating the dwelling from the garage shall be in accordance with Sections R302.5.1 through R302.5.3.

83: - Holes and / or missing wall separation wall covering were noted in the fire rated wall that connects the garage to the main structure. The walls and ceilings of the attached garages should be well sealed where they abut the interior of a house to maintain the integrity of the fire rated materials. Dwelling/garage opening/penetration protection. Openings and penetrations through the walls or ceilings separating the dwelling from the garage shall be in accordance with Sections R302.5.1 through R302.5.3.

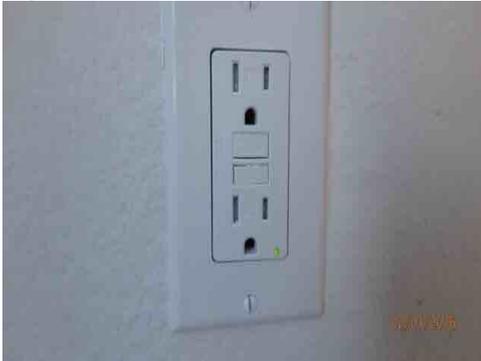
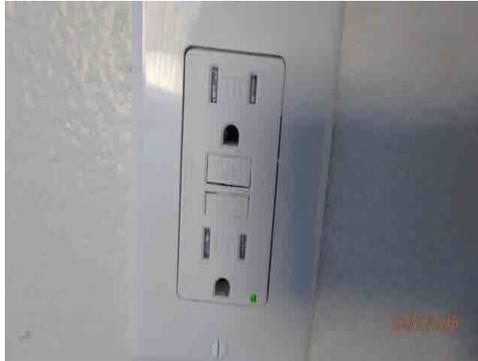
s-7: - There are receptacles within the garage that have been painted over and therefore suggested to be replaced.

92: - There are receptacles within the garage that have been painted over and therefore suggested to be replaced.

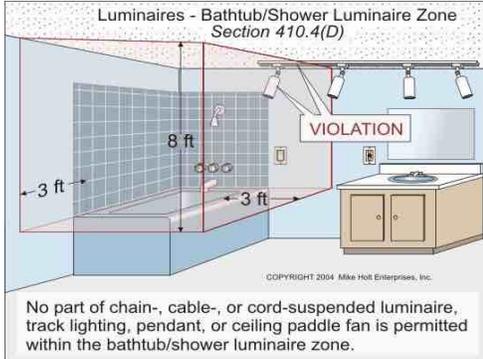
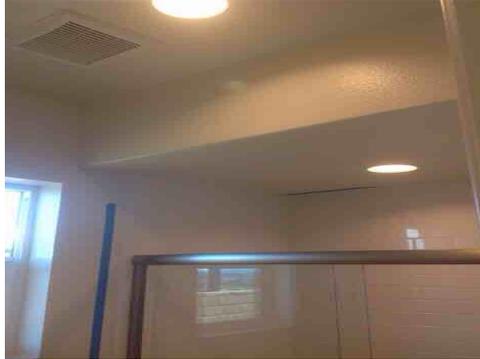
112: - Under normal circumstances there are only certain vent fixture types or light trim types which are allowed to be installed in "wet locations", specifically the 8X3 enclosure zone. We are unable to determine the type currently installed without removal of the fixture. For some older structures, this may be an older code requirement, however, improvements are always suggested as old or new code is the minimum standard and is always suggested to be exceeded. Verification is suggested.

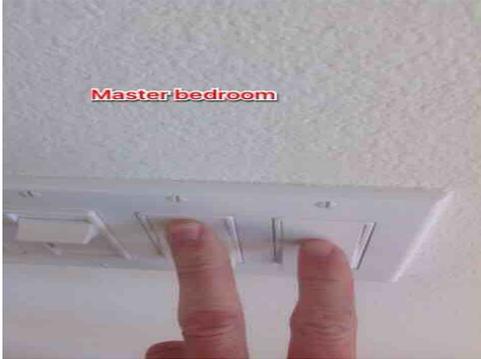
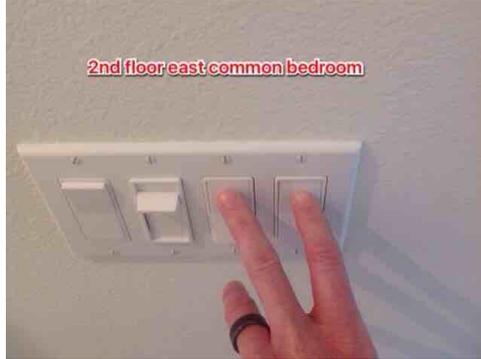
114: - The inspector was unable to determine the function of multiple light switches, throughout the house. Switches may energize either a ceiling light fixture, ceiling fan/light combination or a wall receptacle, typically known as "half-hot receptacles" or bulbs which are not operational. Further evaluation may be necessary in identifying the operation of these light switches, including the replacement of various light bulbs, which may be defective.

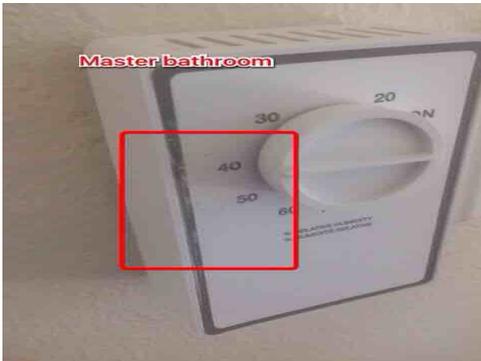
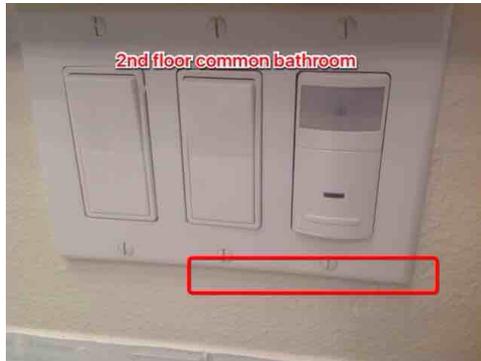
115: - There were switches and / or timers which have been painted over at various locations within the interior of the house.

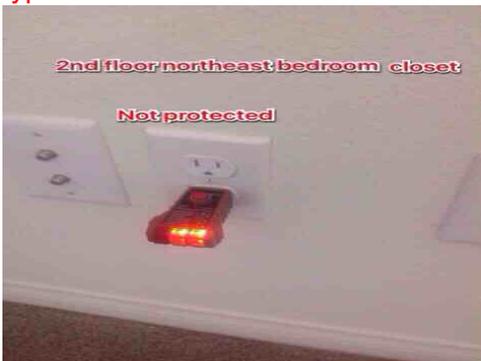
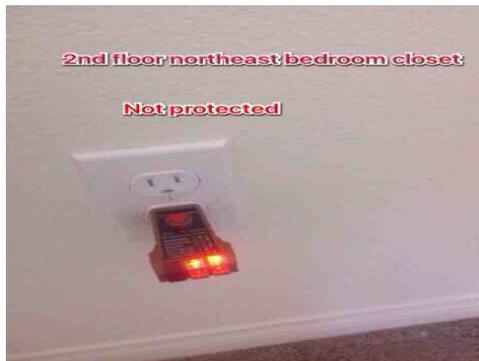
121: - 210.12(A) Where Required. All 15A or 20A, 120V branch circuits in dwelling units supplying outlets in family rooms, dining rooms, living rooms, parlors, libraries, dens, bedrooms, sunrooms, recreation rooms, closets, hallways, or similar rooms or areas must be protected by a listed AFCI device of the combination type.

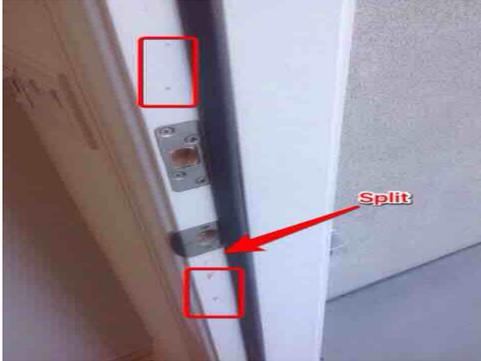
125: - The front door is cosmetically damaged but functional.

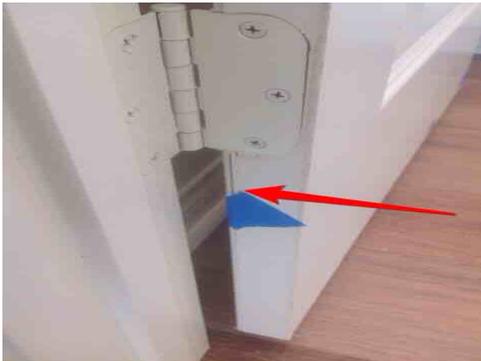
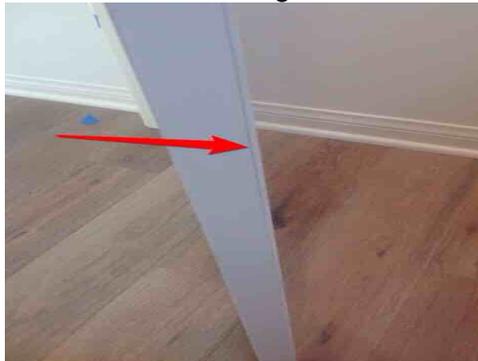
127: - The doors in the 1st floor common bathroom are damaged.

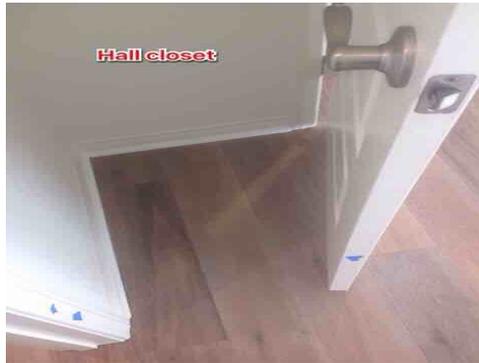
129: - Missing / damaged door stops noted. Installation or repair is recommended to prevent damage to the walls.

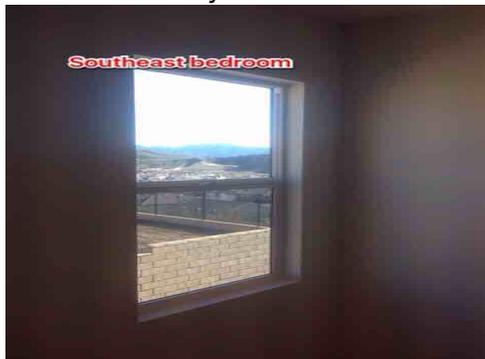
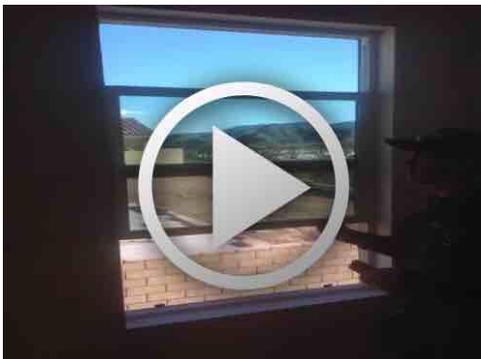
135: - Sash cords / balancers (the ropes that hold up the windows) are inoperable on the window(s) in the southeast bedroom. Repairs are suggested for proper operation of single and double hung windows and should be performed by a professional contractor. All of the inaccessible single hung windows are suggested to be tested once they are made accessible and prior to the close of escrow.

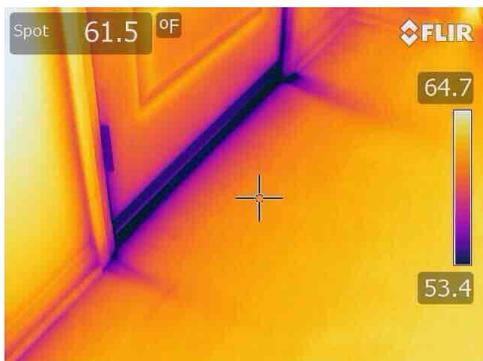
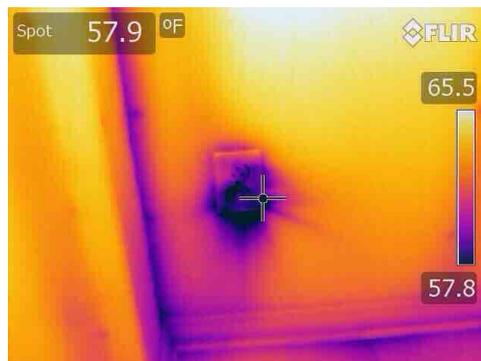
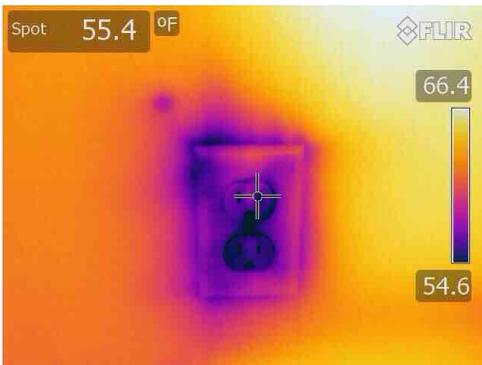
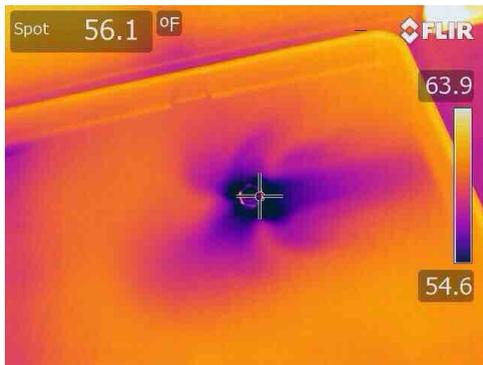
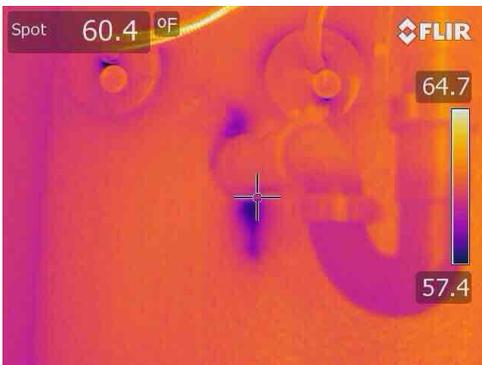
139: - Air infiltration was visible within multiple locations throughout the building at the sill plate, receptacles, ceiling lights and doors as pictured via the infrared images. This condition is considered a breach within the integrity of the thermal envelope.

Section 110.7 - Mandatory Requirements to Limit Air Leakage

All joints, penetrations and other openings in the building envelope that are potential sources of air leakage shall be caulked, gasketed, weather stripped, or otherwise sealed to limit infiltration and exfiltration.

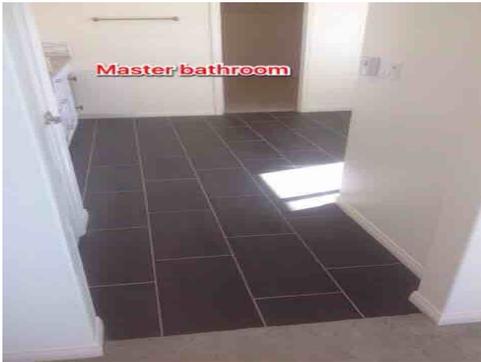
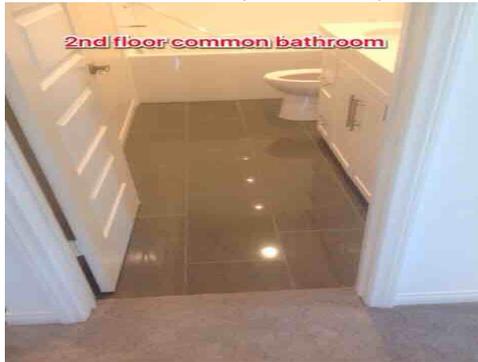
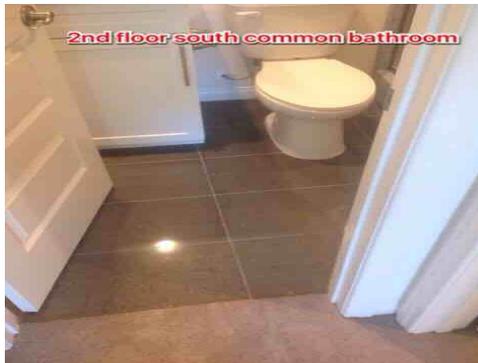
NOTE 144: - We cannot determine what substrate if any, was used under the tile flooring added. Typically, tile flooring will get a solid masonry like substrate prior to installing the tile for a more solid base, especially on a second level or raised foundation. With masonry installations, a vapor barrier or slip sheet will typically be used to reduce cracks, this material is not visible however (if installed).

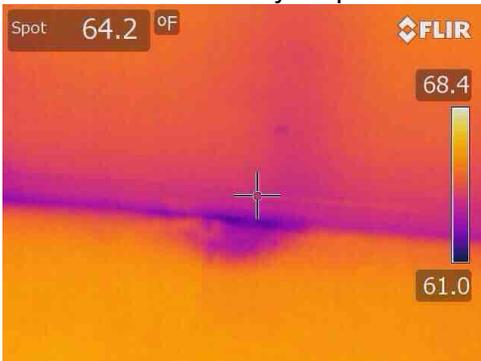
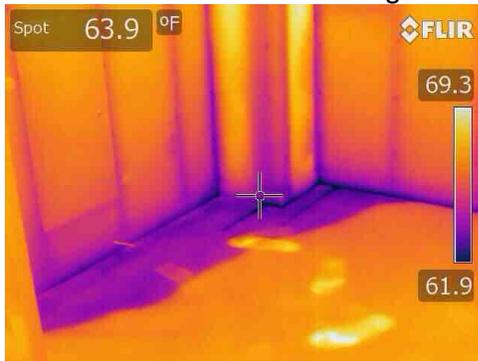
145: - Current moisture was observed within the carpet in the master bedroom closet as well as the upper east bedroom hallway as pictured. We are unable to determine the origin of the moisture at this time.

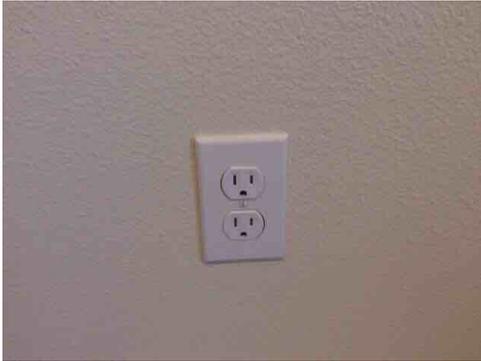
154: - The receptacle in the laundry room is suggested to be a 20 amp designated receptacle per some building standards.

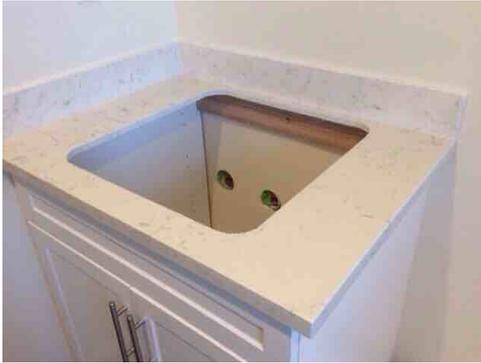
161: - The faucet is not installed.

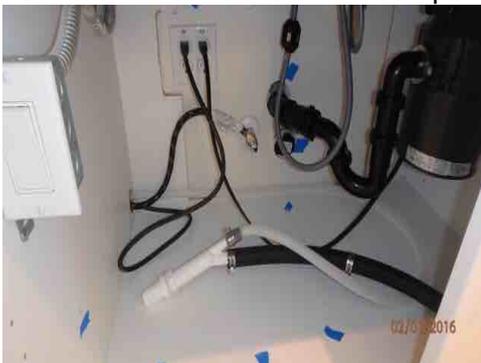
162: - The dishwasher drain components are disconnected so therefore, the dishwasher was not tested.

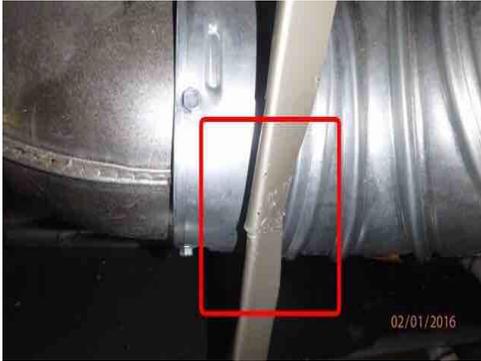
172: - Damage was observed at the furnace cabinet. The damage does not appear to have any adverse affect on the performance of the furnace.

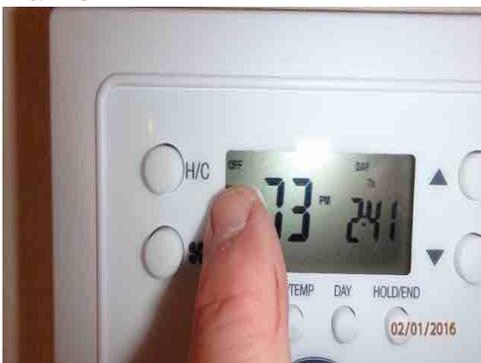
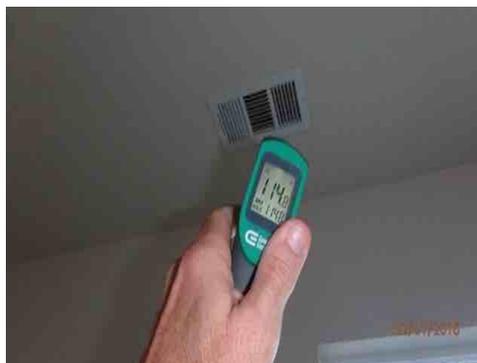
193: - The ducts include thermostatically controlled dampers. The dampers were tested (via thermostats) and found that there were in fact differences in temperature between the lower ambient temperature and the registers of the upstairs area while the downstairs was "on". It should be noted that when this test was performed, the lower system was off. We also feel it prudent to mention that the same test was performed for the upper level and there were no such differences in temperature. It is therefore our opinion based on the test performed, that the damper system may leak allowing air to pass through the dampers. It is not evident how the dampers were designed to perform so we cannot comment on this intended performance. We do suggest however, the buyer contact an HVAC company to thoroughly inspect the damper system and test the damper system to ensure that the system is completely functional and operating in an energy efficient manner.

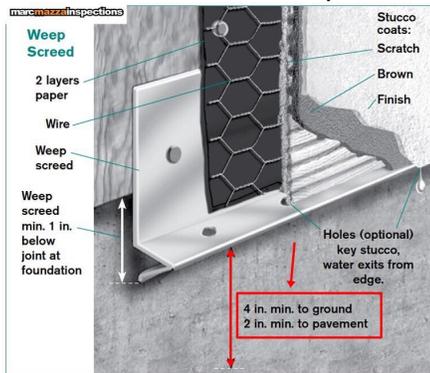
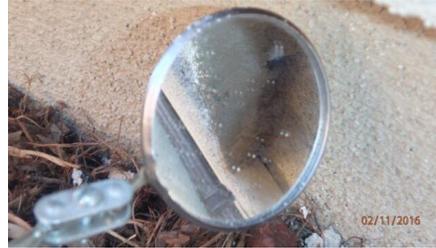
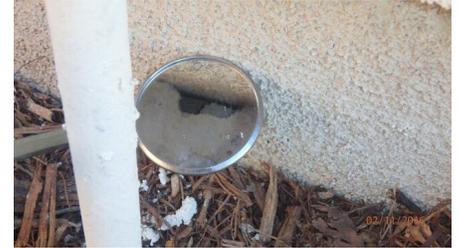
10: - Portions of the weep-screed have been covered. Weep-screed not only allows the house walls to move independent of the foundation and prevents the plate-line cracks that are commonly seen at the base of many stucco walls but allows any moisture that penetrates the stucco to drain. Therefore the interior and exterior plaster in this area should be monitored to ensure that no moisture damage results. There are still gaps located between the weep screed and the wall as pictured.

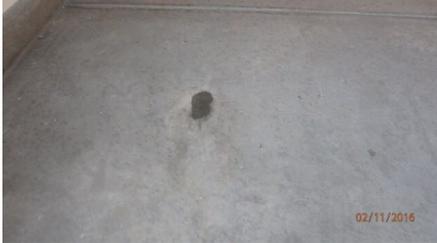
17: - We observed a leaking fire sprinkler head in the garage.

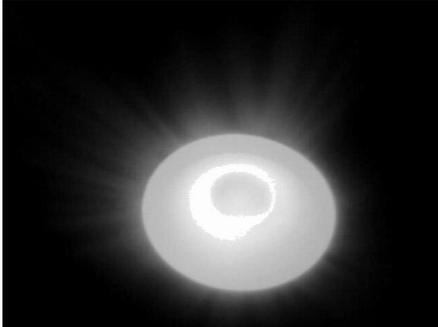
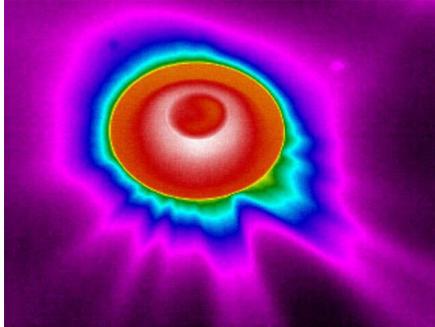
Section 110.7 - Mandatory Requirements to Limit Air Leakage

All joints, penetrations and other openings in the building envelope that are potential sources of air leakage shall be caulked, gasketed, weather stripped, or otherwise sealed to limit infiltration and exfiltration.

19: - Air appears to leak from numerous receptacles within the building in multiple locations. The receptacles are suggested to be sealed appropriately in order to reduce air infiltration.

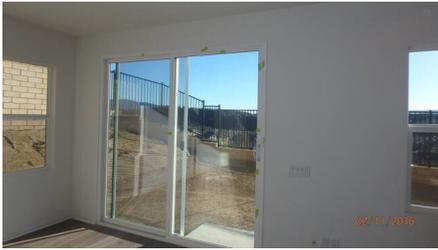
SLIDING GLASS DOORS

20: - The door trim around the sliding glass door is damaged and in need of service as pictured.

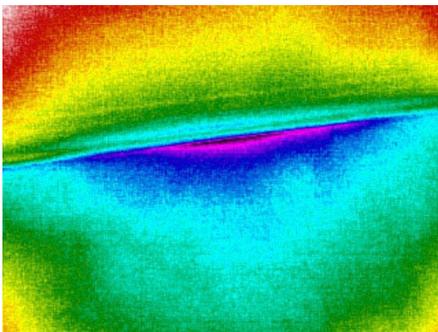
WALLS

21: - Air infiltration was observed under the wall of the southwest wall within the lower level of the building. It is suggested that the area be evaluated from the exterior side to ensure no openings are present within the membrane in this location.

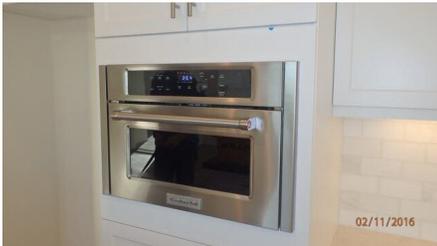
KITCHEN CABINETS

28: - The trim which surrounds the microwave oven is damaged and in need of replacement.

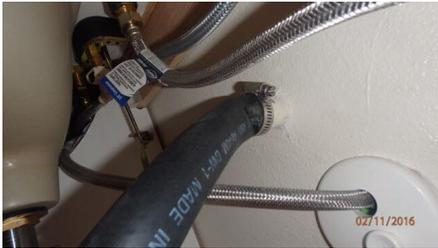
46: - The condensate drain for the furnace located under the sink is kinked and suggested to be serviced.

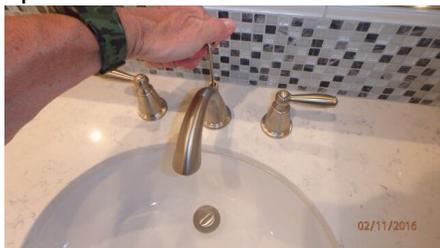
47: - The sink drain stopper did not operate at the right side sink. Recommend replacement for proper operation of the sink.

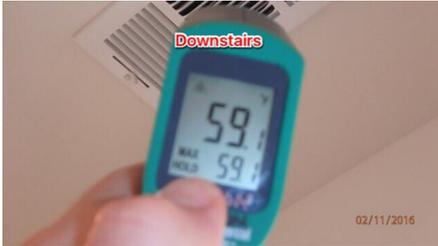
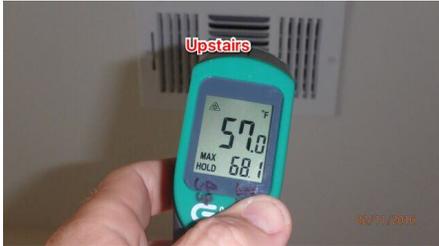
THERMOSTATICALLY CONTROLLED DAMPERS

66: - The ducts include thermostatically controlled dampers. The dampers were tested (via thermostats) and found that there were in fact differences in temperature between the lower ambient temperature and the registers of the downstairs area while the upstairs was "on". It should be noted that when this test was performed, the lower system was off. We also feel it prudent to mention that the same test was performed for the upper level and there were no such differences in temperature. It is therefore our opinion based on the test performed, that the damper system may leak allowing air to pass through the dampers. It is not evident how the dampers were designed to perform so we cannot comment on this intended performance. We do suggest however, the buyer contact an HVAC company to thoroughly inspect the damper system and test the damper system to ensure that the system is completely functional and operating in an energy efficient manner.
