# Property Inspection Report

Tuesday, March 24, 2015

Inspector, Marc Mazza  
Mazza Inspection Group  
(866) 996-2992  
[info@mazzainspections.com](mailto:info@mazzainspections.com)

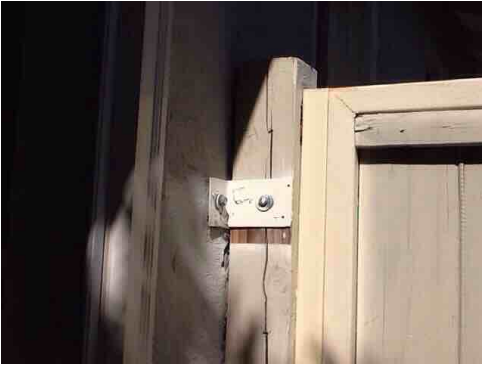
**46:** - Additional stability is suggested where the gate latches onto the post, which connects to the structure at the south side.

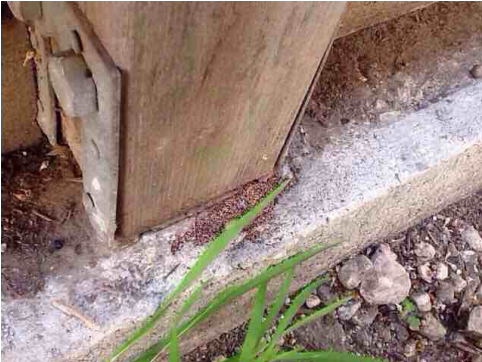
**47:** - The wood fencing was observed to be in generally fair condition. Some conditions which categorize the fencing may include: signs of moisture or insect damage, damaged boards, missing boards, loose boards, etcetera. Possible evidence of termites noted. Further evaluation by a pest control company is suggested.

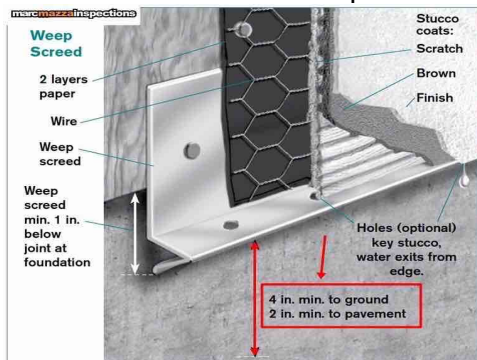
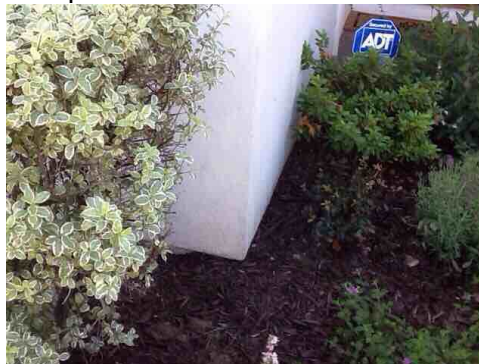
**53:** - There is concrete and soil that is high at the foundation at the time of the inspection. The soil level is up to or above the weep screed. These materials at this level may allow moisture penetration in the interior wood framing members or insect infestation. There should be at least 4 inches between the weep screed (if present) and the soil level and 6 inches between siding and the soil level. There is a recommended space of 2 inches between the weep screed and a solid surface such as concrete. It is recommended that this condition be referred to a qualified termite inspector for further evaluation - IRC 2012 §703.6.2.1.

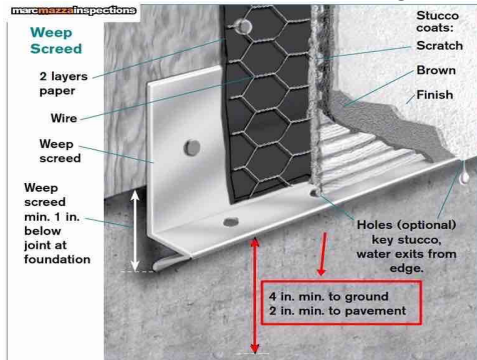
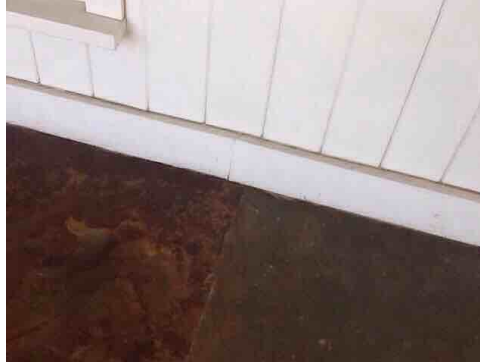
**58:** - The soil / slab level is high at the siding at the time of the inspection. There should be a minimum space of 6 inches between siding and the soil level. This space will help reduce the possibility of insect infestation and moisture contact or damage to the exterior wall covering material - IRC 2012 §703.6.2.1.

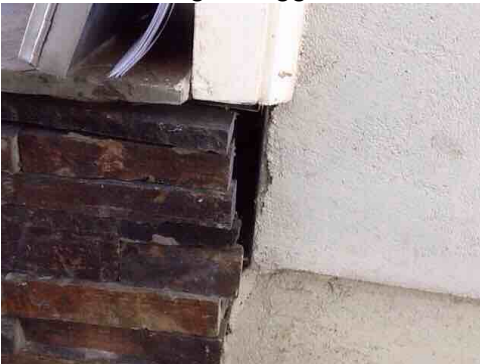
**59:** - The siding is suggested to be better sealed where it makes direct contact to the structure.

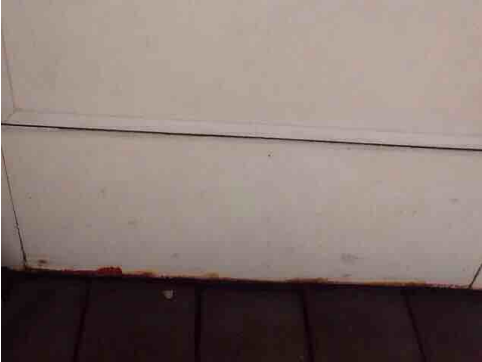
**61:** - Sealant is needed at various areas around the exterior trim to wall connections as preventative maintenance and to prevent the possibility of moisture penetration or damage.

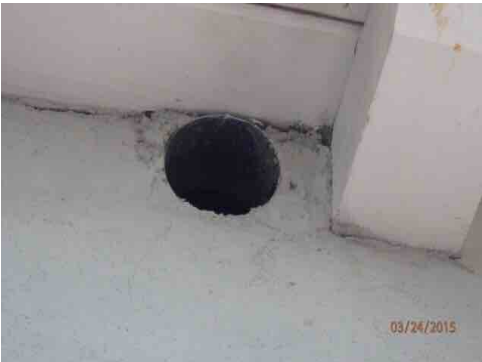
**62:** - We observed a hole of some type at the eave, within the soffit. The vent is suggested to be screened if it is a direct access into the attic. Although we do our best in an attempt to determine why certain conditions exist, we may not have intimate details regarding specific components and conditions. We therefore suggested to inquire with the seller regarding this condition and who may be able to explain this condition in full detail.

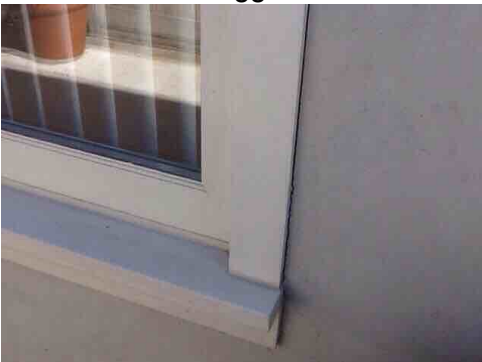
**63:** - There are windows and or door which appeared to have been replaced. The new trim overlaps the exterior wall covering material, leaving a small area exposed to moisture intrusion. Sealant is suggested around the exterior window trim to wall connection to decrease the possibility of moisture entry into the structure. Sealing the connection with an exterior approved material with a 25 / 50 guarantee against deterioration is suggested.

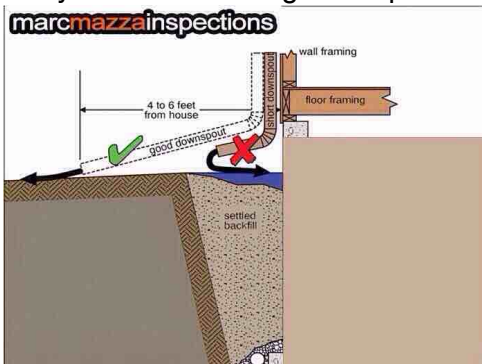
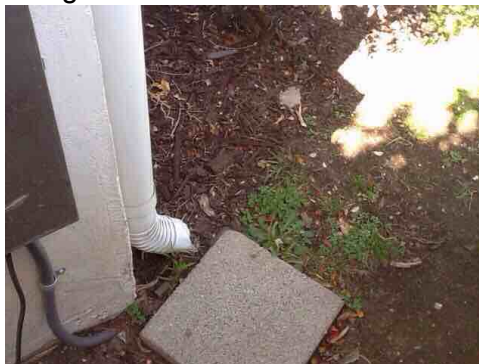
**66:** - We recommend routing all of the downspout(s) away from the structure, or installing the downspout directly into the subsurface drainage, if present. The downspout(s) should discharge water at least five (5) feet from the house or drain into existing sub surface drainage. Storm water should be encouraged to flow away from the building at the point of discharge.

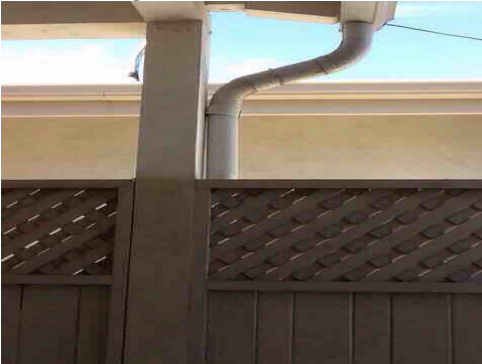
**69:** - The gutter at the side of the yard terminates into the adjacent yard.

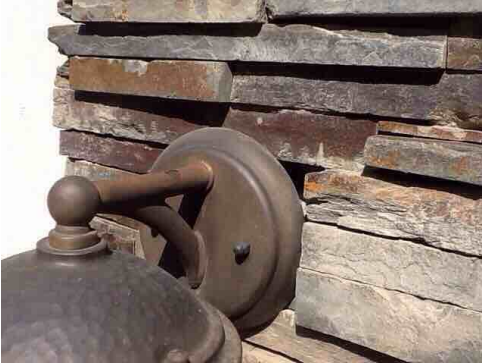
**73:** - Sealant is recommended around the exterior light fixture to wall connection(s).

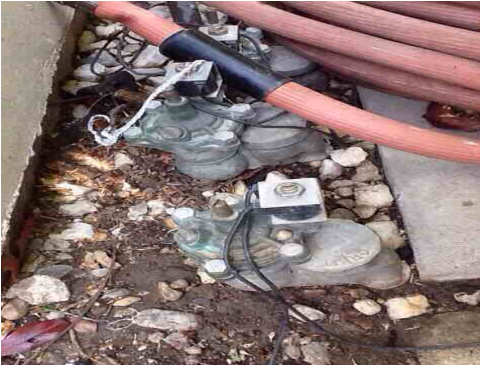
**80:** - There are sprinkler valves that are buried up to or under the soil, which poses a potential hazard of cross contamination. The valves are suggested to be located 6 inches above the ground.

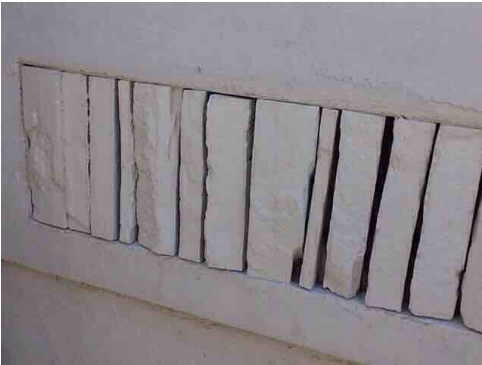
**s-3:** - The crawlspace has some blocked vents which, therefore, may not allow for adequate ventilation. Typical building standards requires a minimum of 1 square foot of ventilation per every 150 square feet of foundation area. We recommend the further review, advice and services of a general contractor.

**97:** - The crawlspace has some blocked vents which, therefore, may not allow for adequate ventilation. Typical building standards requires a minimum of 1 square foot of ventilation per every 150 square feet of foundation area. We recommend the further review, advice and services of a general contractor.

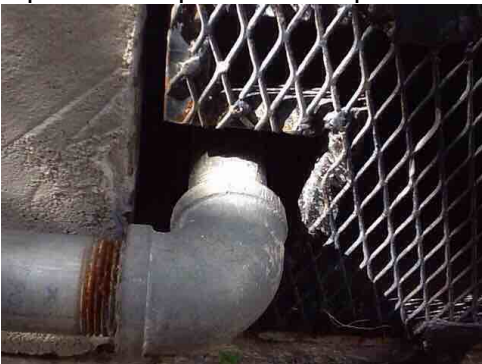
**98:** - We observed foundation ventilation screens which have openings or missing material and should be repaired or replaced to keep rodents and other pests out.

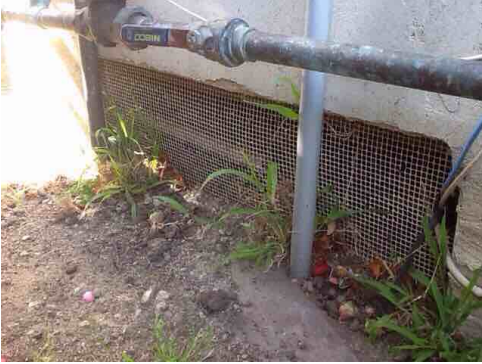
**99:** - The inspection revealed vent ports which are adjacent or below to the grade level. This condition may allow moisture to enter into the crawlspace. Improvements are suggested.

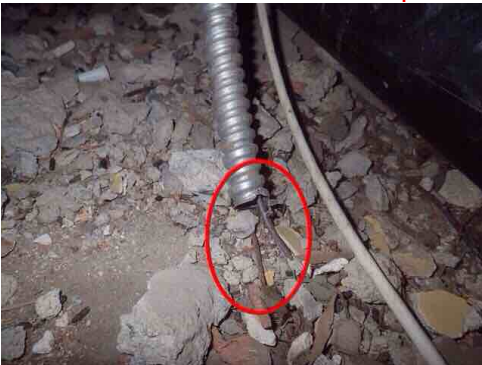
**s-2:** - Electrical conductors exposed and not properly terminated under the house were observed under the structure. These conductors represent a potential safety hazard and are suggested to be improved.

**101:** - Electrical conductors exposed and not properly terminated under the house were observed under the structure. These conductors represent a potential safety hazard and are suggested to be improved.

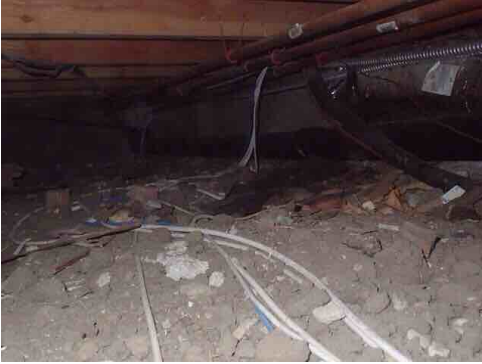
**102:** - There are cables (phone, cable, Internet, etcetera) that are lying on grade under the house and are suggested to be run in conduit for protection.

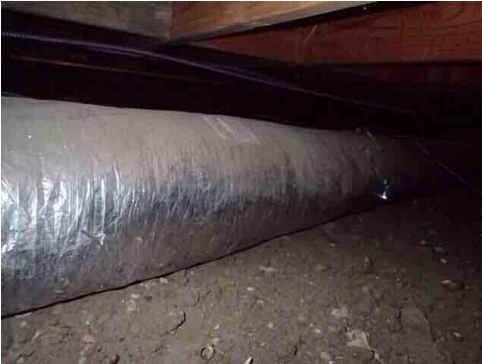
**103:** - There are ducts which have been installed directly on grade. It is suggested that the ducts be raised a minimum of 6" from grade.

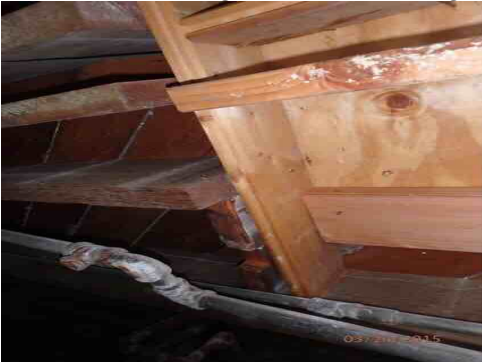
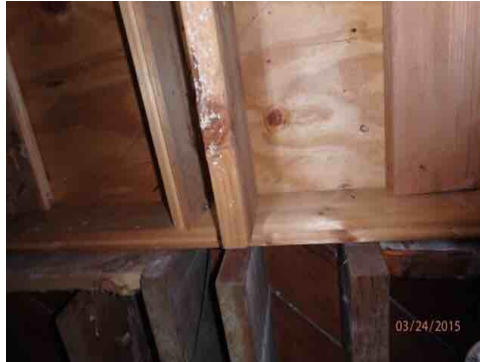
**105:** - There were repairs to the floor framing which are not consistent with today's minimum building standards. No damage was observed as a result, however, improvements may be necessary in order to maintain the integrity of the framing and overall structural stability of this area.

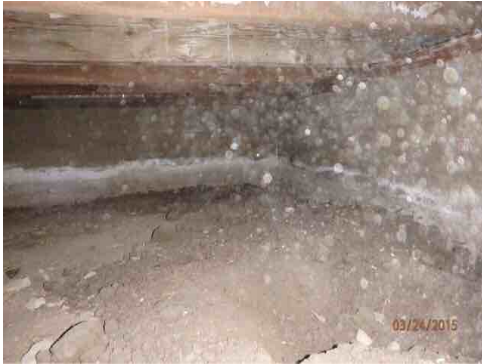
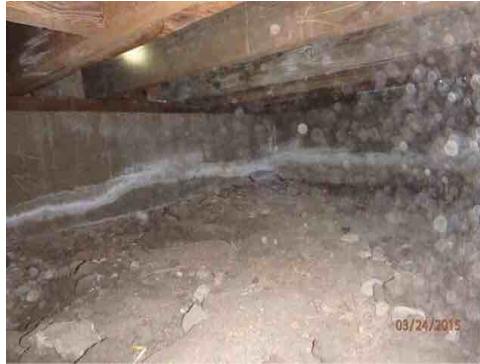
**106:** - There is evidence of past water in the crawl space. Wet crawl spaces risk building damage from rot and insects and can cause interior mold or mildew. This condition may vary seasonally and/or with precipitation intensity. Roof and lot drainage repairs or improvements should be addressed as a first step to controlling water in the crawl space. This condition should then be monitored to determine if additional, potentially costly measures are necessary to protect the building interior from water and moisture damage.

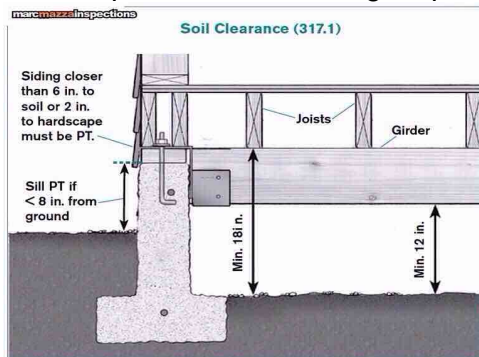
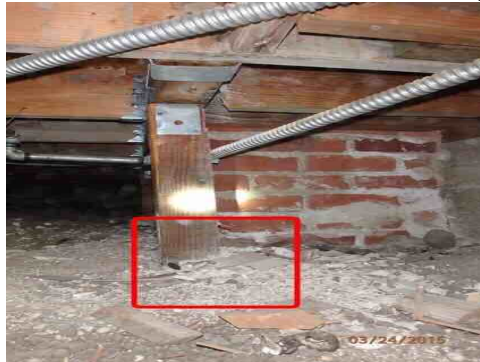
**107:** - There is wood within the crawlspace that is untreated and in direct contact with soil. Untreated wood is not suggested to make contact with soil as this wood is subject to deterioration and may allow insects access to other parts of floor framing. Improvements in accordance with local building standards are suggested.

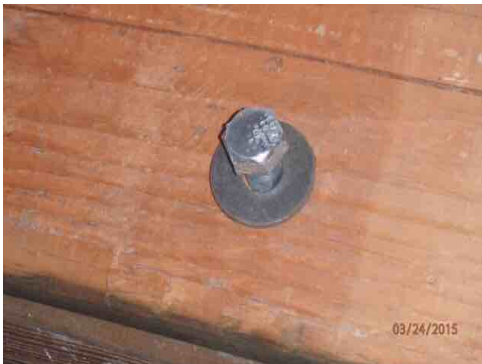
**108:** - We observed a ledger bolt which was not completely seated or screwed in completely. Improvements are recommended and should be carried out by a qualified licensed individual.

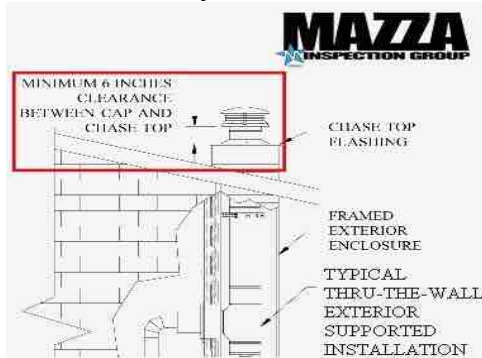
**120:** - It is likely that this chimney flue is shorter than what manufacturer's specifications call for. In many factory built installations, the flue termination is no less than 6" from the chase cover. Improvements if found to be necessary, are recommended and should be carried out by a qualified licensed individual.

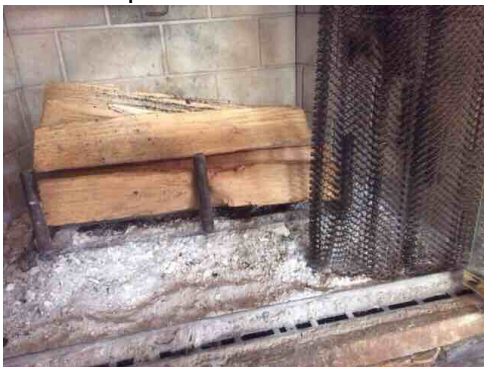
**132:** - Inspection of the firebox was limited due to the mount of debris present.

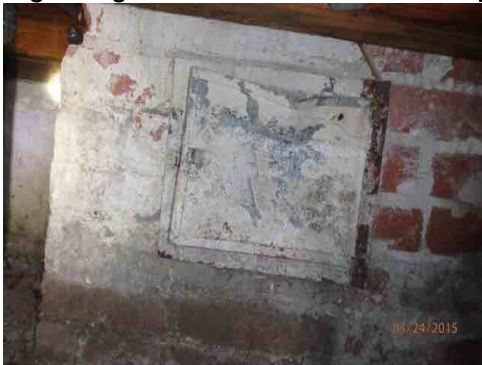
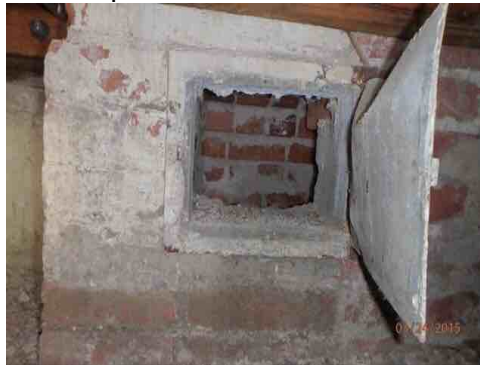
**137:** - There is an ash dump located under the building. The ash dump is located in an area which can be a hazard. That said, we are unable to confirm whether or not the ash dump is currently functional or terminated. Although we do our best in an attempt to determine why certain conditions exist we may not have intimate details regarding specific components and conditions. We therefore suggested to inquire with the seller regarding this condition and who may be able to explain this condition in full detail.

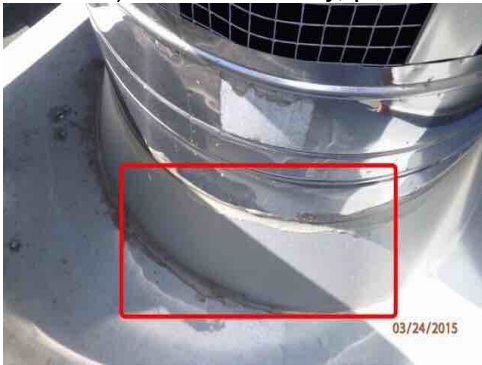
**140:** - The cooling flue which is an integral part of the flue assembly appears to be "choked off" due to the position and possible improper installation of the storm collar present. The installation (if proven to be incorrect) as it is currently, poses a real and present fire hazard. Further assessment is advised.

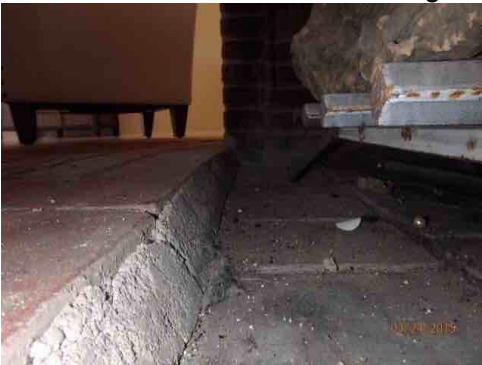
**150:** - The hearth extension is higher than the inner hearth and may have been built up.

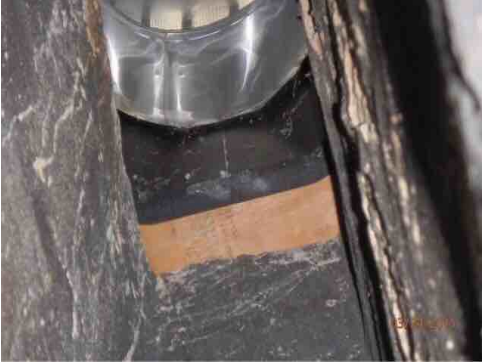
**s-5:** - There is wood within the firebox / flue of this fireplace. In light of this condition, we suggest the buyer have a professional inspect this area to determine what action is necessary to remedy this condition.

**151:** - There is wood within the firebox / flue of this fireplace. In light of this condition, we suggest the buyer have a professional inspect this area to determine what action is necessary to remedy this condition.

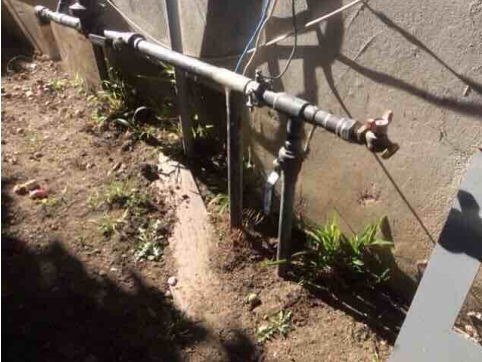
**154:** - The size of the main supply line is .75" inch. In some cases, .75" may be considered small.

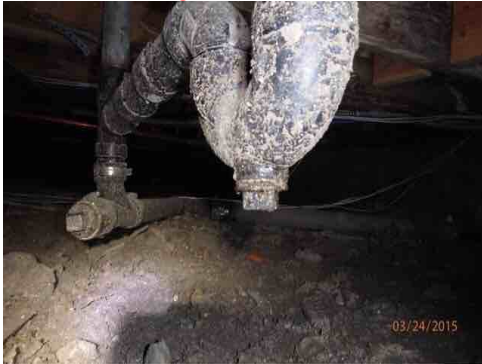
**167:** - Leaking was observed in the crawlspace under the common bathroom at the time of the inspection.

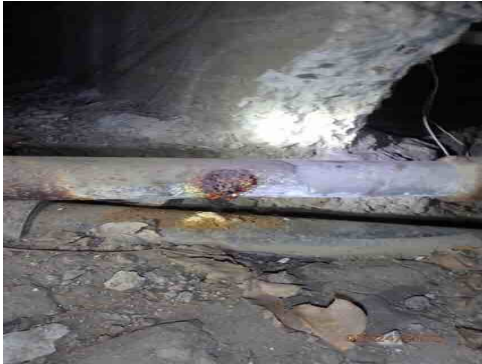
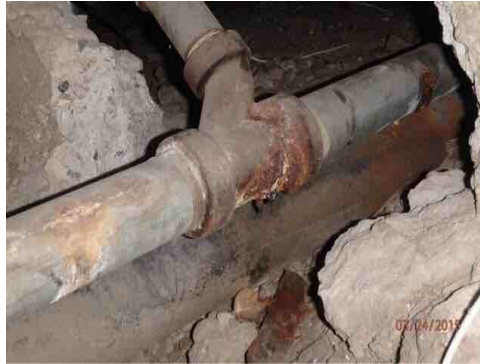
**168:** - The steel drain pipes appear to be an original material and were observed to be somewhat rusted and deteriorated. As a result, the pipe is recommended to be monitored on a regular basis or evaluated by a professional plumbing contractor who can determine with more specificity the longevity of the pipes.

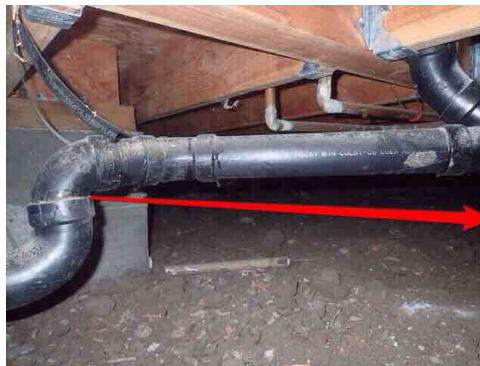
**169:** - There is waste piping that was found to have a substandard slope for proper drainage. This was observed from the west crawlspace, which is underneath the structure. Further assessment is advised.

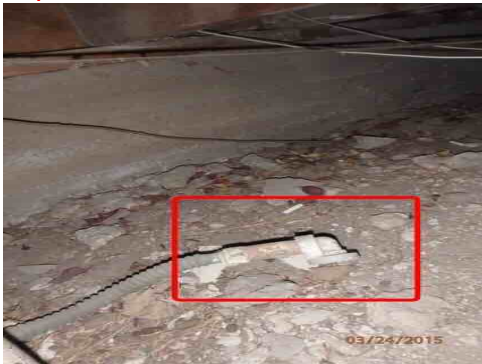
**173:** - The regulator vent for the fuel meter is suggested to terminate away from under the building. Improvements are recommended and should be carried out by a qualified licensed individual.

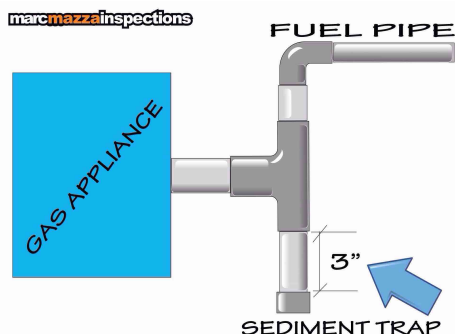
**175:** - There are missing sediment traps at all or some of the fuel piping installed prior to fuel burning appliances e.g. furnace, water heater. A drip leg, also known as a dirt leg, is there to protect the gas train and burner orifices from gas born water and dirt. In a clean piping system, with best quality gas supply, there will never be a need for this. Typically, systems develop some moisture from condensation, as well as some dirt or other contamination. Typically, the drip leg is 3-6 inches in length and prior to the appliance.

Where a sediment trap is not incorporated as a part of the gas utilization appliance, a sediment trap shall be installed downstream of the appliance shutoff valve as close to the inlet of the appliance as practical at the time of appliance installation. The sediment trap shall be either a tee fitting with a capped nipple in the bottom outlet, as illustrated, or other device recognized as an effective sediment trap. Illuminating appliances, ranges, clothes dryers, decorative vented appliances for installation in vented fireplaces, gas fireplaces, and outdoor grills shall not be required to be so equipped - NFPA 54-09:9.6.7.

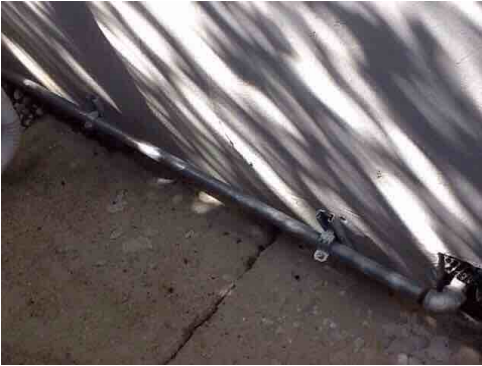
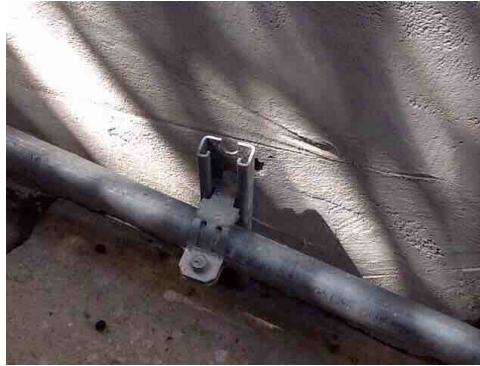
**177: -** There are gas lines which are not supported properly in accordance to building standard at the rear west side of the house.

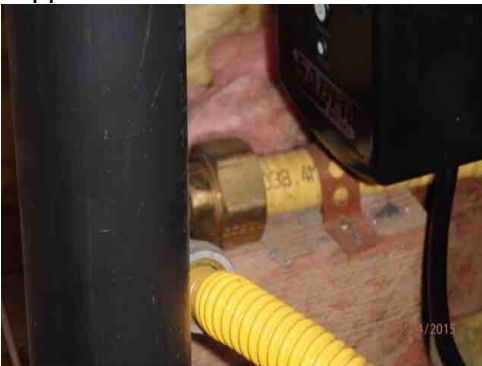
**178: -** We did not view a bonding jumper at the CSST fuel piping in accordance with building code.

1211.15.2 CSST gas piping systems shall be bonded to the electrical service grounding electrode system at the point where the gas service enters the building. The bonding jumper shall be not smaller than six (6) AWG copper wire - NFPA 54-09:7.13.2.

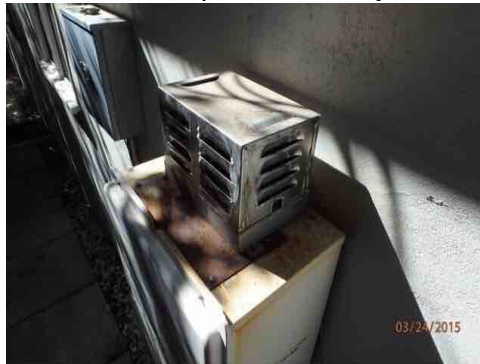
**184:** - Rust and corrosion was observed at the top of the water heater. This condition was likely the result of corrosive material within the exhaust collecting at the top of the unit. This condition is suggested to be monitored for any further deterioration in which case, repairs are likely necessary.

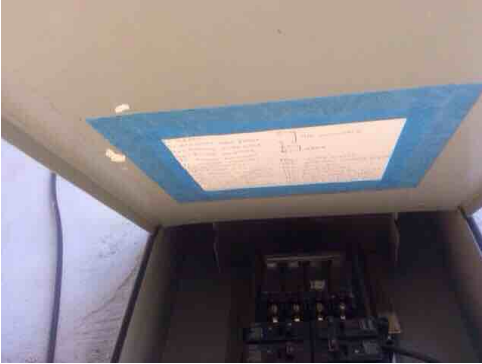
**191:** - The manufacturer's legend is missing or un legible from the main electrical service panel. The manufacturer's legend typically provides information describing the main panel such as the name of the panel manufacturer, the panel model number, the panel amperage rating, limitations related to the environment in which the panel was designed to be installed and grounding/bonding information for that particular model. The Inspector was unable to confirm the existence of proper conditions for this panel (example; number of double pole disconnects allowed, if any) when confirmation would require information taken from this missing legend. It is substandard not to have such a legend present - NEC 2014 §408.58.

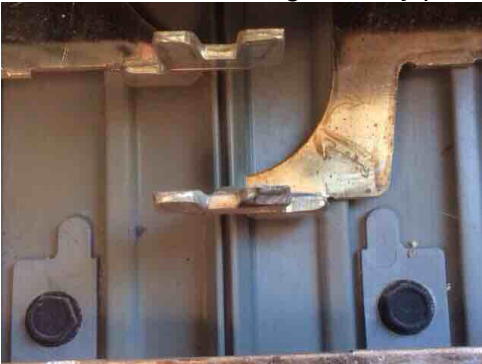
**193:** - There are heat or scorch marks within the panel on the feeder bar. It is our suggestion the buyer employ the services of an electrician who can remove and inspect the bus for any permanent damage. The reason for the scorching is not evident and should be evaluated by an electrician to better determine the cause of this scorching and any possible improvement options.

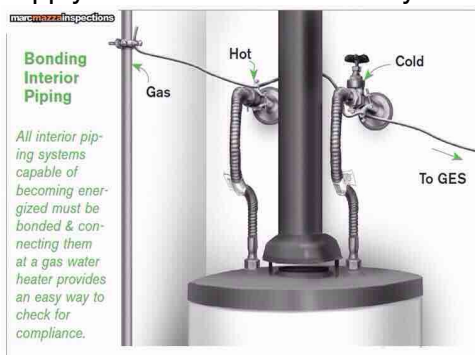
**199:** - We were unable to verify a cold (and hot) water bond at the main water supply, or supply piping. In accordance to building standards; the bond is suggested to be installed in or attached to a building structures metal piping system(s) including hot water, cold water and the gas piping, that are likely to become energized. These aforementioned components should be bonded to the service equipment enclosure in accordance to building standard. The bonding jumper(s) should be sized in accordance with the NEC, using the rating of the circuit that is likely to energize the piping system(s).

\*Note: a) If the house employs plastic water piping, there may not be a cold water bond. b) The water pipe ground/bond may have been removed if the house was re-plumbed in copper. Therefore, it should be traced by an electrician or the panel should be re grounded. c) We did observe grounding electrodes at the water supply but were unable to verify their connection to the panel.

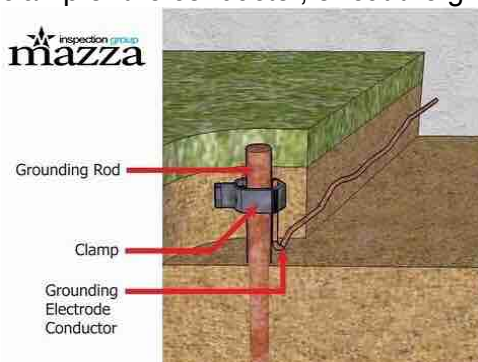
**202:** - The ground rod observed was elevated, and therefore, exposed. The rod was not protected from physical damage in accordance to minimum building standards. The ground rod, which was exposed may not be buried the full length of the rod (providing the rod is a minimum of 8'). The \*minimum\* length a grounding rod or pipe is required to be in contact with earth is 8 feet, if the grounding rod is 8 feet long, then the entire 8 foot length would need to be in contact with earth.

If the ground rod is driven all the way into the ground, the connector for the grounding electrode conductor to the ground rod must be accessible for inspection, and must be protected from physical damage. Some AHJ will allow the top of the ground rod and the connection clamp to be just below grade level and left exposed for the inspection, then covered up afterward. Other AHJ will require a protective sleeve of some type be places around the top of the ground rod and the clamp, leaving it open for inspection and be protected from physical damage by the sleeve.

The ground rod clamp needs to be protected from damage least it become loose and/or the grounding electrode conductor be damaged especially in a planter where a shovel could easily cause damage to the clamp or the conductor, or cut the grounding electrode conductor.

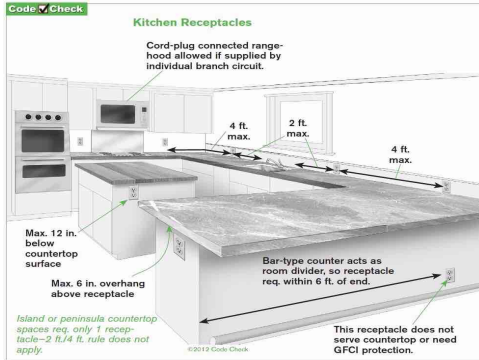
**216:** - There are too few receptacles in the kitchen at the counters than what current building standards suggest. Our inspection is based on the most stringent code standards to date. Our responsibility is not to determine what building standard was in effect at the time of original construction or installation of any component but rather, the protection of our clients and the general public at large by applying today's most at stringent building requirements. We feel determining whether or not a component needs to be improved is best left up to the authority having jurisdiction or contractor in this field.

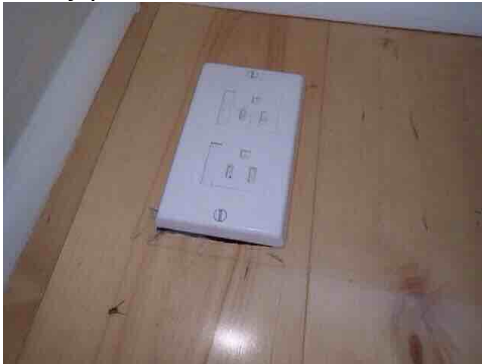
**217:** - It is suggested that the appropriate coverplates be installed on receptacles located in the floor as a safety precaution.

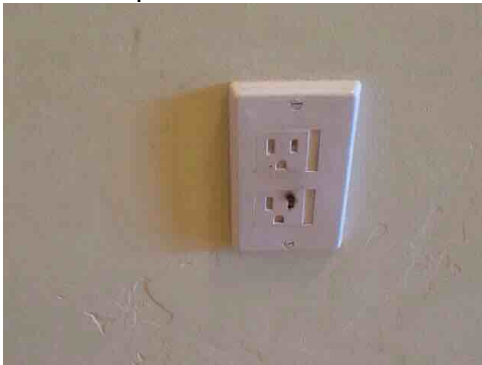
**218:** - The receptacle located in the hallway is scorched / discolored. The receptacle may defective and in need of replacement. We recommend the further review, advice and services of an electrician.

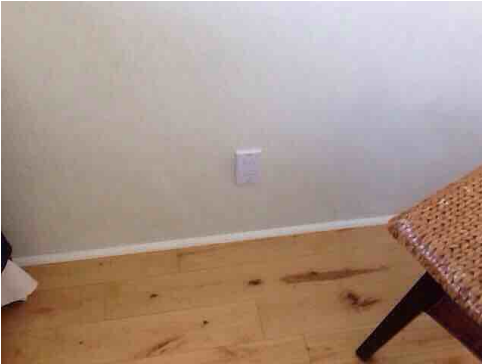
**219:** - The cover plate in the east bedroom appears to be installed upside down. This installation does not allow access to the receptacle. Installing the cover plate in the appropriate upright position is suggested.

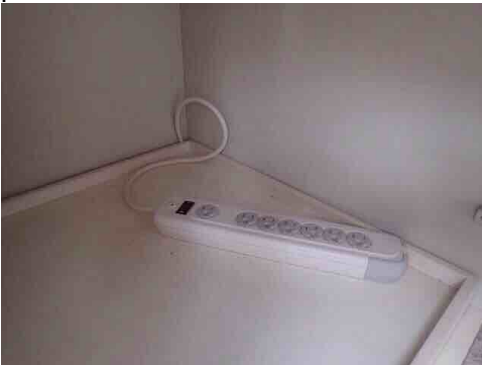
**220:** - Extension cords in the kitchen were used as permanent wiring. Extension cords are not intended to provide permanent power to appliances for extended lengths of time. If permanent wiring is desired, a professional electrical contractor should be contacted for necessary installations or repairs.

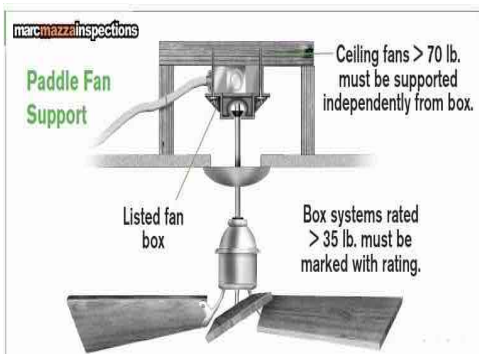
**222:** - We were unable to determine if the ceiling fans were installed with the appropriate junction box in accordance to manufacturer's / building standards.

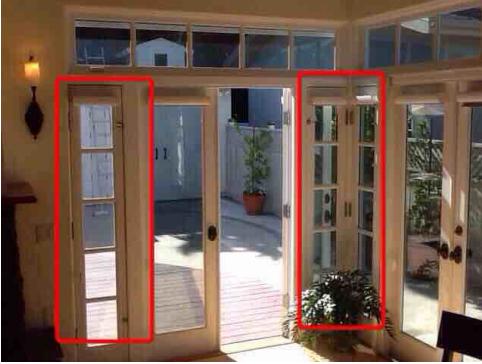
**246:** - The windows in the family room rub the frame when tested. Adjustments may be necessary for proper operation.

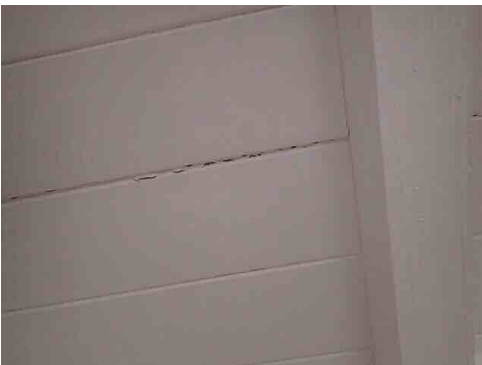
**257:** - The ceiling in the living room appears to be separating, possibly from movement or settlement. This does not appear to pose a structural concern.

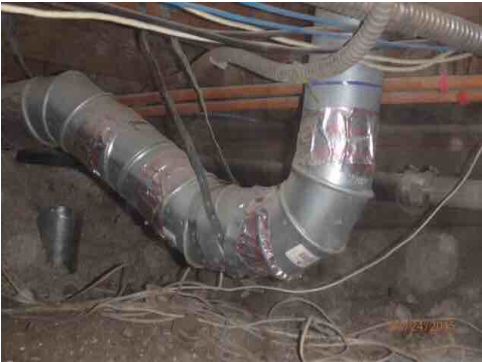
**272:** - The dryer duct under the house slopes upwards. This condition may cause the collection of lint which may result in a blockage and potential fire hazard. Improvements are recommended and should be carried out by a qualified licensed individual.

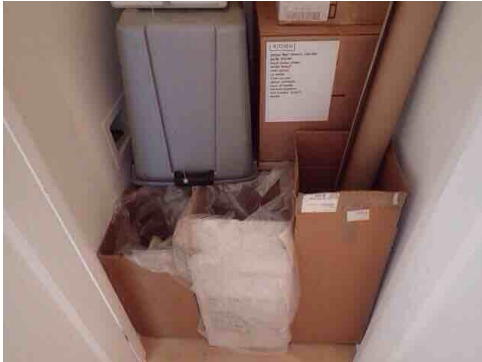
**273:** - The laundry area was not visible to inspect due to the items in the room that are blocking the access. We suggest removing the items and inspecting the laundry area prior to the close of escrow.

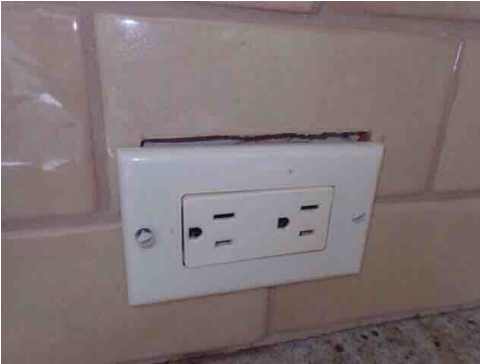
**279:** - There is a gap around a kitchen receptacle on the backsplash. Improvements are suggested for aesthetic purposes.

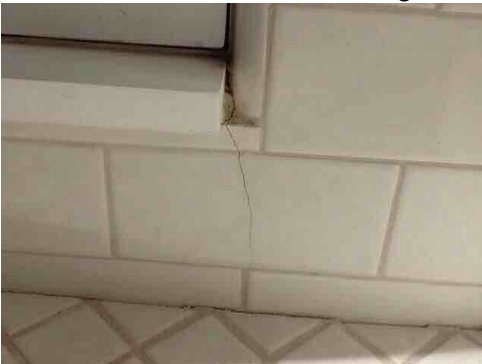
**305:** - Cracked and / or missing tiles were noted at the bathtub enclosure.

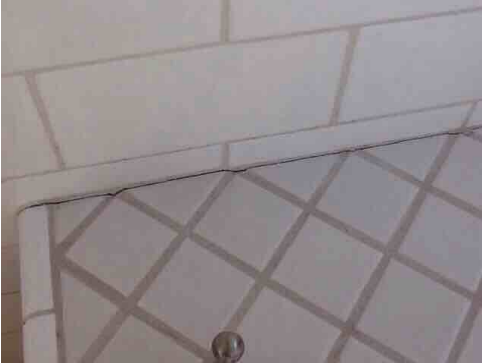
**307:** - Sealant is recommended at the tub platform to prevent moisture intrusion.

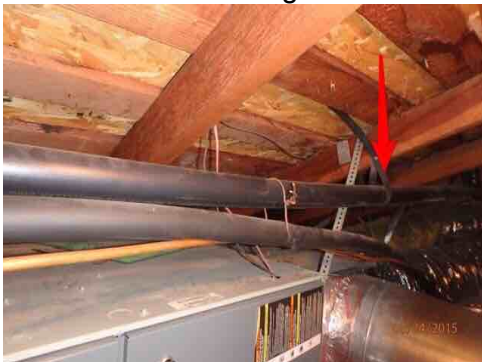
**336:** - The DWV noted in the attic was or appeared to be sloped in a direction which may result in blockage of the vent piping. In light of this condition, we suggest the buyer have the pipe slope increased in accordance to building standards.

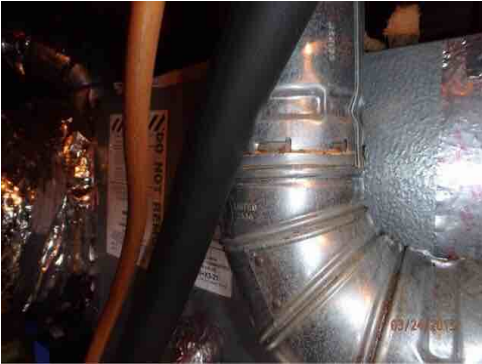
**343:** - Insulation for the refrigerant lines is in contact with the vent pipe and should be removed to a minimum of three inches away.

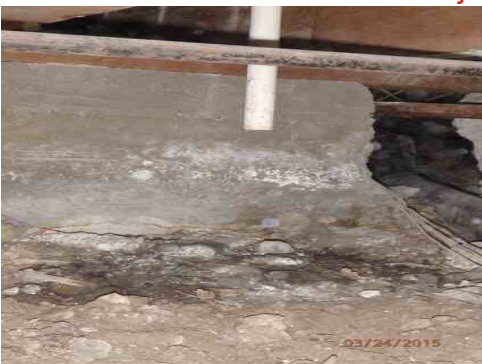
**349:** - The condensate drain was observed below grade level which may cause a back up and potential damage. We suggest having a minimum of 6 inches from the highest point of grade to the bottom of the condensate and not over a walkway.

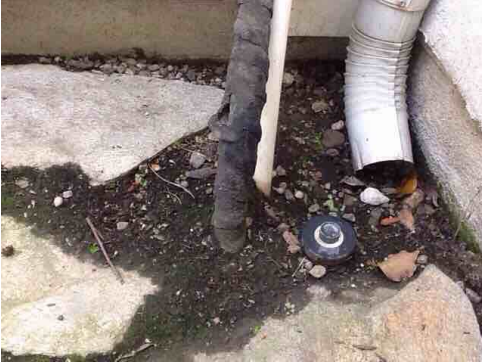
**362:** - The refrigerant line at the AC unit is buried underground. Refrigerant may migrate to the cooler buried section during extended periods of unit shut-down, causing refrigerant slugging and possible compressor damage at start-up. According to the UMC, 'Refrigerant piping placed underground shall be protected against corrosion'. We recommend running the line set inside sch. 40 PVC. We recommend the further review, advice and services of an HVAC technician. Finally, avoid putting refrigerant lines underground

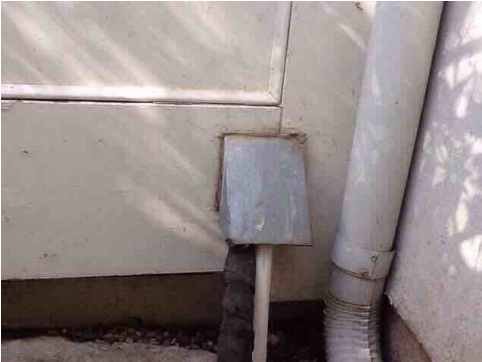
**363:** - The point in which the refrigerant lines pass into the structure at the flashing, is in need of some type of sealant such as expandable foam. The missing material could potentially allow for pest intrusion or moisture.

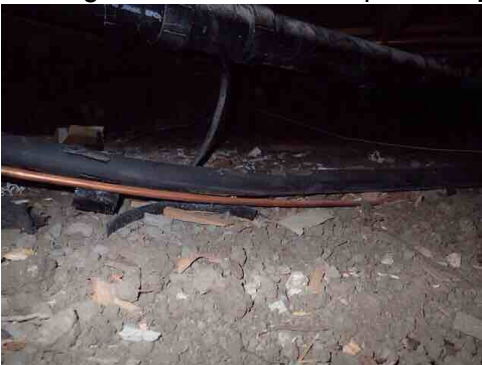
**364:** - The refrigerant lines are lying on the ground in the west crawl space and are suggested to be lifted off of the ground to reduce the possibility of deterioration.

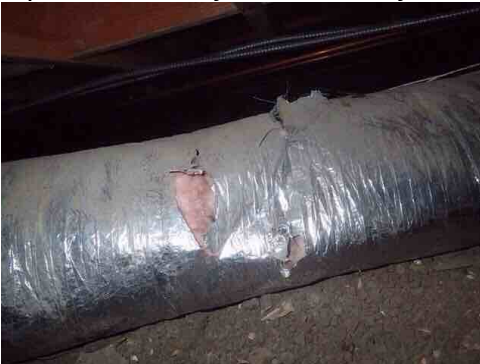
**367:** - There is ductwork that has damaged vapor barriers. This is a thin wrapping that covers the duct to maintain the energy efficiency. Re-wrapping the duct, if possible, is recommended, otherwise, wholesale replacement may be necessary.

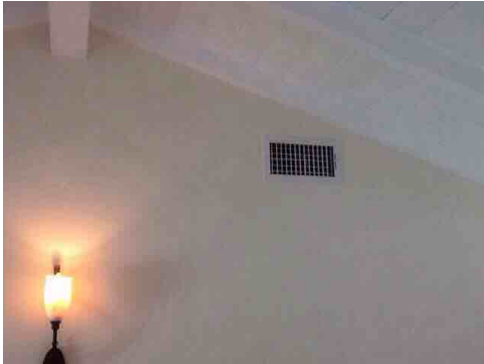
**371:** - The register in the living room (pictured) appears to be "hard piped" into the HVAC system. This is to say that this particular register is not connected to the dampening system.

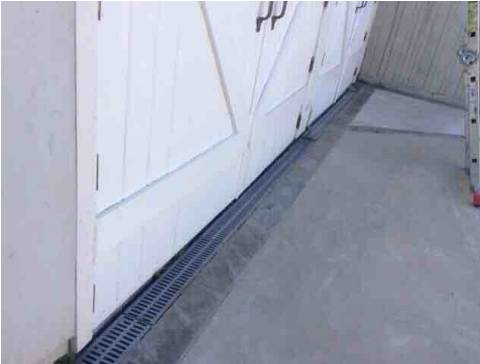
2: - The driveway appears to slope toward the garage. This condition can cause water entry into or underneath the building. Unfortunately, it is difficult to improve this situation without resurfacing the driveway adjacent to the foundation or by adding a special intercept drain system at the garage entry.

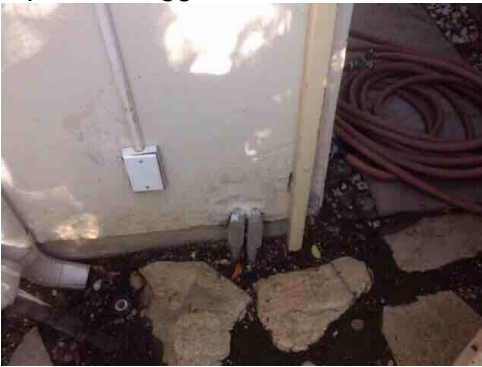
**6:** - Evidence of prior repairs / patching was viewed at exterior wall(s). We are unable to determine if the repairs were performed in a manner which is consistent with minimum building standards. Our concern is that the building paper is not breached or damaged. Further investigation as to the reason for the patching / repairs is suggested.

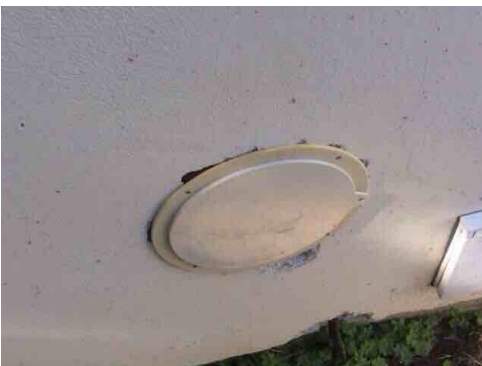
**7:** - Sealant is necessary around holes, cracks, A/C lines, flashing connections into the stucco, pipes and other various areas which may offer an point of penetration into the exterior wall covering materials to prevent moisture intrusion.

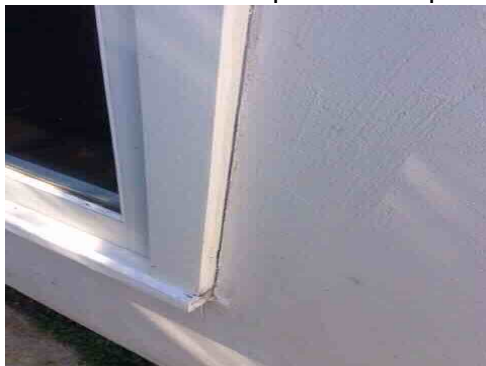
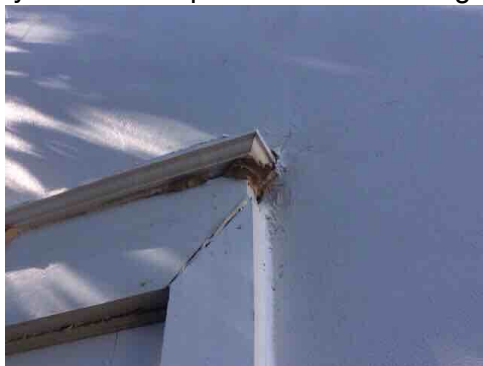
**10:** - Sealant is needed at various areas around the exterior trim to wall connections as preventative maintenance and to prevent the possibility of moisture penetration or damage.

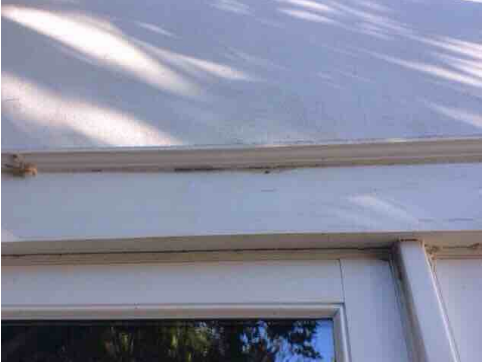
**11:** - Wood trim which appears to be possibly moisture damaged (fascia, trim, door / window frames, eave boards) was observed. As a result, we suggest a professional contractor remove the damaged wood, inspect the interior wall covering for possible damage, and report on his/her findings. Following repair of the damaged areas (which should be combined with exterior painting / maintenance) proper maintenance of the siding and control of water from roof or surface runoff can avoid further damage. Further evaluation is recommended and should be conducted by a professional pest control company.

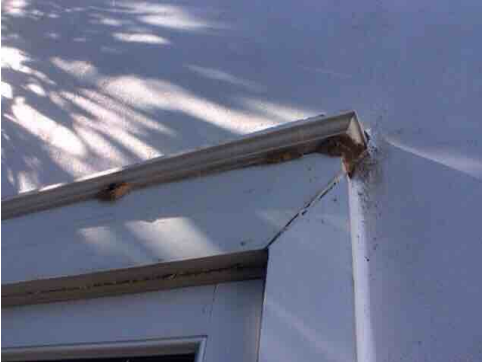
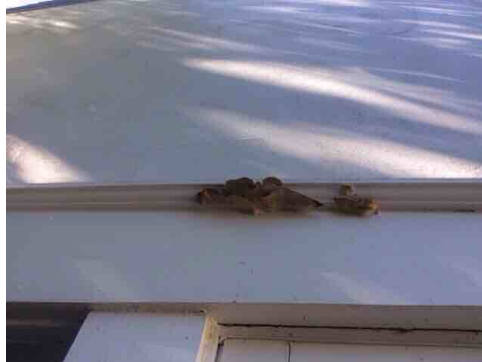
**12:** - We observed a growth on the wood trim around the door pictured here. We suggest the buyer employ the services of a professional pest control company to inspect this condition and repair if necessary.

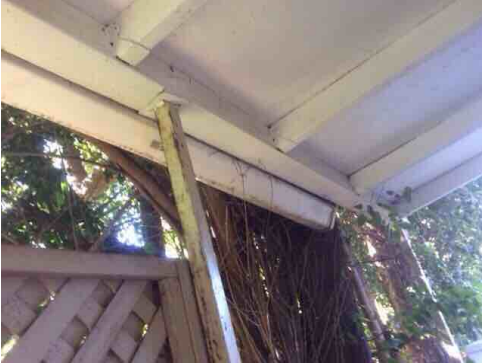
**14:** - The gutter was damaged at the rear side and suggested to be improved.

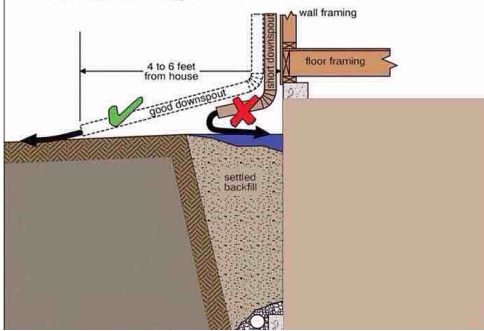
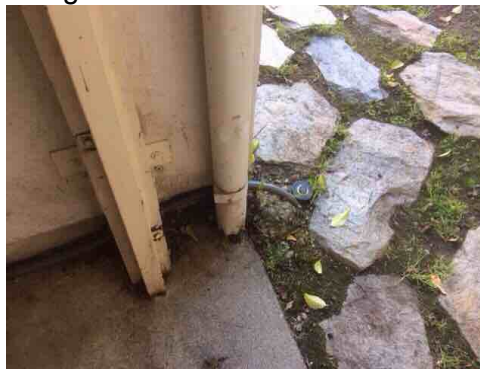
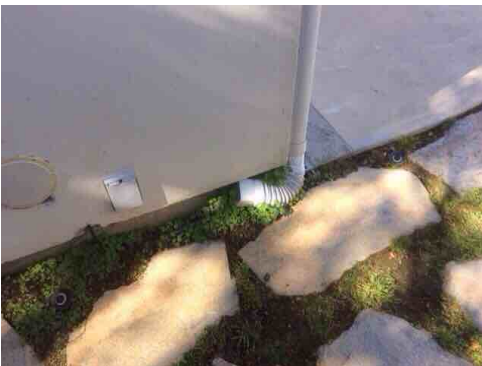
**15:** - We recommend routing all of the downspout(s) away from the structure, or installing the downspout directly into the subsurface drainage, if present. The downspout(s) should discharge water at least five (5) feet from the house or drain into existing sub surface drainage. Storm water should be encouraged to flow away from the building at the point of discharge.

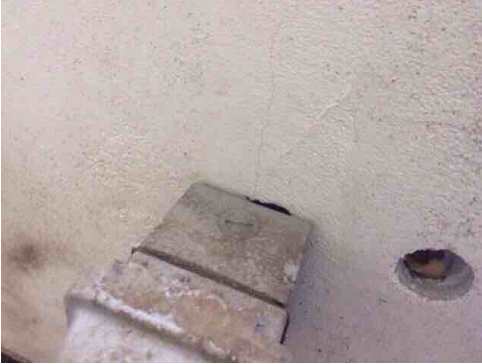
**17:** - Sealant is recommended around the exterior cover plates to wall connections.

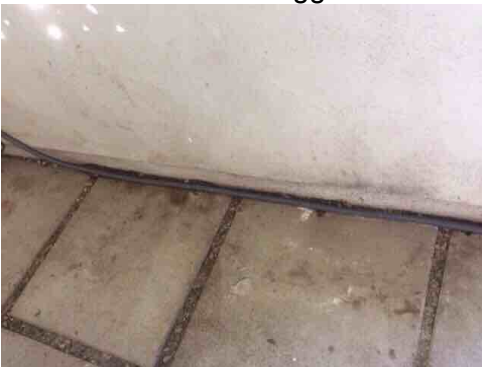
**20:** - The conduit is suggested to be better secured at the rear side of the structure as a safety precaution.

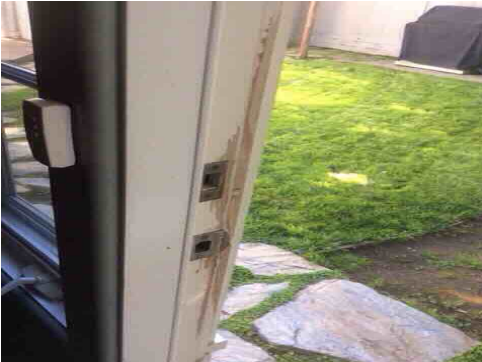
**24:** - The entry door rubs the frame when tested. The reasons for this can range from a result of seismic activity, settlement or improper installation. Further evaluation may be necessary to determine the exact cause of this occurrence. Doors should be trimmed or adjusted as necessary to work properly.

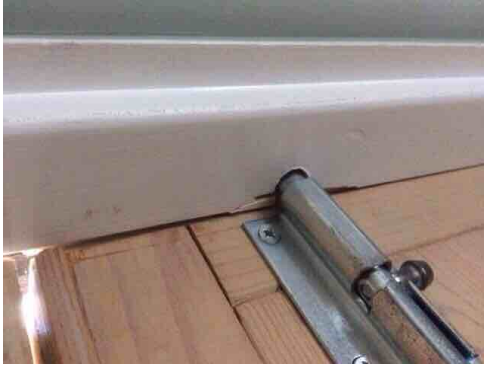
**25:** - The exterior man doors appears to be functional, however, the door, door frame, screens and hardware appear to be somewhat worn due to use. This may be considered normal wear and tear for its age and use. Typical maintenance-type service may be necessary to remedy these issues.

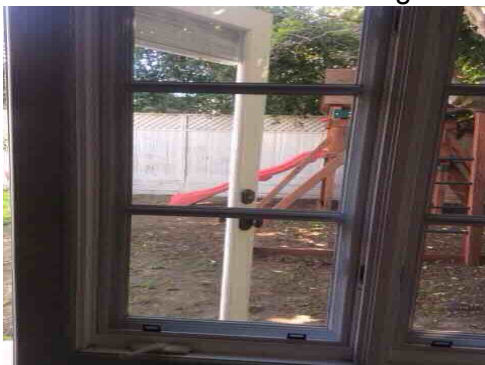
**29:** - The casement windows in the south wall would not open with a "reasonable" amount of force applied to the crank without risk of damage to the arm. The buyer may wish to have the seller improve this condition.

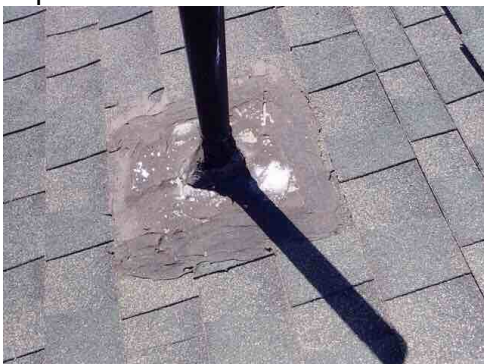
**15:** - There is a flashing on the roof that is not roofed around properly. The flashing is on top of the shingles and has had roof cement spread around it. The back of the flashing should be installed under the shingles to ensure that any water that drains from the shingles will drain onto the flashing instead of under it. Improvements are recommended.

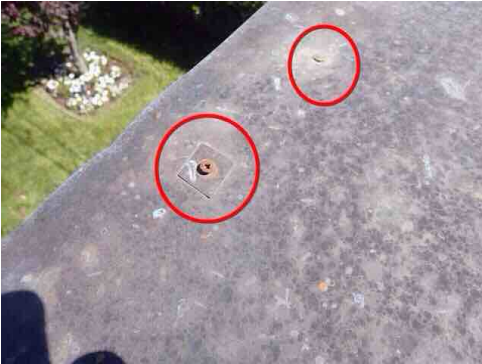
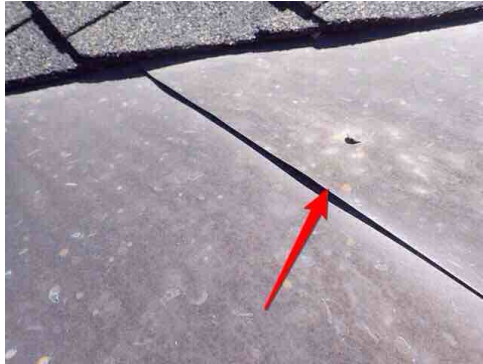
**16:** - The copper sheet roofing installed on the arches has exposed nails/screws and open seams. Sealant is recommended at these areas to prevent moisture intrusion.
