# Property Inspection Report

Tuesday, March 24, 2015

Inspector, Marc Mazza  
Mazza Inspection Group  
(866) 996-2992  
[info@mazzainspections.com](mailto:info@mazzainspections.com)

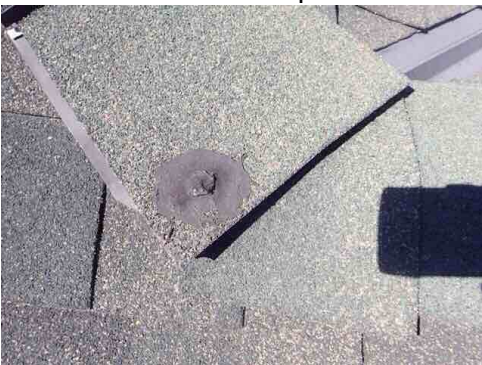
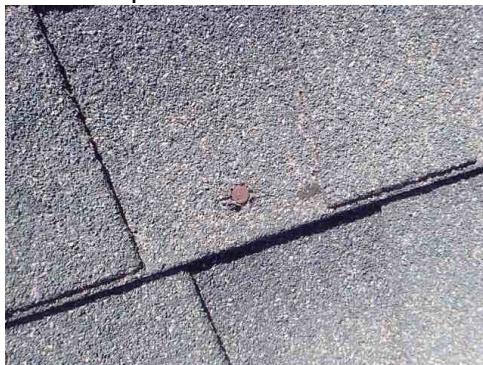
**20:** - Exposed nail heads noted at the main roof surface. Sealant is recommended on the nail heads as preventative maintenance. Keeping the nail heads sealed prevents extrusion and deterioration of the nail head and eliminates a possible moisture intrusion point.

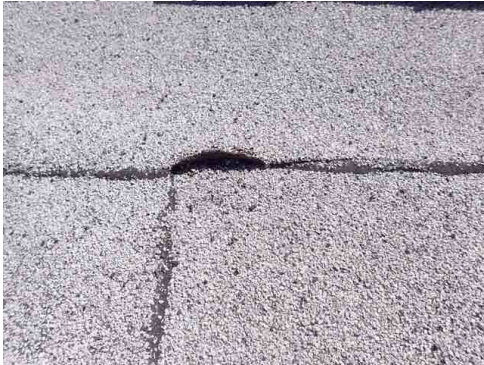
**25: -** We observed "fish mouths" or small areas of the torch down material which is not fully adhered on the laps. These areas could allow moisture underneath the material. Repairs are recommended to maintain the watertight integrity of the membrane.

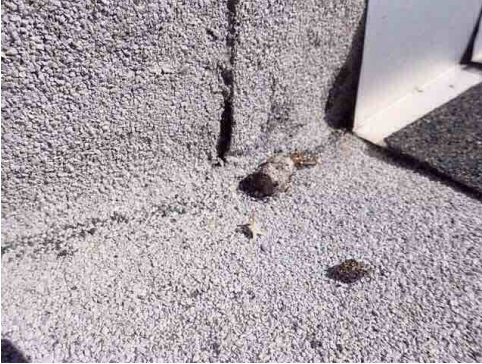
**28:** - There is an open seam in the cricket that is recommended to be sealed to prevent moisture intrusion.

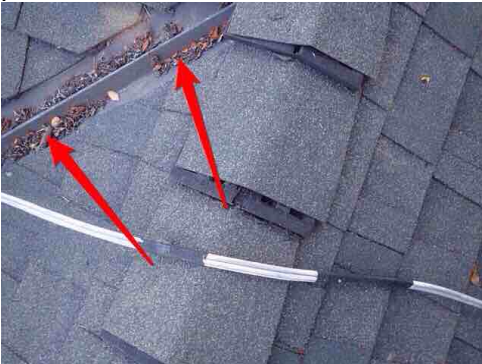
**30:** - There were flashings which were filled with dirt and debris. This material in the flashing pose a potential issue with respect to drainage. The flashing may cause a back up in water run off which may result in a potential leak.

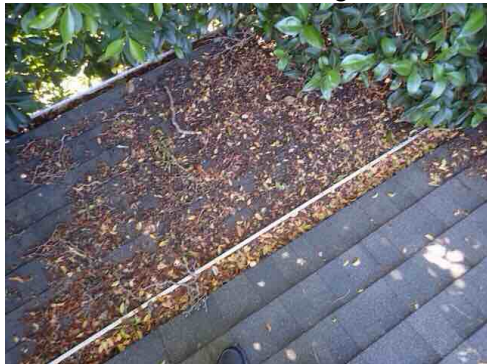
**33:** - Debris was observed on the roof deck, which should be removed to reduce the possibility of premature deterioration of the roofing materials.

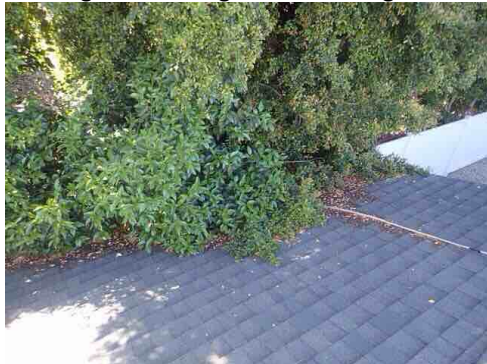
**37:** - The roofing is in contact with tree branches. This condition may reduce the life expectancy of the roofing. Trimming or removing trees could improve this condition.

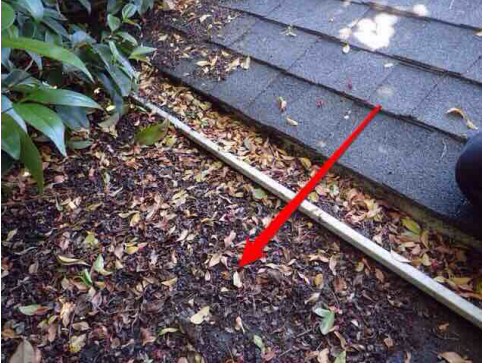
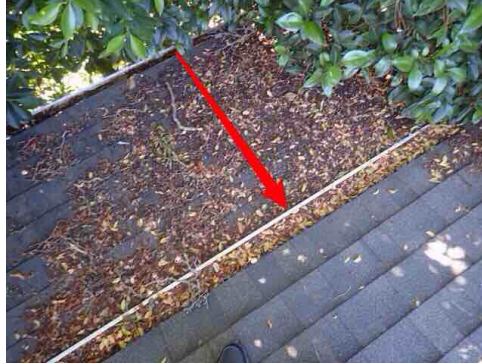
**38:** - The patio cover structure behind the garage terminates at the gutter. This may allow moisture between the roofing and the gutter, which would then leak underneath. Removing the gutter and installing the proper flashing or membrane that terminates under the shingles on the garage roof and properly sheds water is recommended.

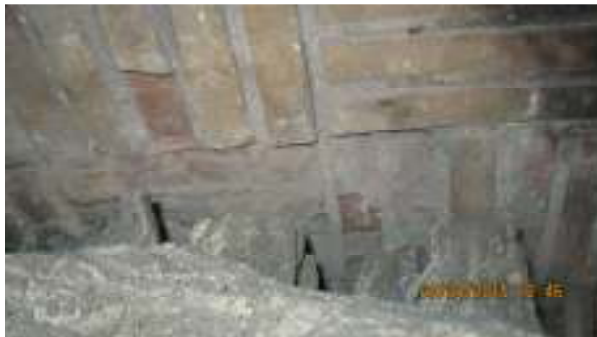
The back wall of the firebox is eroding and falling apart. The firebox walls are built to protect the structure from high levels of heat. When the integrity of the bricks are compromised, the back wall should be rebuilt to maintain the integrity.

1. Remove the shroud.
2. Do an inspection on the inside of the chase to determine if the bond beam was poured properly. If the bond beam is correct then the wood will have to be removed and between the transition and chamber will need to be sealed with the proper high temperature sealant.
3. Rebuild the back wall of the firebox.
4. Install the spacers on the chase cover.

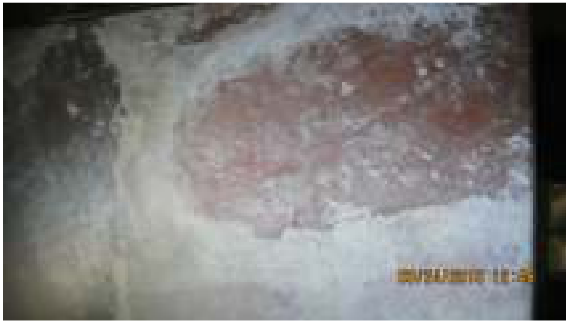
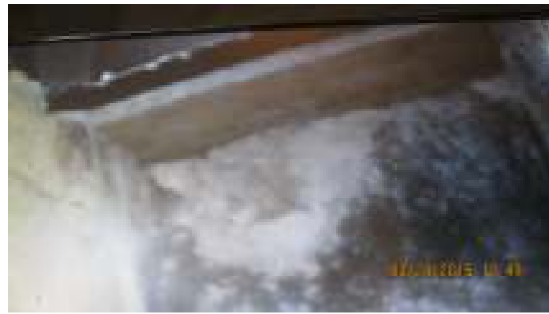
When viewing the flue area via video camera, there were many areas visible where there is coating that is coming apart and falling off of the brick. The chimney appears to have been previously rebuilt. The bond beam was not properly constructed. There are two pieces of wood still holding the transition cone. Heat and sparks can get through the gaps. This condition poses a potential fire hazard.

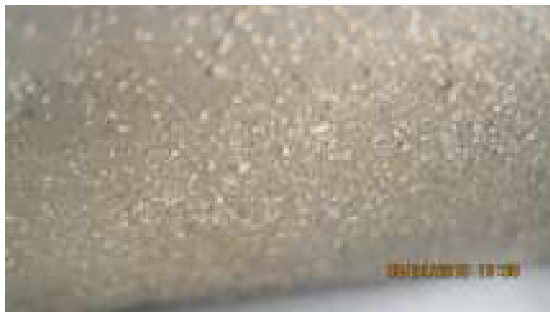
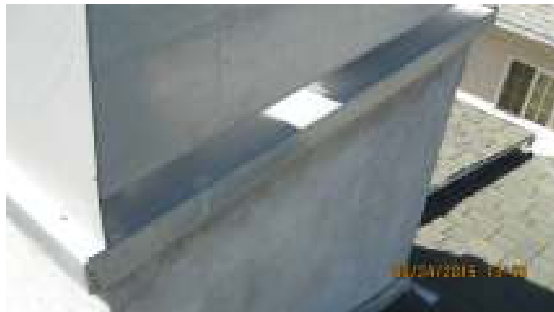
Overall the structure of the chimney was in good condition at the time of inspection. There is a shroud at the top of the chimney. This shroud is choking the termination cap. This condition can cause smoke to enter into the living space. The chase cover doesn't have any spacers under the cover.

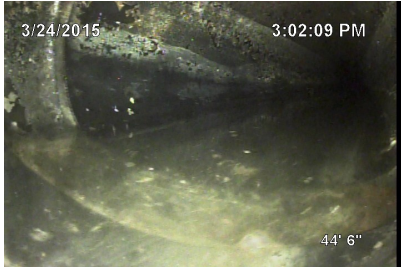
44' 6"

minor debris

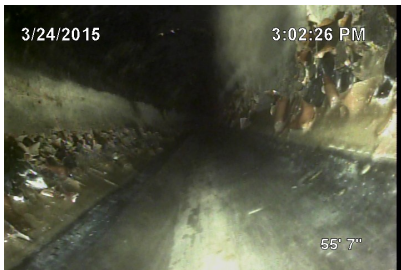
55' 7"

start of standing water section

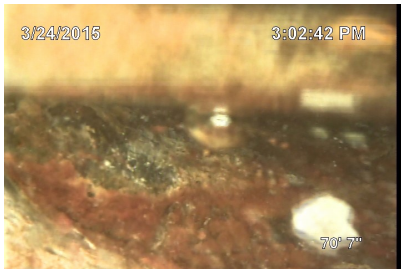
70' 7"

minor debris

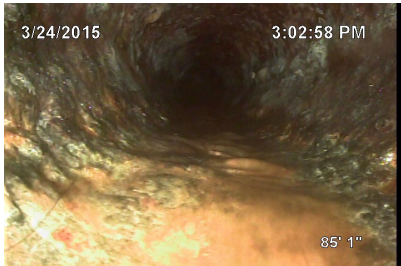
85' 1"

moderate debris

**RECOMENDATIONS :** Have sewer line undergo cleaning by means of a jetter which is a high pressure water system used to flush and clear all debris settling in sewer main line. Jetting is typically estimated at \$400.00. An annual cleaning is also recommended to help prevent future blockages or damage. After jetting is completed, have a qualified plumber look at the sections of pipe with standing water for possible solutions to the problem area. Recommendation costs are only estimates as there are a wide range of contractors that charge various prices for their work.

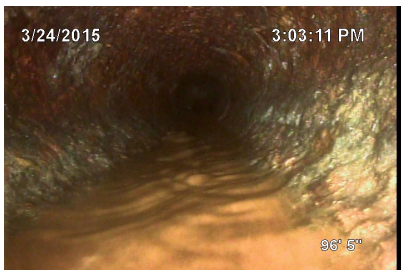
96' 5"

moderate debris

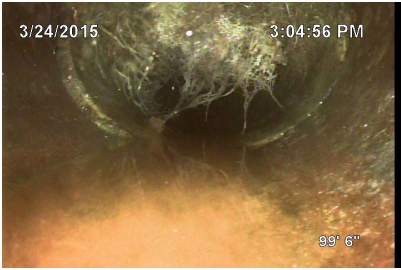
99' 6"

**SEWER LINE OBSERVATIONS :** After running camera through 117 feet of 4 inch Cast Iron, A.B.S. and Clay sewer pipe from the 4 inch cleanout to the city sewer connection, the conclusion was a root intrusion 95 feet into the sewer system. Although minor, roots can grow inside of the sewer system and cause potential problems in the future. There are also 2 sections of pipe at 55 feet, and 67 feet with standing water. Standing water is stagnant water in the pipe that does not drain due to debris in the system or insufficient slope of the actual pipe. Sloping is 1 / 4 inch per foot of fall as per code. No major offsets inside of the sewer line were viewed. Inner walls of main line contain a moderate buildup of scale and sewage debris in various areas which is typical in homes over 20 years of age with no routine maintenance ever performed.

3/24/2015 3:04:56 PM  
root intrusion

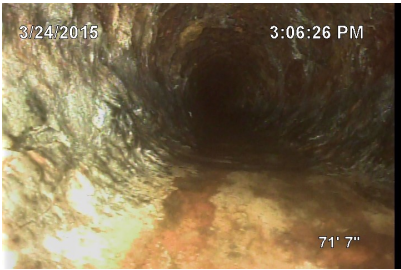
71' 7"

3/24/2015 3:06:26 PM  
moderate debris
