COMMERCIAL BUILDING INSPECTION REPORT

SAMPLE REPORT

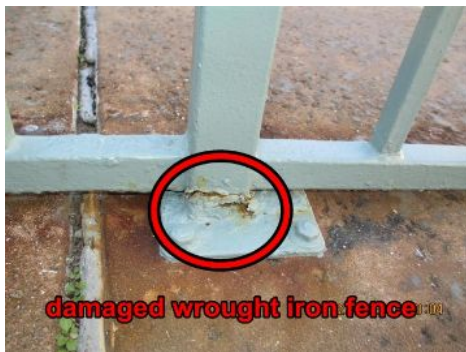
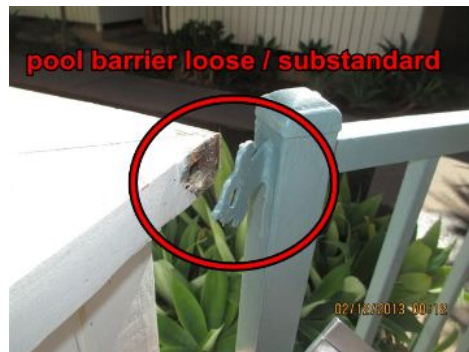
5.1. The wrought iron fence was observed to have areas of rust. Proper surface preparation and painting are necessary to prevent further / future deterioration. In some cases, wrought iron components may have to be replaced.

5.2. Loose and / or disconnected wrought iron fencing was noted where the fence is connected into the wood patio fence system. Reinforcing the area where the attachment is loose is suggested.

damaged / rusted wrought iron
fencing

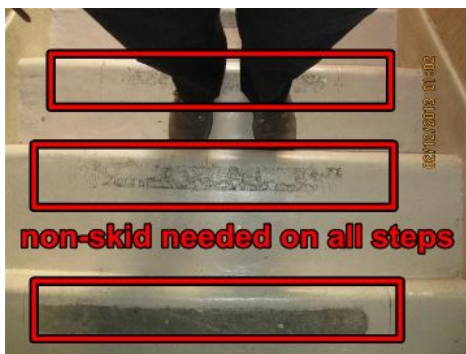
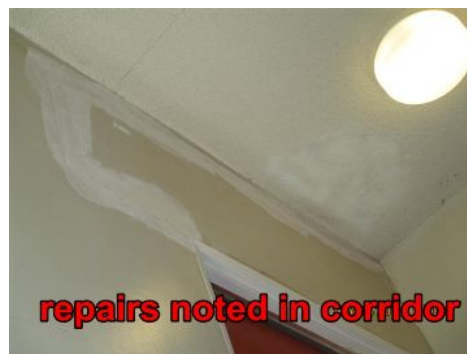
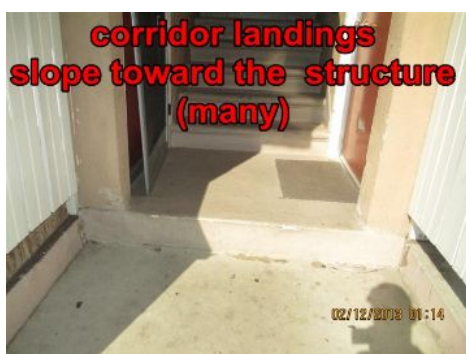
9.1. The lower landings are suggested to be re inspected for proper drainage. This area of stairwells, #1 and #4, poses a slip hazard, should it collect moisture.

9.2. Signage was observed damaged in multiple stairwells and corridors. In some corridors, signage was non existent.

9.3. The steps throughout the stairwells within all of the corridors collectively are all suggested to possess non skid tape at the foot of the tread as a safety precautionary measure.

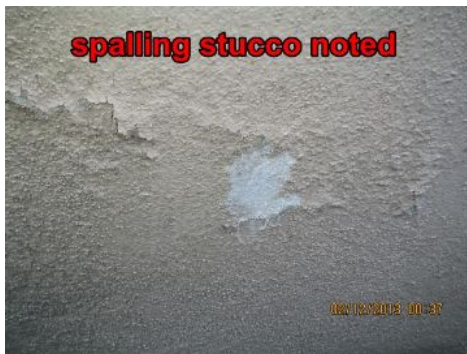
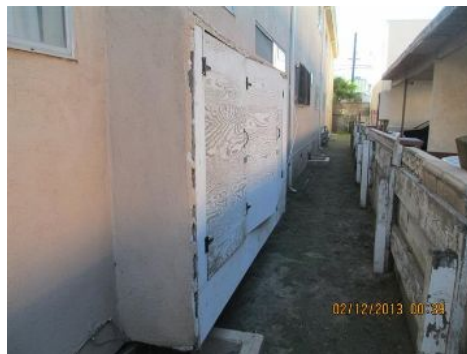
1.8. Moderate to excessive damage was observed at the electrical service housing structures.

electrical service closets

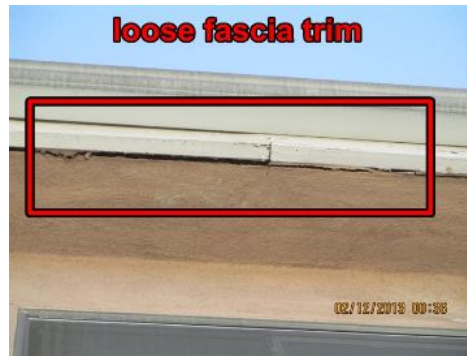
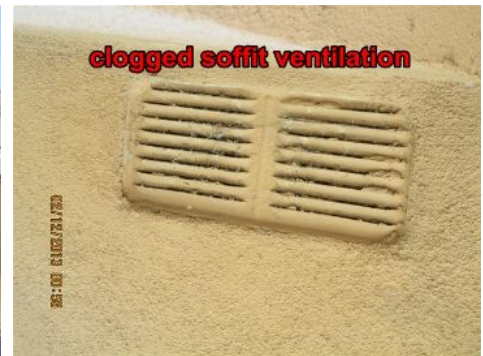
soffit vents are clogged

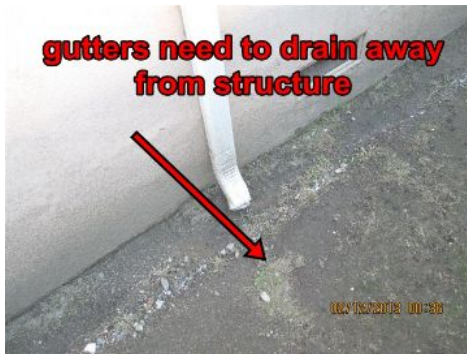
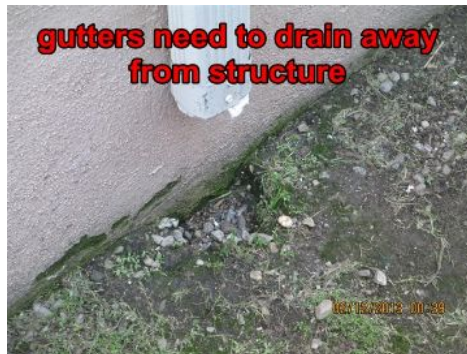
5.2. There was damage observed at the south downspout. Repair or replacement is suggested to allow for adequate drainage.

5.1. We recommend routing all of the downspout(s) away from the structure, or installing the downspout directly into the subsurface drainage, if present. The downspout(s) should discharge water at least five (5) feet from the structure or drain into existing sub surface drainage. Storm water should be encouraged to flow away from the building at the point of discharge.

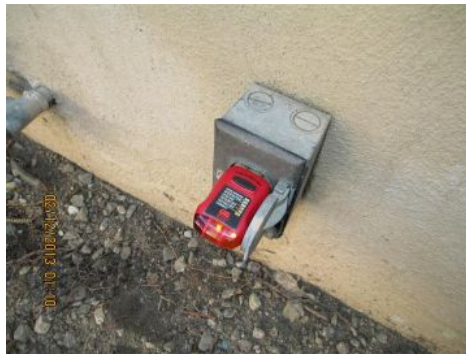
6.1. Three prong ungrounded receptacles were observed at the rear of the structure. Ungrounded receptacles are suggested to be repaired by a professional including adding a GFI if necessary.

courtyard south side receptacle not grounded

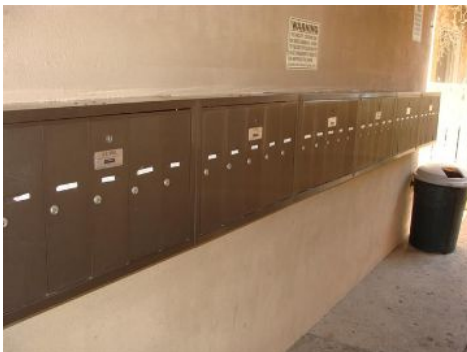
main boxes omitted from this evaluation

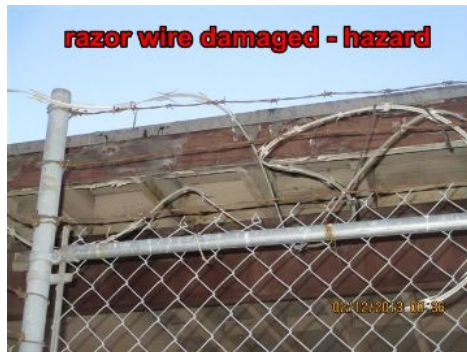
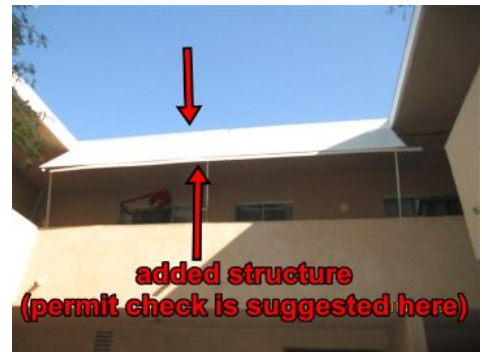
10.3. The metal awning in the courtyard appears to have been added to the structure. The buyer is suggested to research this component and obtain building permits associated with its installation.

added awnings

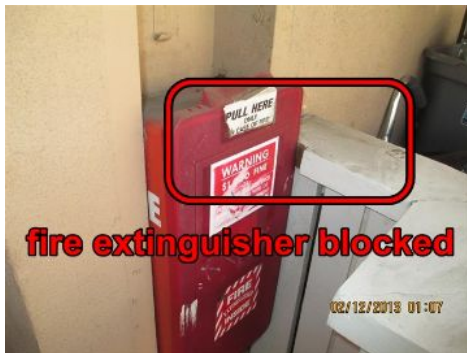
13.1. We observed fire extinguishers which were obstructed.

fire extinguisher blocked

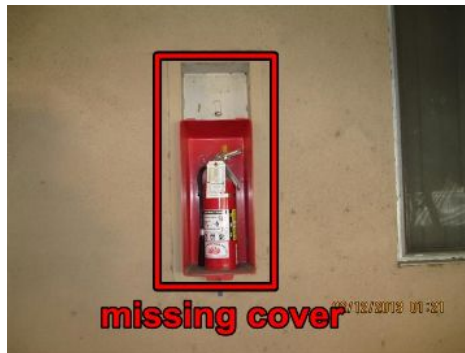
13.3. Missing covers to fire extinguishers were observed.

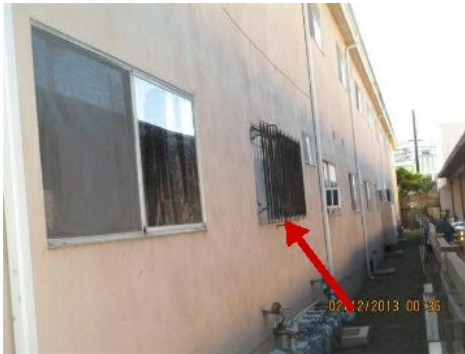
14.1. There were windows around the perimeter which possess security bars. These bars pose a potential hazardous condition if they fail to operate. In light of this condition we suggest the window bars be tested individually for correct operation and in accordance to CFC, California Fire Code section 1029.4 Operational constraints. Emergency escape and rescue openings and any exit doors shall be maintained free of any obstructions other than those allowed by this section and shall be operational from the inside of the room. Bars, grilles, grates or similar devices are permitted to be placed over emergency escape and rescue openings provided the minimum net clear opening size complies with Section 1029.2 and such devices shall be releasable or removable from the inside without the use of a key, tool, special knowledge or effort or force greater than that which is required for normal operation of the escape and rescue opening. Where such bars, grilles, grates or similar devices are installed, smoke alarms shall be installed in accordance with Sections 907.2.11 regardless of the valuation of the alteration. The release mechanism shall be maintained operable at all times. Such bars, grills, grates or any similar devices shall be equipped with an approved exterior release device for use by the fire department only when required by the authority having jurisdiction.

bars need to be functional

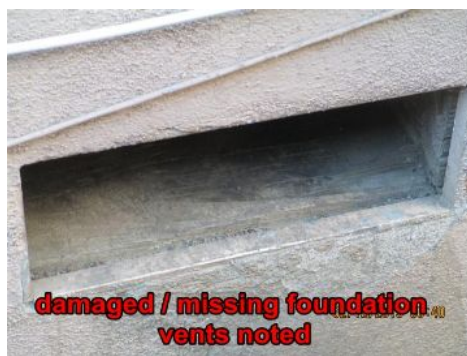
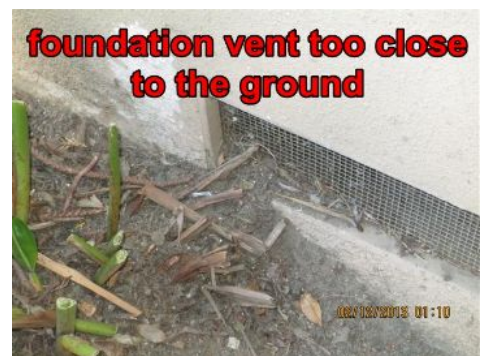
foundation vents on grade

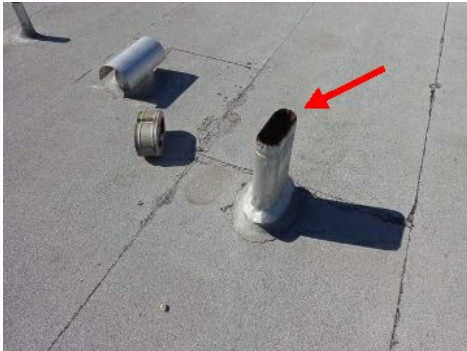
4.2. A vent cover was missing and suggested to be replaced.

BW vent cap missing

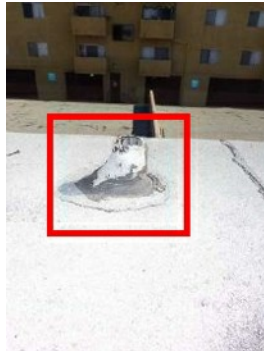
4.3. There were vents that appear to have been cut to a height at or below 4" from the roof deck, which is substandard. We recommend that the vents be inspected by a plumber and improved as necessary.

short vent

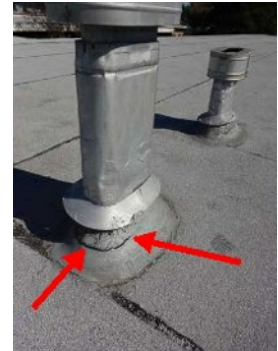
vents need sealant

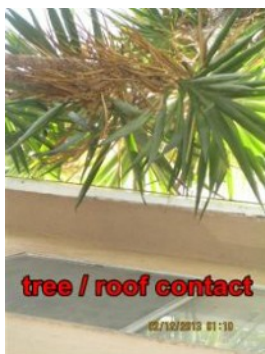
tree contact with roofing

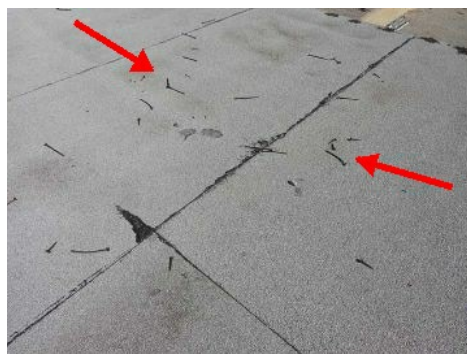
loose nails on deck

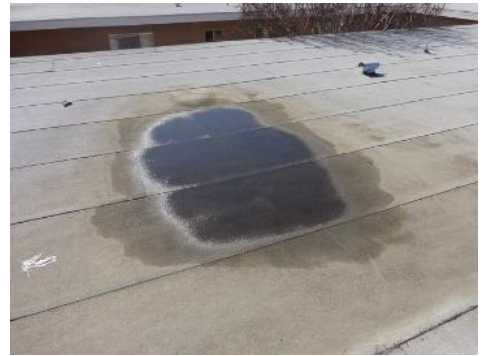
ponding at roof

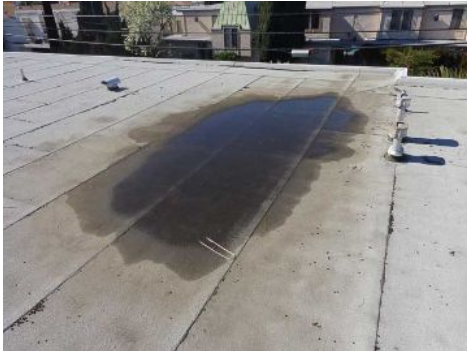
additional ponding at roof

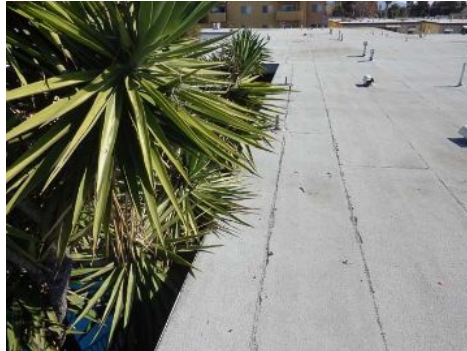
tree contact noted

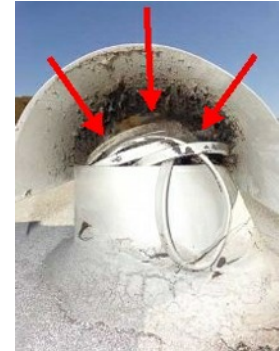
vent filled with wires

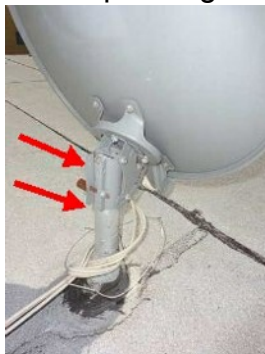
satellite dish attached to vent

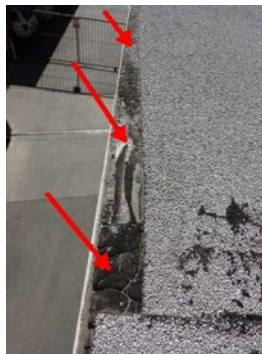
missing material at edge of roof

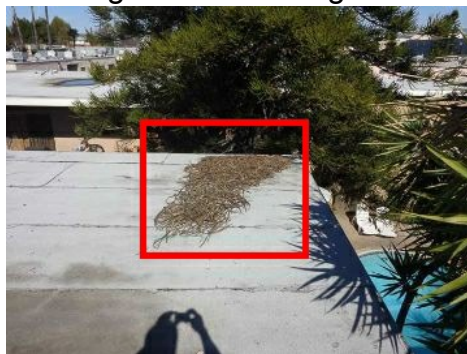
debris on deck

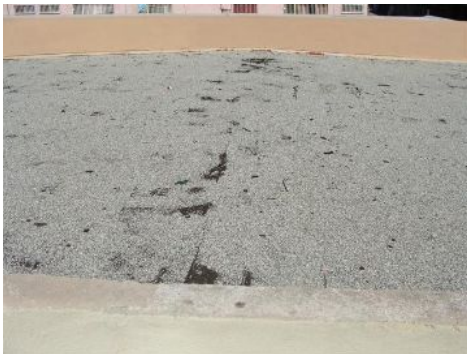
obvious bare areas missing
ballast

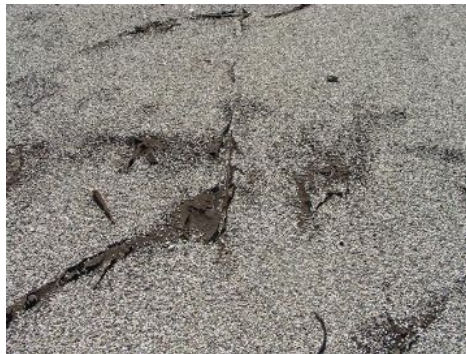
deteriorated surface missing
ballast

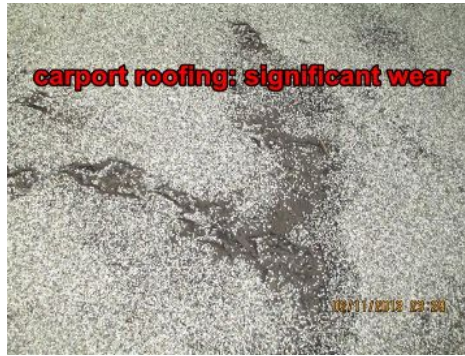
7.1. The low sloped builtup roof was observed to be at the end of its useful life and in poor condition, overall, and displays numerous deficiencies.

carport roofing: significant wear

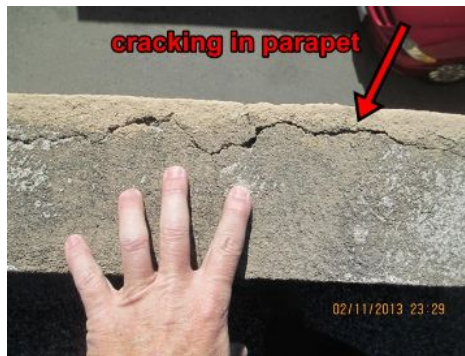
7.3. There are cracks at the top of the parapet walls. If they are not sealed, deterioration and damage could result.

cracking in parapet

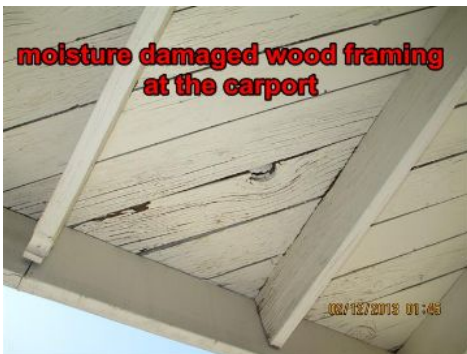
7.5. The wood on the underside of the flat roof B, which supports the roofing load, displays evidence of moisture penetration, possible moisture damage and possible fungus. We suggest the buyer obtain an inspection from a qualified pest control company.

moisture damaged wood framing at the carport

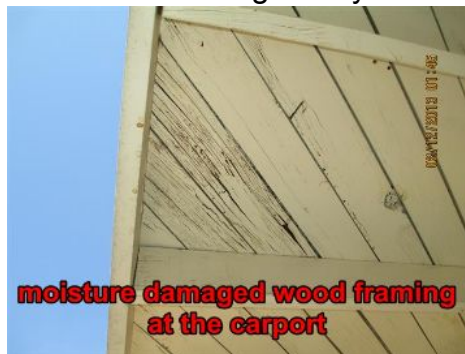
moisture damaged wood framing at the carport

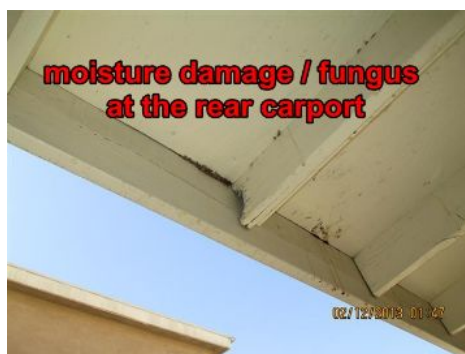
moisture damage / fungus at the rear carport

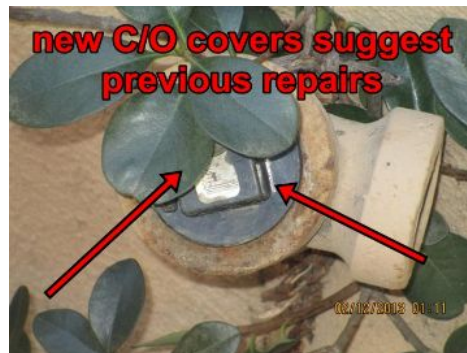
2.1. A new clean out cap was observed. Typically, new clean out covers will be installed after some type of service or repair has been performed. We are unable to determine if any service has been performed by this visual inspection.

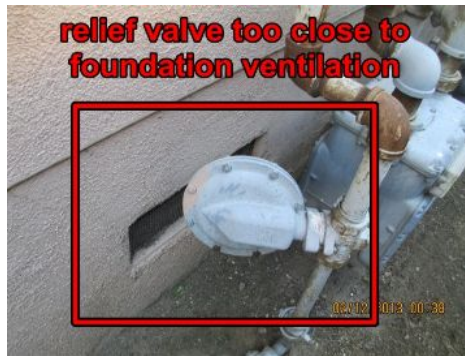
3.1. There were fuel meters which appears to be too close to a foundation vent. A standard 3 foot setback is suggested to be maintained between the meter and open vents.

fuel meter regulator close to foundation vent/opening

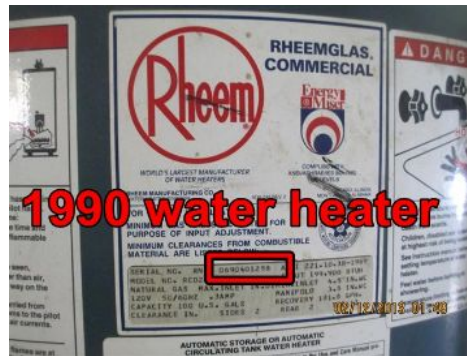
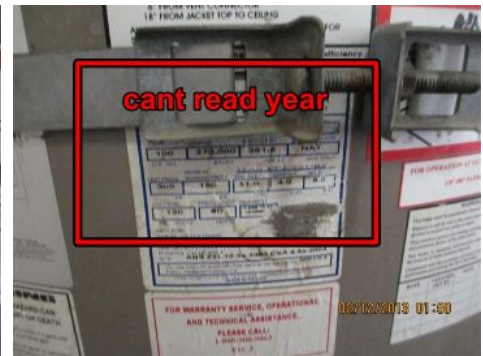
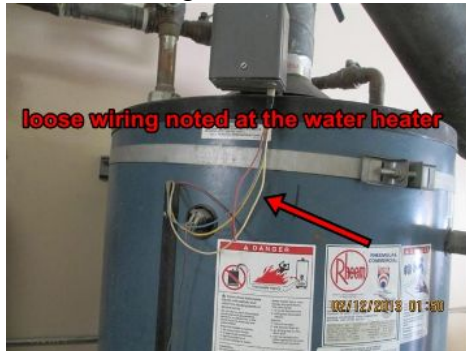
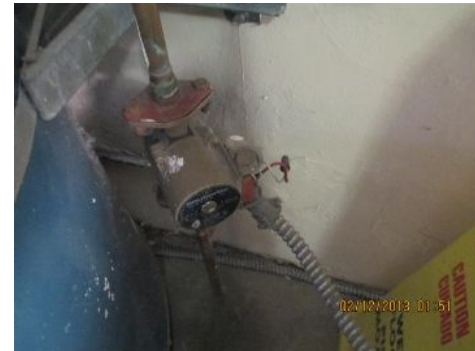
water circulators not within the scope of testing

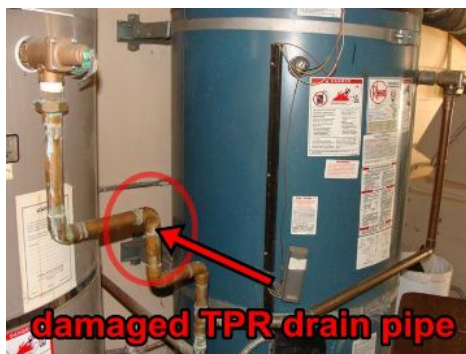
3.1. The TPR drain for unit B was damaged, thus restricting the flow when necessary. The combination of both A and B together, suggest the need to have the main drain for the TPRs to be a larger diameter in accordance to industry standards.

TPR drain suggested to be a larger DIA.

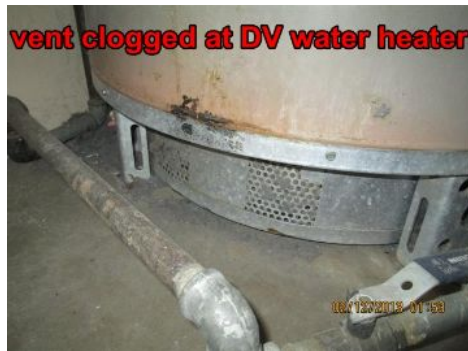
1.4. The water heaters are installed in a location which requires fresh air ventilation for combustion / makeup air. This air replaces the air used during combustion and exhausted. At the time of the inspection, we noted clogged vents in this area. Vents are suggested for this combustion / make up air and should be better provided.

clogged vents/screens

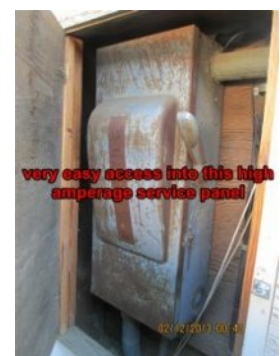
5.1. The main service panels (2) were easily accessible to anyone, which poses a real and present hazard. Protection, while allowing access to those of authority, should be considered. Furthermore, the individual disconnects for the individual units were not tested or removed, nor were their dead front covers.

service disconnects are very easily accessible and pose a real and present danger

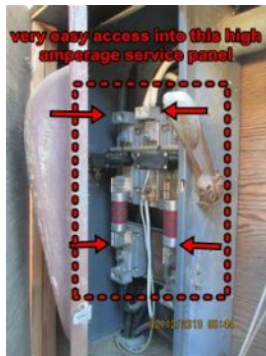
service disconnects are very easily accessible and pose a real and present danger

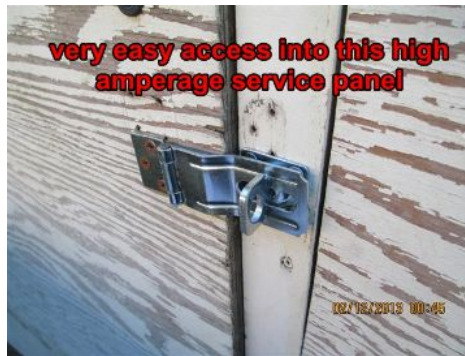
service disconnects are very easily accessible and pose a real and present danger

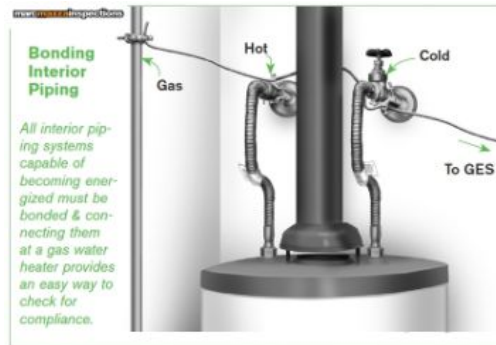
8.2. We were unable to verify a cold (and hot) water bond at the main water supply, or supply piping. This is not to suggest that this bond was not installed, just not visible to us at the time of the inspection. With that said, and in accordance to building standards; the bond is suggested to be installed in or attached to a building structures metal piping system(s) including gas piping, that are likely to become energized. These aforementioned components should be bonded to the service equipment enclosure in accordance to building standard. The bonding jumper(s) should be sized in accordance with the NEC, using the rating of the circuit that is likely to energize the piping system(s).

correct bonding means in accordance to NEC

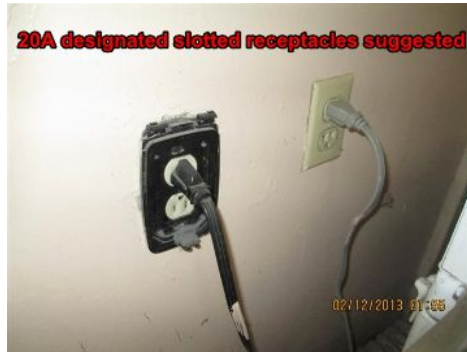
3.2. The receptacle in the laundry room is suggested to be a 20 amp designated receptacle per some building standards.

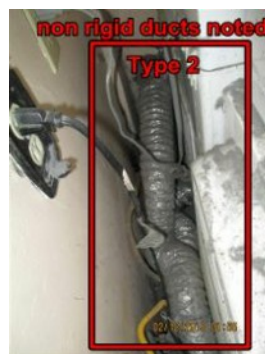
6.1. The dryer duct is a flexible type that is suggested to be replaced with a smooth wall vent in accordance to NFPA section 10.7.3.

flexible ductwork not suggested

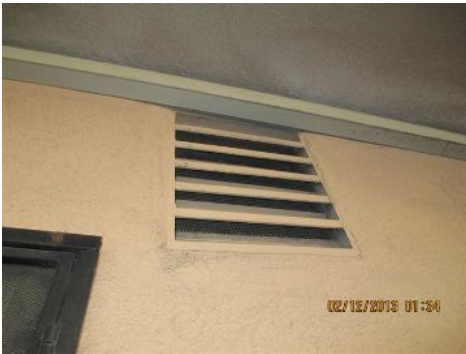
8.1. The combustion air vents are suggested to be cleaned to provide necessary combustion air.

vents need to be cleaned

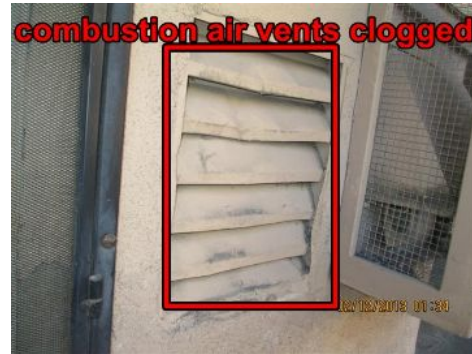
vents need to be cleaned

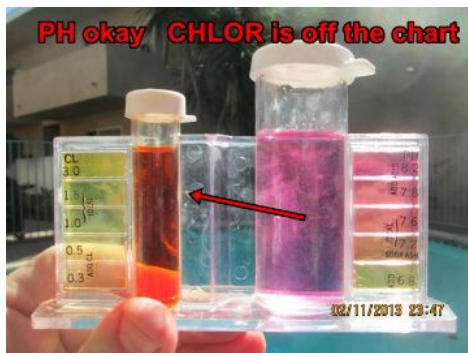
2.1. The pool chemistry, specifically, the chlorine level, was at breakpoint well above what was / is considered to be industry standard. Furthermore, in light of the level of the chlorine at the time of the test, we did not observe any locked gates or signage alerting the community of the extremely high levels of chlorine. The PH level was correct.

chemistry out of balance

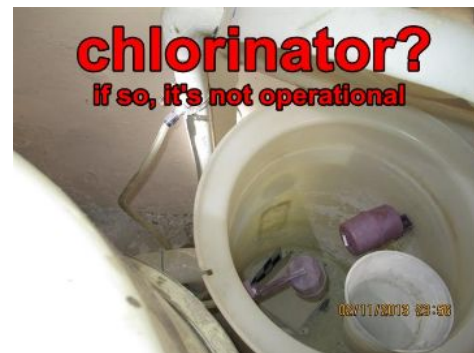
2.2. We did not observe a chlorinator that was functional. We observed a bucket in the equipment room which may be used for this purpose, or possibly the dispersment of diatomaceous earth (?).

is this a chlorination system or for dispersment of DE?

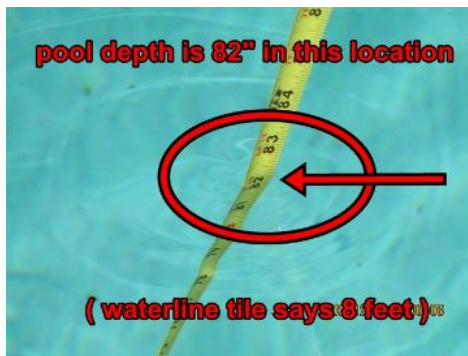
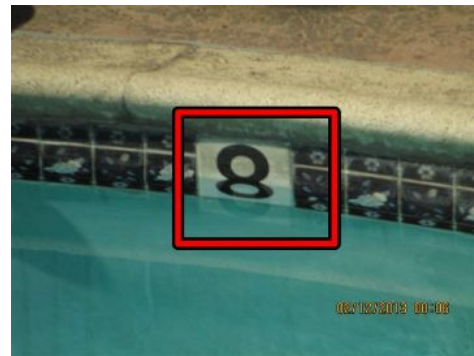
5.2. The pool markers at the deep end were not consistent with the actual depth of the swimming pool.

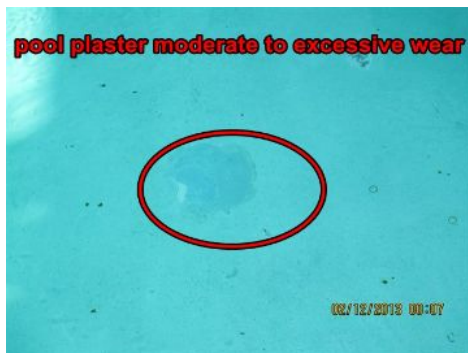
6.1. The pool interior finish is older, in poor condition and displays evidence of heavy wear consistent with age, use, chemical impregnation and etching. In general, unless there is substantial loss of material creating issues with the filtration system or holes in the plaster exposing rebar or unite, the shell can be improved when the finish becomes aesthetically intolerable.

damaged / deteriorated plaster finish

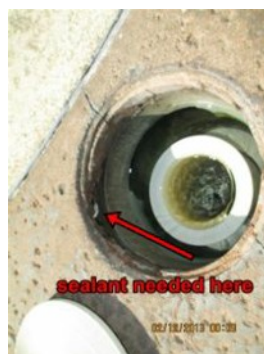
8.1. The connection of the skimmer box to the concrete deck is in need of sealant.

damage / skimmer needs to be sealed

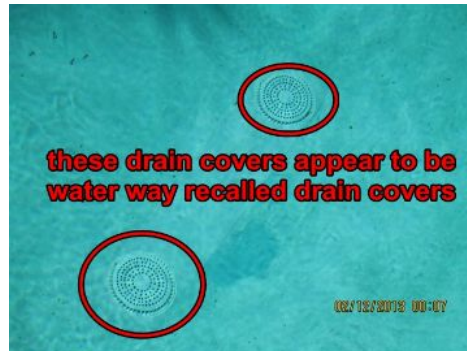
10.1. Recently, there has been a recall on antientrapment type grid drains. These drain covers were in fact on this list of recalled drain covers. We suggest the buyer verify this however. We suggest the buyer visit this web site for additional information to determine if this drain falls into this category prior to use. <http://www.cpsc.gov/cpscpub/prerel/prhtml11/11230.html>

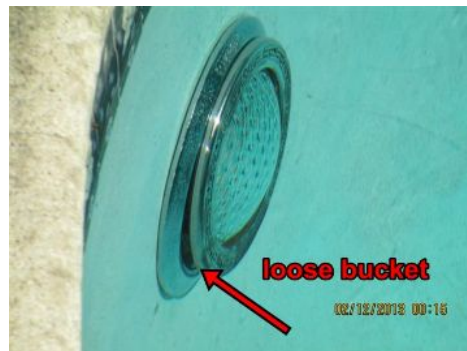
11.2. The light bucket was loose to the niche. This represents a potential hazard and is suggested to be improved.

bucket may be loose

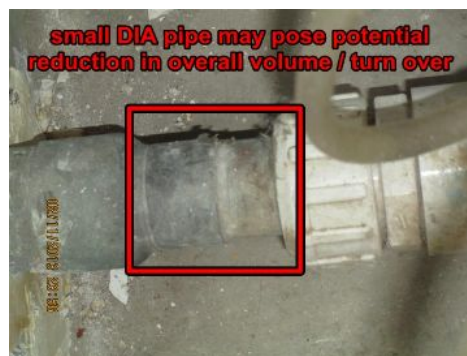
14.1. The piping for the pool system is suggested to be further scrutinized in light of the size of the smallest pipe in the system. We are unable to determine the flow rate or head pressure for this system in order to achieve adequate turnover.

piping size small for run / subject to further testing and evaluation

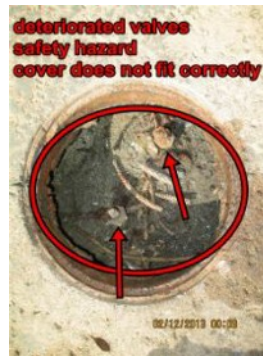
15.1. There were valve(s) present in the slab behind the pool in the deck but were not tested. We were unable to determine the purpose a valves are, installed. Contacting the current pool service company concerning this valve may offer an explanation. We did, however, observed significant deterioration of these valves and no visible bonding.

valves in deck/ rusted deteriorated / may not be bonded to system

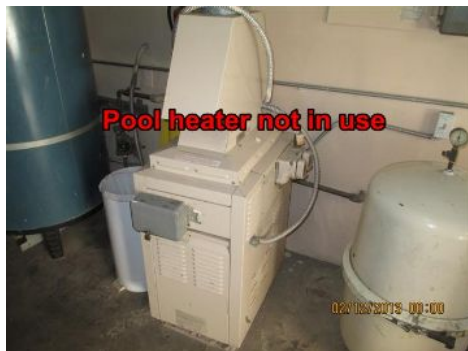
17.1. The swimming pool heater is old, obsolete and is suggested to be removed.

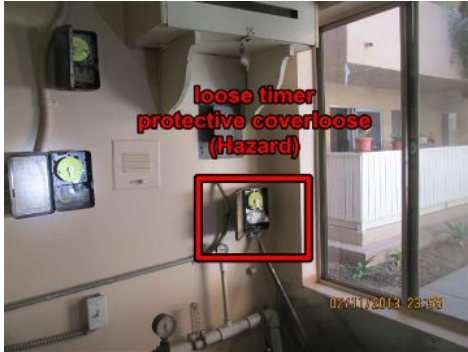
19.1. A plastic electrical cover or shield, which exposes the interior conductor connections, is missing from a timer box in the pool equipment area, and should be replaced.

19.2. The pool timer is loose and poses a potential hazard. We recommend the further review, advice and services of an electrician.

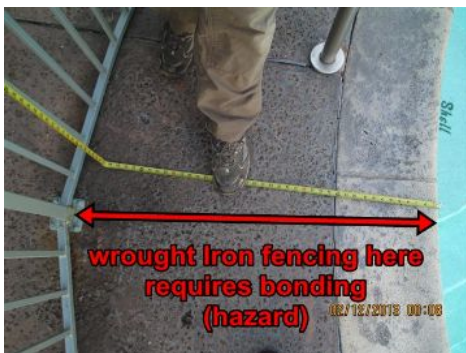
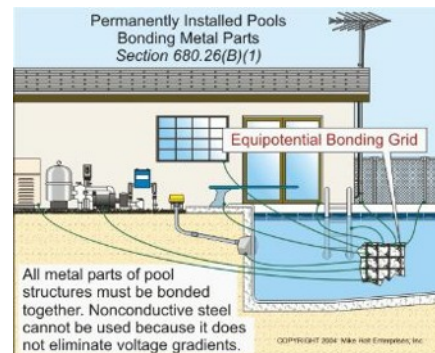
20.2. National electrical standards require that all metal pool equipment (pumps, filters, motors, heater, railings, diving board etcetera) be bonded to a common wire that conveys errant electricity harmlessly to ground, which we recommend as a safety improvement. Furthermore, any metal components within a 5' radius from the pools waters edge must be bonded as well.

The wrought iron fencing was closer than what building standards suggest without a visible bonding conductors.

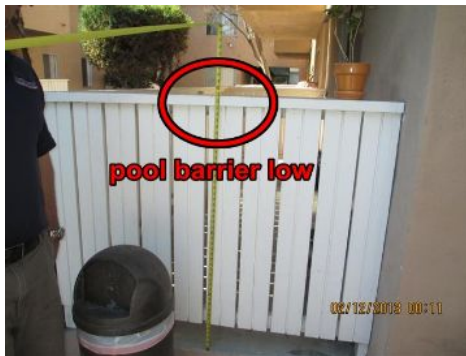
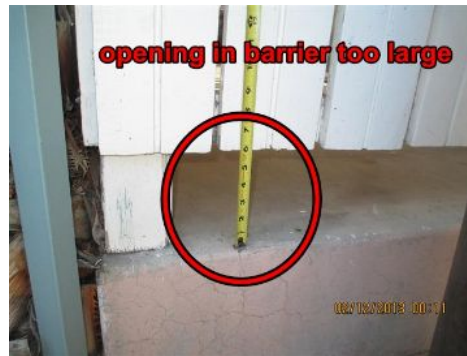
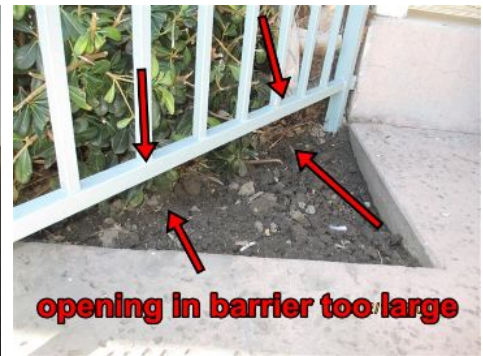
22.1. It is our position that all of the pool barrier system collectively is substandard and poses a real and present hazard. The buyer is suggested to have the entire barrier system evaluated and improved prior to the close of this escrow.

Fence height at the pool/spa area was too low as per local building standards. Fencing which leads to a yard which poses a swimming pool must not be lower than 60 inches with no gaps less than 2*4* inches below the fence. Pool barriers must remain 60 inches height.

** The bottom and / or sides of the fence / gate exceeded the minimum allowable space of 2 inches over grade and 4 over solid surface per building standard for barriers which lead to a pool yard. This applies to fencing and gates alike. Repairs are suggested to adhere to the safety provisions set.

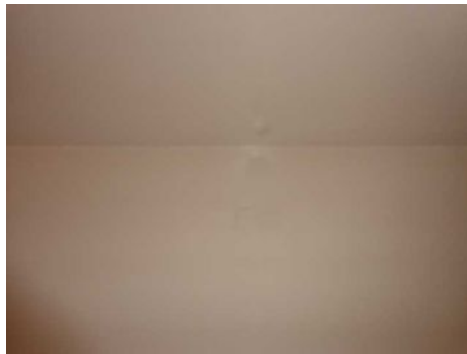
8.2. The paint on the ceiling / walls in the bathroom is bubbling and peeling.

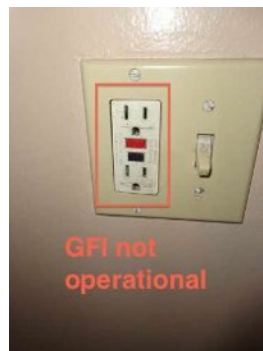
3.2. A ground fault circuit interrupter (GFCI) outlet in the common bathroom did not respond correctly when tested. This receptacle should be replaced as a safety precautionary measure.

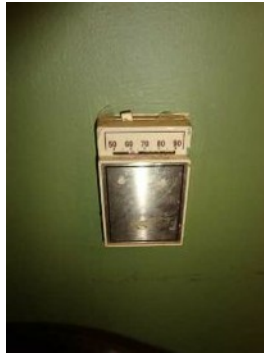
1.1. The thermostat for the wall heater was taped a the time of the inspection. The unit was not tested for operation.

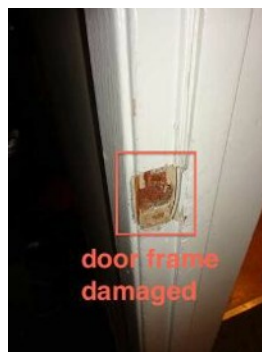
2.2. The interior door at the west bedroom failed to properly latch when tested and is damaged at the frame.

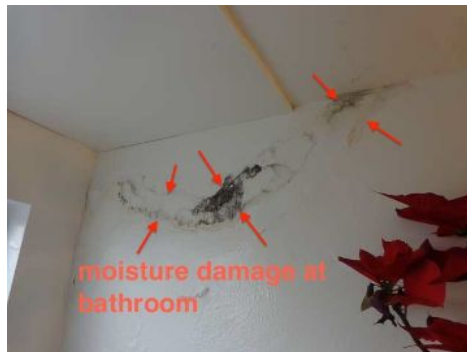
- 7.1. Cracks were noted at the interior walls. These cracks suggest that some type of movement within the structure has occurred. It is well beyond our scope as well as our expertise to attempt to draw a definitive conclusion as to the cause of these cracks without additional investigations which may include destructive testing.
- 7.2. Evidence of prior repairs / patching was observed at the interior walls.
- 7.3. Moisture damage and mold was observed in the the common bathroom at the time of the inspection. This is potentially an indication of a current leak. We cannot determine the extent of the moisture intrusion but we can say, with a certain degree of accuracy, that moisture is currently active (with the addition of moisture) in this location. In light of this issue, we recommend further investigation by a general contractor.

visible mold observed on the wall

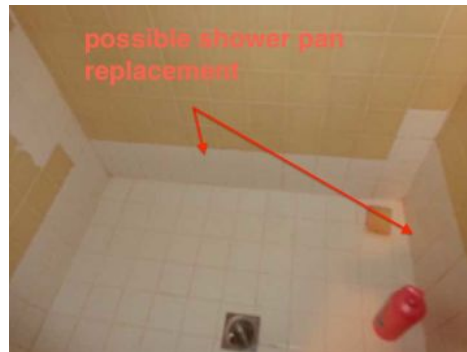
4.1. At the time of the inspection, the shower and faucet tested were in operational condition. No visible leaks were detected. The enclosure was observed to be in generally good condition with signs of normal wear. There are indications that the shower pan may have had previous repairs or replacement.

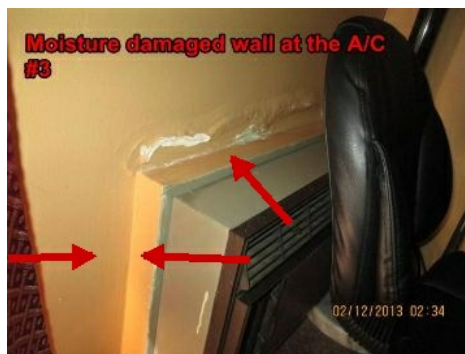
7.2. Moisture damage noted on the wall at the wall mounted A/C unit.

moisture damaged wall at the AC unit

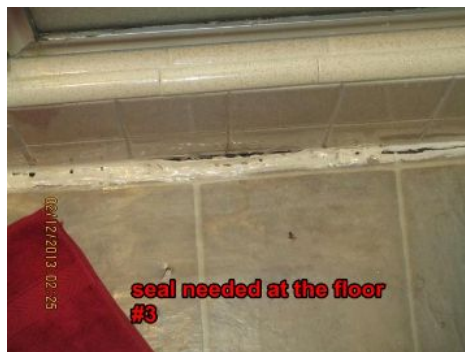
9.2. There is excessive sealant present at the master shower to vinyl floor connection.

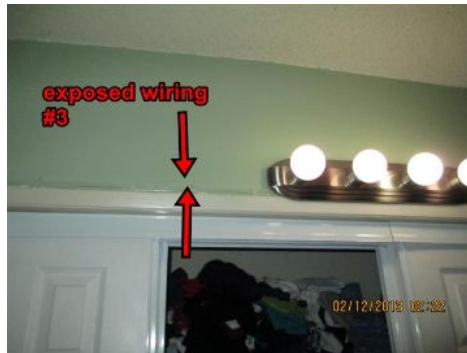
4.1. Substandard wiring noted in the master bedroom. Repairs are recommended for safety of the occupants.

romex is exposed and presents a hazard

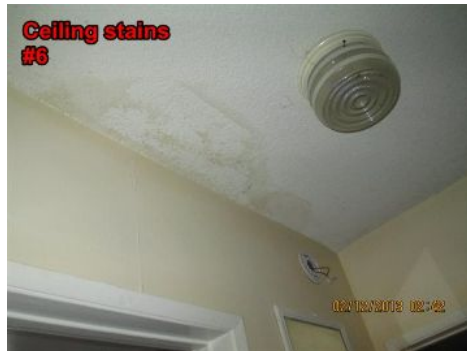
8.3. Moisture staining was observed on the hallway ceiling at the time of the inspection.

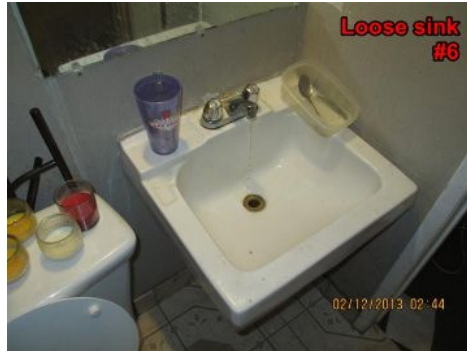
2.1. At the time of the inspection, the sink, faucet and plumbing tested were in operational condition. No visible leaks were detected. The sink is loose at the wall.

loose sink noted

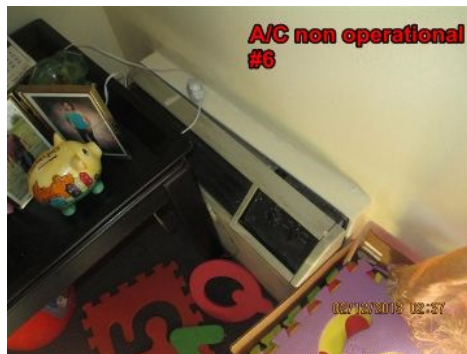
1.1. The wall mounted A/C unit was not operational when tested. The cover is loose.

AC non operational

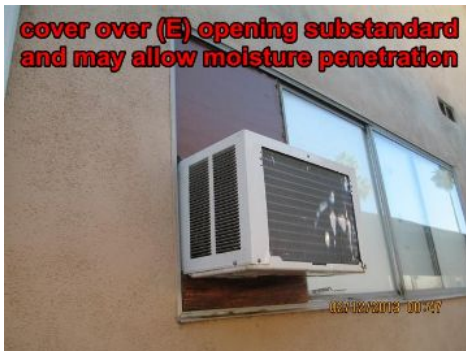
5.3. There is an A/C unit installed in the window of this unit.

ac unit in window subject to moisture intrusion

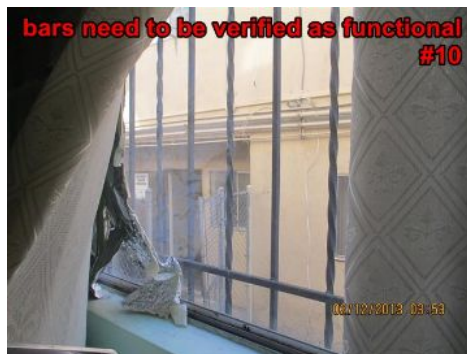
5.2. Security bars were observed on windows within this residence. These security bars were not accessible to test for proper operation due to the occupant's belongings. Egress is a serious concern and is not to be taken lightly. These windows are suggested to be tested for operation and verified that they are all in fact functional and provide necessary egress in accordance to building code.

R310.4 Bars, grilles, covers and screens. Bars, grilles, covers, screens or similar devices are permitted to be placed over emergency escape and rescue openings, bulkhead enclosures, or window wells that serve such openings, provided the minimum net clear opening size complies with Sections R310.1.1 to R310.1.3, and such devices shall be releasable or removable from the inside without the use of a key, tool, special knowledge or force greater than that which is required for normal operation of the escape and rescue opening. The release mechanism shall be maintained operable at all times. Such bars, grills, grates or any similar devices shall be equipped with an approved exterior release device for use by the fire department only when required by the authority having jurisdiction. Where security bars (burglar bars) are installed on emergency egress and rescue windows or doors, on or after July 1, 2000, such devices shall comply with California Building Standards Code, Part 12, Chapter 123 and other applicable provisions of this code. Also reference CALIFORNIA CODES HEALTH AND SAFETY CODE SECTION 1310013135

security bars need to be functional

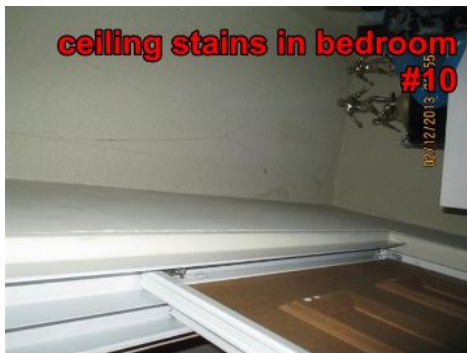
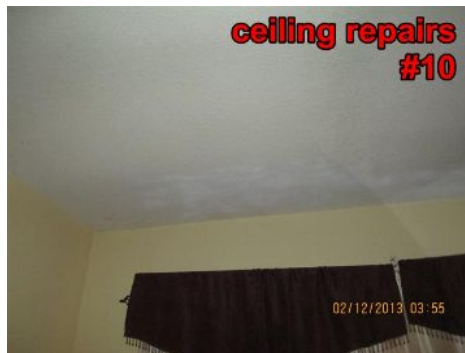
Moisture staining was observed on th ceiling in the master bedroom closet, east common bedroom and kitchen at the time of the inspection.

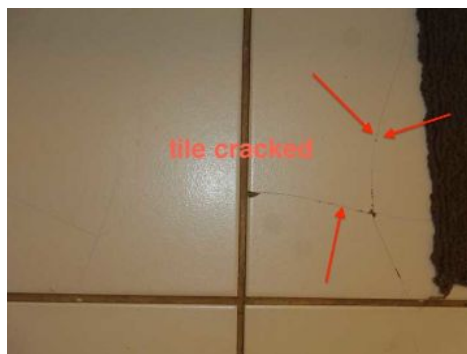
9.2. There were cracked floor tile observed at the interior flooring (the common bathroom) at the time of the inspection. We cannot view under the tile and, as a result, we are unable to determine the reason for the cracking (e.g. cracked concrete slab).

9.3. Floor squeaks were heard when walking on the flooring at the time of the inspection.

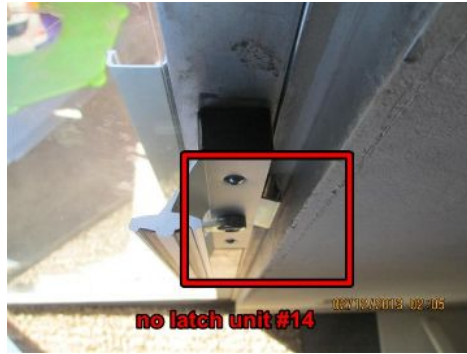
- 4.1. The sliding glass doors / unit is damaged but functional.
- 4.2. The sliding glass doors will need to be adjusted to align, engage the lock, or allow the door to roll more smoothly. This is typical of older metal sliding glass doors. In addition, many older sliding glass doors may not have tempered glass. In the event that the glass is not tempered, upgrading would be a prudent choice. There were no markings to indicate that the glass is tempered.

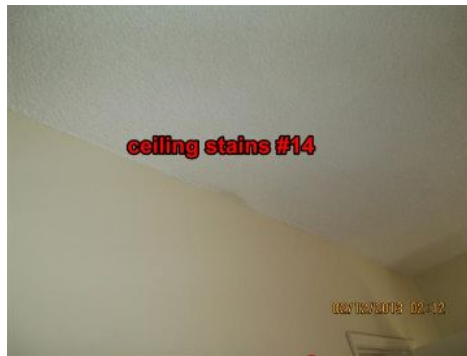
- 8.1. Textured or "popcorn" ceiling material was visible. If the buyer is concerned that the material may contain asbestos, it is recommended to contact a professional contractor familiar with the testing of this material. Detection or testing is beyond the scope of this inspection.
- 8.2. The general condition of the ceilings was observed to be in good condition (unless otherwise noted) with signs of normal wear at the time of the inspection.
- 8.3. Moisture staining was observed on the master bedroom ceiling at the time of the inspection.

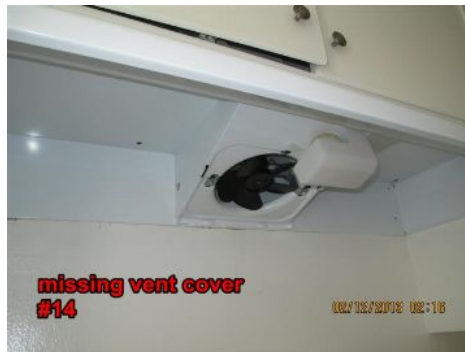
8.3. The vent cover is missing and suggested to be replaced.

vent cover missing

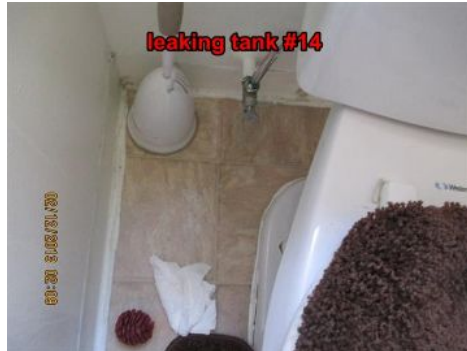
1.2. The toilet was loose and leaking.

leaking toilet tank

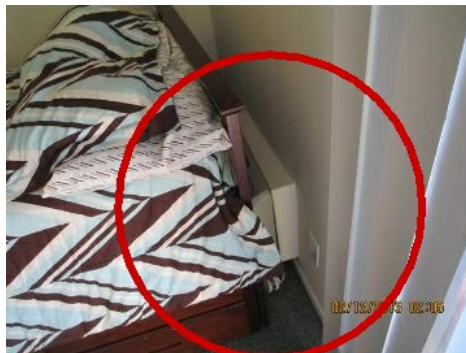
1.1. The wall mounted A/C unit was blocked and not tested for operation.

wall AC blocked

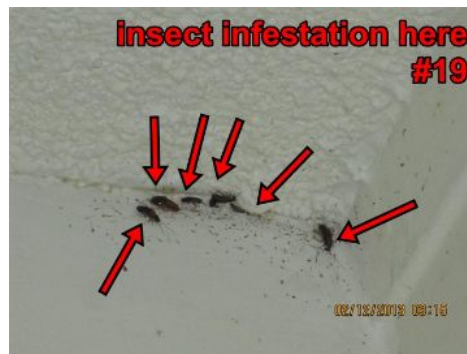
8.4. Insect infestation was observed within residence 19. In accordance to 2012 IPMC section 309.1, all structures shall be kept free of insect or rodent infestation.

insect infestation

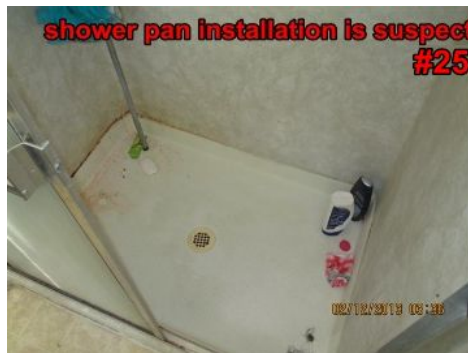
4.1. At the time of the inspection, the shower and faucet tested were in operational condition. The enclosure appears suspect or has been repaired / altered.

shower pan appears to be suspect
