SEWER INSPECTION REPORT

SAMPLE REPORT

Date of inspection : April 07 , 2014 - Time : 11:00 a.m. Technician : Charles Brunsmann.

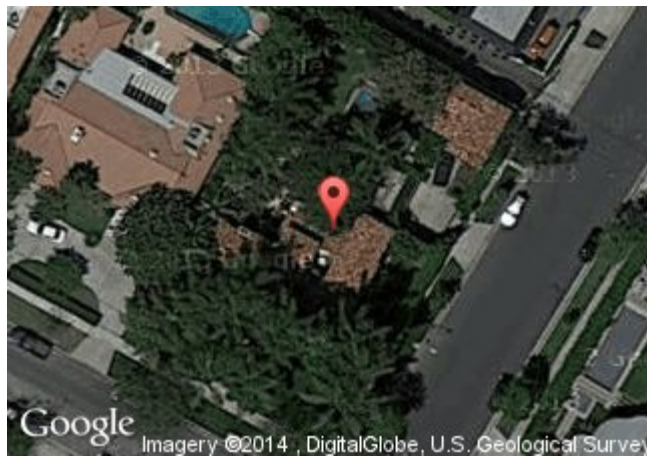
4/7/2014 11:37:38 AM

SEWER LINE OBSERVATIONS : After running camera through a total of 41 feet of 4 inch Cast iron and A.B.S. plastic sewer line from house connection, the conclusion was there was an obstruction 29 feet into the main line of the home after going into 4 inch sewer main line at 3 inch cleanout in primary garage of home. Large root intrusions and dirt appear to be obstructing flow of waste after cleanout transition before or near kitchen sink. Pipe is potentially broken or collapsed when high amounts of dirt are in sewer system. Although water is draining, it is at an unsufficient flow. Inner walls of pipe have a moderate buildup of corrosion and scale due to age of pipe. Camera could not go beyond root intrusion to view pipe in front yard that connects to city sewer. Repairs must be completed before front of home can be viewed. It was also noted that 4 inch A.B.S. plastic sewer pipe for guest house above secondary garage was not tied into the main line sewer. Pipe appears to have a 4 inch rubber jim cap that is partially on. The pipe has also been burried in the ground before connection to live sewer was performed. It is important that sewer line on this portion of the home is not used until the line is connected by a licensed plumber to prevent debris from the ground entering the system causing potential back ups.

RECOMENDATONS : Hire a licensed Plumber to Clear 4 inch main line of root intrusions by means of 1/2 inch snake cable and cutting tip. Cost is estimated at \$300.00. Also have main line sewer jetted with high pressure water jetter to remove all debris from root intrusions and scale buildup off inner walls of pipe. Cost is estimated at \$400.00. Due to potential broken or collapsed pipe it is also recommended to have a plumber inspect area of root intrusion for damage to pipe and estimate price to repair pipe. Recommendation costs are only estimates as there are a wide range of contractors that charge various prices for their work.
