## Property Inspection Report

Saturday, April 4, 2015

Inspector, Marc Mazza  
Mazza Inspection Group  
(866) 996-2992

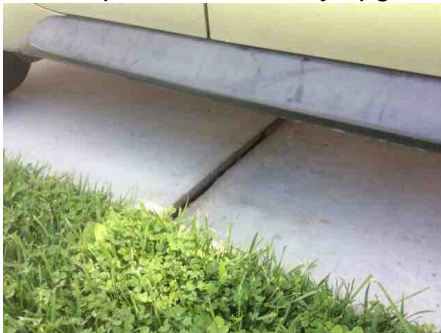
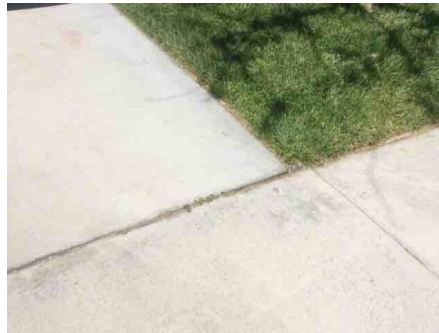
**14:** - The driveway has material that is raised. This may pose a possible tripping hazard and is recommended to be repaired as a safety upgrade.

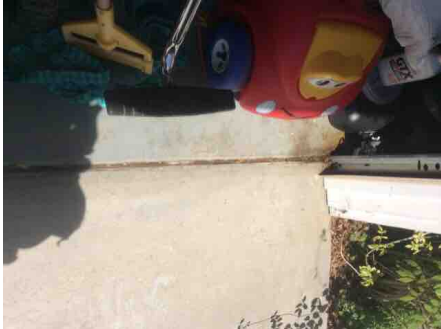
**15:** - Sealant is recommended at the top of the driveway to garage slab connection to reduce the potential for intrusion.

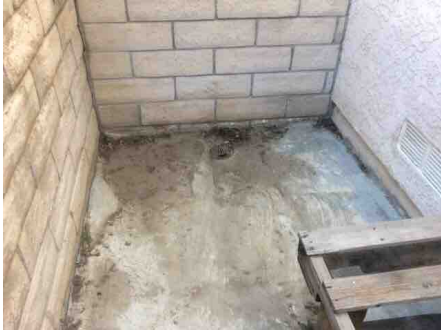
**18:** - The sidewalks show evidence of moisture staining as well as standing water, which may indicate chronic ponding or poor drainage. In time, this condition can accelerate the wear and deterioration of the sidewalk.

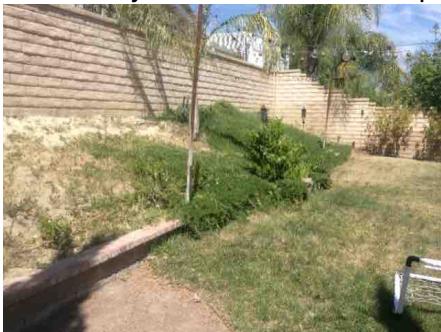
**23:** - The yard wall was not completely visible to inspect due to the foliage present.

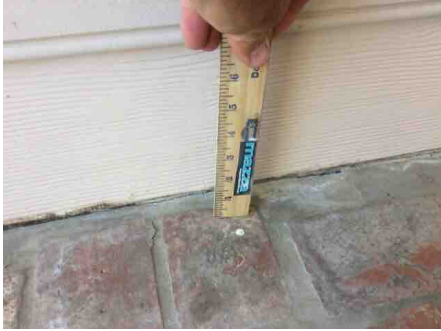
**26:** - The porch surface material is high at the foundation, which does not allow a complete inspection of the foundation. Furthermore, moisture may penetrate beyond the slab into the interior wood framing members via the weep screed flashing (or under a house with a crawlspace). Sealant is recommended to be installed at the slab to foundation connection(s) as preventative maintenance - IRC 2012 §703.6.2.1.

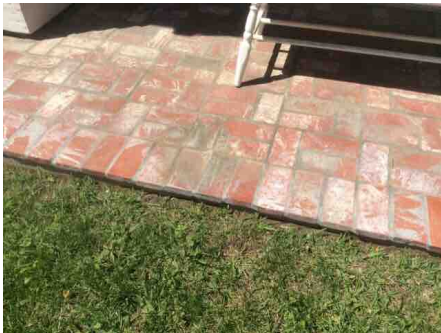
**27:** - The porch surface showed signs of poor drainage or ponding judging by the stains present. Standing water poses a threat to the interior wood framing thru foundation weep screed if the wall is equal or lower than the slab. We recommend monitoring the drainage of the patio when moisture is present. Repairs may include the installation of drains.

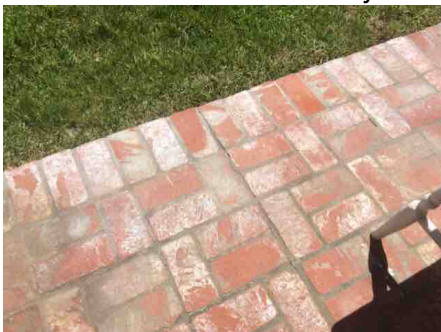
**28:** - The porch surface was settled at the time of the inspection. This poses a possible tripping hazard and should be serviced for safety.

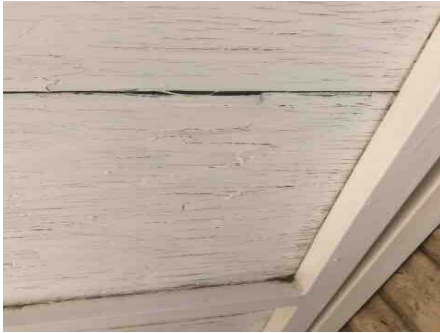
**33:** - The gate was functional when tested for operation, however, moisture damaged or heavily weathered wood was noted at the gate.

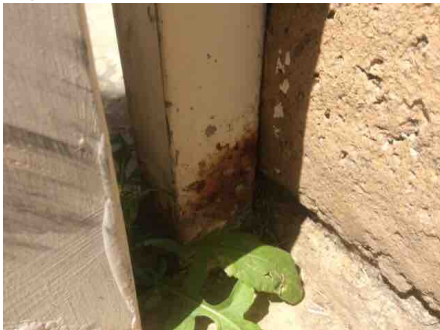
**34:** - The wrought iron gate was observed to have areas of rust. Proper surface preparation and painting are necessary to prevent further / future deterioration. In some cases, wrought iron components may have to be replaced.

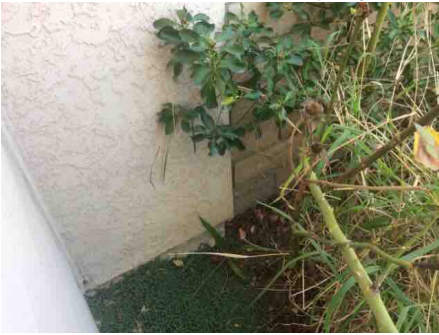
**37:** - There are some of the "cap" bricks (block / bricks at the top of the wall) that are loose and appear to be lifting somewhat.

**38:** - Deterioration of the blocks in the block wall was noted at the time of the inspection. The wear may have been the result of over spray from the sprinkler system or moisture from the adjacent yard.

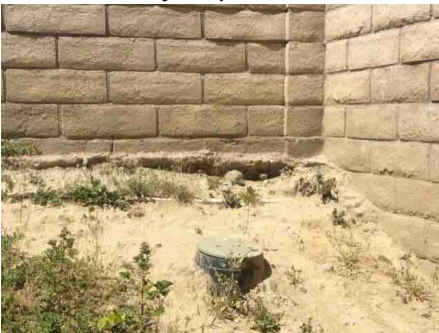
**39:** - The footing is exposed at the block wall system. This footing is the foundational support for the fence and without proper stability, the block wall is subject to failure. Repairs are recommended and should be conducted by a qualified contractor.

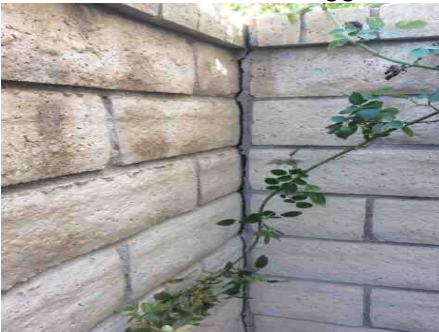
**40:** - The block wall is suggested to be grouted where the wall connects to the adjacent wall.

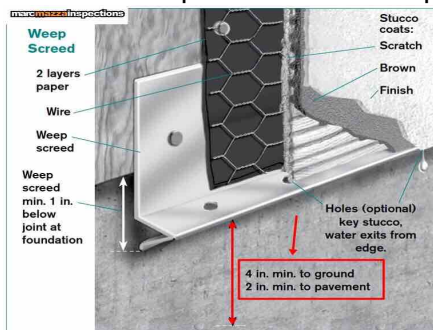
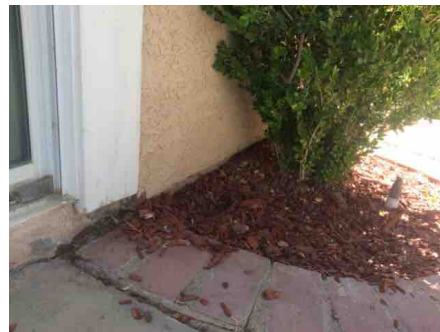
**43:** - There is concrete and soil that is high at the foundation at the time of the inspection. The soil level is up to or above the weep screed. These materials at this level may allow moisture penetration in the interior wood framing members or insect infestation. There should be at least 4 inches between the weep screed (if present) and the soil level and 6 inches between siding and the soil level. There is a recommended space of 2 inches between the weep screed and a solid surface such as concrete. It is recommended that this condition be referred to a qualified termite inspector for further evaluation - IRC 2012 §703.6.2.1.

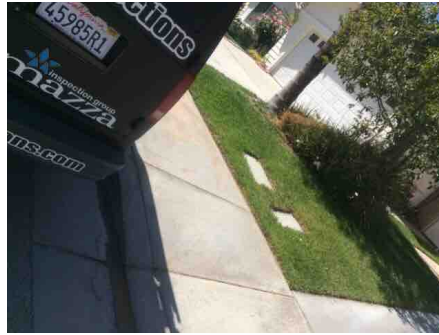
**45:** - A tree or trees, are located in an area that is considered close to the subsurface drains. There is no way to determine whether or not the trees have had any affect on the drains without the use of a sewer scope/ camera.

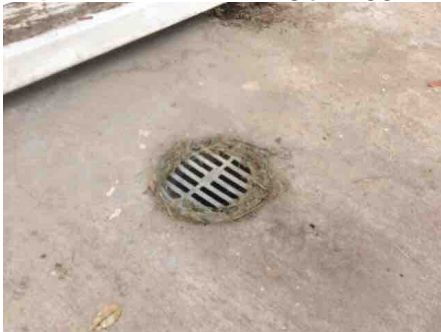
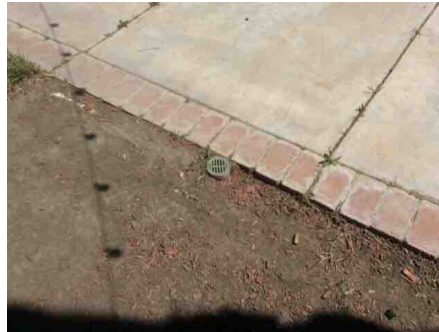
**46:** - There were subsurface drains which were observed to be higher in areas than the surface making proper drainage difficult at various locations around the property. The drains were not tested at the time of the inspection but is strongly suggested.

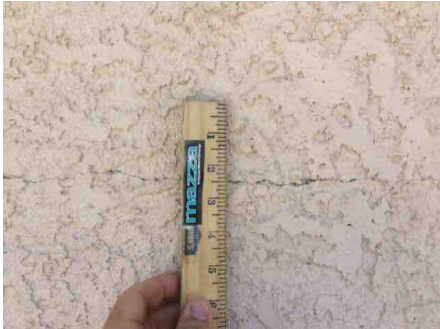
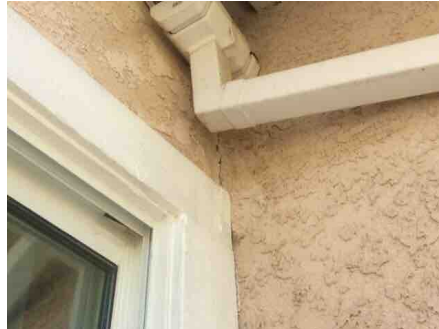
**47:** - Cracks were noted at the exterior wall covering materials. These cracks suggest that either some type of movement within the structure has occurred. It is well beyond our scope, as well as, our expertise to attempt to draw a definitive conclusion as to the cause of these cracks without additional investigations, which may include destructive testing. In light of these findings, we must suggest the buyer employ the services of a contractor who is familiar with structural movement and/or other reasons for stucco cracking. At the very least, the buyer should monitor the cracks for further movement.

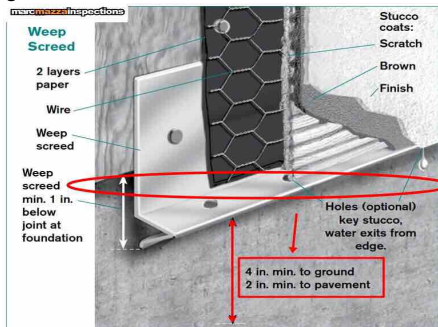
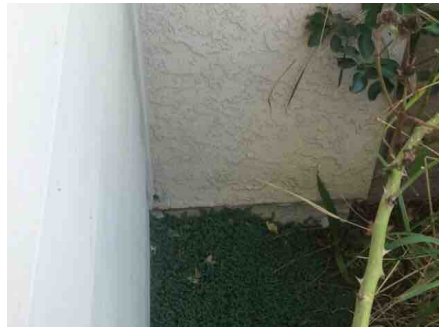
**48:** - The weep screed (flashing at the bottom of the stucco wall) is rusted and deteriorated, which may suggest the over exposure of moisture. This may be a direct result of sprinkler contact or improper drainage, or both. This area is suggested to be monitored or tested for poor drainage or otherwise - IRC 2012 §703.6.2.1.

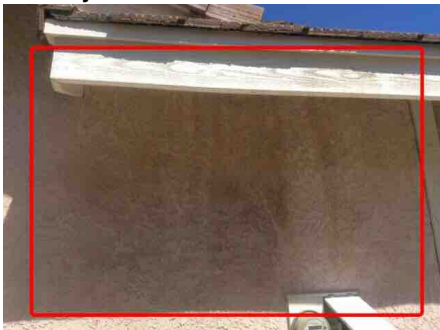
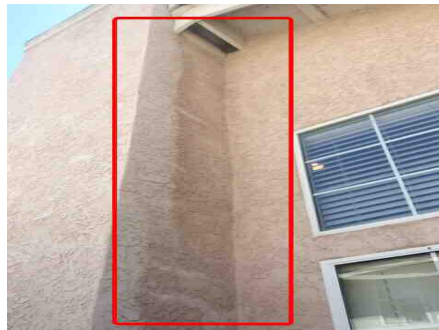
**49:** - Moisture staining was observed on the south and north side(s) of the exterior stucco walls under the eave. It is possible that the water is passing behind the fascia, under the gutter (if installed) or eave board, however, this is merely speculation. It may also be runoff from the roof. Without a calibrated water test there is no way to determine where these stains derived.

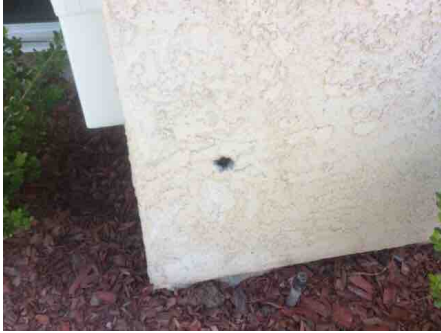
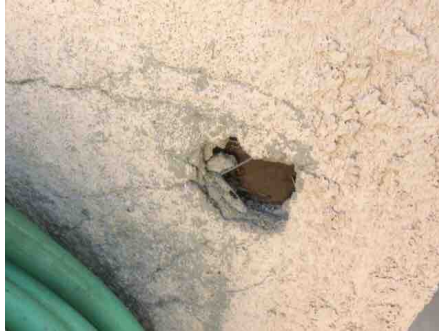
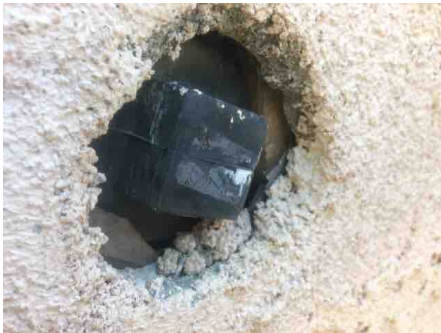
**50:** - There is missing stucco (holes, openings, missing covers, chips) noted at the exterior wall of the house. These openings may allow moisture to enter into the structure resulting in possible damage to interior wood framing members. In addition, openings in the stucco may also allow pests to enter and should be sealed as preventative maintenance.

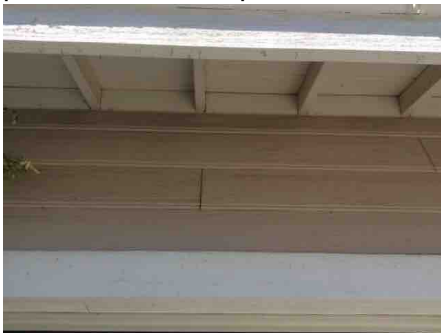
**51:** - Sealant is recommended around siding joints and connections as regular maintenance to prevent possible moisture penetration.

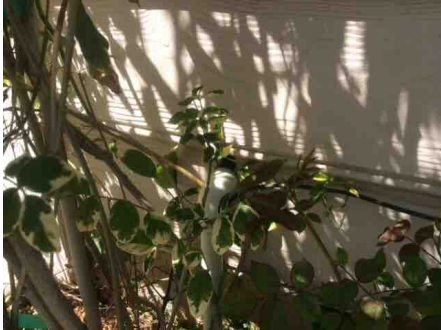
**52:** - Sealant is necessary around some pipes, which penetrate into the exterior wall covering materials, to prevent moisture intrusion.

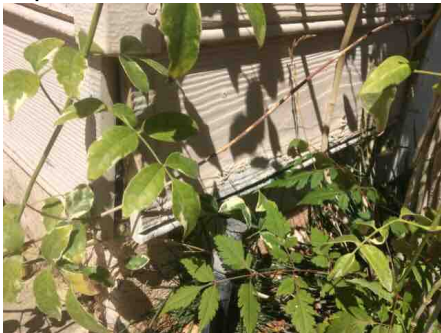
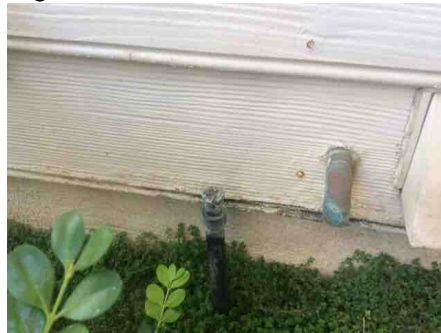
**54:** - The siding paint / finish is weathered at various locations. Localized repairs, replacement and / or painting may extend the life of the siding. Wholesale replacement may eventually be necessary at a significant expense, which can be deferred with regular maintenance.

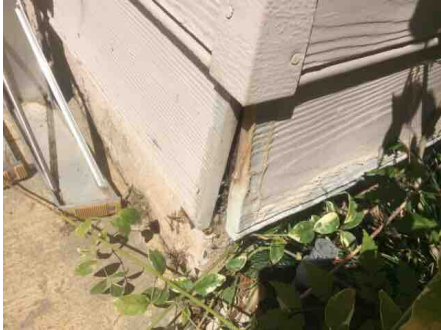
**55:** - There is corner-beading missing from the siding. To ensure against moisture intrusion replacement of this material is suggested.

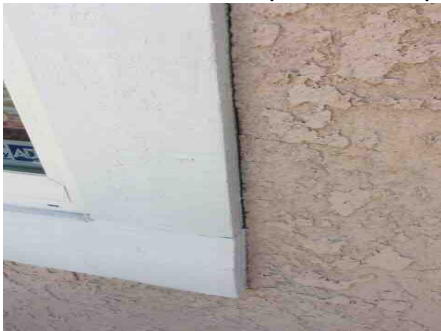
**56:** - There are areas of exterior trim where the paint / finish was observed to be generally fair condition with signs of being weathered and/or deteriorated. Regular maintenance type service is required to decrease the possibility of premature damage.

**57:** - Sealant is needed at various areas around the exterior trim to wall connections as preventative maintenance and to prevent the possibility of moisture penetration or damage.

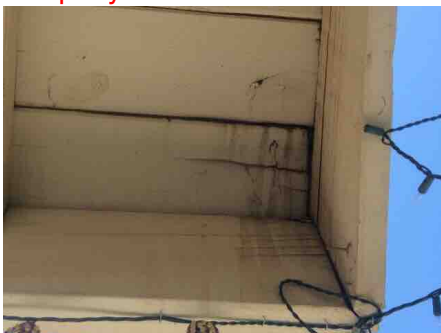
**s-1:** - Moisture stains and possible moisture damage were observed at the rear eaves at the time of the inspection. Additional evaluations may be necessary and should be conducted by a professional pest control company.

**58:** - Moisture stains and possible moisture damage were observed at the rear eaves at the time of the inspection. Additional evaluations may be necessary and should be conducted by a professional pest control company.

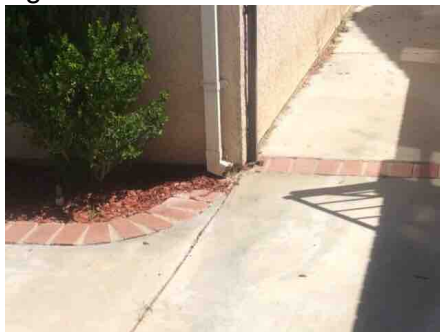
**61:** - We recommend routing all of the downspout(s) away from the structure, or installing the downspout directly into the subsurface drainage, if present. The downspout(s) should discharge water at least five (5) feet from the house or drain into existing sub surface drainage. Storm water should be encouraged to flow away from the building at the point of discharge.

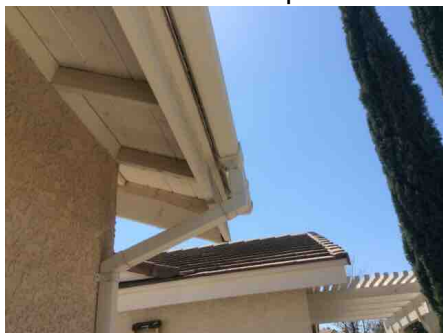
**62:** - The west downspout was disconnected and is suggested to be better secured for proper operation.

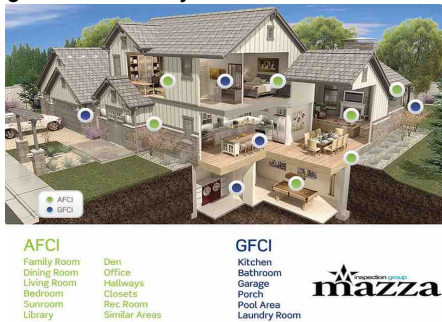
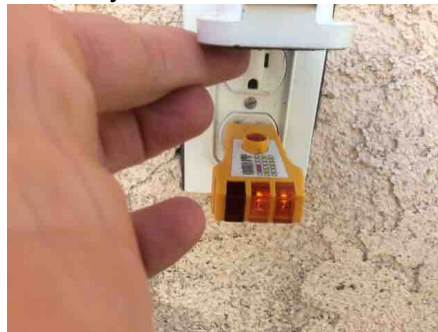
**63:** - All of the exterior outlets are suggested to have ground fault protection. Although, the installation of Ground Fault Circuit Interrupter (GFCI - a safety device for outlets close to any water) receptacles may not have been required to be installed at the time of this houses initial construction, however, they are now and because this new code is the most stringent, we feel it prudent that this is the code to follow. NEC 2014 §210.8 Local jurisdictions to some extent, may offer a different version of this standard.

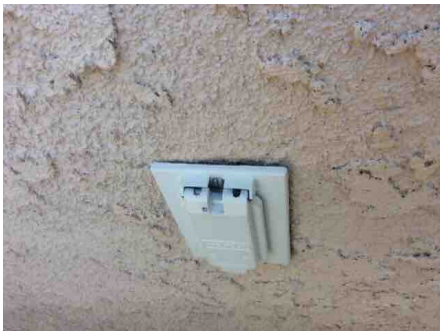
**65:** - Sealant is recommended around the exterior cover plates to wall connections.

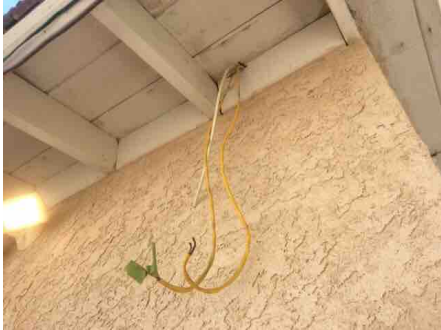
**67:** - Loose and exposed wiring was observed at the north side of the structure, which poses a potential safety hazard and is suggested to be improved.

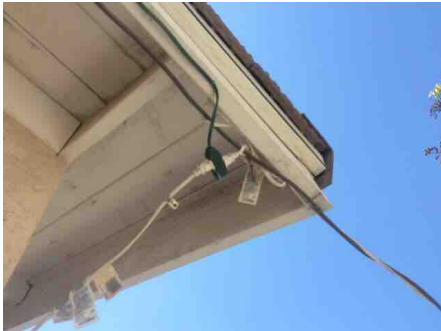
**68:** - Extension cords are used as permanent wiring at the exterior. Extension cord materials are not intended to provide permanent power to appliances for extended lengths of time. Improvements are suggested.

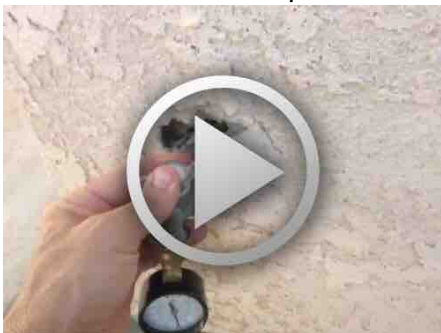
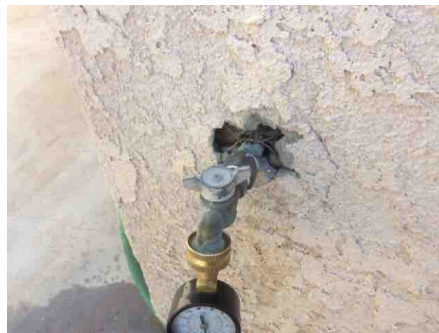
**70:** - The rear side hose bib is loose where it penetrates the exterior rear wall and is suggested to be better secured at the wall to prevent damage.

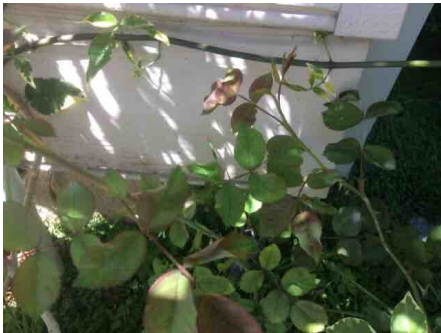
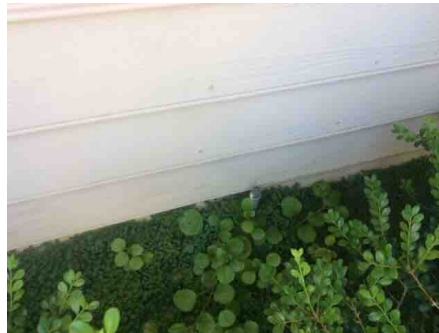
**73:** - Readjusting the sprinklers away from the structure walls, walkways, fences, HVAC components, etcetera, is recommended, due to the staining created by the over spray. Over time, the sprinklers can cause excessive wear and tear to these materials.

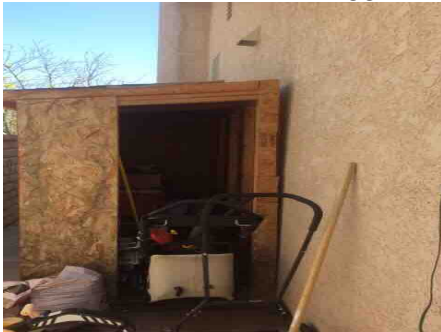
**74:** - The shed present is too close to the main structure per building standards. A standard 3 foot setback is suggested between the structure and the shed. The small structures (sheds) are not within the scope of this inspection, and therefore, not inspected. Sheds may include the following: electrical components, flammable materials, hazardous materials, plumbing and more. The sheds are not entered as part of this inspection therefore the sheds are suggested to be inspected prior to the close of this escrow.

**75:** - We do not have the expertise or the authority to establish property lines, which are determined by surveyors, however, using walls or fences as boundaries, the shed in the rear yard encroaches on what would be the standard 3 to 15 foot setback. The permit should be verified for this structure because we do not endorse or tacitly approve of any structure built without a permit.

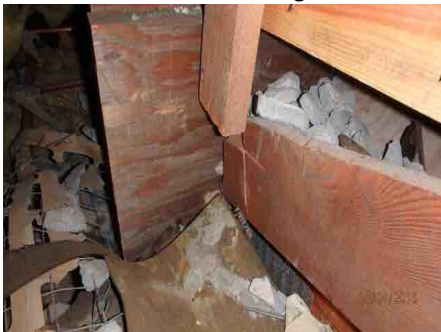
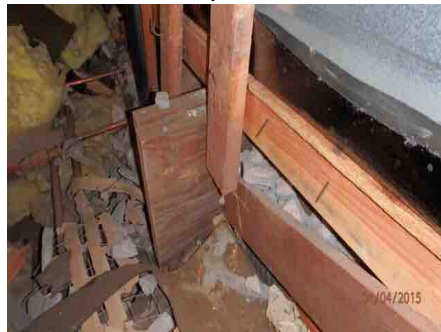
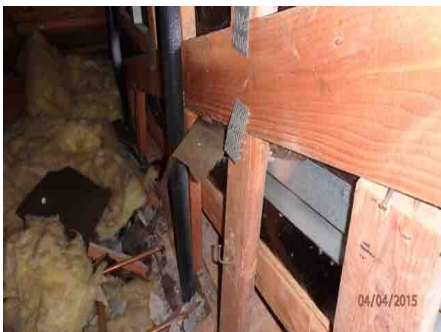
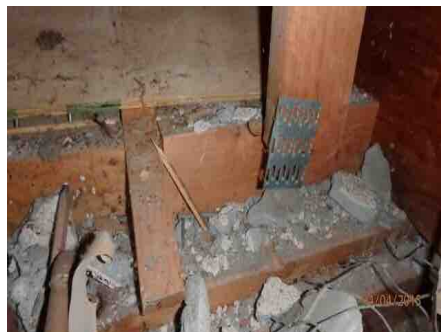
**84:** - Portions of the framing system (cripples) system have been modified, damaged, sub standardly modified or re-installed. We have no way to determine if this framing was modified and re-supported with the adjacent ledger from the addition. In light of this, further assessment is advised. We recommend the advice and services of a licensed general contractor who can inspect this condition and improve upon it as / if necessary.

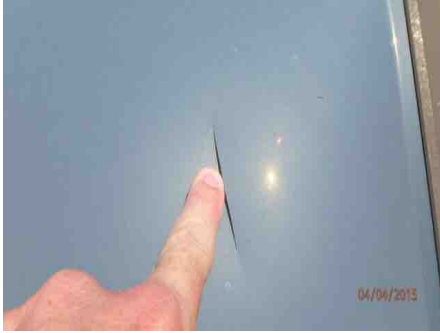
**92:** - The skylight dome is cracked, could leak, and should be replaced.

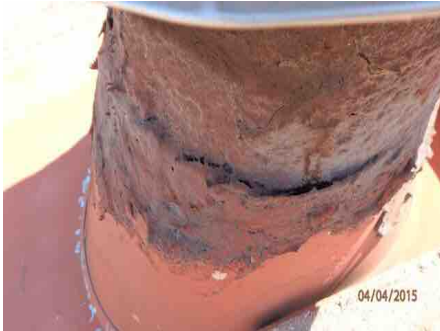
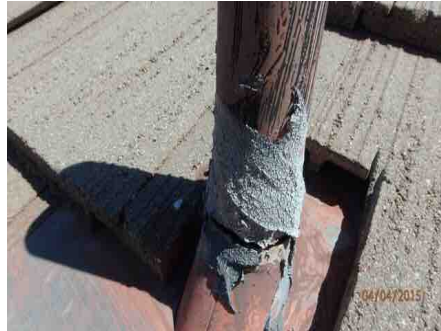
**93:** - The roof flashings that are visible, are suggested to be sealed as part of typical service. They are comprised of metal that seals valleys, plastic or metal vents and other roof / wall penetrations, and are the most common point of leaks. This is particularly true of the flashings on a layered roof, which are covered by the roofing material and are even more susceptible to leaks - Reference Building Code IRC-P3103.3.

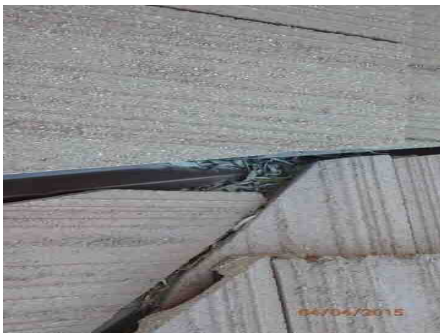
**94:** - We observed debris building in the valleys. Debris is suggested to be removed and the valleys monitored.

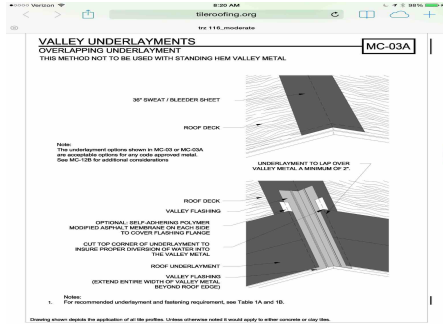
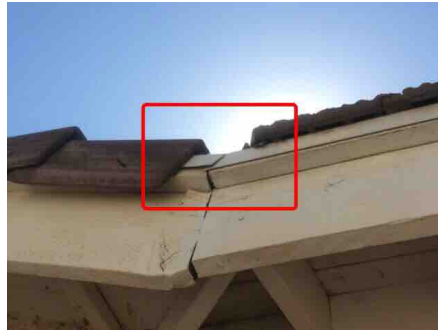
**95: -** We observed an under-cut valley flashing. This single crown valley flashing appears to be cut short prior to extending over the eave and drip edge flashing.

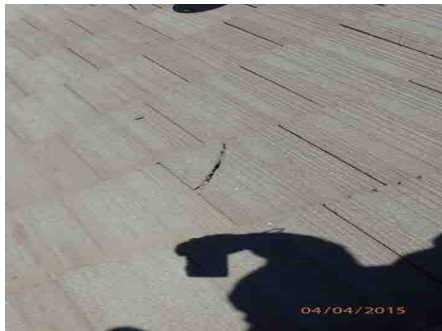
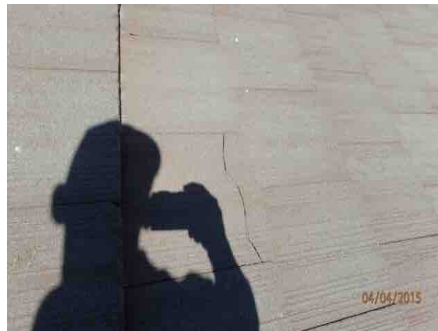
**96: -** There are cracked roof tiles that were observed at the main roof. This should be expected as regular wear and tear, however, the tile should be serviced to maintain the water tight integrity of the roof.

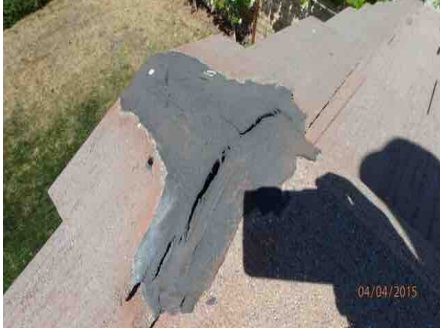
**99:** - The tile roof has junctions where the ridge (top tiles) and rake (side tiles) tiles meet each other. These junctions are sealed with cement or a bitumen material. Occasionally, the cement cracks or the bitumen material deteriorates or separates which may lead to a vulnerable possible moisture entry point. It is recommended that the junctions be sealed properly by a qualified roofing contractor in order to maintain the water tight integrity of the roofing system.

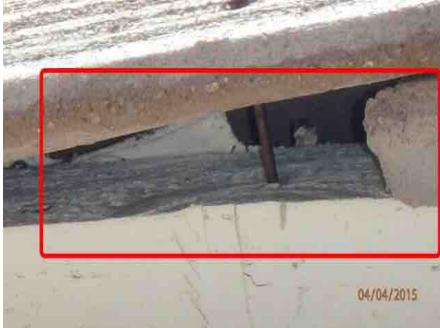
**100:** - We failed to verify roofing paper which will typically turn down the fascia at least 1-3 inches.

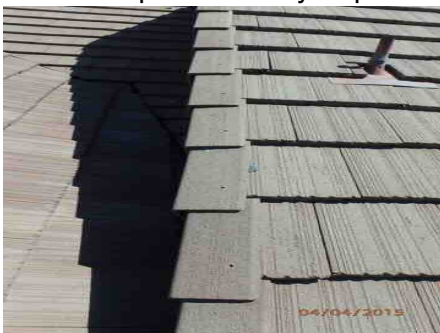
**101:** - There are loose "rake" tile(s) (tiles on the sides of the roof decks) observed at the roof structure. This is common and is considered normal for this type of roof material. Repairs are considered to be minimal and should be performed by a qualified roofing contractor.

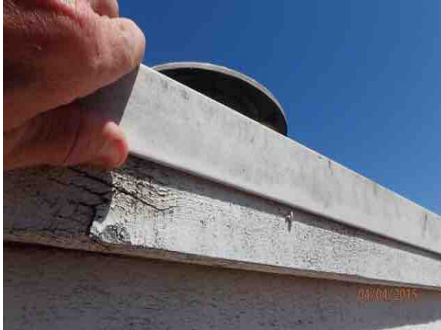
**107:** - The chase cover has been installed tightly around the chase, which will not allow for complete ventilation and thus cooling of the fireplace chase, should it be required by this specific fireplace system. Some fireplace systems require such a gap and some do not. Improvements are recommended if necessary and should be carried out by a qualified licensed individual.

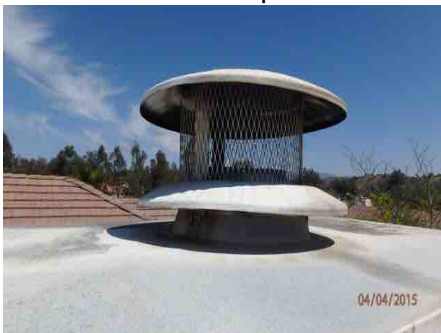
**110:** - A functional spark arrestor is in place on the chimney.

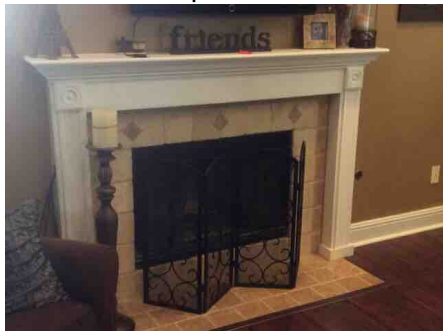
**111:** - This fireplace is located in the living room.

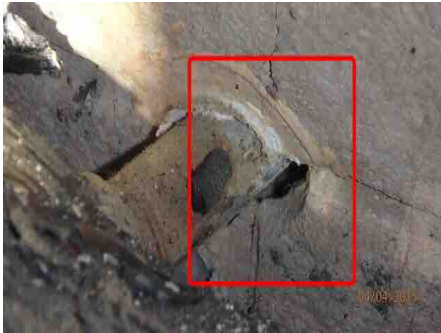
**117: -** The void / separation around the gas pipe in the sidewall of the fireplace should be sealed with refractory caulk to prevent any possibility of back-drafting a flame beyond the combustion chamber, where it could come into contact with combustible material.

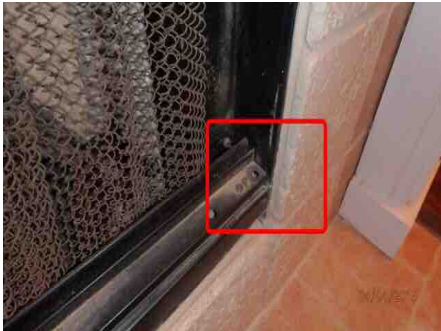
**119: -** There are no glass doors installed on the fireplace. This fireplace may have been tested with doors in which case doors would be required, in accordance to manufacturer's standards. Further assessment and advice by a qualified fireplace specialist is advised.

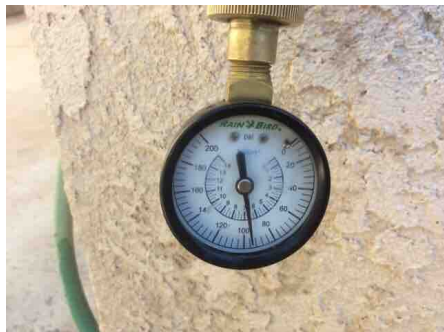
**125:** - As the static water pressure of the supply plumbing system exceeds 80 pounds per square inch (psi) it would be wise to (install) or adjust the pressure regulator. Otherwise, the plumbing system may be prone to leaks in piping, fittings or other equipment. The water pressure was taken from the nearest accessible hose bib or at the laundry.

**608.2 Excessive Water Pressure.** Where static water pressure in the water supply piping is exceeding eighty (80) pounds per square inch (552 kPa), an approved-type pressure regulator preceded by an adequate strainer shall be installed and the static pressure reduced to eighty (80) pounds per square inch (552 kPa) or less.

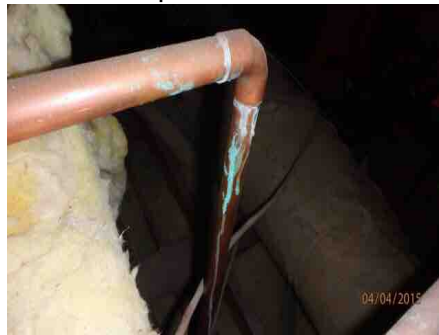
**130:** - Surface corrosion was observed at the copper piping. This is a condition that should be monitored for further corrosion and possible leakage. Future repairs may ultimately be necessary if leaking is discovered. There was no active leaking at the time of the inspection.

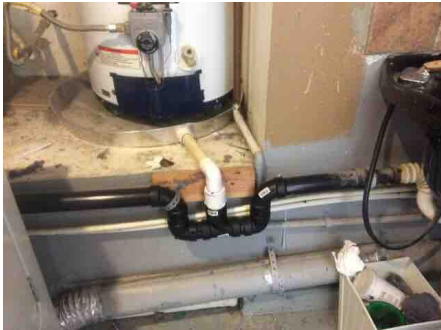
**135:** - A drain that appears to have been added to the system was observed in garage. The added drain appears to have been installed in a substandard manner should be corrected by a professional plumber.

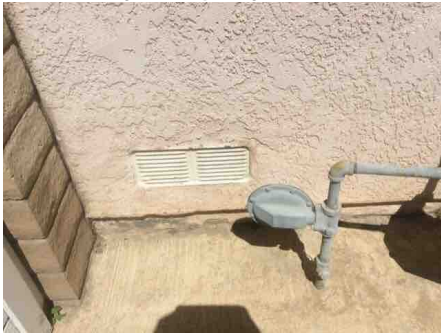
**139:** - The gas meter air relief vent is too close to the garage intake vent, according to building standards. A three foot clearance is suggested to be maintained as not to conflict. This meter was obviously installed by the local utility company, who with the AHJ, has complete jurisdiction over the installation of this component.

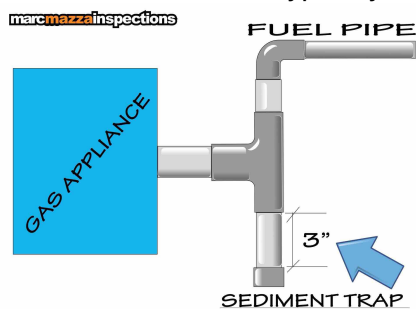
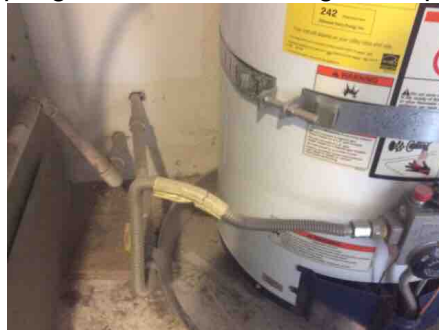
**141:** - There are missing sediment traps at all or some of the fuel piping installed prior to fuel burning appliances e.g. furnace, water heater. A drip leg, also known as a dirt leg, is there to protect the gas train and burner orifices from gas born water and dirt. In a clean piping system, with best quality gas supply, there will never be a need for this. Typically, systems develop some moisture from condensation, as well as some dirt or other contamination. Typically, the drip leg is 3-6 inches in length and prior to the appliance.

Where a sediment trap is not incorporated as a part of the gas utilization appliance, a sediment trap shall be installed downstream of the appliance shutoff valve as close to the inlet of the appliance as practical at the time of appliance installation. The sediment trap shall be either a tee fitting with a capped nipple in the bottom outlet, as illustrated, or other device recognized as an effective sediment trap. Illuminating appliances, ranges, clothes dryers, decorative vented appliances for installation in vented fireplaces, gas fireplaces, and outdoor grills shall not be required to be so equipped - NFPA 54-09:9.6.7.

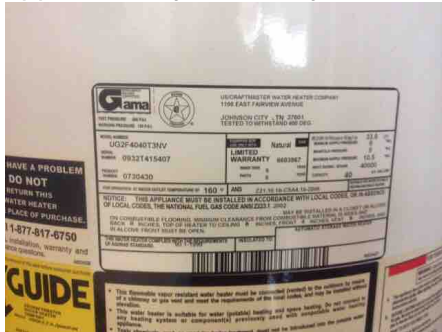
**145:** - The water heater appears to be newer than original and /or replaced therefore, we suggest the buyer inquire as to the possibility of permits for the replacement of this unit.

**146:** - The approximate age of the water heater is 2009. The typical life span of a water heater is approximately 10 to 12 years.

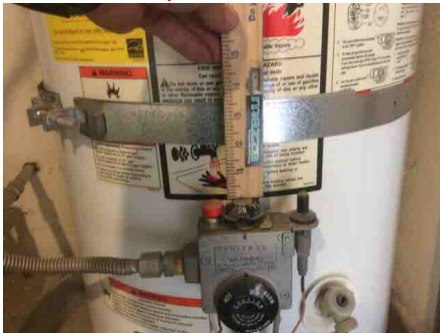
Code Reference CPC 508.2

Strapping shall be at a point within the upper 1/3 and the lower 1/3 of the water heater's vertical dimensions. At the lower point, a minimum distance of four (4) inches shall be maintained above the controls to the strap.

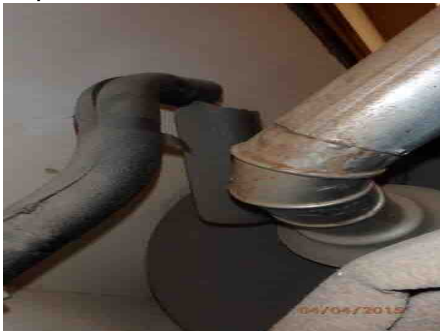
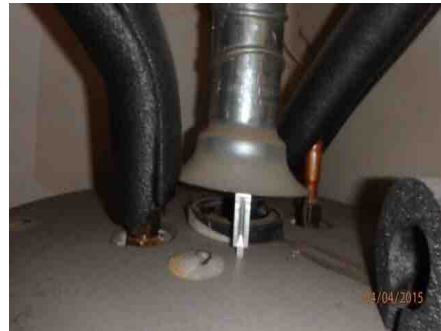
**153:** - The ribs of the vent pipe are visible at the water heater. The vent pipes should connect together in such a manner that the ribs or material should be tight. Improving the vent, which may include replacement, is suggested.

**154:** - Screws (minimum of 3) were not observed in the water heater vent at each of the connections. Improvements are recommended.

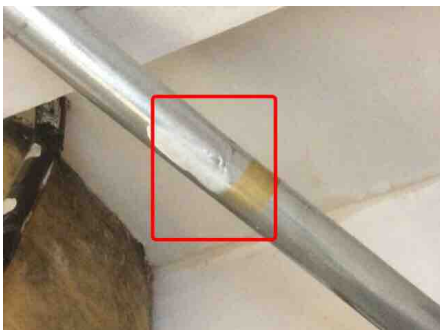
**155:** - The vent off the water heater is dented or damaged, which may restrict or alter the flow of exhaust.

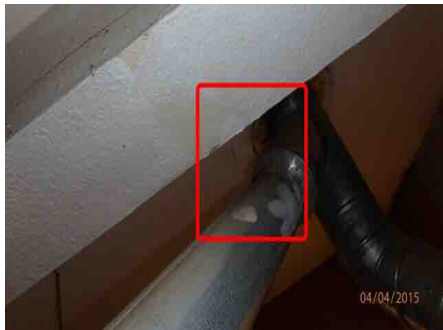
**156:** - We are unable to determine if the water heater vent is a SW (single wall) vent from our vantage. Should the vent be in fact a SW vent, clearance to combustibles is no less than 6" to combustibles which this vent is not.

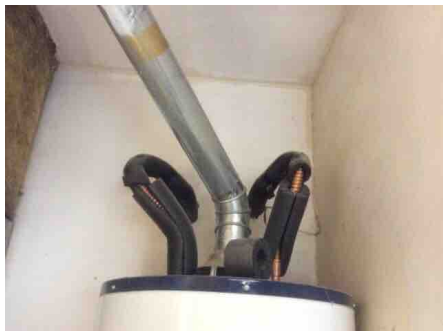
**158:** - The connectors were not visible for inspection because they were covered by foam.

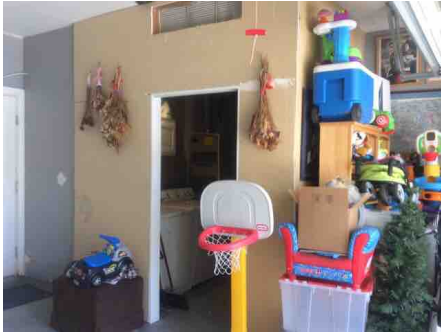
**162:** - A portion of the garage appears to have been converted into a mechanical room. The work was performed in a substandard manner and likely may not possess permits for the work performed. We omit any work performed without the endorsement of the authority having jurisdiction from this inspection.

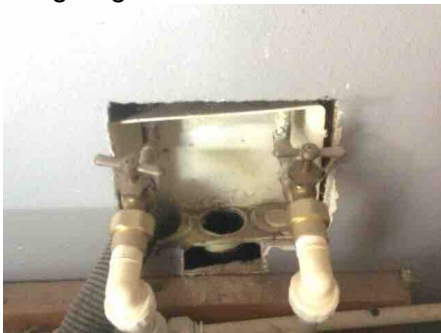
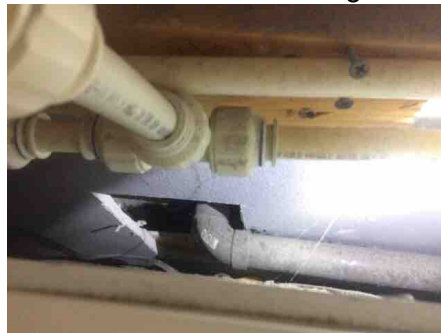
**165:** - Holes and / or missing wall separation wall covering were noted in the fire rated wall that connects the garage to the main structure. The walls and ceilings of the attached garages should be well sealed where they abut the interior of a house to maintain the integrity of the fire rated materials. Dwelling/garage opening/penetration protection. Openings and penetrations through the walls or ceilings separating the dwelling from the garage shall be in accordance with Sections R302.5.1 through R302.5.3.

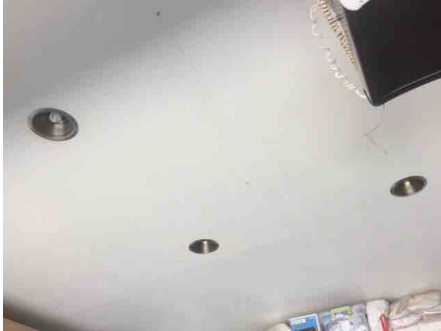
**168:** - There are recessed lights installed into the fire separation ceiling within the garage. This ceiling is suggested to be maintained with no penetrations except for those rated for such an installation if the garage ceiling connects to the attic of the structure with holes or penetrations.

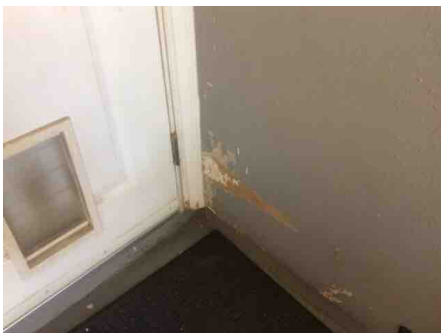
**171:** - Drywall damage noted in the west wall in the garage. Repairs are recommended and are primary cosmetic in nature.

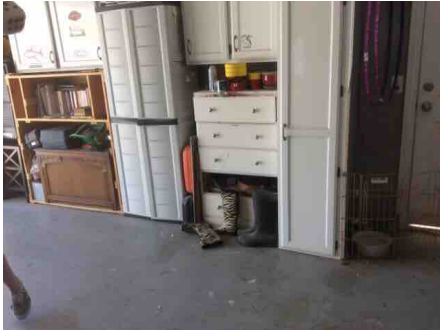
**173:** - There are ventilation ports in the garage wall that have been blocked, covered. When there is a water heater and/or furnace installed in a garage, it/they require fresh air ventilation for combustion make-up air. This air replaces the air used during combustion and exhausted. At the time of the inspection we were unable to locate any vents in the garage to the exterior. Vents are suggested for this make up air and should be provided.

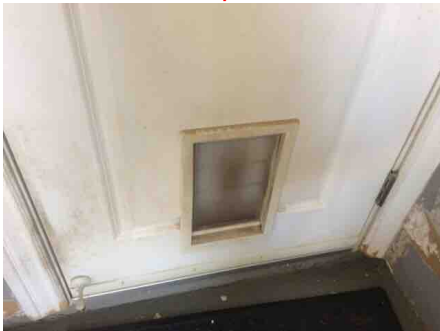
**174:** - The entry door from the garage into the house has a pet door installed into the door. This door is required to be solid-core, to maintain the necessary firewall separation between a garage and living quarters, and should be replaced.

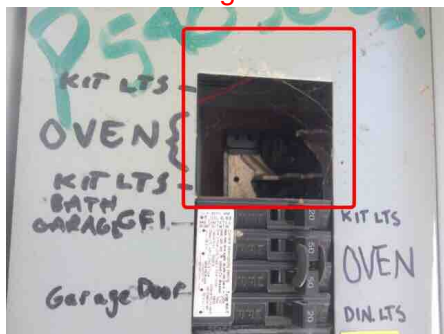
**185:** - There are voids and / or open knockouts in the panel box of the main electrical panel that should be covered with a rigid material as a safety precautionary measure.

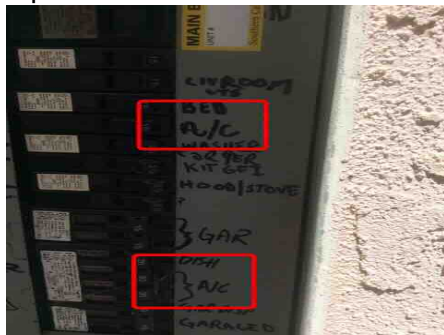
**186:** - The electric panel appears to be obviously mis-labeled. Other disconnects would require the services of a professional to determine the remaining labeling system.

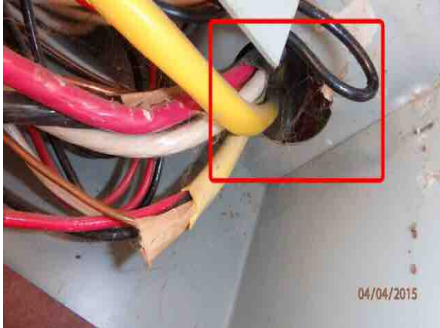
**190:** - We observed openings within the service equipment panel. Openings in the panel are not suggested and should be closed or sealed off by a professional.

Code reference NEC 110.12(A) Unused Openings. Unused openings, other than those intended for the operation of equipment, those intended for mounting purposes, or those permitted as part of the design for listed equipment, shall be closed to afford protection substantially equivalent to the wall of the equipment. Where metallic plugs or plates are used with nonmetallic enclosures, they shall be recessed at least 6 mm ( $\frac{1}{4}$  in.) from the outer surface of the enclosure.

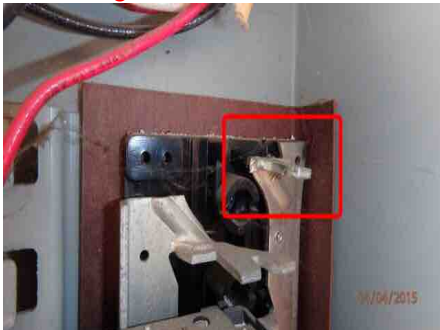
**191:** - There is visible damage within the panel on the feeder bar. It is our suggestion the buyer employ the services of an electrician who can remove and inspect the bus for any permanent damage. The reason for the scorching is not evident. We should note that this bus stab is not suggested to be used.

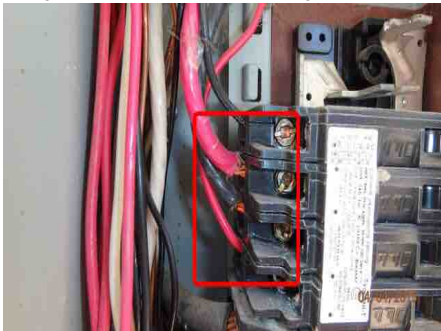
**197:** - The wiring installed (as pictured) is installed with a radius or bend which appears to be too tight and may cause unnecessary stress at the connection.

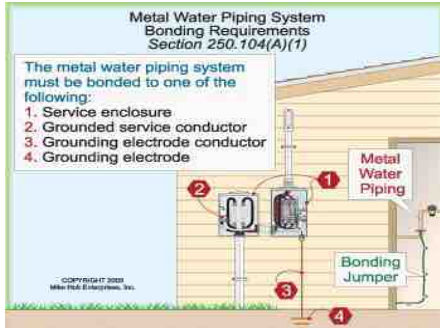
**200:** - What is metal water pipe bonding? Section 250.104(A) of the NEC (National Electric Code) requires a metallic piping system installed in or attached to a building to be bonded back to the electrical service. To remove dangerous voltage on metal parts from a ground fault, electrically conductive metal water piping, metal fire sprinkler piping, metal gas piping or other metal piping systems as well as any metal structural members that are likely to become energized must be bonded to an effective ground fault current path. [250.4(A)(4)]. The main purpose of this bond is to ensure that the metal water pipe is at the same zero voltage to ground as the service grounded conductor. A secondary purpose is to ensure that there is a path back to the service for electrical current flow if the metal pipe becomes energized.

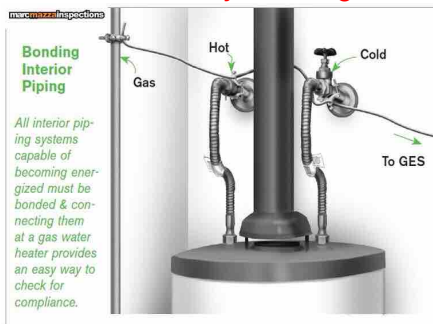
**201:** - We were unable to verify a cold (and hot) water bond at the main water supply, or supply piping. In accordance to building standards; the bond is suggested to be installed in or attached to a building structures metal piping system(s) including hot water, cold water and the gas piping, that are likely to become energized. These aforementioned components should be bonded to the service equipment enclosure in accordance to building standard. The bonding jumper(s) should be sized in accordance with the NEC, using the rating of the circuit that is likely to energize the piping system(s).

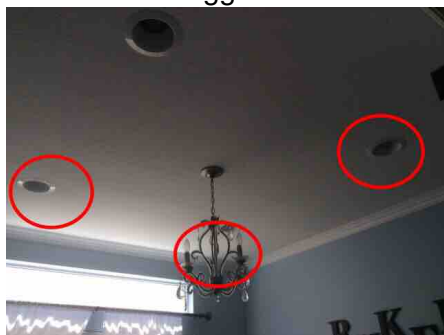
**209:** - There were multiple light bulbs that were tested but failed to operate in various locations within the south bedroom. As a result, the inspector cannot determine if the fixture is operational. In many cases the bulb is usually missing or blown, however, it is recommended that each of the bulbs be replaced and the fixtures be once again checked for proper operation prior to the close of escrow. As a consequence, we were unable to confirm the operation of various switches throughout the residence where inoperable lights exist. For additional information or an explanation regarding this condition, we suggest the buyer attempt to contact the current or past occupants, owners or bank asset manager for specific details.

Note: It is safe to assume that if a light was inoperable, then the switch or switches were also, not verified. All of which are suggested to be tested and verified prior to the close of this escrow.

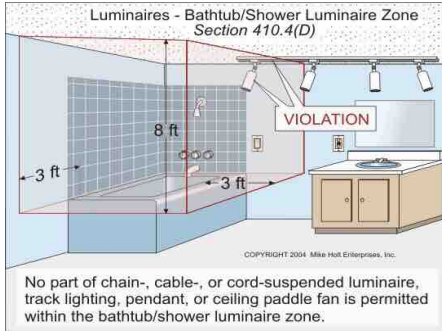
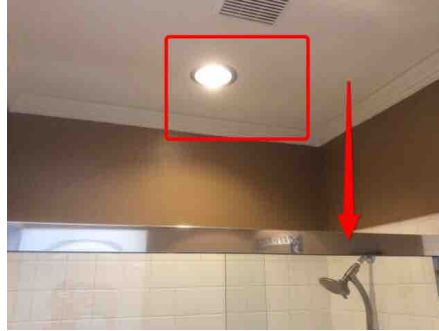
**211:** - The ceiling lights installed in the common bathroom does not possess a wet type fixture trim kit and appeared to be installed within the 8 x 3 shower spray zone of the shower enclosure. For some older structures, this may not have been a code requirement, however, improvements are always suggested as old or new code is the minimum standard and is always suggested to be exceeded - Reference from NEC 410.10-(D).

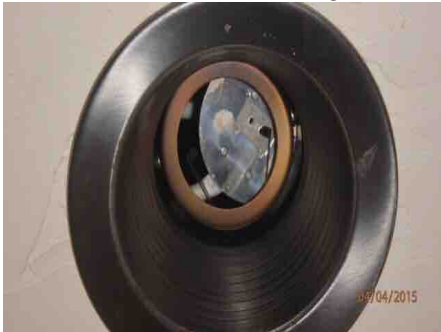
**212:** - There was a can light (bucket) that is damaged in the common bathroom and suggested to be replaced.

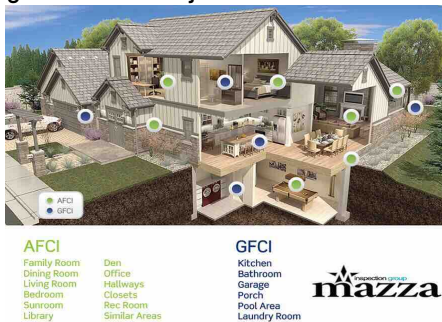
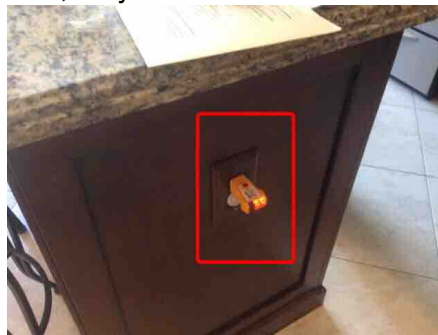
## RECEPTACLES

**214:** - Although the installation of Ground Fault Circuit Interrupter (GFCI - a safety device for outlets on islands, laundry sinks, kitchens, bathrooms, locations close to water, closets, garage and all exterior receptacles, etcetera) receptacles may not have been required to be installed at the time of the initial construction of this structure, the installation of the GFCI receptacle is recommended at all interior and exterior outlets which may be within 6 feet of, or in direct contact with water. They are also required to be installed at all wet locations when the receptacle is replaced. In the event receptacles in the bathrooms, kitchen or any area where water is present are replaced or remodeled, the new receptacle must be installed as a GFCI.

These outlets may be used for small tools and appliances, but should not be used for refrigerators or freezers. Such larger appliances use a greater amount of electrical current, and since these plugs have a very minimum tolerance for overload, they generally cause the GFI to trip, which is its designed purpose. Therefore, we recommend that you do not use these outlets for your refrigerator or freezer. In most cases when improvements are performed in bathrooms and kitchens, GFCIs must be installed even though the structure may not have been equipped with GFCI receptacles when it was initially constructed. The bathrooms are suggested to possess at least one 20amp circuit in accordance with minimum building standards - NEC 2014 §210.8. Local jurisdictions to some extent, may offer a different version of this standard.

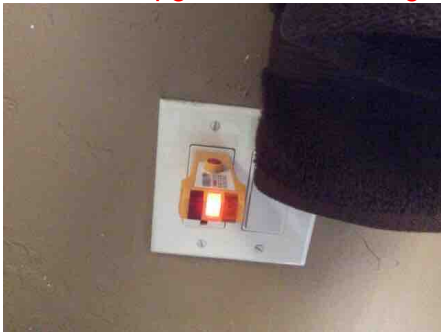
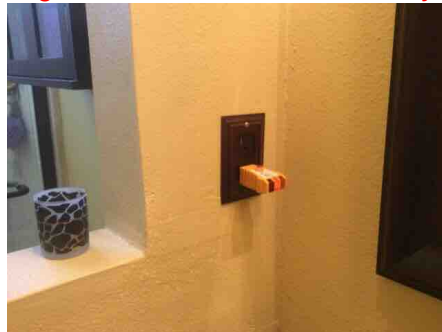
**218:** - Ungrounded three prong receptacles was/were identified in the common and master bathrooms. In many cases, the original two prong receptacle was replaced with the new three prong type without adding a grounding conductor or grounding to the metal junction box (if applicable). Or in a modern house, the grounding conductor is not attached to the receptacle (providing the conductor is present). The receptacles should be upgraded to include grounding conductors where necessary and all wet areas by GFI protection.

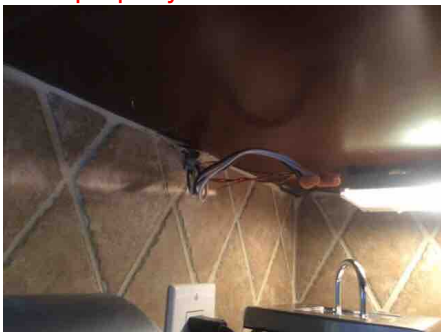
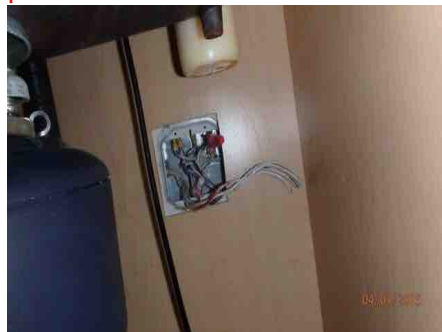
**219:** - Exposed electrical conductors were observed in the kitchen, which represents a potential safety hazard if not properly terminated/covered. Improvements are recommended as a safety precautionary measure.

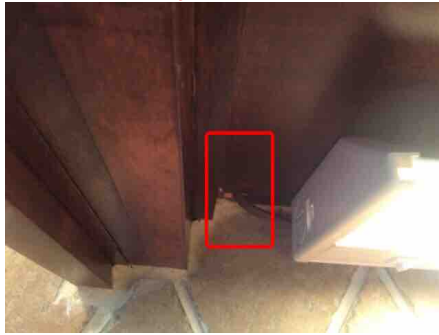
**220:** - NM cable wiring (I.E. Romex, cord etc..) exposed to physical damage or contact was observed in the kitchen which is within harms reach should be relocated or protected from damage or contact by the use of conduit. Improvements are recommended for safety.
