## Property Inspection Report

Saturday, April 4, 2015

Inspector, Marc Mazza  
Mazza Inspection Group  
(866) 996-2992

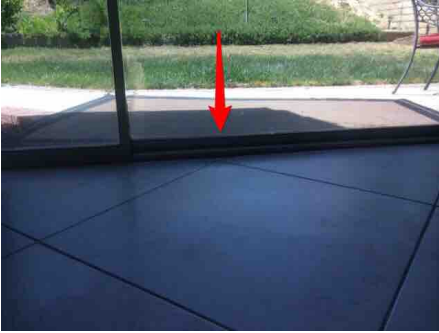
**230:** - The sliding glass doors appeared to be high centered which cause the doors to operate with difficulty.

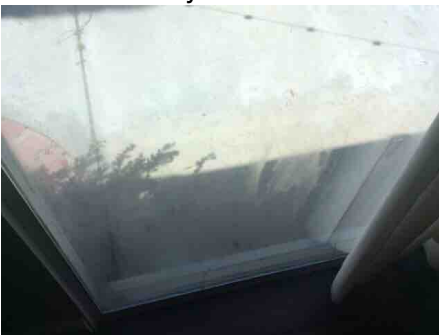
**231:** - The sliding glass door was very dirty at the time of the inspection. It was in fact so dirty that we were unable to verify whether or not the double pane glass has a broken harmonic seal.

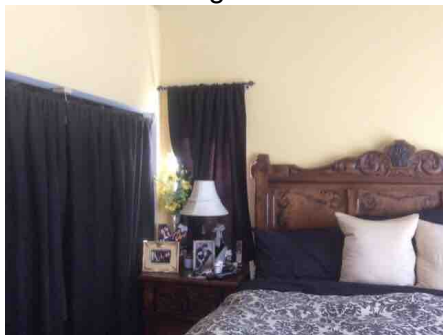
**234:** - There were multiple interior windows which were not tested due to personal belongings or furniture which blocked the access to the windows at the time of the inspection. These windows are suggested to be tested once accessible and prior to the close of escrow to ensure that proper egress is available and, there is no visible damage.

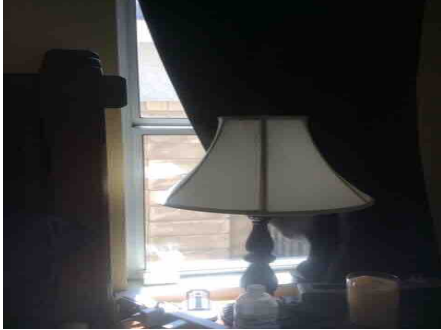
**235:** - Sash cords / balancers (the ropes that hold up the windows) are inoperable on the window(s) in the master bedroom. Repairs are suggested for proper operation of single and double hung windows and should be performed by a professional contractor. All of the inaccessible single hung windows are suggested to be tested once they are made accessible and prior to the close of escrow.

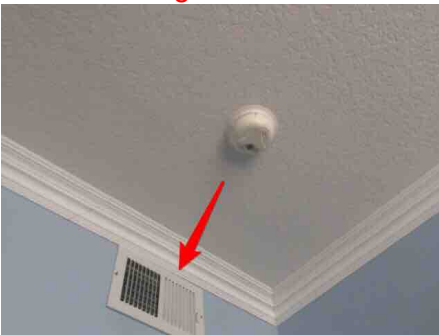
**245:** - Smoke alarms and smoke detectors shall not be installed within a 36 in. (910 mm) horizontal path from the supply registers of a forced air heating or cooling system and shall be installed outside of the direct airflow from those registers.

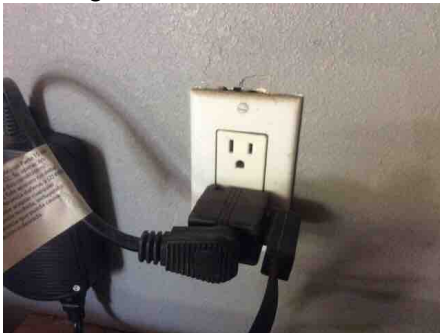
**251:** - The receptacle in the laundry room is suggested to be a 20 amp designated receptacle per some building standards.

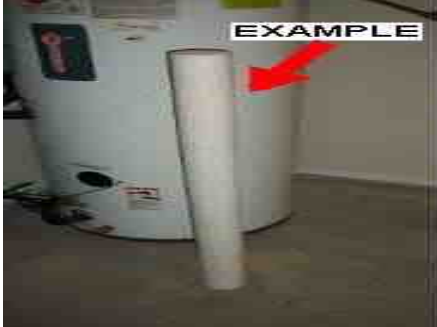
**255:** - A bollard is suggested to be installed in the front of the laundry components.

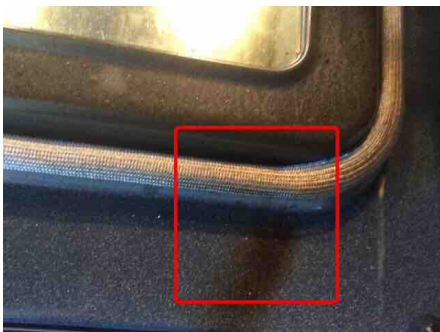
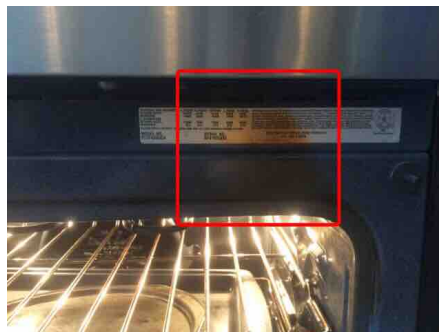
**268:** - The door on the built-in, electrical, oven does not seal effectively, which could affect its performance, and should be serviced.

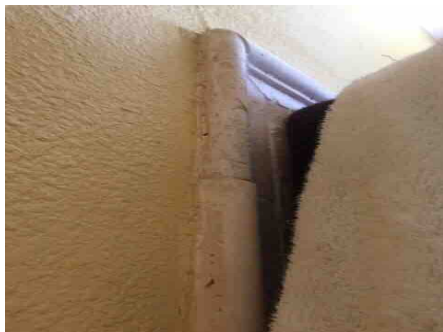
**282:** - Based on the tile and how it appears to have been installed onto the wall, may suggest that the tile is without an appropriate backing sub straight such as hardi backer or concrete. These sub straights are necessary to maintain a water tight assembly and without it, the unit may leak. The buyer is suggested to ask the seller if such a material was installed prior to the tile being installed.

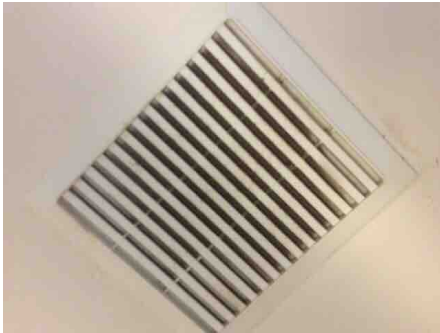
**289:** - The bathroom ventilation fan is recommended to be cleaned for adequate ventilation.

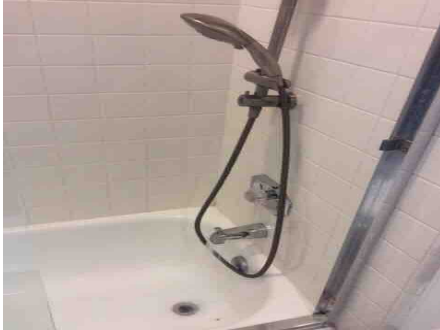
**293:** - The shower diverter was working at 50% when tested ( half of the water was coming from the tub spout and half was coming from the shower head). Recommend repair / replacement for improved operation.

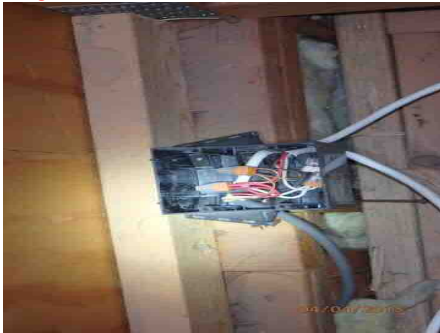
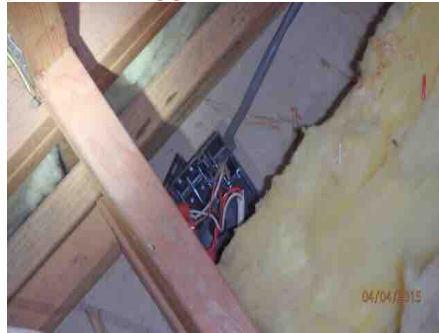
**301:** - There are open electrical junction boxes, which should be sealed to contain any arching or sparking that might occur. The installation of cover plates is suggested.

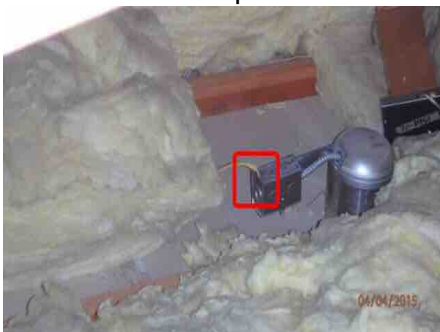
**302:** - There are loose/exposed wires inserted into the junction box of the pictured light fixture in the attic at the time of the inspection.

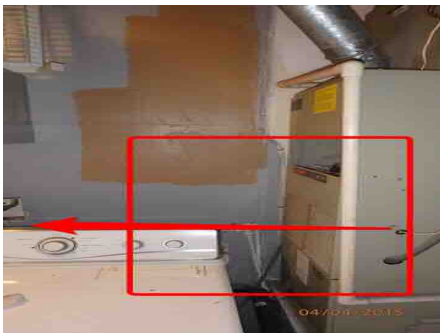
**309:** - The furnace lacks necessary clearance to the front of the unit for service.

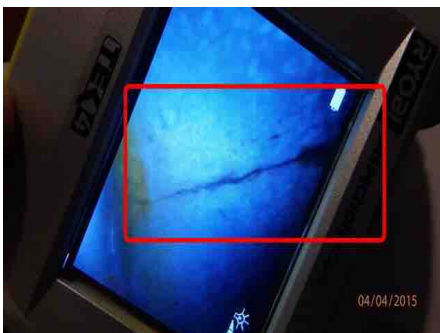
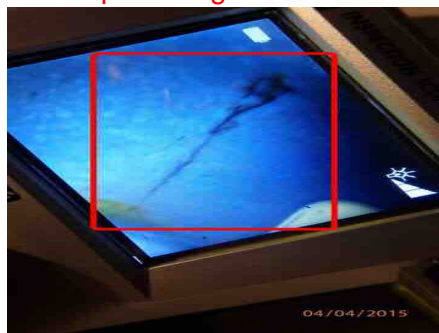
**310:** - We observed what may be a crack in the heat exchanger. To error on the side of caution, we feel it prudent that until this condition is inspected by a HVAC technician the furnace should not be used for fear of interior contamination and carbon monoxide poisoning.

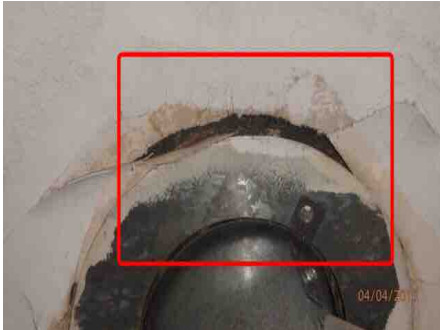
**311:** - The furnace vent pipe is not well seated at the transition between the FAU and the roof vent (reducer), which not only could inhibit the bi-products of combustion from being vented beyond the residence but which could contaminate the residence, and should be serviced by an HVAC contractor.

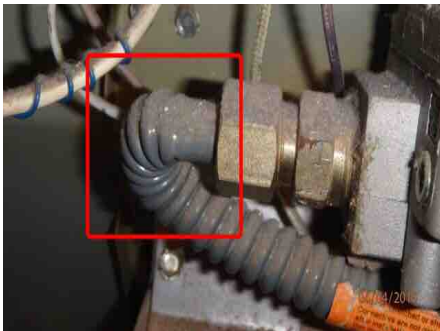
**312:** - You should be aware that the gas feed line that passes through the furnace sidewall is flexible, but is required by current standard to be rigid until it passes beyond the furnace cabinet, and then flexible can be installed to the point where it connects to the gas valve. This condition should be corrected by an HVAC contractor.

**313:** - The fuel line to the furnace is kinked and suggested to be replaced or improved.

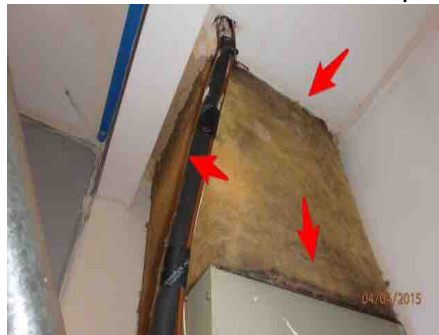
**316:** - The filter hold down was missing and suggested to be replaced or installed.

**317:** - Sealant / tape is recommended at the air handler / plenum. Conditioned air appears to be leaking from this area. Sealing this area will reduce energy loss, as well as, the infiltration of airborne contaminants within the attic space. A professional HVAC contractor is recommended to perform this task.

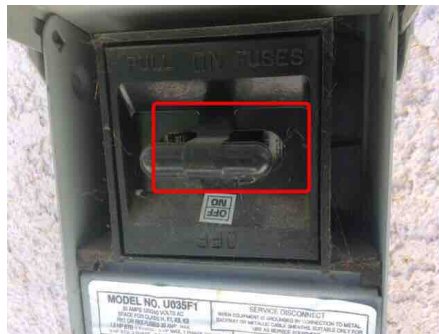
**331:** - The air condition service disconnect which possesses 30 amp fuses and breaker which are too large for this condenser.

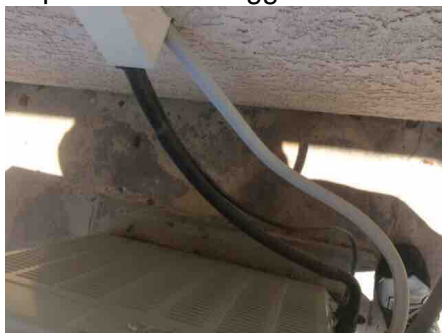
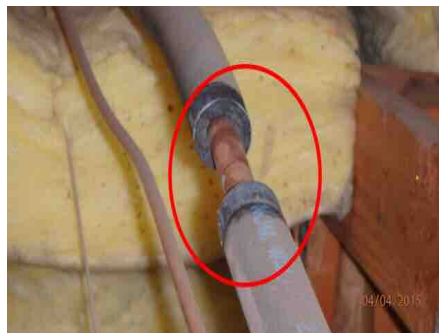
**332:** - The foam insulation is missing from the refrigerant lines, either at the condenser and/or FAU. Replacement is suggested.

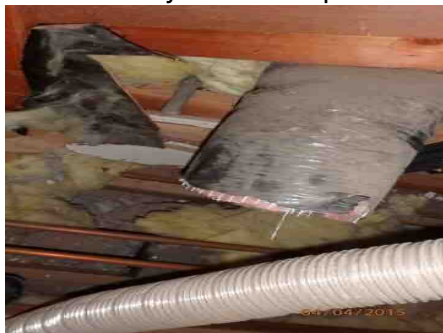
**337:** - One of the flexible ducts in the attic appears to have been terminated or disconnected. Although we do our best in an attempt to determine why certain conditions exists we may not have intimate details regarding specific components and conditions. We therefore suggested to inquire with the seller regarding this condition and who may be able explain this condition in full detail.

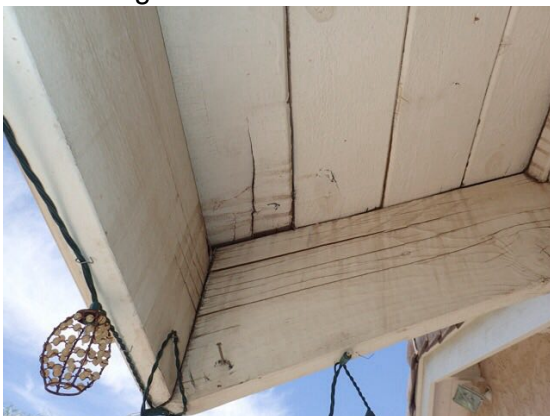
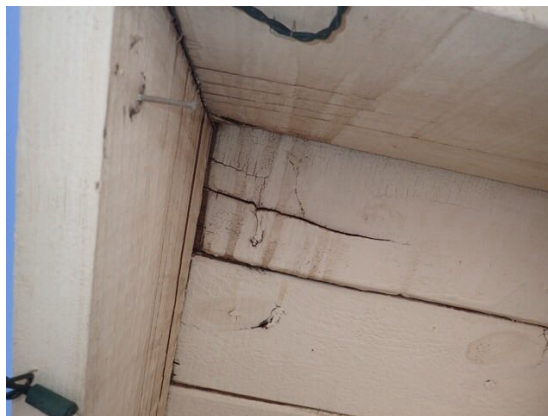
6: - Damaged eave boards were observed at the back side of the structure.

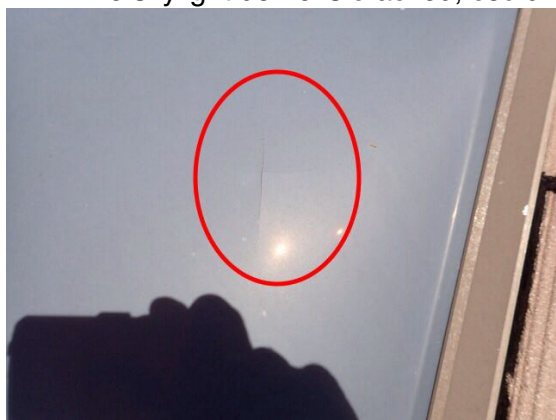
**11:** - The skylight dome is cracked, could leak, and should be replaced.

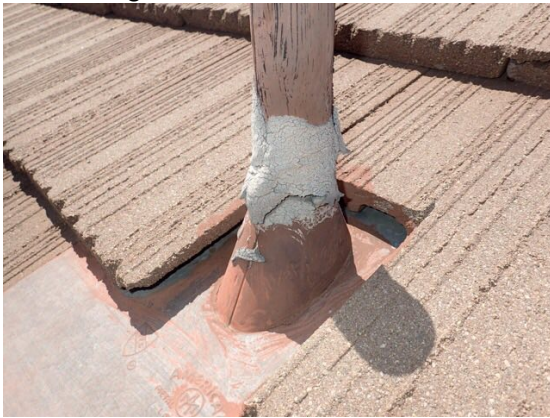
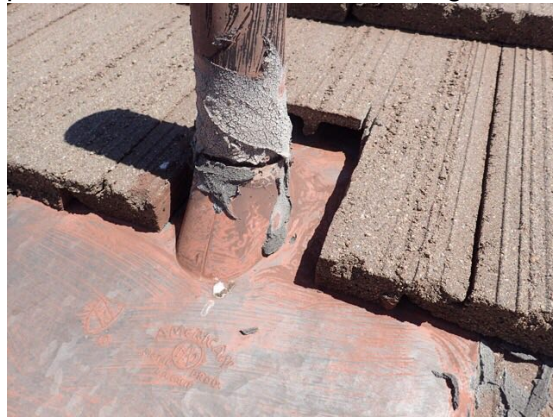
**13:** - The roof flashings that are visible, are suggested to be sealed as part of typical service. They are comprised of metal that seals valleys, plastic or metal vents and other roof / wall penetrations, and are the most common point of leaks. This is particularly true of the flashings on a layered roof, which are covered by the roofing material and are even more susceptible to leaks - Reference Building Code IRC-P3103.3.

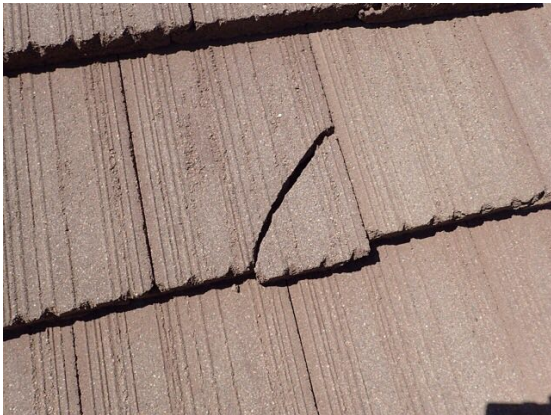
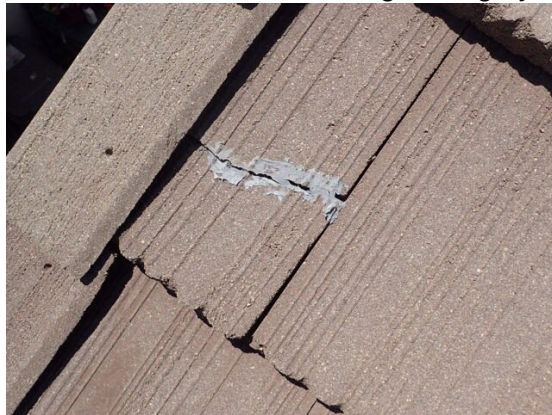
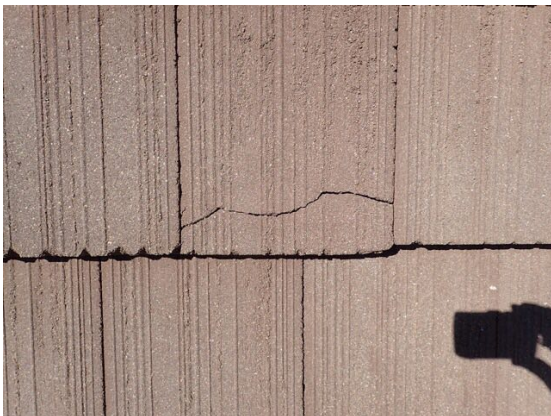
**18:** - There are cracked roof tiles that were observed at the main roof. This should be expected as regular wear and tear, however, the tile should be serviced to maintain the water tight integrity of the roof.

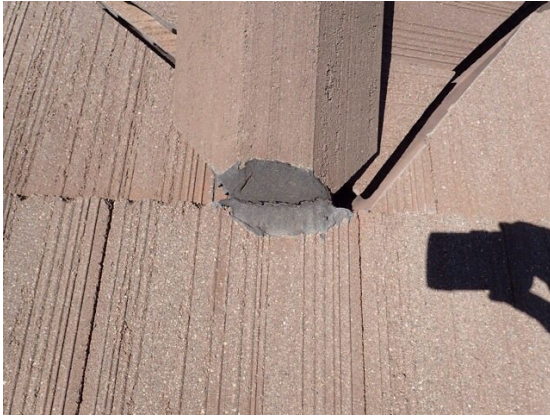
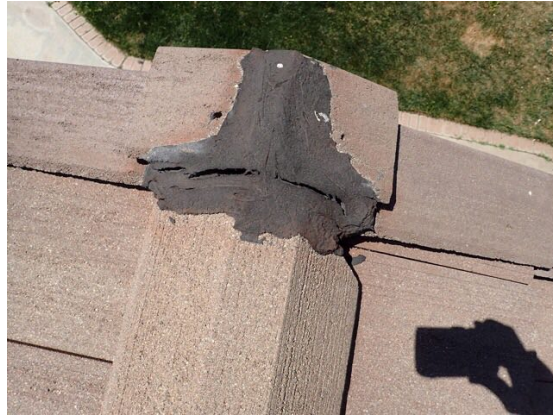
**20:** - The tile roof has junctions where the ridge (top tiles) and rake (side tiles) tiles meet each other. These junctions are sealed with cement or a bitumen material. Occasionally, the cement cracks or the bitumen material deteriorates or separates which may lead to a vulnerable possible moisture entry point. It is recommended that the junctions be sealed properly by a qualified roofing contractor in order to maintain the water tight integrity of the roofing system.

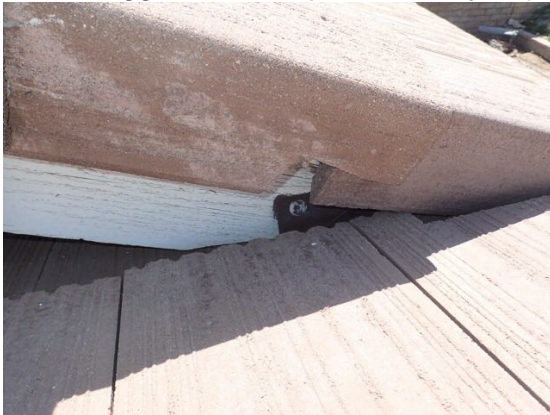
**22:** - There are cracked and missing "rake tile". These tiles are located on the sides of the roof. It is quite common for concrete tiles to become loose and is considered normal. Work is still recommended however, and is suggested to be performed by a qualified roofing contractor.

- Seal all pipes and junctions- \$275
- Replace/repair all broken tiles and rakes, including the damaged tiles under the skylight and tightening the loose rakes- \$350
- Remove the tile and properly roof the flat addition area in the back of the house with a torch down membrane. This includes repairing the area where the water is running under the adjacent side, replacing the damaged eave boards and sealing the exposed nails- \$1400
- Replace the broken skylight \$700
- Clean debris from the valleys \$400
- Remove the rake tiles and install paper that turns down the fascia boards- \$750
- Extend the short valley metal and install flashing where it is missing from the fascias- \$225
- Repair the damaged truss in the attic with permits- \$850

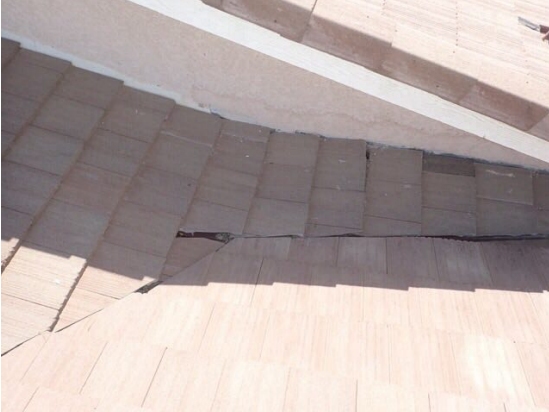
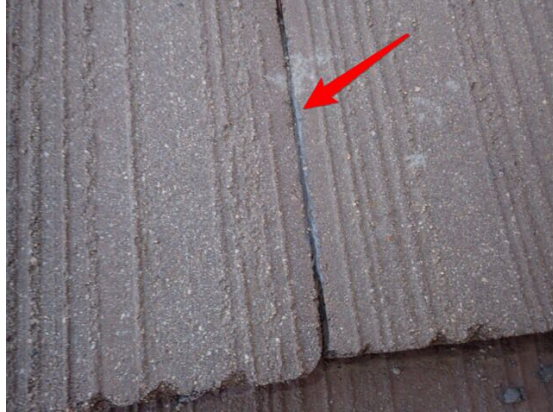
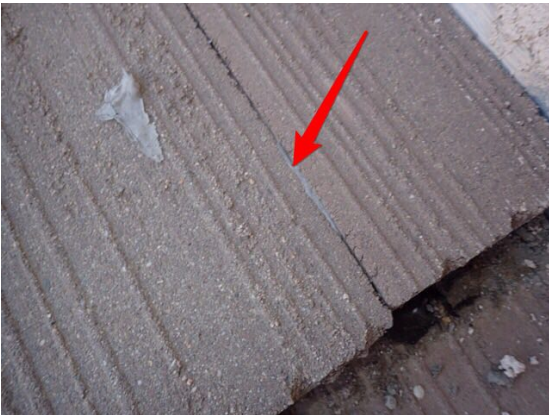
**24:** - The added area on the back of the house has a low pitch and should not be roofed with tile. This area is recommended to be roofed with a torch down or similar membrane that welds at all the seams. Currently, the area has a fiberglass base sheet installed that is not suitable for this application. Furthermore, the laps or "channels" of the tiles have a roof cement in them. This may impede water from draining because when it runs down the channel the water hits the roof cement and runs off the channel and onto the membrane underneath, rather than down the channel. This area appears to be roofed in a substandard manner. Improvements are recommended.

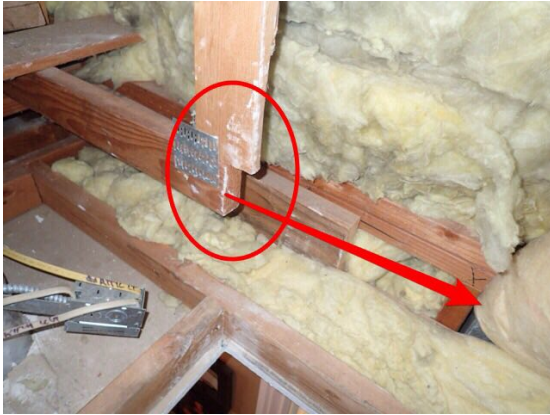
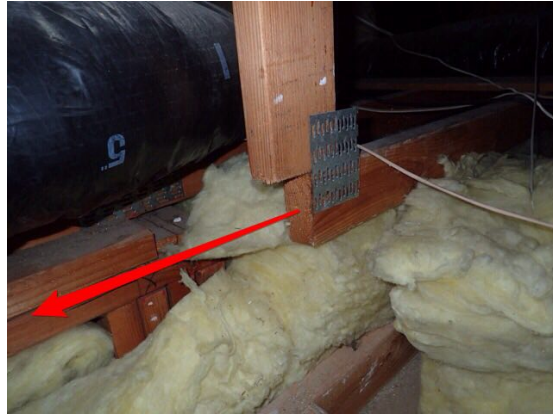
**31:** - A member of a truss was observed to be cut. Damage to the truss system may compromise this stability and make it weak. We suggest repairing this truss member as the truss is engineered for maximum structural stability.
