Property Inspection Report

xxx

Acton, California

Mazza Inspection Group

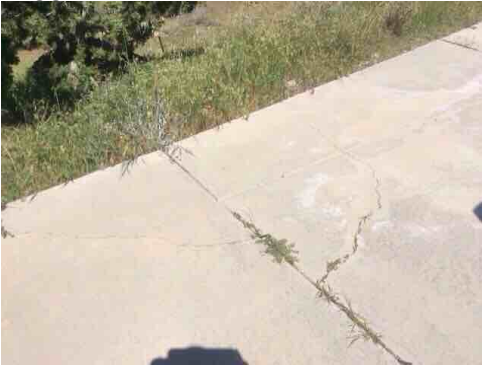
13: - Areas of the driveway surface are settled, which may pose a potential tripping hazard. These areas are suggested to be addressed as necessary by the appropriate trade or craftsman.

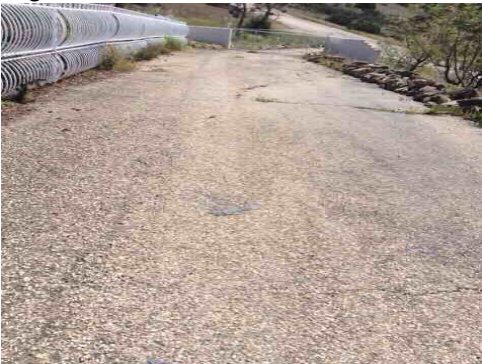
14: - The asphalt driveway shows evidence of excessive wear that includes large cracks, raised or settled surfaces, which can accelerate or hasten the life and deterioration of the driveway surface. Sealant and regular maintenance is recommended.

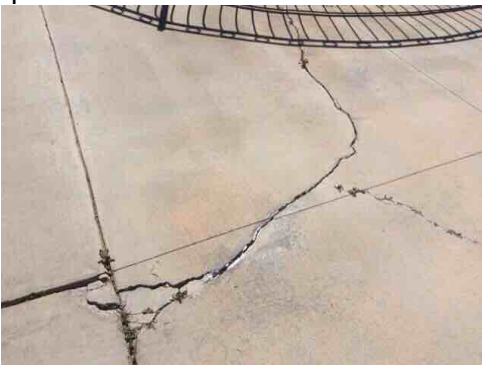
15: - Larger than typical cracks were observed in the driveway at the time of the inspection. The rate of movement cannot be predicted during a one-time inspection. A complete evaluation of the driveway is recommended to be performed, if desired, and should be conducted prior to the close of the escrow by a qualified contractor.

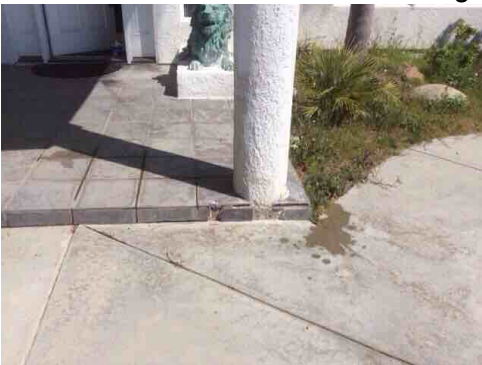
20: - There was tile that was damaged at the porch.

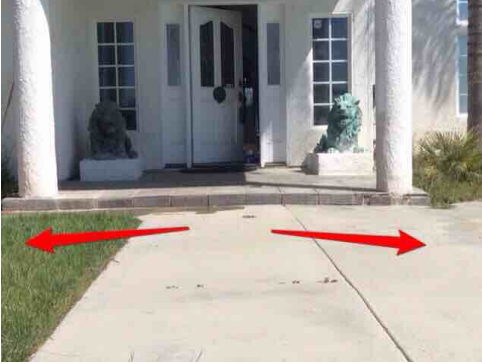
21: - The front porch possess a slope which is suspect. The slope may be contributed to settlement. On the other hand the porch may have been constructed in this manner.

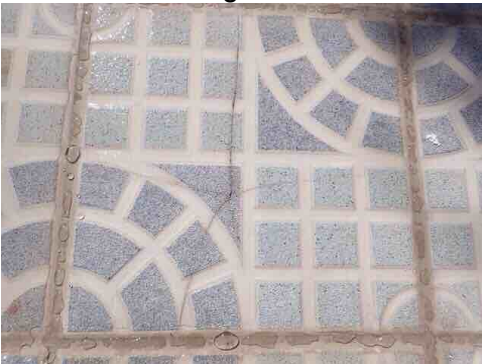
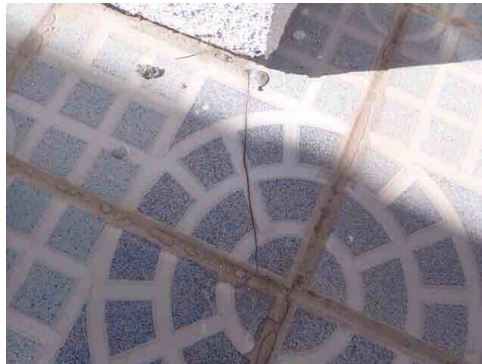
27: - There are cracked tiles on the deck. We cannot determine the reason for this cracking without destructive testing.

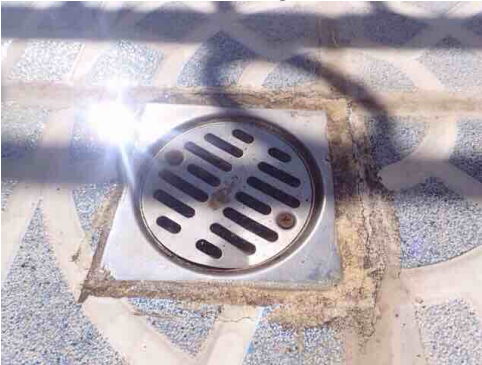
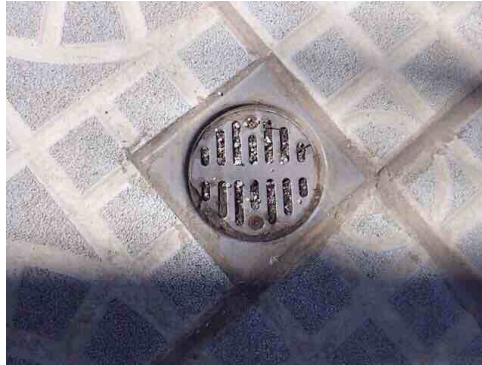
s-3: - The deck does not appear to be properly sloped to shed water and has areas of poor drainage. Repairs are recommended to ensure proper drainage of the deck.

28: - The deck does not appear to be properly sloped to shed water and has areas of poor drainage. Furthermore, the drains in the deck are clogged and do not drain properly. Repairs are recommended to ensure proper drainage of the deck.

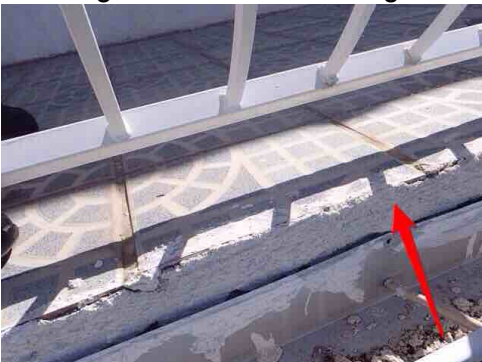
s-6: - Drip edge metal is suggested to be installed at the perimeter of the deck under the tile to protect the sheeting from moisture damage as well as to properly shed water into the gutters.

31: - Drip edge metal is suggested to be installed at the perimeter of the deck under the tile to protect the sheeting from moisture damage as well as to properly shed water into the gutters.

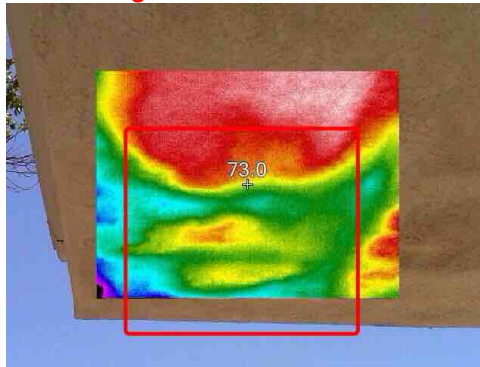
s-7: - Moisture staining was observed on the stucco underneath the deck, which may suggest that the deck leaks. We are unable to determine the methods in which the deck is waterproofed without destructive testing. Our fear is that the wood framing members of the deck may be damaged/rotten and in need of replacement. Further evaluation is recommended by a licensed general contractor.

43: - Moisture staining was observed on the stucco underneath the deck, which may suggest that the deck leaks. We are unable to determine the methods in which the deck is waterproofed without destructive testing. Our fear is that the wood framing members of the deck may be damaged/rotten and in need of replacement. Further evaluation is recommended by a licensed general contractor.

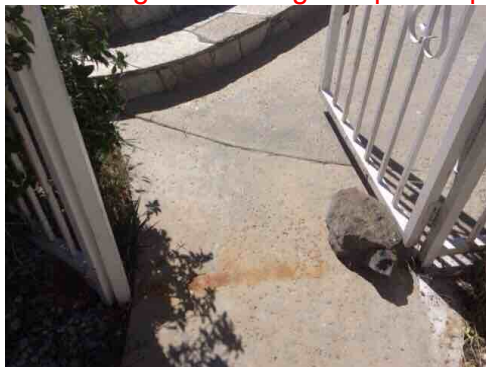
48: - The gates leading to a pool / spa are suggested to open outward in accordance to building standards.

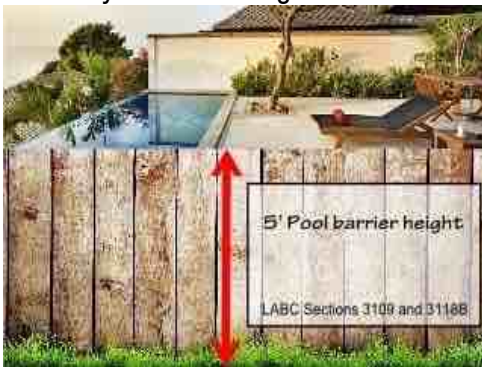
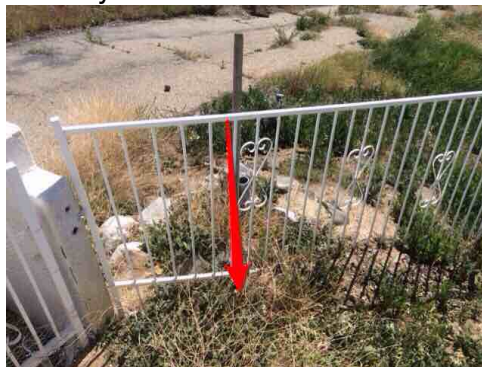
50: - The pool barrier is short. The barrier should be maintained at the local minimum building standard height of 60 inches (depending on code in jurisdiction) but this figure should be verified with the local building authority - 2012 IRC §AG105 Local code is likely more restrictive.

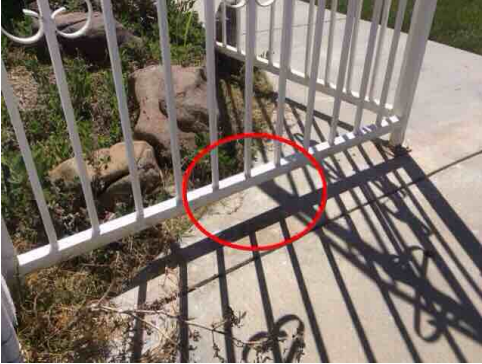
52: - The bottom and / or sides of the fence / gate exceeded the minimum allowable space of 2 inches over grade for barriers which lead to a pool yard. This applies to fencing and gates alike. Repairs are suggested to adhere to the safety provisions set forth by the local building authority - 2012 IRC §AG105. Local code is likely more restrictive.

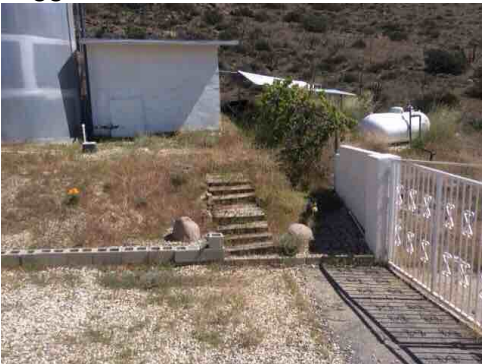
53: - Railroad-tie steps are landscape components and would not conform to common standards requiring certain dimensions, handrails, guardrails, etcetera. In light of this, we suggest the buyer take caution when using these steps as they do inherently represent a potential hazard. For safety, all stair treads and risers are suggested to be constructed to a minimum building standard - ICC R311.7.5.

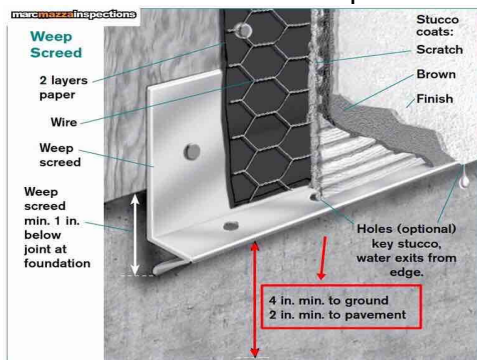
57: - There is concrete and soil that is high at the foundation at the time of the inspection. The soil level is up to or above the weep screed. These materials at this level may allow moisture penetration in the interior wood framing members or insect infestation. There should be at least 4 inches between the weep screed (if present) and the soil level and 6 inches between siding and the soil level. There is a recommended space of 2 inches between the weep screed and a solid surface such as concrete. It is recommended that this condition be referred to a qualified termite inspector for further evaluation - IRC 2012 §703.6.2.1.

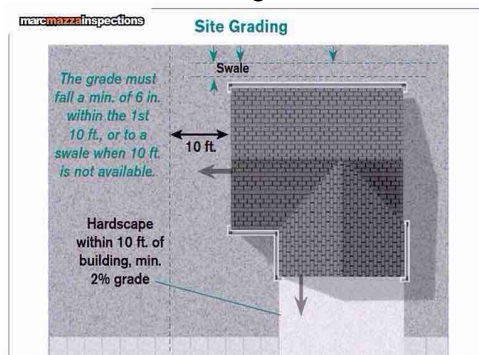
59: - Grading and drainage plays a crucial role in the longevity and performance of the foundation. This grading in some areas is neither negative nor neutral adjacent to the residence, and moisture intrusion will remain a possibility. The soil or the hard surfaces should slope away from the residence to a distance of at least 10 feet, to keep moisture away from the footings. We could elaborate on this issue further, but you should seek a second opinion from a grading and drainage contractor to understand the potential risks involved with having a house on a slope combined with poor drainage.

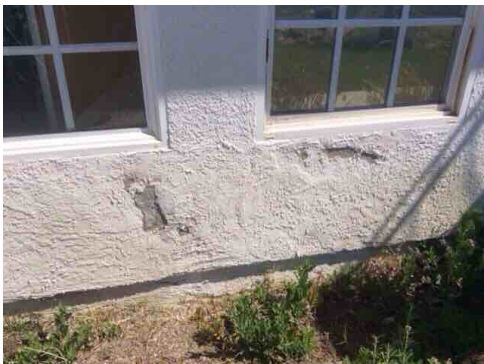
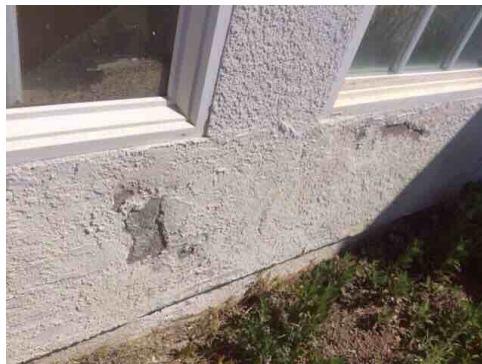
64: - Surface deterioration (spalling, crumbling material) was observed at the exterior walls. This condition is common in many old homes and does not usually represent a serious structural concern unless there is substantial loss of material. In an effort to prevent long term deterioration, it would be wise to consider parging (a concrete stucco-like coating) over deteriorated areas. Sprinkler and lot drainage improvements and elimination of water or roof runoff splashing against foundation walls can reduce possibility of damage deterioration.

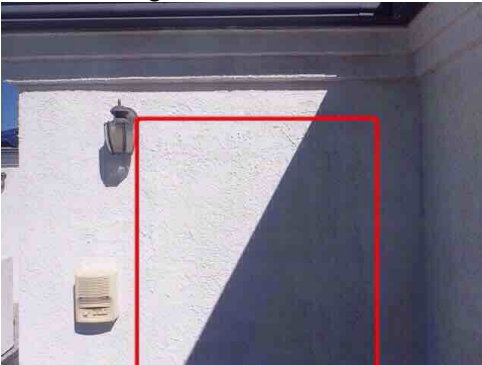
67: - Cracking was observed in the stucco around windows or doors which appear to have been removed and then stuccoed over. The cracking appears to be in a similar location to where the frame or nailing flange would have been. There may be many reasons for the cracking, however, all we can do is speculate as to the reasons for the cracks. Windows and / or doors removed and stuccoed over, requires water-proofing paper and wood studs in the opening as well as a method in which the stucco is repaired to reduce the potential for cracks. All of which must be installed in accordance to minimum building standards. Inquiring with the current owner in regard to this condition is recommended.

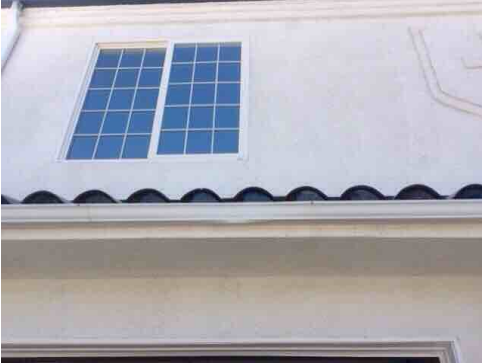
73: - The gutter is damaged at the front side and suggested to be improved.

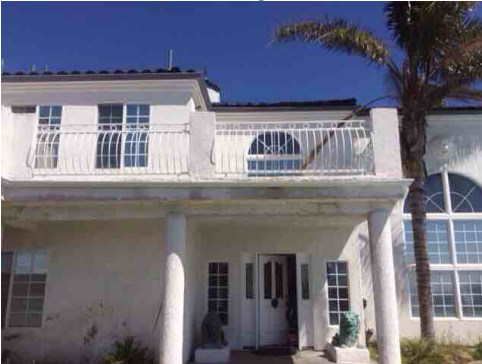
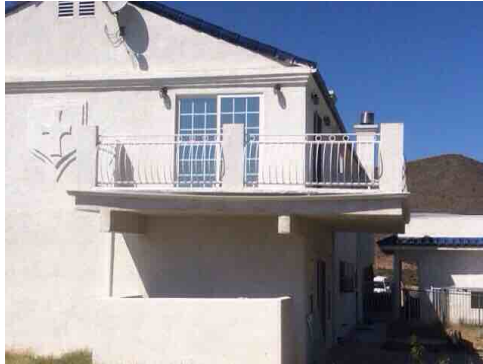
74: - The gutters appear to be improperly sloped at various sides of the building which can result in substandard drainage, backup, premature wear, rust, roof leaks and trim damage.

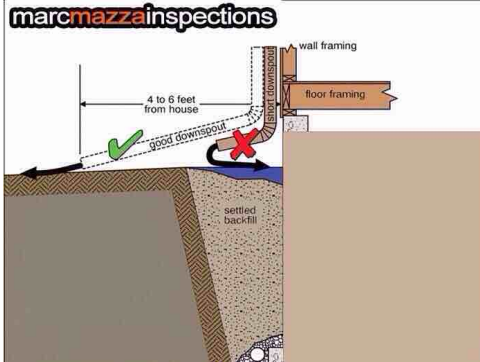
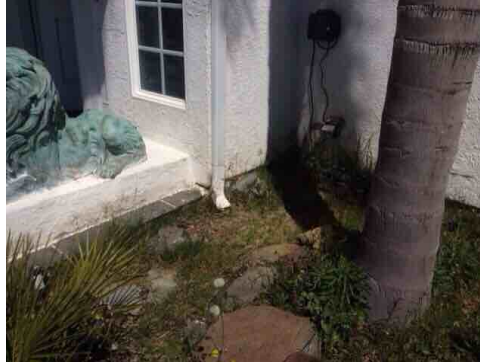
76: - We recommend routing all of the downspout(s) away from the structure, or installing the downspout directly into the subsurface drainage, if present. The downspout(s) should discharge water at least five (5) feet from the house or drain into existing sub surface drainage. Storm water should be encouraged to flow away from the building at the point of discharge.

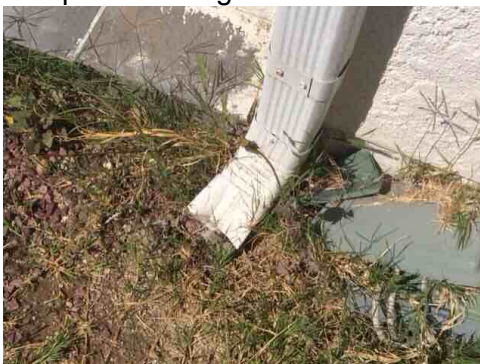
78: - There was damage observed at the west downspout. Repair or replacement is suggested to allow for adequate drainage.

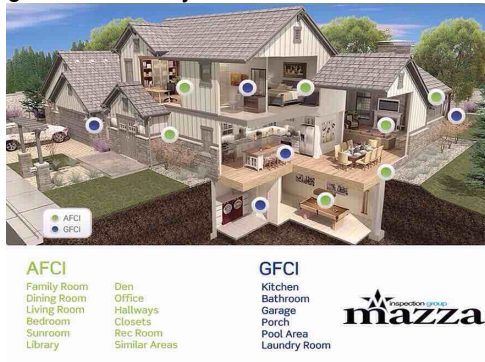
79: - All of the exterior outlets are suggested to have ground fault protection. Although, the installation of Ground Fault Circuit Interrupter (GFCI - a safety device for outlets close to any water) receptacles may not have been required to be installed at the time of this houses initial construction, however, they are now and because this new code is the most stringent, we feel it prudent that this is the code to follow. NEC 2014 §210.8 Local jurisdictions to some extent, may offer a different version of this standard.

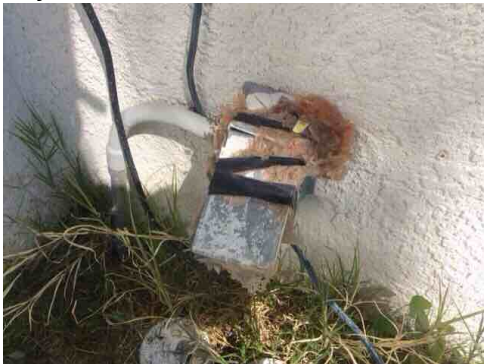
80: - Rain tight exterior rated cover boxes are recommended where plugs are permanently plugged into the exterior receptacles. This cover will help reduce the possibility of moisture penetration into the receptacle and any chances of shorts in the circuit or even shock. NEC 2014 §406.9

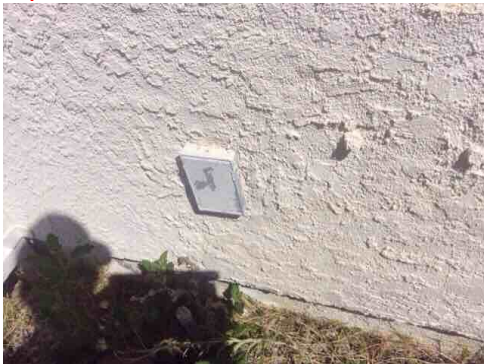
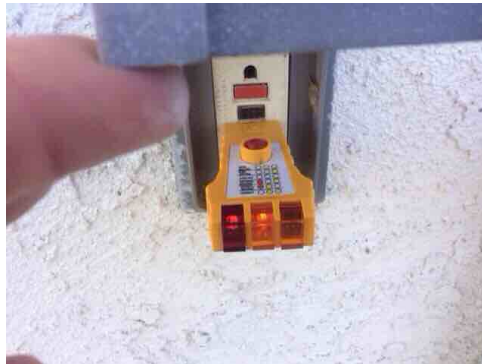
s-12: - All of the exterior ground-fault protected outlets did not trip or are not protected upon test, and should be replaced.

81: - All of the exterior ground-fault protected outlets did not trip or are not protected upon test, and should be replaced.

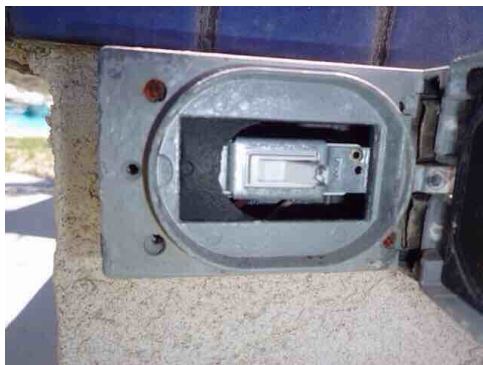
82: - We observed missing coverplates at the north side switch. Improvements are recommended as a safety precautionary measure.

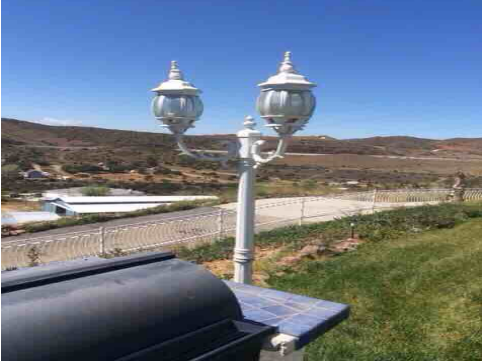
87: - The front lights installed on the pole were believed to have been tested, however, were non functional. We suggest the buyer have the seller demonstrate the operation of this component prior to the close of escrow. Many times components are functional, but it may take the seller who understands intimate details regarding their own property to demonstrate their operation.

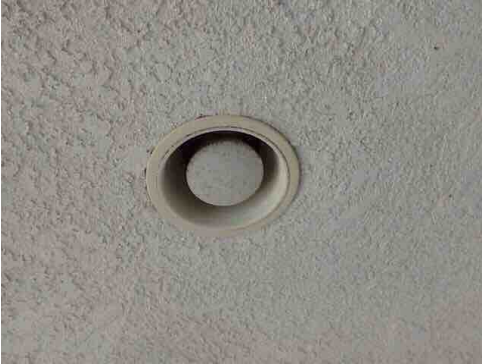
88: - The light bulbs on the front porch appear to be painted over and are suggested to be replaced.

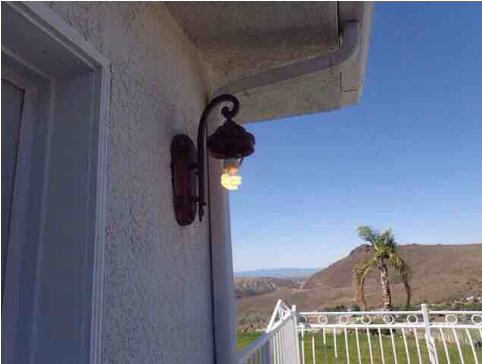
89: - One of the carriage lights on the garage is damaged and in need of repair.

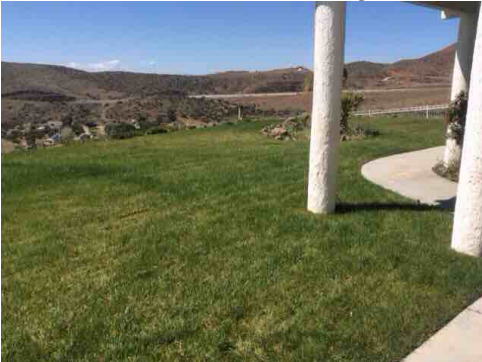
93: - The west grounds appear to be over watered and saturated. If the watering schedule indicates that the yard receives a minimum amount of water, we suggested that the underground pipes be investigated for leaks. Furthermore, the long term affects of over watering may be detrimental to the foundation.

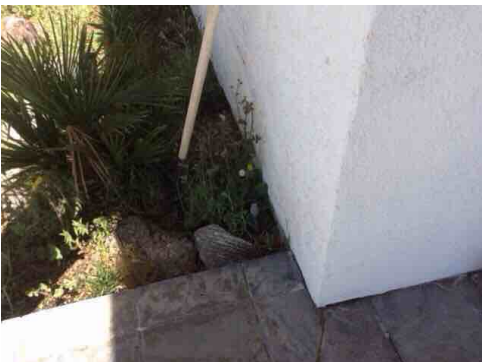
94: - Readjusting the sprinklers away from the structure walls, walkways, fences, HVAC components, etcetera, is recommended, due to the staining created by the over spray. Over time, the sprinklers can cause excessive wear and tear to these materials.

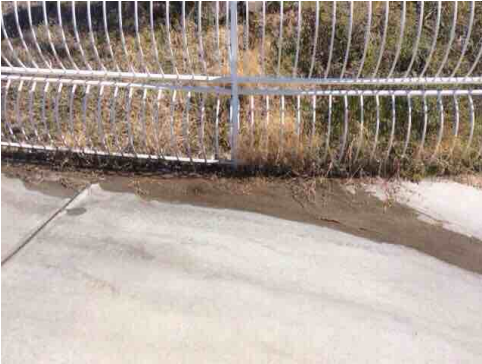
95: - We observed a leaking irrigation supply pipe at the north side. We recommend the advice and services of a licensed contractor who can inspect this condition and improve upon it as / if necessary.

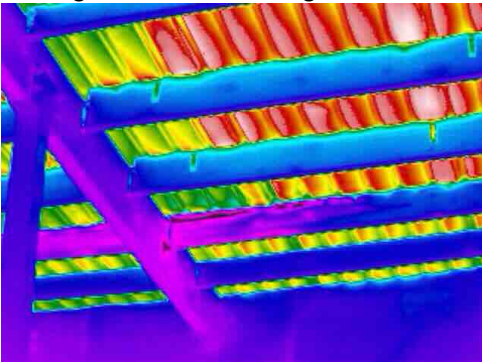
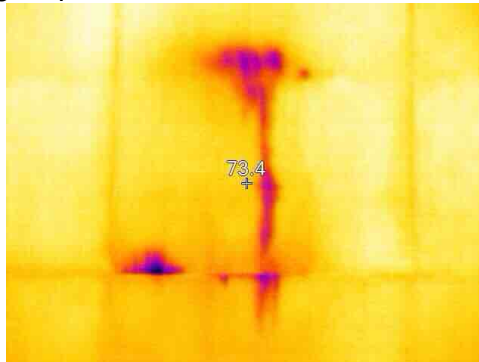
99: - It should be noted that the work shop structure although not inspected, showed indication of significant leakage/moisture throughout the building as pictured.

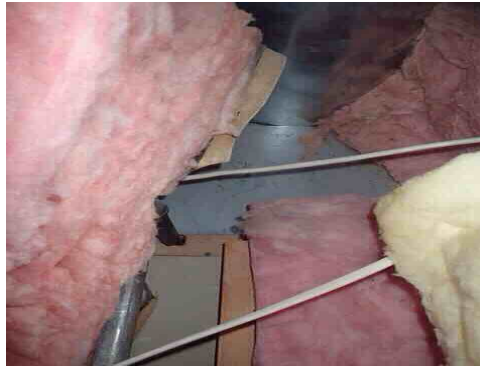
108: - We observed several damaged trusses within the attic. These trusses are structural components and as such will require the evaluation of an engineer to better determine what repairs are necessary to remedy this condition.

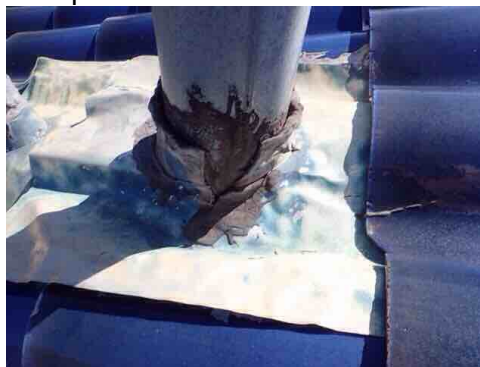
117: - There were flashings which were filled with dirt and debris. This material in the flashing poses a potential issue with respect to drainage. The flashing may cause a back up in water run off which may result in a potential leak.

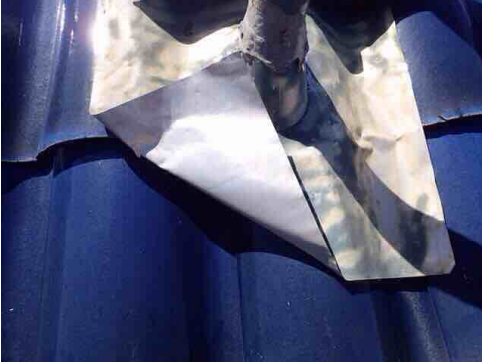
118: - The toe of a flashing (lower portion of the flashing), has lifted, probably by the wind, and should be serviced. Re securing the flashing or sealant is suggested to reduce the potential of moisture penetration.

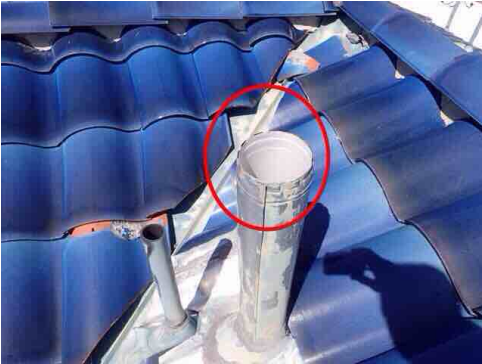
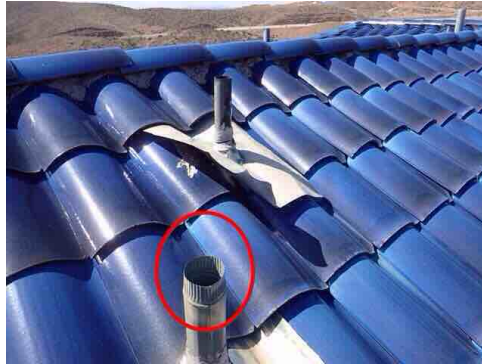
119: - There were vent caps which were missing from B vents located at the roof deck. Replacement is suggested to reduce the potential for deterioration or damage to the vent or appliance.

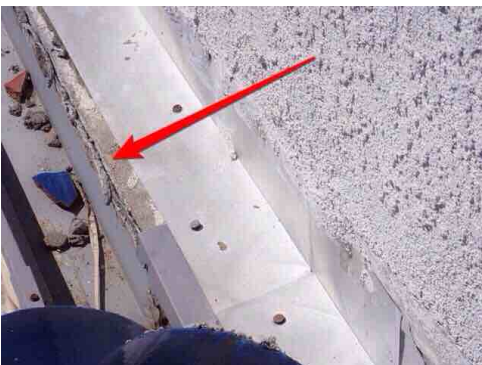
121: - There is an area at the front of the house that is missing drip edge metal. Improvements are recommended.

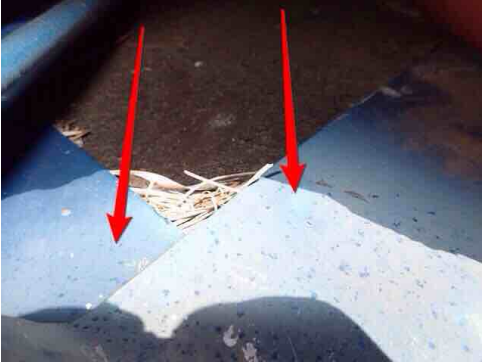
122: - The tile membrane does not appear to terminate on top of the valley metal. The membrane should terminate on top of the valley metal to properly shed water into the valley instead of underneath it.

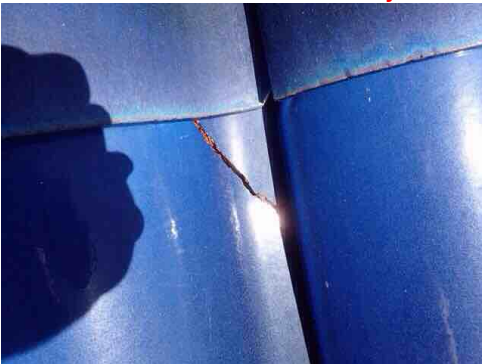
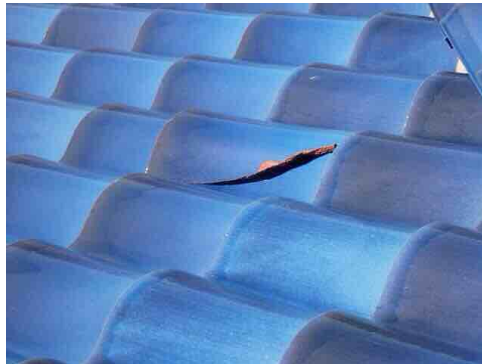
124: - There were cracked and slipped roof tiles which were observed at the main roof. This should be expected as regular wear and tear, however, the tile should be serviced to maintain the water tight integrity of the roof. This type of material should be replaced by a qualified roofing contractor as walking on this roof material may crack and / or break many tiles and cause more damage than necessary. Regular inspections and maintenance are recommended. This type of roof structure is recommended to be inspected every 2-3 years for any slipped, cracked or missing tiles. It is also recommended that the vents be inspected at this time and sealed as necessary. The tile roof covering material observed is a type that is typically walked on by Mazza Inspections, however, in some cases we may choose not to. For example, the seller may request that we not walk on their roof or the height or weather may represent a hazard. Other examples may be a steep pitch or the roof is a clay tile roof, where the possibility of damage to the tiles is greater. In which case, the roof is inspected from the inside of the house as well as all exterior accessible areas of the roof that are visible. There may be portions of the roof that were viewed from the ground and / or ladder using binoculars. Some sections of the roof may not be viewed at all.

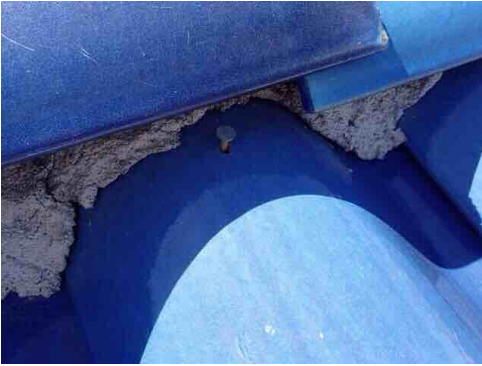
126: - There are nails that are exposed at the top row of tile. Sealing the nails is recommended to prevent moisture intrusion.

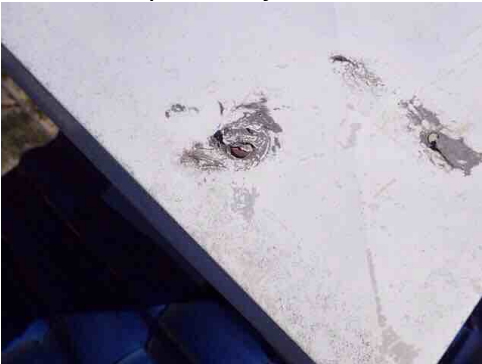
133: - The metal chase cover at the top of the chimney has nails that are recommended to be re-sealed to reduce the possibility of moisture intrusion.

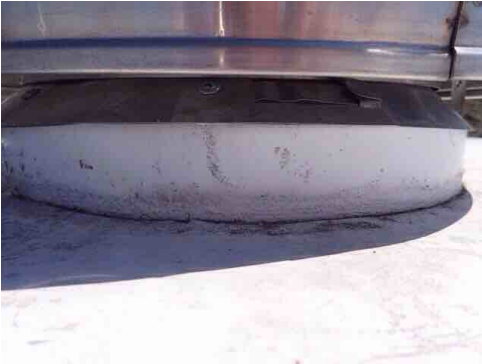
135: - The cooling flue which is an integral part of the flue assembly appears to be "choked off" due to the position and possible improper installation of the storm collar present. The installation (if proven to be incorrect) as it is currently, poses a real and present fire hazard. Further assessment is advised.

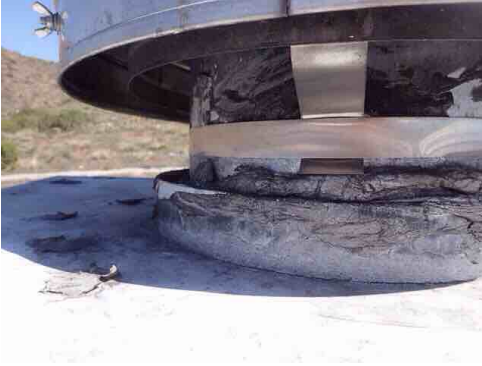
146: - There is no storm collar present or visible to us from our prospective.

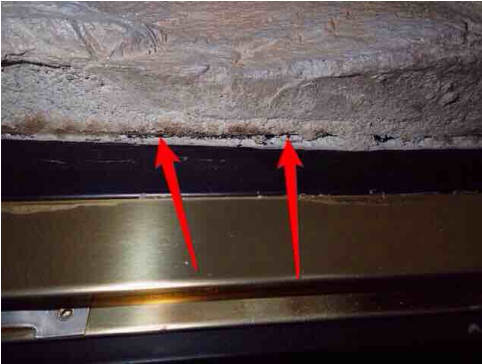
162: - Sealant is suggested at the firebox connection to the face in front of or behind the lintel as a safety precautionary measure.

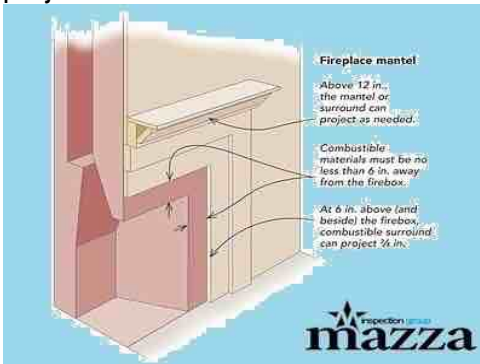
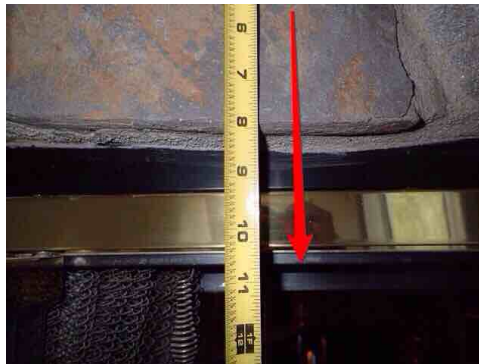
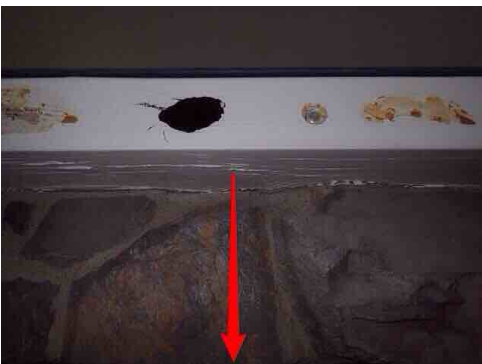
163: - There is wood which has been installed closer to the opening of the fireplace than what building standards suggest for any combustible materials.

In accordance to the NFPA 211 section 11.2.5.3, the sides must maintain a 6" clearance when the projection is less than 1.5". When the material at the top projects less than 1.5" the clearance is 6". When the material projects in excess of 1.5" the minimum clearance is 12".

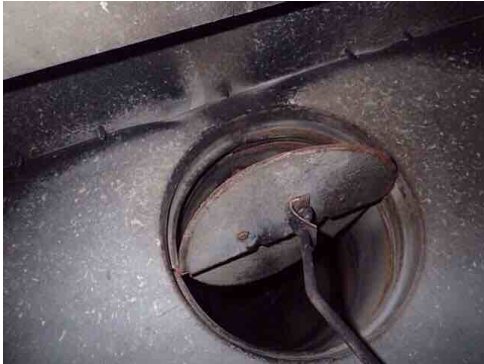
166: - Rust/staining was noted inside the chimney flue, which may suggest that moisture is passing down the flue from the termination. Further evaluation is recommended by a licensed fireplace contractor.

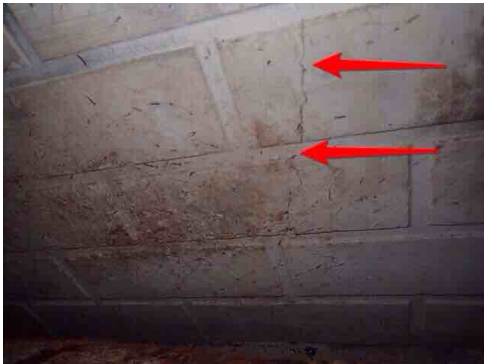
167: - There are cracks in the refractory (firebricks) in the fireplace. These cracks warrant attention and necessary repairs (which may include replacement) to reduce possible future damage or deterioration. We recommend the further review, advice and services of a professional contractor.

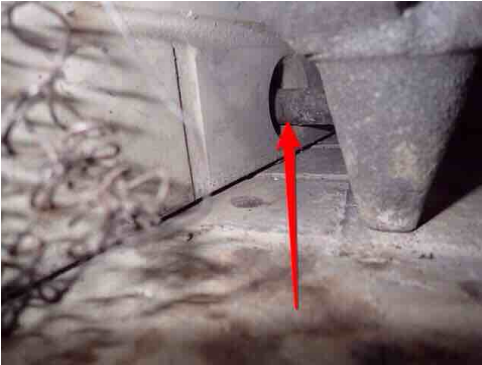
170: - The void / separation around the gas pipe in the sidewall of the fireplace should be sealed with refractory caulk to prevent any possibility of back-drafting a flame beyond the combustion chamber, where it could come into contact with combustible material.

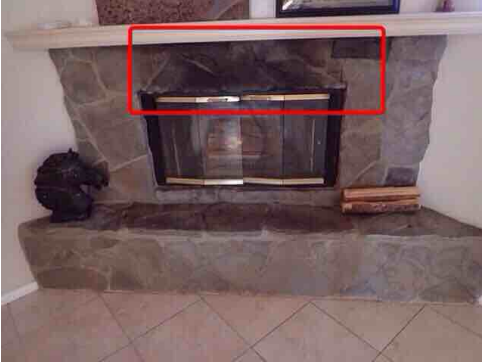
179: - The fireplace has a discoloration on the face of the fireplace. The discoloration may be directly related to poor drafting or operating the fireplace with the flue closed.

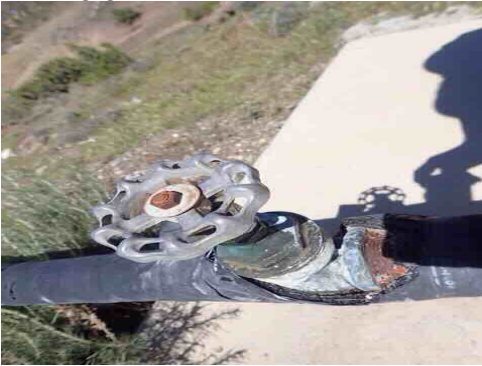
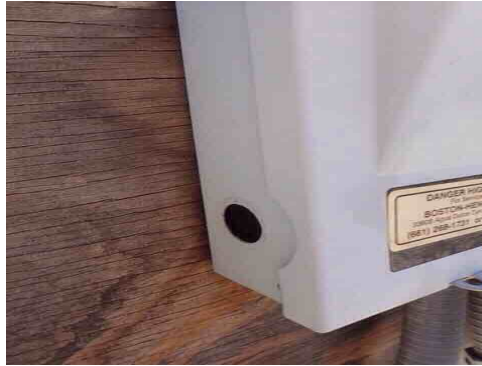
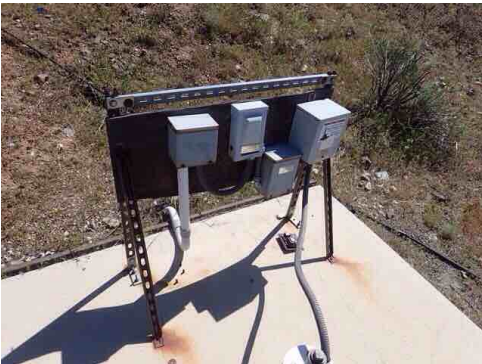
182: - We observed an open knockout at the well electrical supply junction box. We further observed a leaking gate valve in this area as pictured.

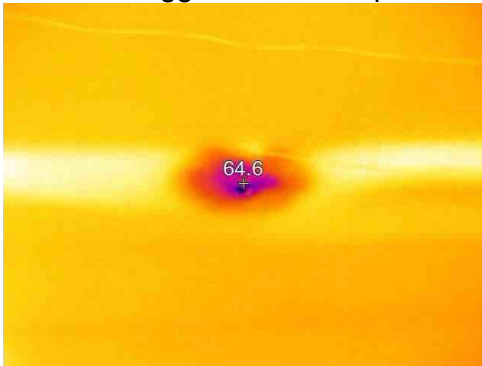
189: - The drain, plumbing was leaking from the upper common bathroom at the time of the inspection and is therefore suggested to be repaired.

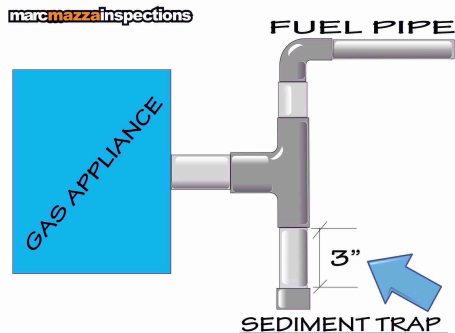
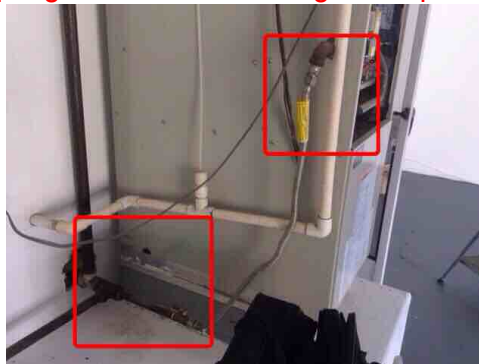
193: - There are missing sediment traps at all or some of the fuel piping installed prior to fuel burning appliances e.g. furnace, water heater. A drip leg, also known as a dirt leg, is there to protect the gas train and burner orifices from gas born water and dirt. In a clean piping system, with best quality gas supply, there will never be a need for this. Typically, systems develop some moisture from condensation, as well as some dirt or other contamination. Typically, the drip leg is 3-6 inches in length and prior to the appliance.

Code 194: - 1212.7 Sediment Trap

Where a sediment trap is not incorporated as a part of the gas utilization appliance, a sediment trap shall be installed downstream of the appliance shutoff valve as close to the inlet of the appliance as practical at the time of appliance installation. The sediment trap shall be either a tee fitting with a capped nipple in the bottom outlet, as illustrated, or other device recognized as an effective sediment trap. Illuminating appliances, ranges, clothes dryers, decorative vented appliances for installation in vented fireplaces, gas fireplaces, and outdoor grills shall not be required to be so equipped - NFPA 54-09:9.6.7.

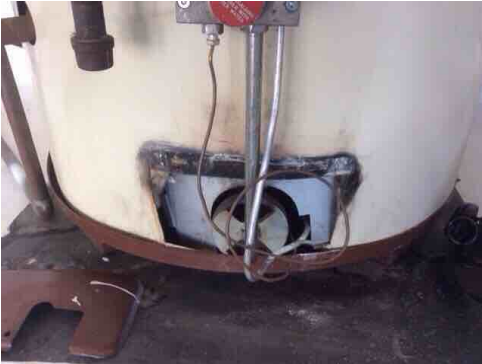
206: - There is a discoloration at the front of the combustion chamber which resembles that of scorching. The reason for this discoloration was not evident, however, there was no immediate evidence of damage as a result.

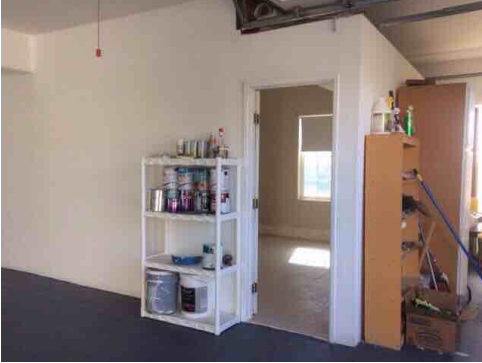
207: - The garage appears to have been converted into living quarters. The work was performed in a substandard manner and likely may not possess permits for the works performed. We omit any work performed without the endorsement of the authority having jurisdiction.

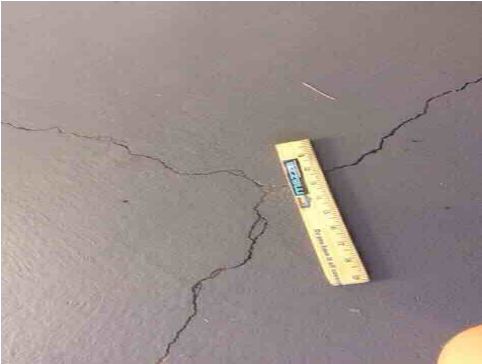
209: - The garage slab is cracked substantially. Such cracks are the result as a consequence of the curing process, seismic activity, ordinary settling, or the presence of expansive soils. We can elaborate, but you may wish to have a foundation professional examine this condition further.

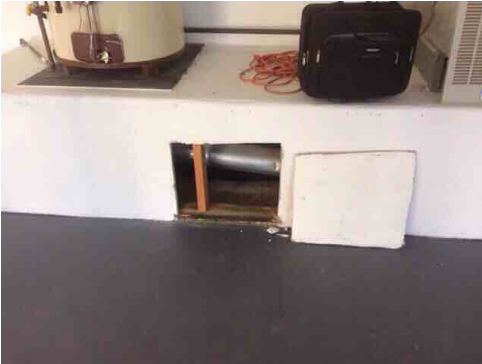
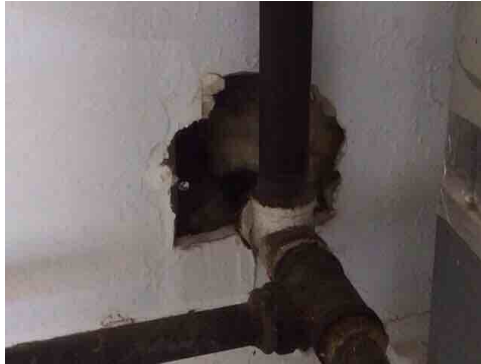
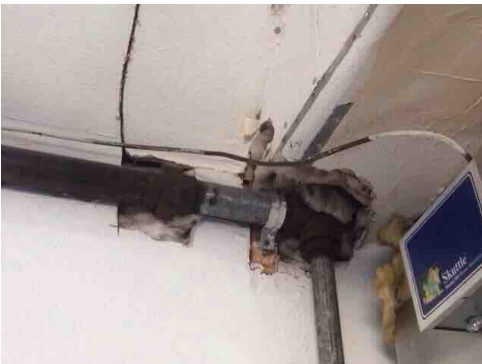
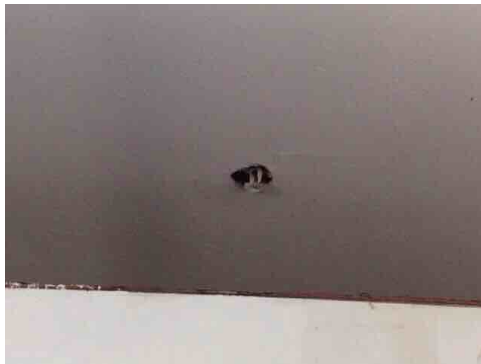
211: - Holes and / or missing wall separation wall covering were noted in the fire rated wall that connects the garage to the main structure. The walls and ceilings of the attached garages should be well sealed where they abut the interior of a house to maintain the integrity of the fire rated materials. Dwelling/garage opening/ penetration protection. Openings and penetrations through the walls or ceilings separating the dwelling from the garage shall be in accordance with sections R302.5.1 through R302.5.3.

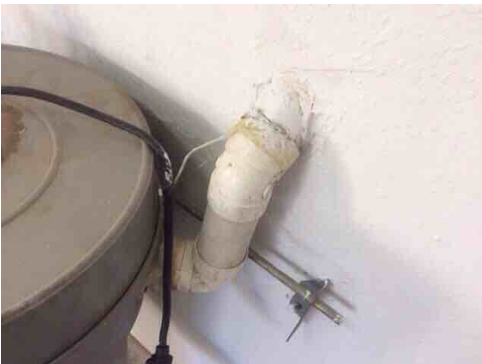
212: - The plastic piping penetrates the garage firewall. The point of penetration is suggested to employ a metallic material to maintain the fire rating of the firewall.

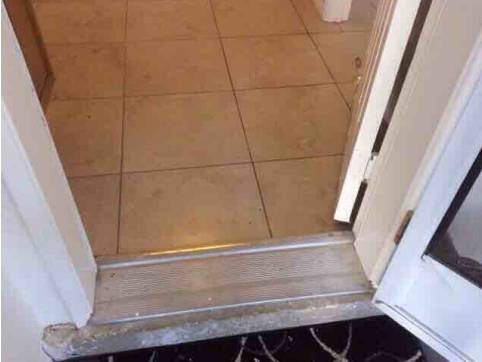
215: - The entry door from the garage was not fully self-closing. As per building standards, this door is to be a solid door, 1 3/8" minimum, solid steel, or fire rated, that should fully close unassisted. IRC Code 302.5.1.

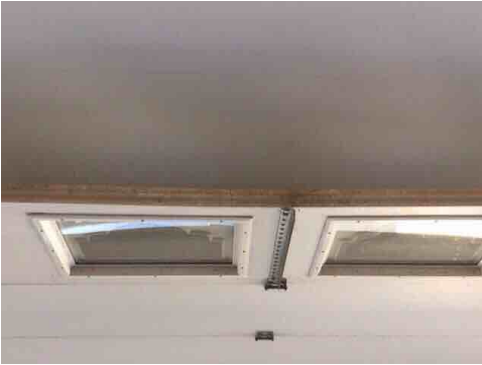
VEHICLE DOOR C

221: - The garage vehicle door is damaged. The panels on the garage door were bent and in need of repair or replacement.

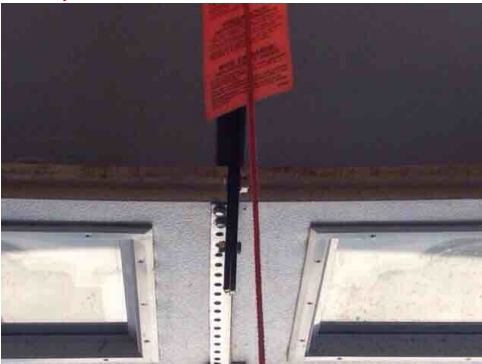
VEHICLE DOOR D

222: - The garage vehicle door is damaged. The panels on the garage door were bent and in need of repair or replacement.

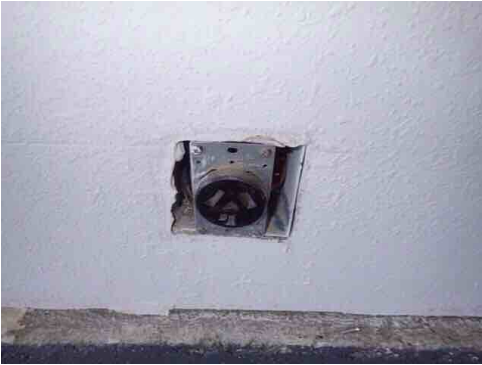
229: - There are receptacle cover plates which are missing in the garage. Replacement is suggested for safety purposes - NEC 2014 §406.6 & 410.22.

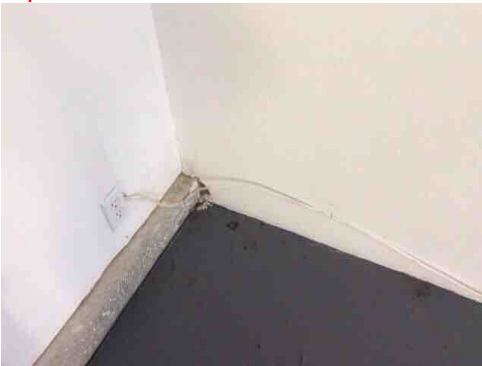
230: - Exposed wiring noted, exposed to physical damage or contact was observed in the garage. Wiring which is exposed and within harms reach should be relocated or protected from damage or contact by the use of conduit. An electrical contractor should be contacted for further evaluation and to make any necessary repairs - NEC 334.15.

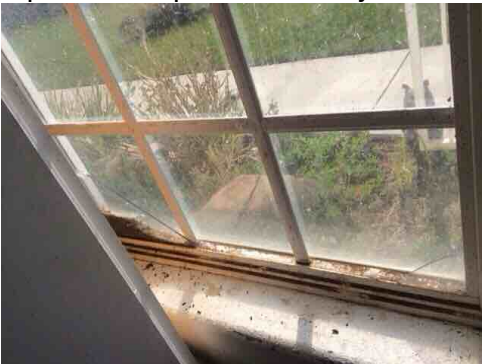
231: - We observed a broken glass window at the south side of the garage. Repairs are suggested as this represents a potential safety issue.

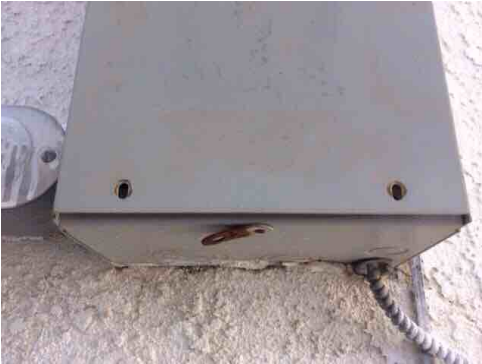
DEAD FRONT COVER

236: - Screws are recommended in the dead front cover. Replacing the screws is suggested to prevent unnecessary intrusion by anyone other than a professional.

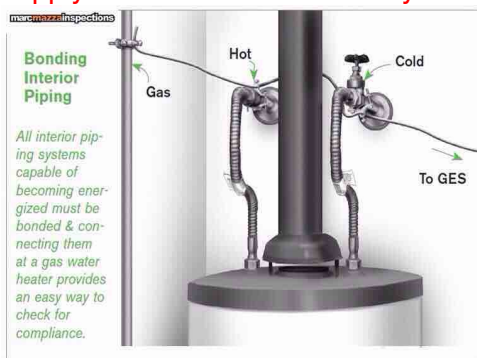
239: - We were unable to verify a cold (and hot) water bond at the main water supply, or supply piping. In accordance to building standards; the bond is suggested to be installed in or attached to a building structures metal piping system(s) including hot water, cold water and the gas piping, that are likely to become energized. These aforementioned components should be bonded to the service equipment enclosure in accordance to building standard. The bonding jumper(s) should be sized in accordance with the NEC, using the rating of the circuit that is likely to energize the piping system(s).

*Note: a) If the house employs plastic water piping, there may not be a cold water bond. b) The water pipe ground/bond may have been removed if the house was re-plumbed in copper. Therefore, it should be traced by an electrician or the panel should be re grounded. c) We did observe grounding electrodes at the water supply but were unable to verify their connection to the panel.

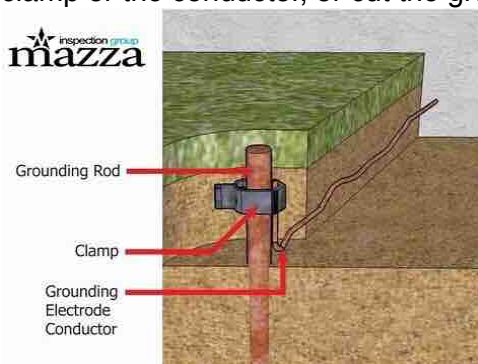
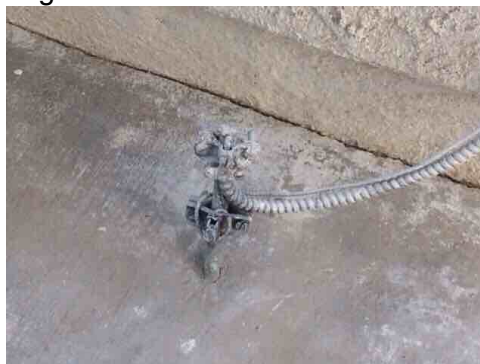
242: - The ground rod observed was elevated, and therefore, exposed. The rod was not protected from physical damage in accordance to minimum building standards. The ground rod, which was exposed may not be buried the full length of the rod (providing the rod is a minimum of 8'). The *minimum* length a grounding rod or pipe is required to be in contact with earth is 8 feet, if the grounding rod is 8 feet long, then the entire 8 foot length would need to be in contact with earth.

If the ground rod is driven all the way into the ground, the connector for the grounding electrode conductor to the ground rod must be accessible for inspection, and must be protected from physical damage. Some AHJ will allow the top of the ground rod and the connection clamp to be just below grade level and left exposed for the inspection, then covered up afterward. Other AHJ will require a protective sleeve of some type be placed around the top of the ground rod and the clamp, leaving it open for inspection and be protected from physical damage by the sleeve.

The ground rod clamp needs to be protected from damage least it become loose and/or the grounding electrode conductor be damaged especially in a planter where a shovel could easily cause damage to the clamp or the conductor, or cut the grounding electrode conductor.

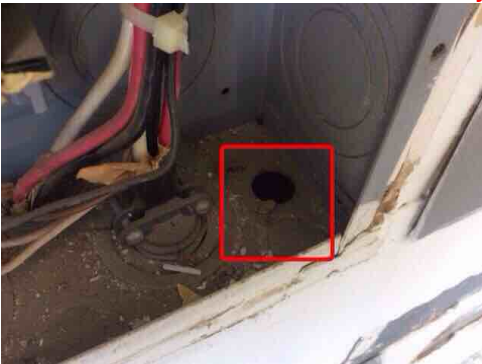
246: - We observed openings within the service equipment panel. Openings in the panel are not suggested and should be closed or sealed off by a professional contractor.

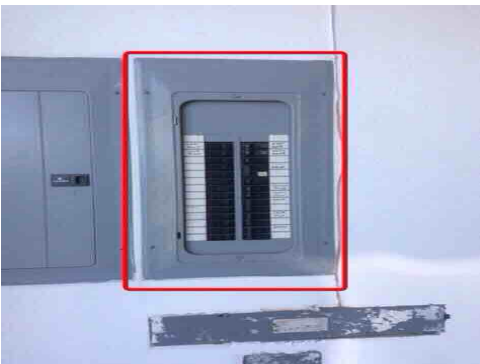
252: - The exterior cover for the main electrical panel is missing, and should be replaced.

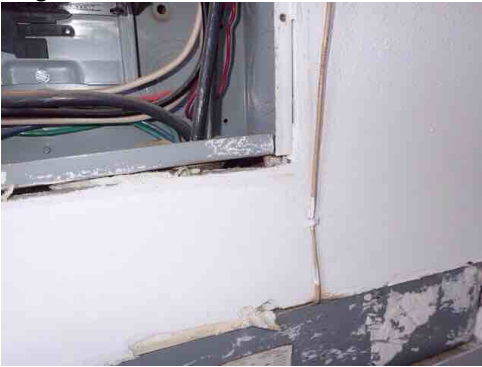
254: - There is an opening in the drywall where it connects to the panelboard, which is substandard. Gaps larger than 1/8" are suggested to be closed/repaired.

Plaster, drywall, or plasterboard surfaces that are broken or incomplete around boxes employing a flush-type cover or faceplate shall be repaired so there will be no gaps or open spaces greater than 3 mm (1/8 in.) at the edge of the box.

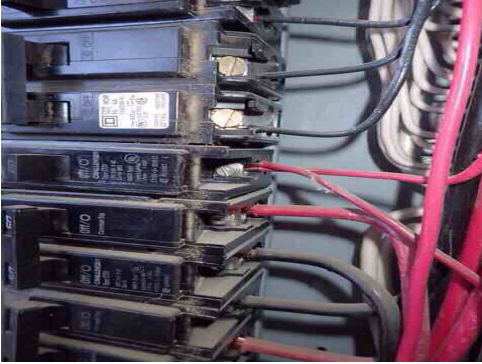
257: - There are two wires connected to one breaker in the electrical panel. Circuits within the panel that are doubled up (referred to as "double taps"), should be verified for this application by a professional electrician. As inspectors, we are unable to remove the breaker to determine if the breaker is manufactured for this application. Double taps may allow the terminal to become loose and lead to more serious issues. With that being said, a complete evaluation including the inspection of the breaker(s) is suggested. Any repairs are suggested to be performed by a qualified electrical contractor.
