Property Inspection Report

xxx

Acton, California

Mazza Inspection Group

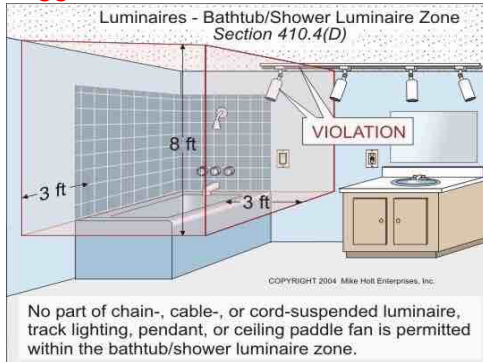
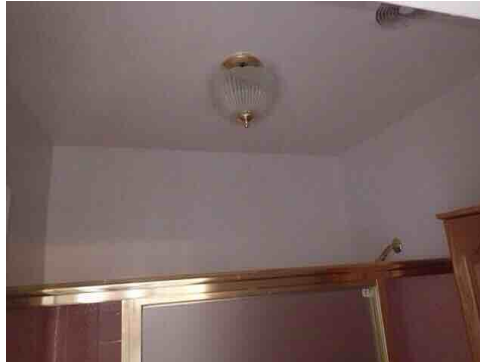
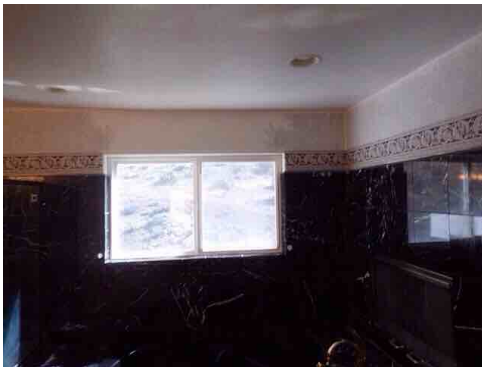
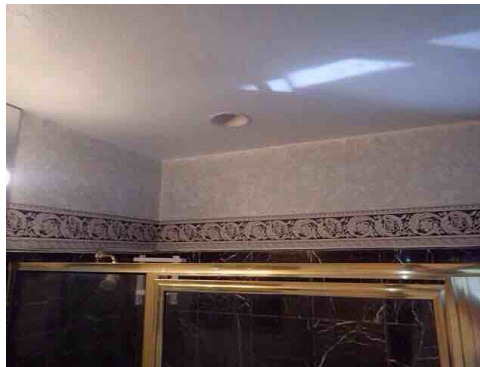
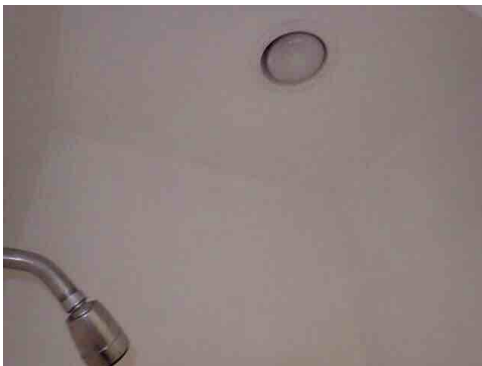
263: - The ceiling lights installed in the Jack and Jill bathroom, the master bathroom and the garage bathroom do not possess a wet type fixture trim kit and appeared to be installed within the 8 x 3 shower spray zone of the shower enclosure. For some older structures, this may not have been a code requirement, however, improvements are always suggested as old or new code is the minimum standard and is always suggested to be exceeded - Reference from NEC 410.10-(D).

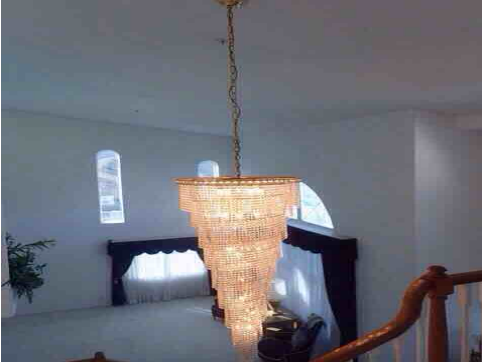
264: - The light fixture located at the front entry appears to be somewhat larger than typical and thus, may weigh much. The junction box is suggested to be verified to withstand the weight of the light fixture. The weight limit of junction boxes is limited to 50 pounds.

(B) Maximum Luminaire (Fixture) Weight. Outlet boxes or fittings installed as required by 314.23 shall be permitted to support luminaires (lighting fixtures) weighing 23 kg (50 lb) or less. A luminaire (lighting fixture) that weighs more than 23 kg (50 lb) shall be supported independently of the outlet box unless the outlet box is listed for the weight to be supported.

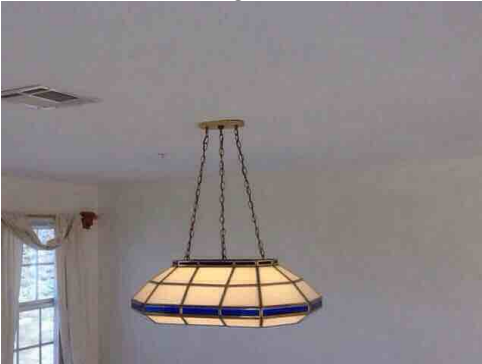
265: - The table light in the loft is loose at the ceiling and should be secured.

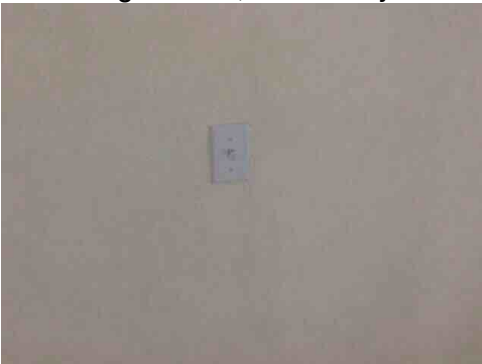
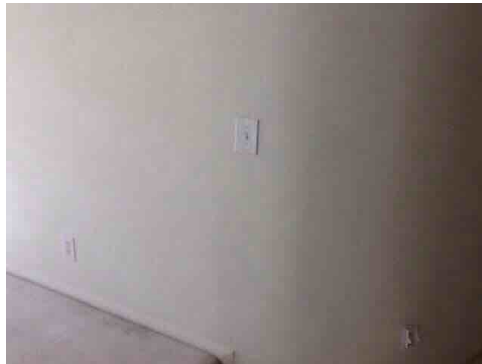
266: - The inspector was unable to determine the function of multiple light switches, throughout the house (office, master bedroom). Switches may energize either a ceiling light fixture, ceiling fan/light combination or a wall receptacle, typically known as "half-hot receptacles" or bulbs which are not operational. Further evaluation may be necessary in identifying the operation of these light switches, including the replacement of various light bulbs, which may be defective.

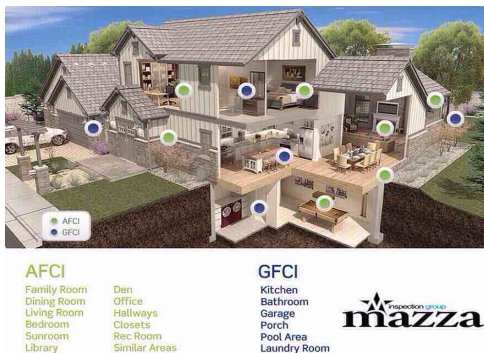
267: - Although the installation of Ground Fault Circuit Interrupter (GFCI - a safety device for outlets on islands, laundry sinks, kitchens, bathrooms, locations close to water, closets, garage and all exterior receptacles, etcetera) receptacles may not have been required to be installed at the time of the initial construction of this structure, the installation of the GFCI receptacle is recommended at all interior and exterior outlets which may be within 6 feet of, or in direct contact with water. They are also required to be installed at all wet locations when the receptacle is replaced. In the event receptacles in the bathrooms, kitchen or any area where water is present are replaced or remodeled, the new receptacle must be installed as a GFCI.

These outlets may be used for small tools and appliances, but should not be used for refrigerators or freezers. Such larger appliances use a greater amount of electrical current, and since these plugs have a very minimum tolerance for overload, they generally cause the GFI to trip, which is its designed purpose. Therefore, we recommend that you do not use these outlets for your refrigerator or freezer. In most cases when improvements are performed in bathrooms and kitchens, GFCIs must be installed even though the structure may not have been equipped with GFCI receptacles when it was initially constructed. The bathrooms are suggested to possess at least one 20amp circuit in accordance with minimum building standards - NEC 2014 §210.8. Local jurisdictions to some extent, may offer a different version of this standard.

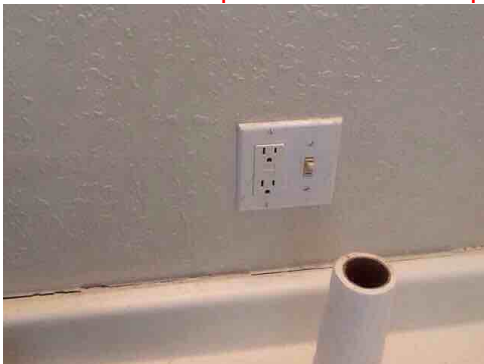
269: - A ground fault circuit interrupter (GFCI) outlet in the garage kitchen did not respond correctly when tested. This receptacle should be replaced as a safety precautionary measure.

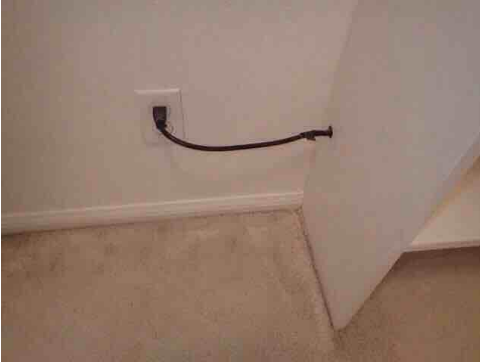
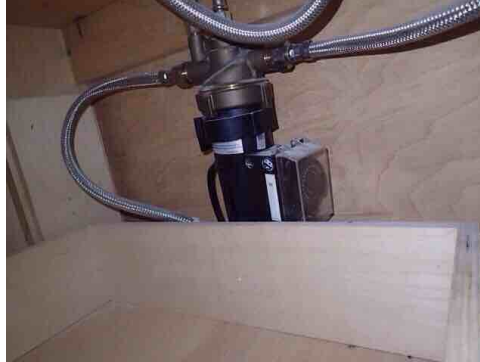
275: - The circulator under the sink in the master bathroom is plugged into a receptacle in the closet. The wiring is subject to physical damage in its current state. Improvements are recommended.

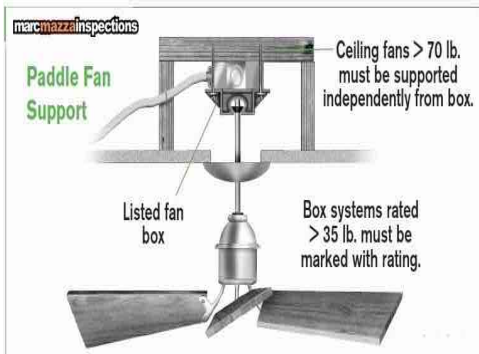
277: - We were unable to determine if the ceiling fans were installed with the appropriate junction box in accordance to manufacturer's / building standards.

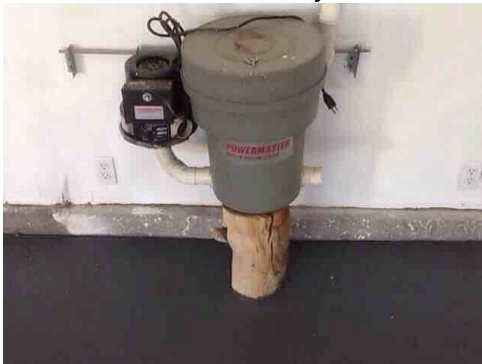
284: - The central vac system is resting on a log, which may not be a suitable base.

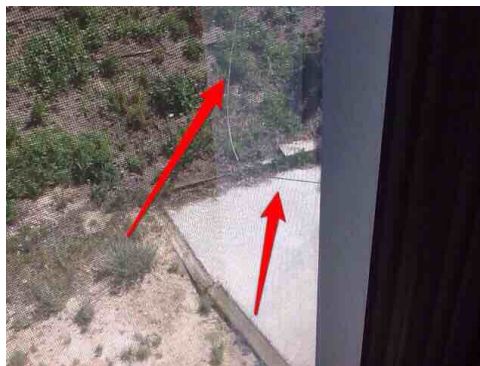
311: - **The window located in master bedroom is cracked / broken. Improvements are recommended for obvious safety purposes.**

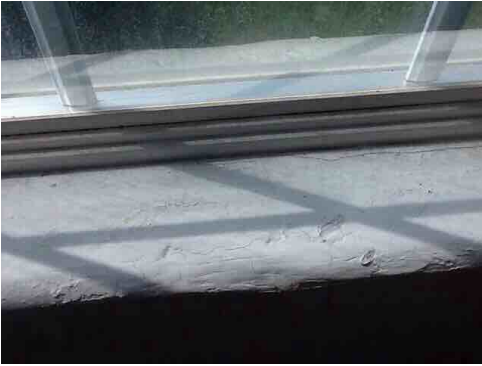
315: - The sill in the living room is damaged / cracked and may suggest the drywall has suffered moisture intrusion or damage.

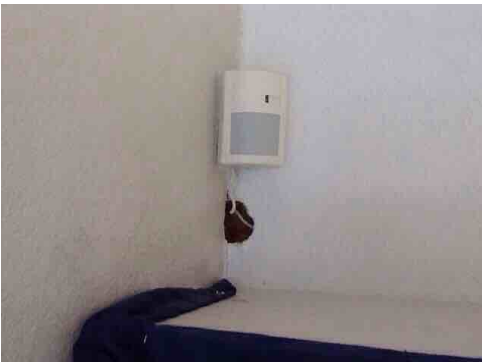
322: - A hole was observed in the wall in the living room at the time of the inspection.

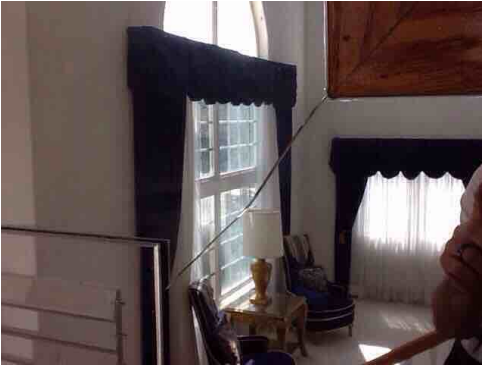
323: - The mirror in the front entry is cracked and should be repaired for safety purposes.

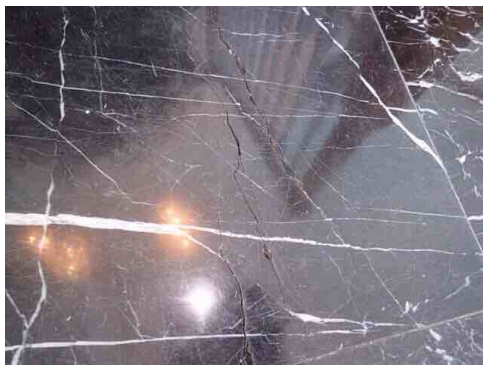
331: - There were cracked floor tile observed at the interior flooring in the front entry. We cannot view under the tile and, as a result, we are unable to determine the reason for the cracking (e.g. cracked concrete slab).

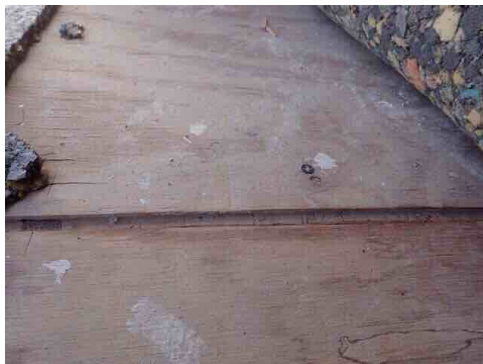
333: - There is an area in the loft where we noted uneven flooring. Upon lifting the carpet, we noticed the subfloor is uneven and is not level with the adjacent piece. Further evaluation is recommended by a licensed general contractor who can determine the cause for this and make recommendations for repairs.

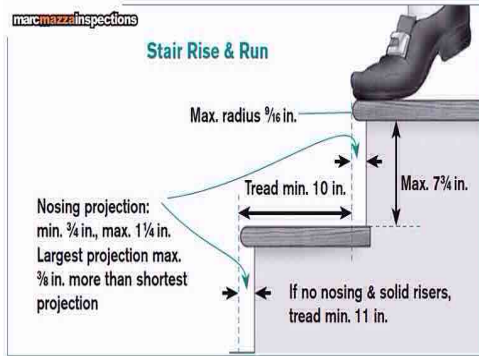
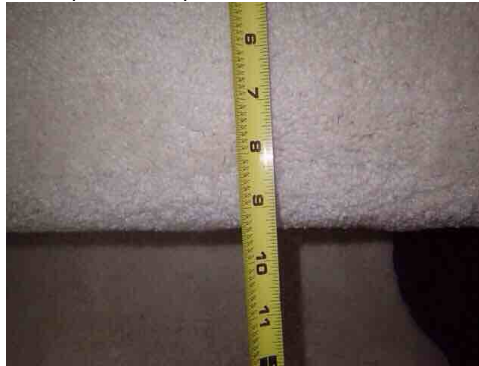
335: - The treads in the north stairwell are not uniform and could prove to be a trip-hazard. The treads are those components on which a person steps, and which, for safety reasons, should be a minimum of 10 inches.

Code Reference R311.7.4.2 Tread Depth

The minimum tread depth shall be 10 inches (254 mm).

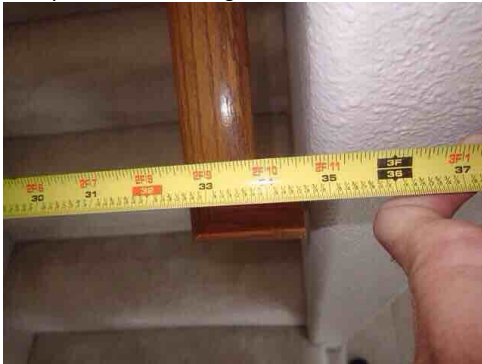
336: - The width of the north stairwell appears to be smaller than what current building standards require (3 feet) - 2012 IRC §311.7.1.

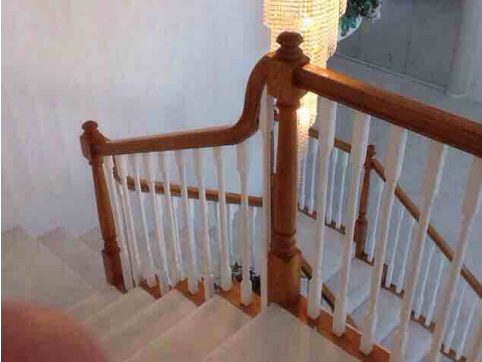
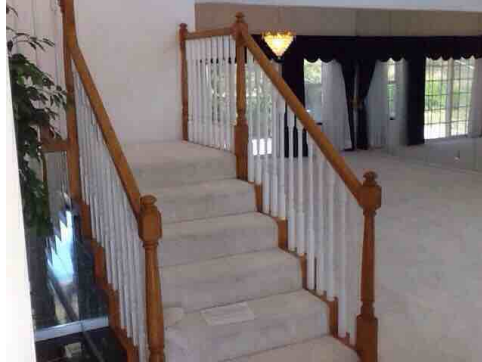
338: - The balusters in the stair rails are loose and suggested to be serviced for safety.

339: - The stair railing is loose, and is suggested to be serviced. The 2000 IRC (IRC Table R301.5) and other typical building codes requires that a guardrail or a handdrail be able to resist a 200-pound concentrated load applied along the top in any direction, while some local codes still in effect specify a smaller load of 20 pounds per linear foot. We suggest the buyer contact the local building and safety for the local jurisdictional standard.

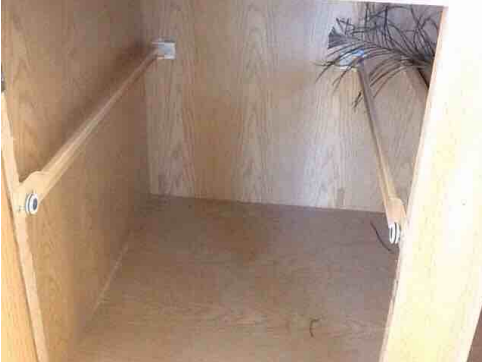
340: - There are missing drawers at the cabinets in the loft.

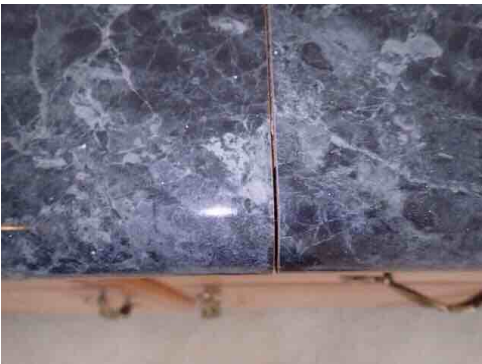
341: - The counter top in the loft has a gap between the two pieces which may suggest an amateur installation.

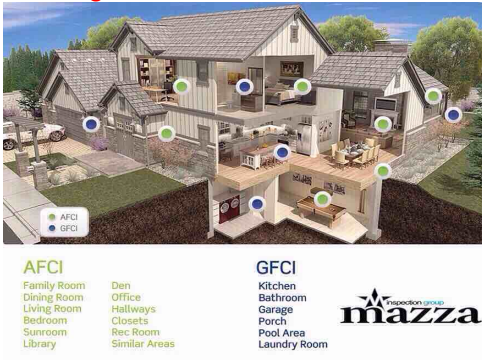
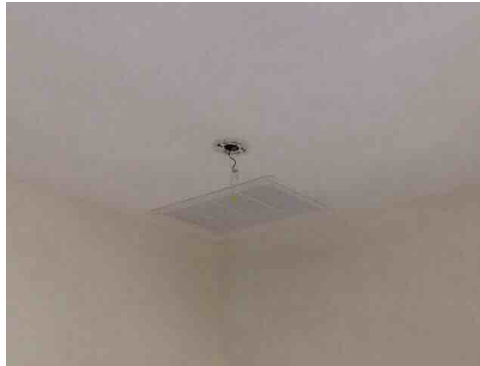
344: - A smoke detector is missing from the upstairs loft and is recommended to be installed per local building standards.

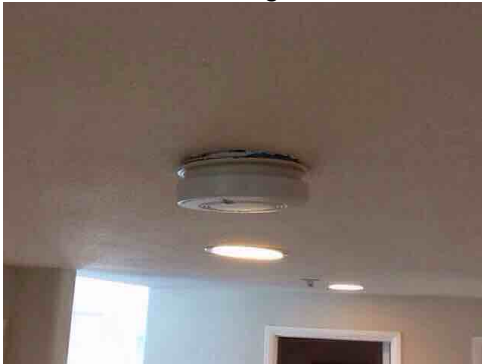
346: - The smoke alarm junction box in the downstairs hallway is installed low and is suggested to be better secured in the ceiling.

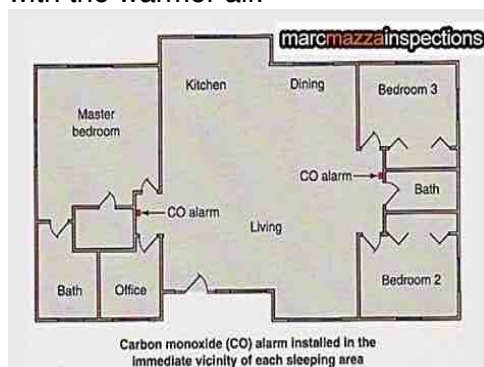
349: - There are no carbon monoxide detectors present, or installed in accordance to building or manufacturer's standards. A carbon monoxide detector is required to be installed in accordance to manufacturer's or local building standards.

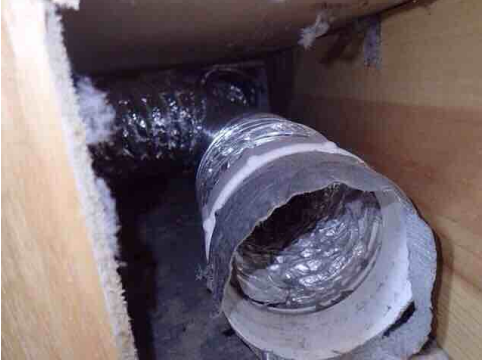
357: - The dryer duct is a flexible type that is suggested to be replaced with a smooth wall vent.dryer
Section 504.3.2.1 Clothes dryer vent ducts shall be metal and shall have a smooth interior surface.
An approved “flexible duct connector” of not more than 6 feet in length may be used to connect the dryer to the dryer vent pipe. “Flexible duct connectors shall not be concealed within the construction.” (Flex duct connectors shall not pass into or through a concealed space. This includes cabinets, walls and attic spaces).

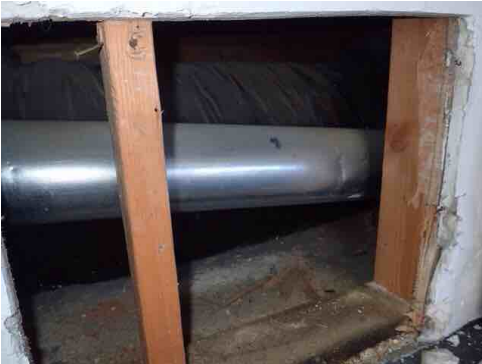
358: - The gas dryer vents incorrectly through a return-air compartment. This could contaminate the return-air compartment with the bi-products of combustion, and the should be isolated or rerouted. We fell it prudent to note that there is in fact an isolated return air duct which may or may not allow contamination of the interior if such a leak of the dryer duct exists.

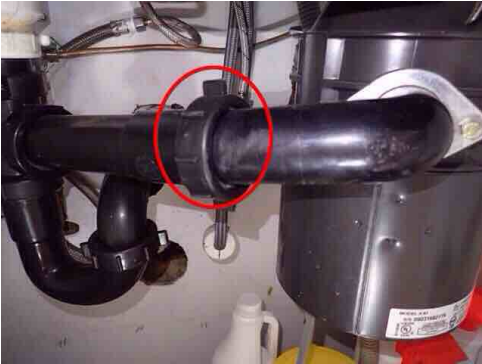
369: - The garbage disposal tail piece is loose where it connects to the plumbing. No leaking was observed, however, securing the plumbing is recommended to prevent a leak.

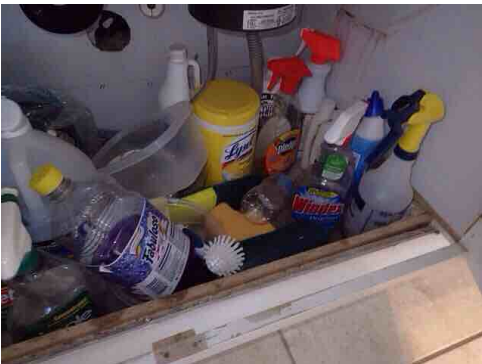
373: - The sink cabinet is missing the bottom. This may suggest previous damage to the cabinet. Repairs are recommended.

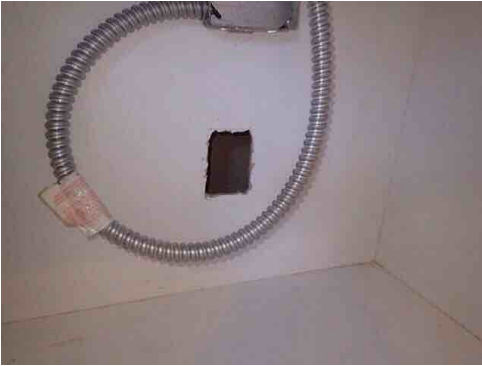
374: - There is a hole in the cabinet under the cook top that is suggested to be sealed.

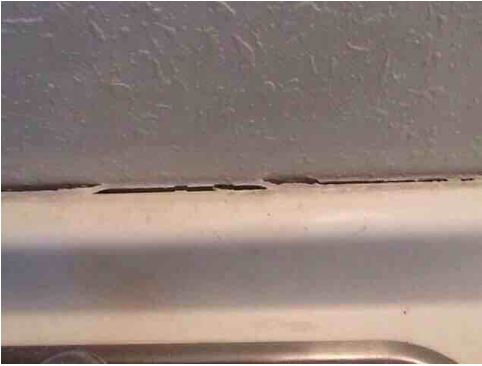
385: - A typical separation between the kitchen counter top backsplash and wall should be grouted or caulked to forestall moisture intrusion.

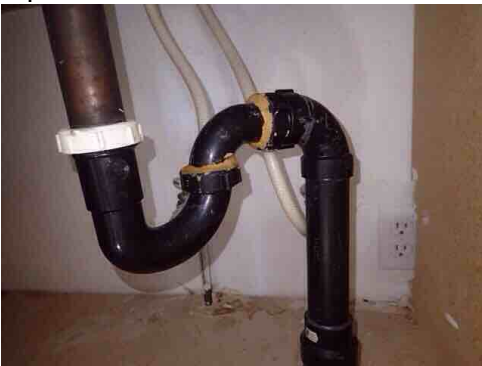
389: - There is evidence of corrosion on the drain below the sink. This may be evidence of prior leaks / problems.

390: - An improper "S" trap was noted. These types of traps are not allowed and are suggested to be replaced.

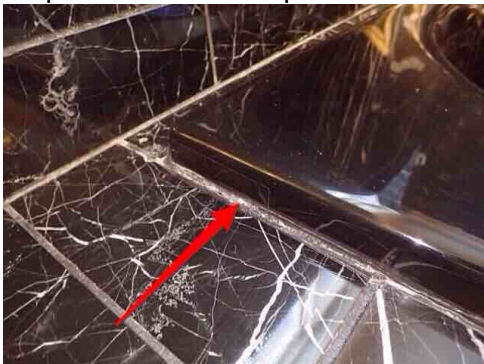
400: - It was noted that caulking was needed at the tub to platform connection in the bathroom as prevention for possible moisture penetration.

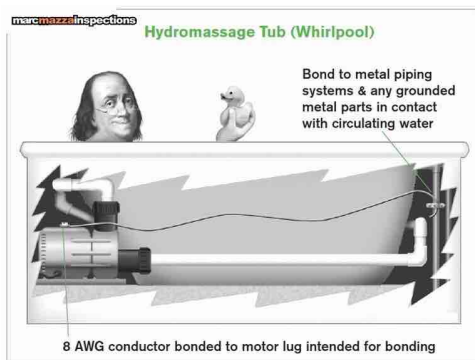
402: - Upon inspection of the spa motor, we were unable to verify a bonding conductor attachment to the pump and interior piping due to inaccessibility. Verification of the bond is recommended prior to use of the spa tub.

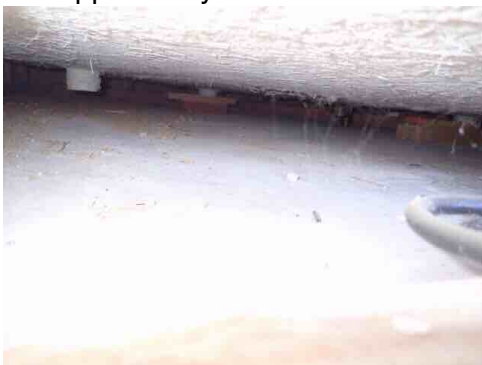
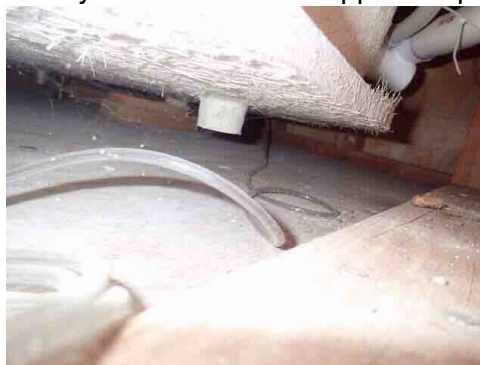
404: - The spa tub does not appear to be sitting on a poured masonry mix material. The tub appears to only be supported by a few wooden blocks and may need additional support. Improvements are recommended.

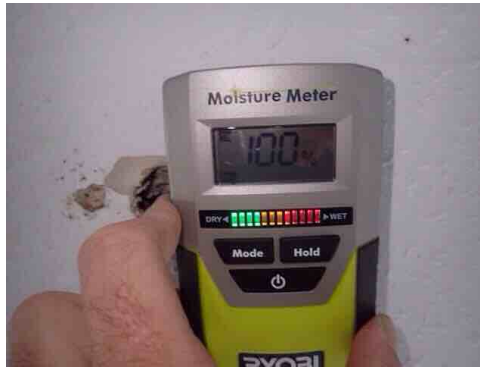
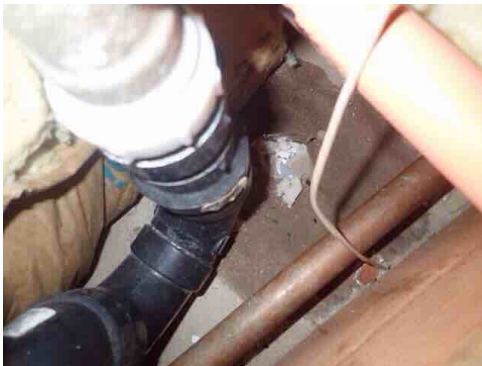
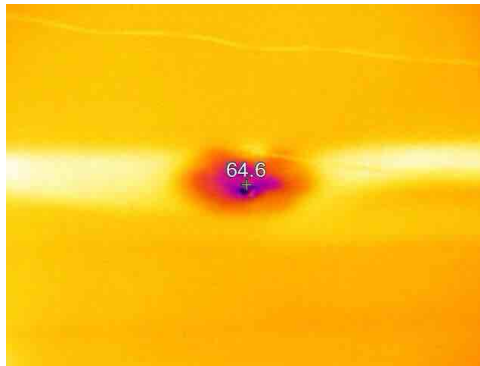
422: - The bathtub drain pipe was leaking at the time of the inspection. The leaking noted appears to be from under the tub. Repairs are recommended.

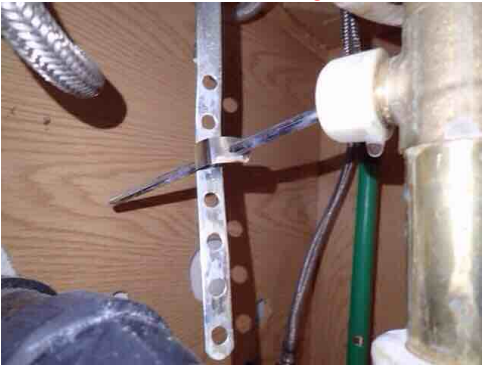
429: - The sink plumbing leaks when tested. Repairs are recommended.

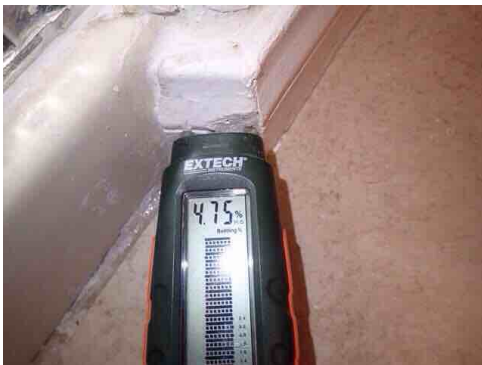
444: - Moisture was observed in the wall directly next to the shower. The moisture appears to be leaking from the tile bench portion of the shower. Repairs are suggested so the shower enclosure may function properly. Further assessment is advised.

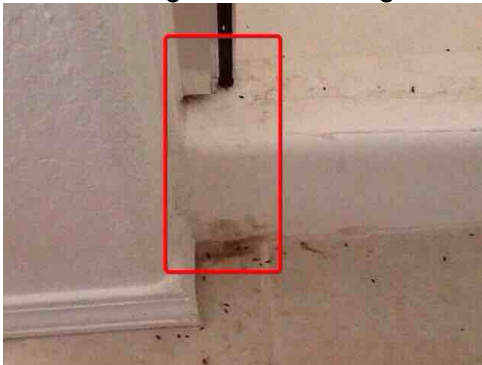
451: - Discoloration and / or moisture was observed around the shower glass enclosure which suggests a point of moisture penetration. Repairs are recommended at this location to prevent possible moisture damage to the flooring or wall covering material.

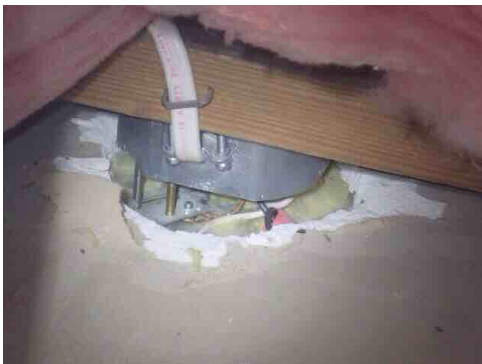
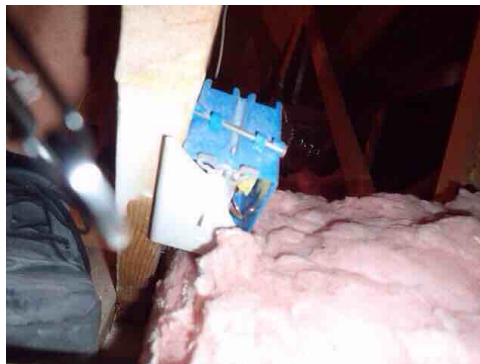
458: - There are open electrical junction boxes within the attic, which should be sealed so that any arcing or sparking would be contained within the box. Improvements are recommended as a safety precautionary measure.

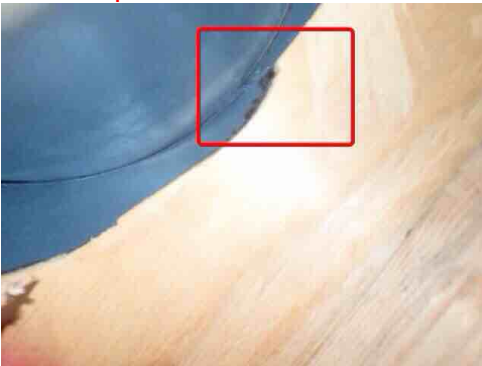
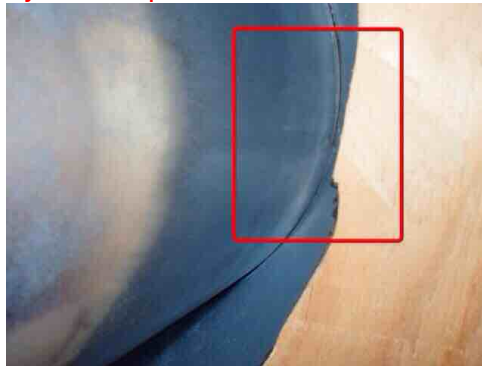
462: - The vent pipe of the factory built fireplace vent is too close to combustible material according to the listed requirements located on the chimney flue. Repairs are recommended for safety.

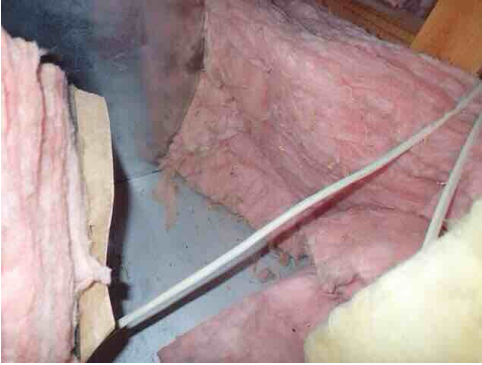
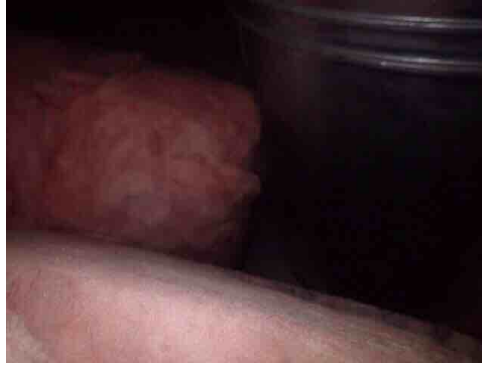
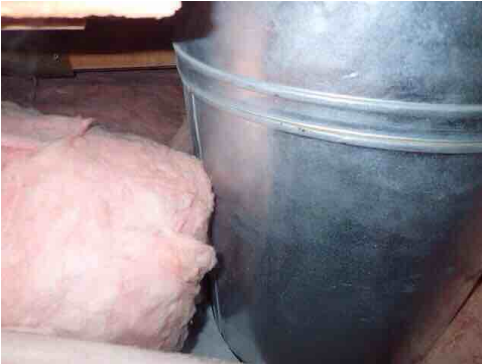
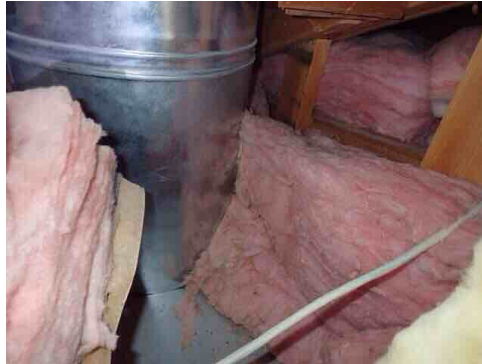
463: - Attic insulation was observed in direct contact with the chimney flue. The contact of batt insulation has been known to create pyrophoric conditions, thereby, reducing the ignition temperature of combustible materials, which may also be in direct contact with the insulation, resulting in fires. This insulation is suggested to be removed in order maintain all clearances mandated by the manufacturer. Further assessment is advised.

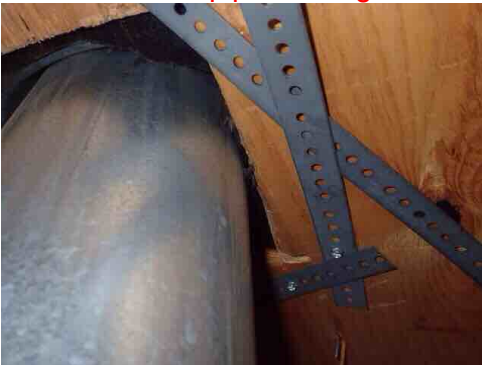
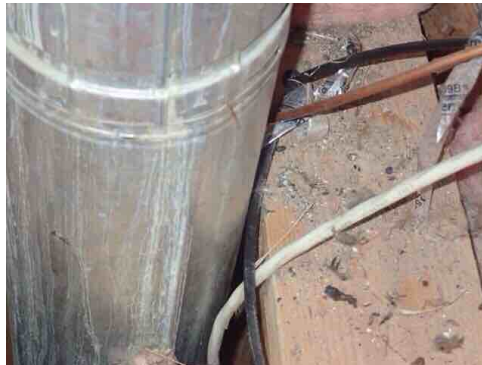
464: - The vent pipe of the gas fired appliance is too close to combustible material, and should be serviced.

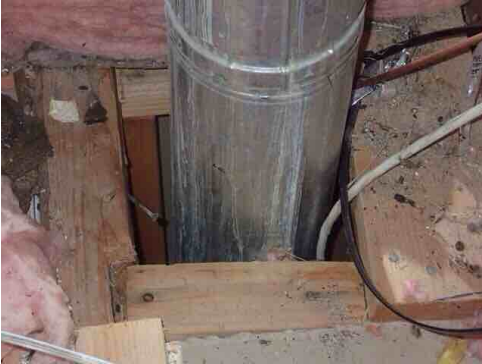
465: - The fire stop / blocking is incomplete around the flue vent as pictured, when viewed from the attic. Building code stipulates that fire stop / blocking be placed at every floor level, ceiling / attic or at a minimum of 8 or 10 feet.

Note: Insulation is not a fire-stop replacement or substitute due to the potential heat transfer capabilities. Only an approved material is suggested in this location. Code Reference CRC R302.11 Fireblocking
In combustible construction, fireblocking shall be provided to cut off all concealed draft openings (both vertical and horizontal) and to form an effective fire barrier between stories, and between a top story and the roof space.

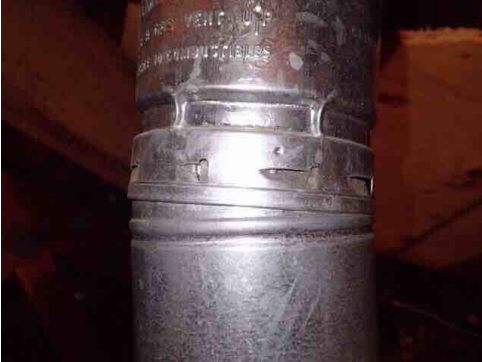
471: - The vent pipe appears to be separated, which will allow the bi-products of combustion to contaminate the residence. It should be repaired by an HVAC contractor before the furnace is used.

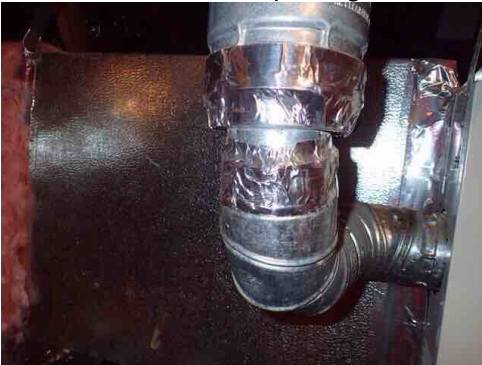
472: - The vent was wrapped in a metal tape therefore, the vent was not fully visible for inspection. Vent piping is suggested to be tightly assembled therefore not needing any auxiliary sealant such as tape. Furthermore, many manufacturers do not approve of the installation of this material on their venting systems as a means to seal openings.

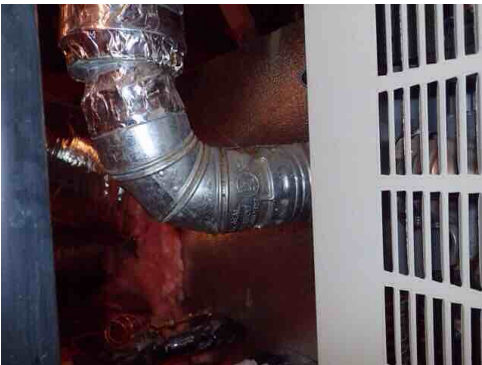
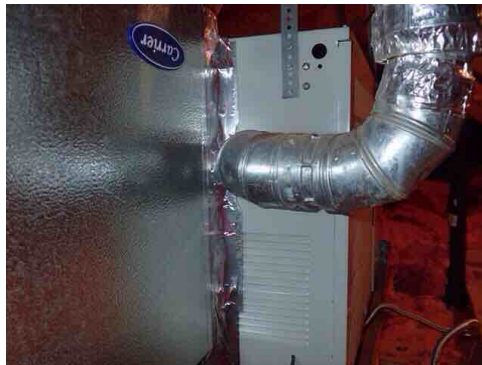
473: - The vent pipe has a negative pitch, which could hinder the bi-products of combustion from being vented beyond the residence, and which could contaminate the residence, and should be serviced by an HVAC contractor.

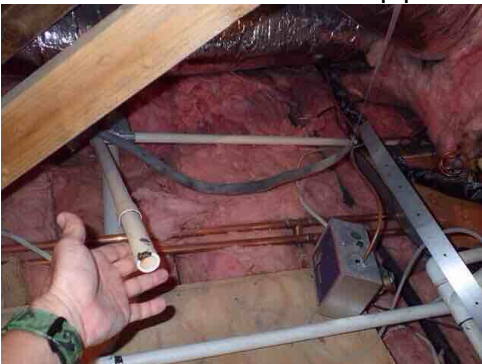
481: - The condensate drain pipe for the pan was disconnected at the heating unit.

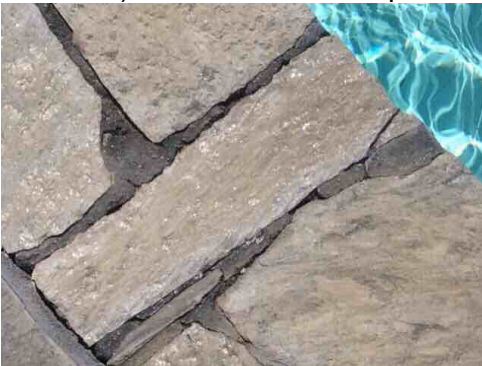
530: - The coping masonry materials should be re-pointed (replacement of the mortar between the coping materials) in various areas to prevent further deterioration and evade further damage and cost as a result.

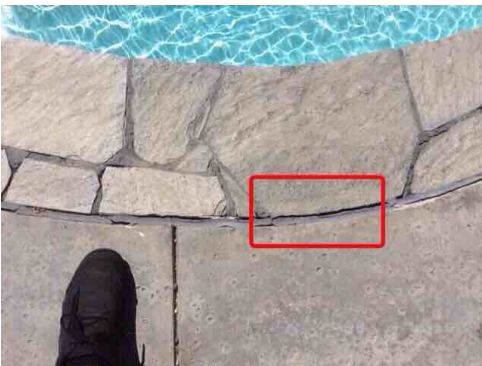
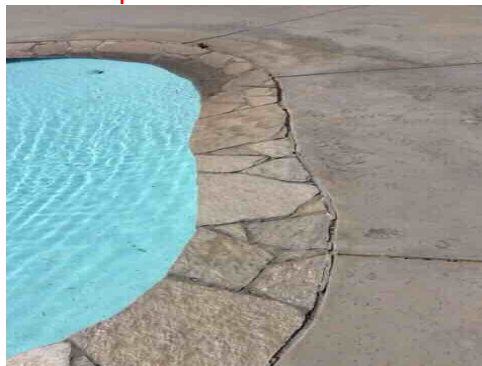
531: - The caulk in the expansion joint (elastomeric seal) of the pool deck has cracked. This should be resealed to forestall moisture intrusion below the pool deck.

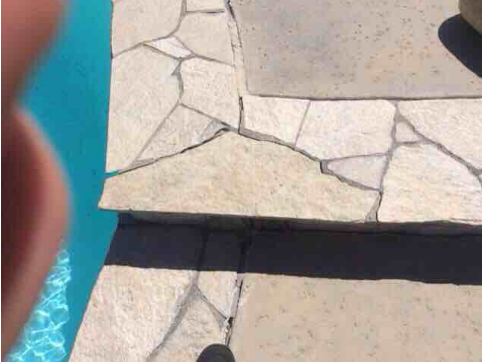
532: - We observed loose coping materials at the pool. Improvements are recommended and should be carried out by a qualified licensed individual.

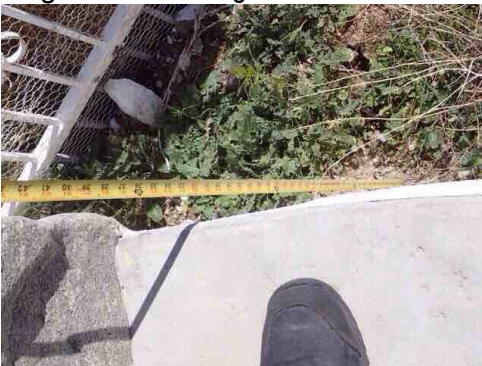
536: - Due to the height of the deck surface above grade, (+ 30"), a railing system is recommended to be installed as a safety precautionary measure. Small children and elderly may be subject to injury due to the height. IRC 2012 §312.1.

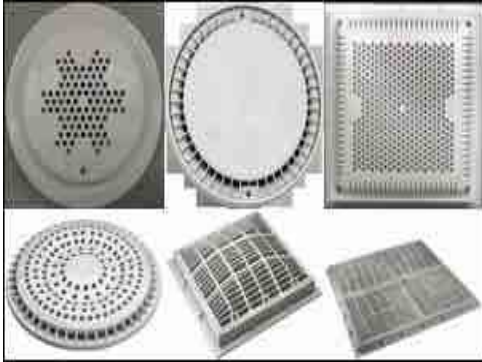
541: - Recently, there has been a recall on anti- entrapment type grid drains. We suggest the buyer visit this web site for additional information to determine if this drain falls into this category prior to use of the swimming pool and / or spa. <http://www.cpsc.gov/cpscpub/prerel/prhtml11/11230.html>

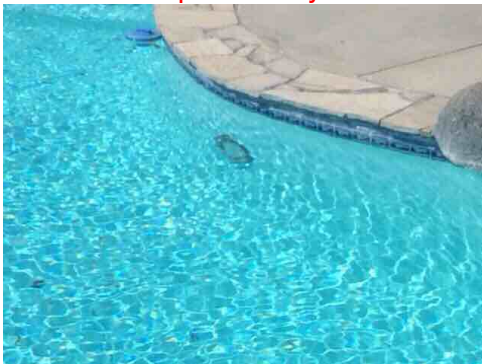
543: - The pool light did not respond when it was tested. The light is suggested to be serviced by a professional, confirmed to have ground-fault protection and demonstrated prior to use of the pool / spa.

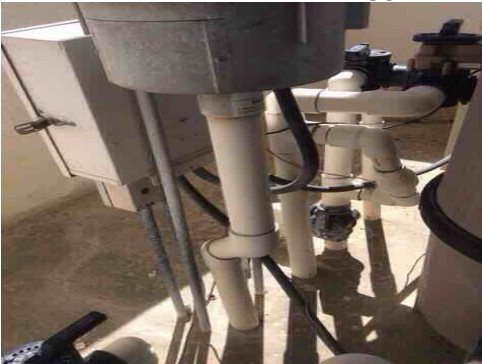
548: - We did not locate a "visible" bond wire for the blower. For a complete examination of this condition, including any potential repairs, we suggest further assessment by a professional pool contractor prior to the close of escrow.

549: - The pool blower is suggested to possess a check valve.

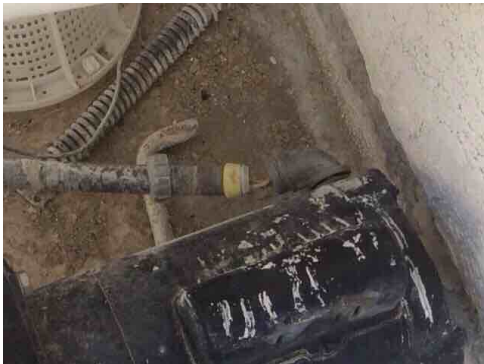
557: - A flexible metal conduit in the blower pool equipment is loose and disconnected from the pump and is recommended to be serviced.
