Property Inspection Report

XXX

Thursday, February 26, 2015

Inspector, Marc Mazza
Mazza Inspection Group
(866) 996-2992
info@mazzainspections.com

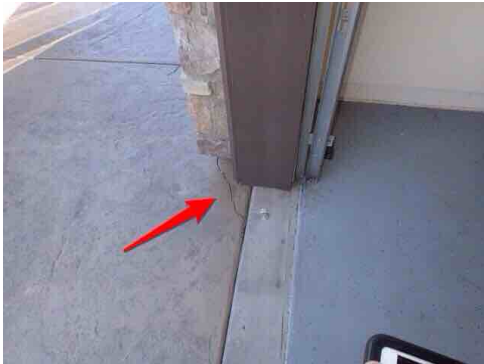
14: - Cracks were noted at the driveway. This implies that movement and or settlement has occurred, which is typical with concrete slabs. Sealant is recommended on the driveway to prevent further damage and should be performed on a regular basis to prevent extended wear. We recommend that this condition be monitored and further evaluated by a qualified contractor if the buyer so chooses, or if any sign of significant movement is observed.

15: - Areas of the driveway surface have settled. These areas are suggested to be addressed as necessary by the appropriate trade or craftsman.

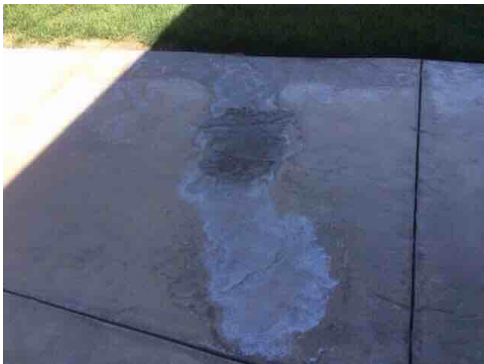
16: - There is efflorescence, or salt-crystal formations, at various points on the driveway. Such efflorescence is relatively common and is activated by moisture, but has only a cosmetic significance unless substantial loss of material has occurred.

17: - The driveway has moisture staining, which may indicate ponding or poor drainage. In time, this condition can accelerate the wear and deterioration of the concrete. Moisture should always run away from the structure.

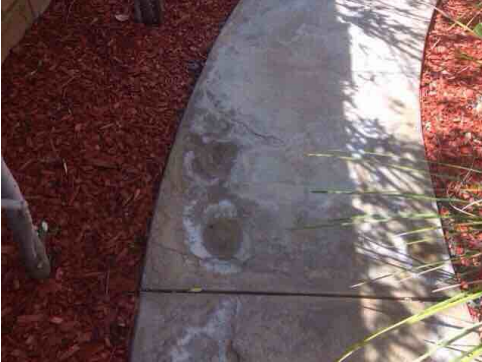
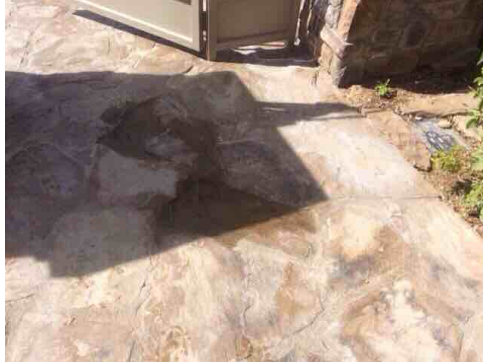
19: - The sidewalks show evidence of moisture staining as well as standing water, which may indicate chronic ponding or poor drainage. In time, this condition can accelerate the wear and deterioration of the sidewalk.

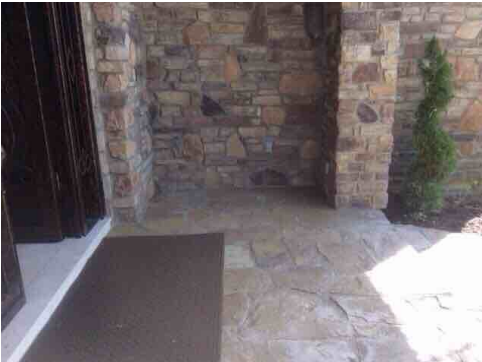
22: - The porch surface material is high at the foundation, which does not allow a complete inspection of the foundation. Furthermore, moisture may penetrate beyond the slab into the interior wood framing members via the weep screed flashing (or under a house with a crawlspace). Sealant is recommended to be installed at the slab to foundation connection(s) as preventative maintenance - IRC 2012 §703.6.2.1.

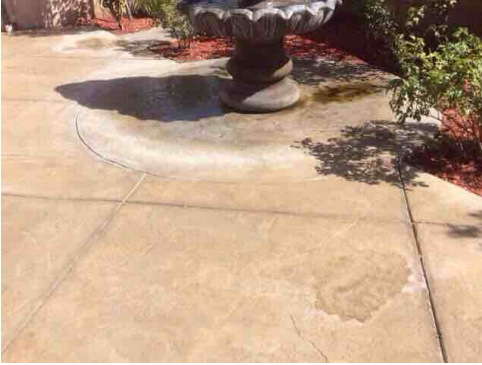
24: - Cracks were noted at the patio(s). This implies that movement, such as settlement, has occurred. Sealant is recommended on the patio cracks to prevent further damage. This should be performed to prevent extended wear. We recommend that this condition be monitored and further evaluated by a qualified contractor if any sign of more significant movement is observed.

25: - The patio surface shows signs of poor drainage or ponding judging by the stains present. Standing water poses a threat to the interior wood framing through the foundation weep screed if the wall is equal or lower than the slab. We recommend monitoring the drainage of the patio when moisture is present. Repairs may include the installation of drains.

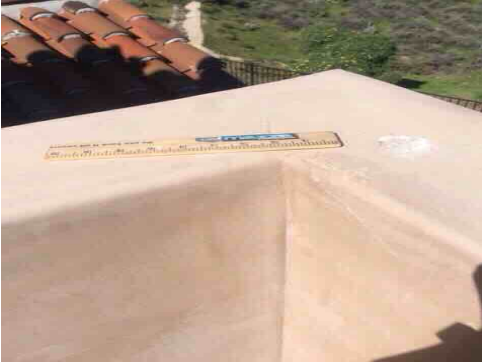
31: - Cracks were observed at the masonry clad parapet walls at the deck. The cracks are suggested to be serviced which may include sealing or parging of the crack to prevent moisture intrusion.

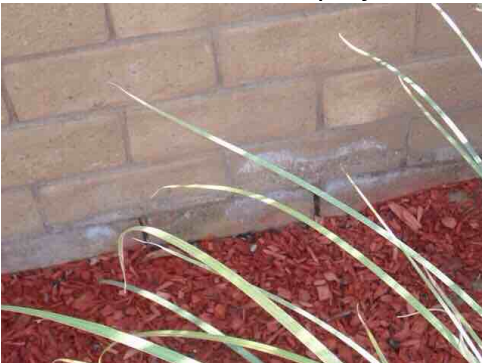
37: - Deterioration of the blocks in the block wall was noted at the time of the inspection. The wear may have been the result of over spray from the sprinkler system or moisture from the adjacent yard.

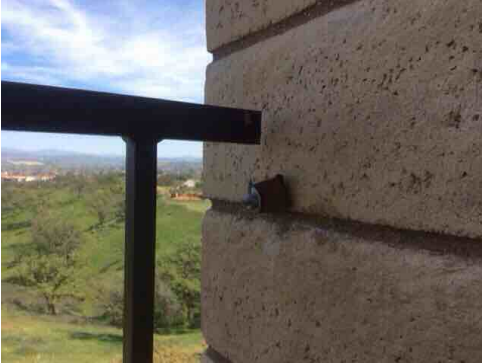
41: - The wrought iron fencing is detached from the block wall at the east side of the rear yard.

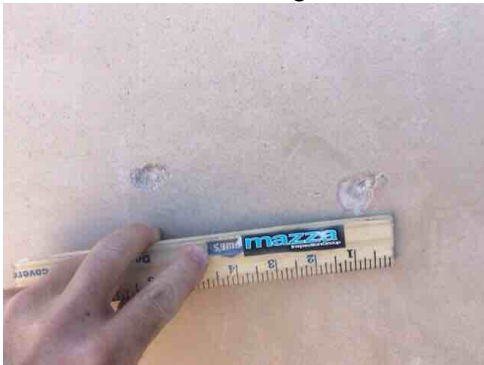
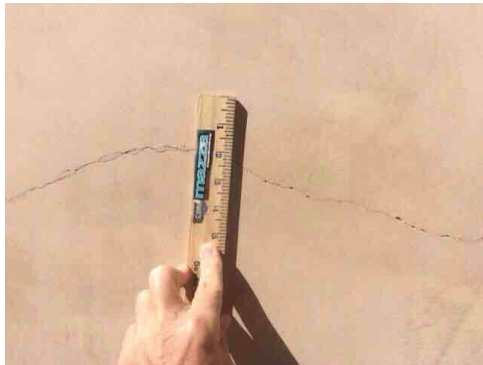
43: - The walls are clad with stucco or plaster in a smooth finish. We further noted that the finish was cracked in multiple areas around the perimeter of the structure as well as having "Pitts". The cracking may be the result of many things but commonly is related to the manner in which the materials were applied, the conditions under which the materials were applied or the lack of proper preparation of the materials. A professional masonry contractor is, however, the individual who may offer a definitive explanation as to the reason for this cracking.

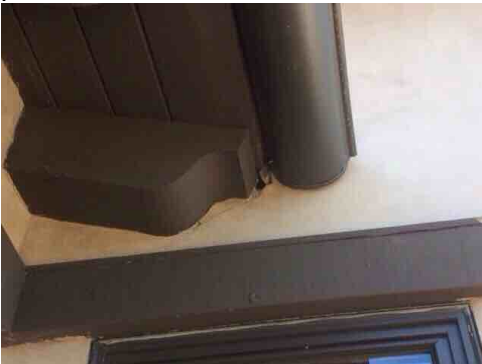
46: - There is missing stucco (holes, openings, missing covers, chips) noted at the exterior wall of the house. These openings may allow moisture to enter into the structure resulting in possible damage to interior wood framing members. In addition, openings in the stucco may also allow pests to enter and should be sealed as preventative maintenance.

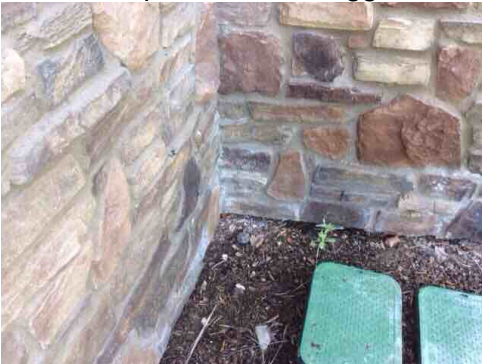
48: - The sprinklers are suggested to be redirected away from the building to prevent deterioration.

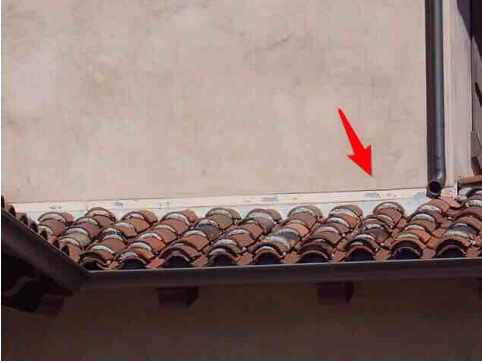
50: - There are areas of exterior trim where the paint / finish was observed to be generally fair condition with signs of being weathered and/or deteriorated. Regular maintenance type service is required to decrease the possibility of premature damage.

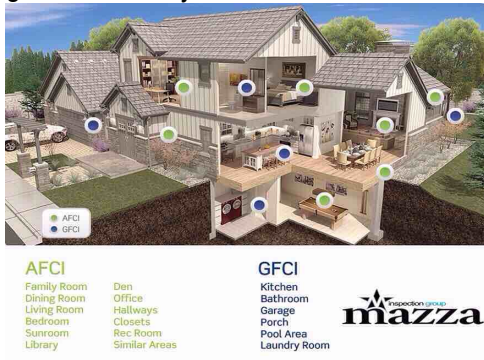
54: - All of the exterior outlets are suggested to have ground fault protection. Although, the installation of Ground Fault Circuit Interrupter (GFCI - a safety device for outlets close to any water) receptacles may not have been required to be installed at the time of this houses initial construction, however, they are now and because this new code is the most stringent, we feel it prudent that this is the code to follow. NEC 2014 §210.8 Local jurisdictions to some extent, may offer a different version of this standard.

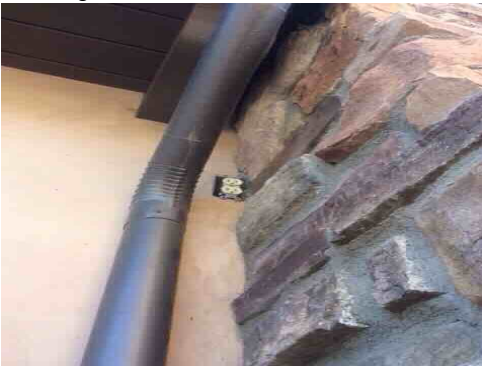
57: - There are receptacles at the deck that are missing their exterior cover plate(s). These special type cover plates are designed to keep moisture out of the receptacle replacement of these covers is suggested - NEC 2014 §406.9.

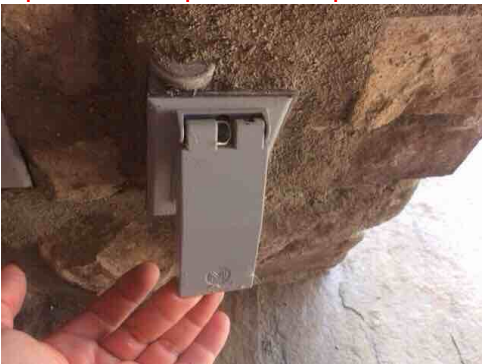
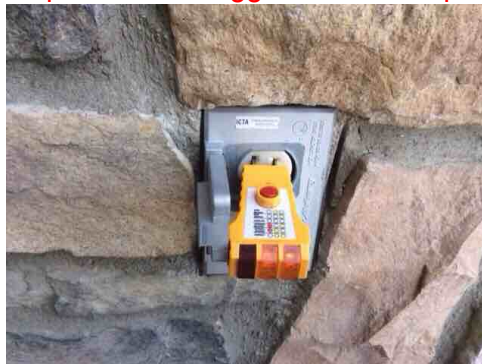
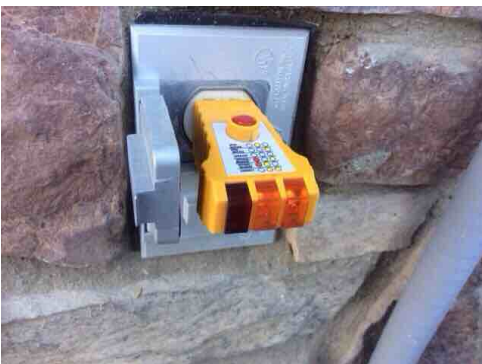
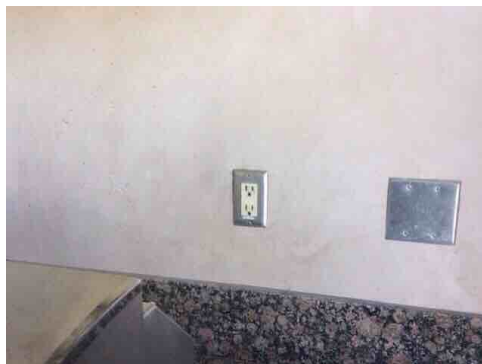
s-1: - The front porch, north side, east side rear, south side, upper deck ground-fault protected outlets did not trip or are not protected upon test. The receptacles are suggested to be repaired or replaced as necessary.

58: - The front porch, north side, east side rear, south side, upper deck ground-fault protected outlets did not trip or are not protected upon test. The receptacles are suggested to be repaired or replaced as necessary.

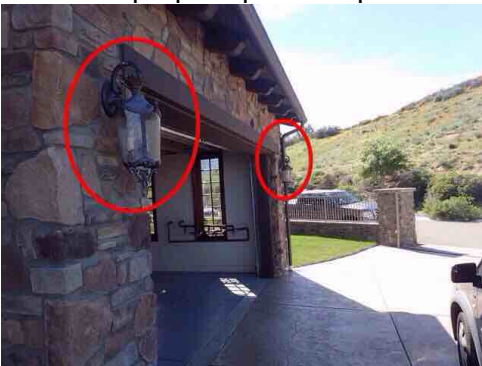
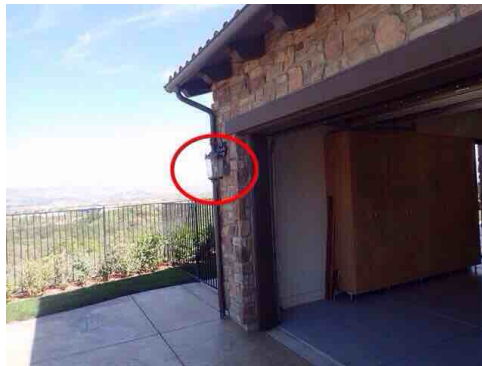
60: - The garage carriage exterior lights which were believed to have been tested, failed to operate. In many cases, the bulb is usually blown, however, it is recommended that the bulb be replaced and the fixture be tested for proper operation prior to the close of escrow.

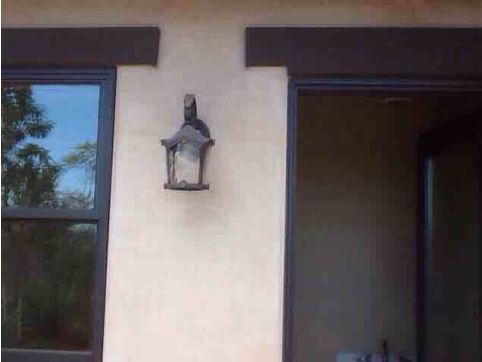
61: - The south side exterior light, failed to operate by the switch. In many cases, the bulb is usually blown, however, it is recommended that the bulb be replaced and the fixture be tested for proper operation.

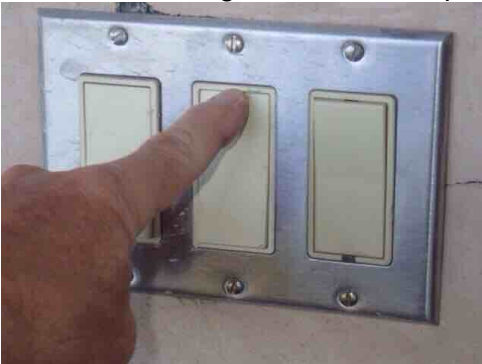
63: - There were exterior light switches (rear) that were tested but failed to operate any component. In many cases with lights, the bulb is usually blown, however, it is recommended that the bulb be replaced and the fixture be once again checked for proper operation prior to the close of escrow.

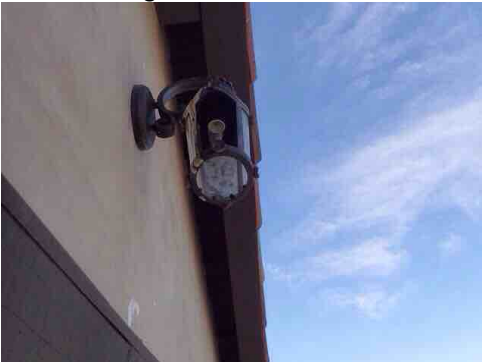
65: - The light fixture outside the second floor south bedroom is damaged and in need of repair.

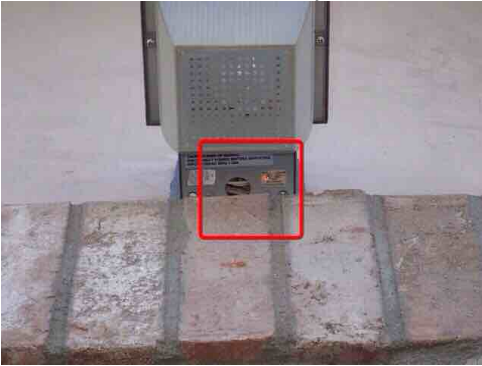
66: - The east rear side junction box has a knock out which is suggested to be covered for protection.

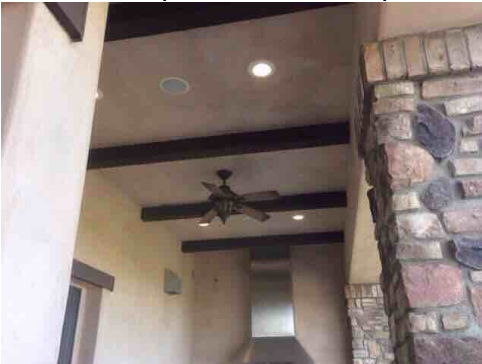
68: - The east exterior ceiling fan was not operational when tested. For additional information or an explanation regarding this condition, we suggest the buyer attempt to contact the current occupants or owners for specific details or perform other tests to rule out any latent defects.

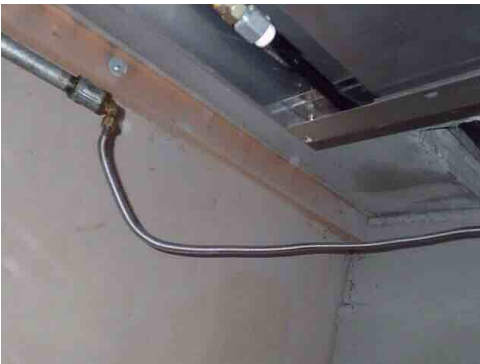
73: - The barbecue structure appears to possess wood within the structure, which is not suggested as wood represents a potential combustion hazard. The gas barbecue is not within the scope of the inspection and was not tested.

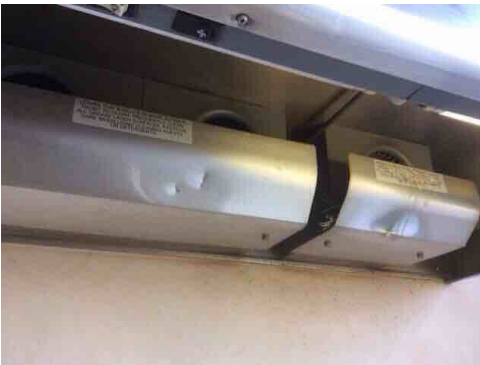
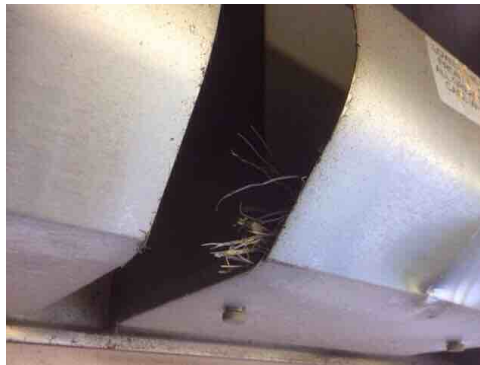
74: - We Observed cosmetic damage to the barbecue vent but the unit remains functional. We further observed a "nest" within the ventilation fan.

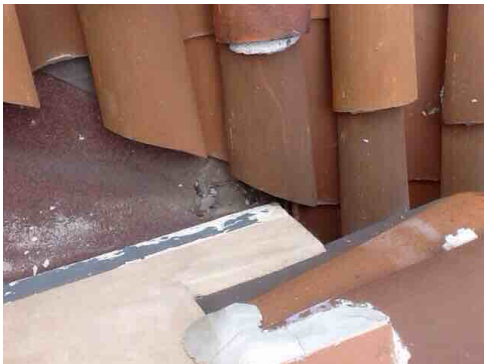
91: - There is debris in some of the cricket areas that should be removed to ensure proper drainage.

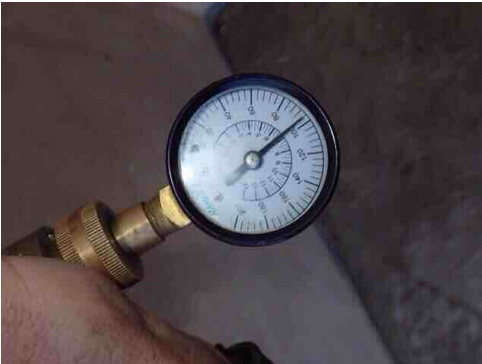
98: - As the static water pressure of the supply plumbing system exceeds 80 pounds per square inch (psi) it would be wise to (install) or adjust the pressure regulator. Otherwise, the plumbing system may be prone to leaks in piping, fittings or other equipment. The water pressure was taken from the nearest accessible hose bib or at the laundry.

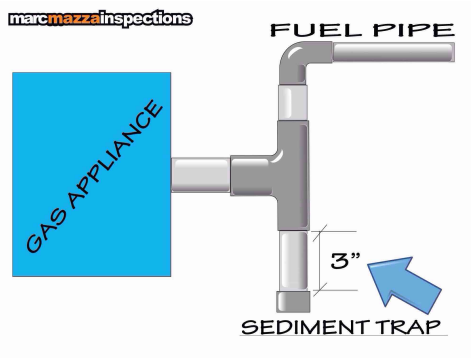
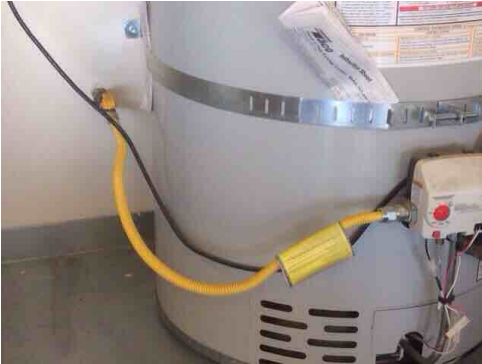
115: - There are missing sediment traps at all or some of the fuel piping installed prior to fuel burning appliances e.g. furnace, water heater. A drip leg, also known as a dirt leg, is there to protect the gas train and burner orifices from gas born water and dirt. In a clean piping system, with best quality gas supply, there will never be a need for this. Typically, systems develop some moisture from condensation, as well as some dirt or other contamination. Typically, the drip leg is 3-6 inches in length and prior to the appliance.

116: - 1212.7 Sediment Trap

Where a sediment trap is not incorporated as a part of the gas utilization appliance, a sediment trap shall be installed downstream of the appliance shutoff valve as close to the inlet of the appliance as practical at the time of appliance installation. The sediment trap shall be either a tee fitting with a capped nipple in the bottom outlet, as illustrated, or other device recognized as an effective sediment trap. Illuminating appliances, ranges, clothes dryers, decorative vented appliances for installation in vented fireplaces, gas fireplaces, and outdoor grills shall not be required to be so equipped - NFPA 54-09:9.6.7.

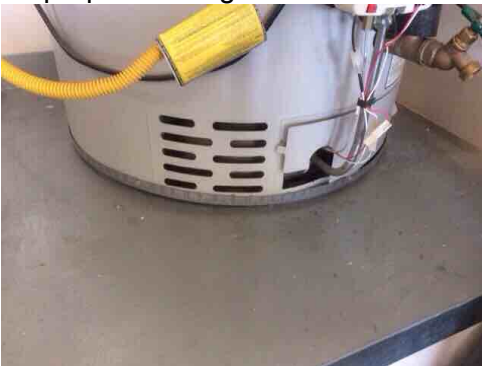
125: - The water heater should be located in an area where leakage of the tank or connections will not result in damage to the area adjacent to the water heater or to floors of the structure. Due to the normal corrosive action of the water, the tank will eventually leak after an extended period of time. It is recommended that a suitable drain pan be installed under the water heater. This pan is to protect the property from damage which may occur from normal condensate formation on the tank or leaks in the tank and pipe connections. The pan must limit the water level to a maximum depth of 2-1/2 inches and be two inches wider than the heater and piped to an adequate drain. Locate the water heater near a suitable indoor drain. Outside drains are subject to freezing temperatures which can obstruct the drain line. The piping should be at least 3/4 inch and pitched for proper drainage.

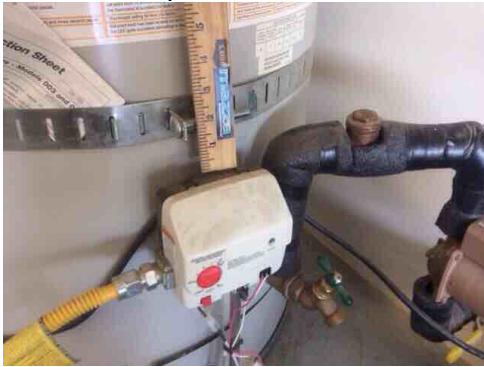
Code Reference CPC 508.2

Strapping shall be at a point within the upper 1/3 and the lower 1/3 of the water heater's vertical dimensions. At the lower point, a minimum distance of four (4) inches shall be maintained above the controls to the strap.

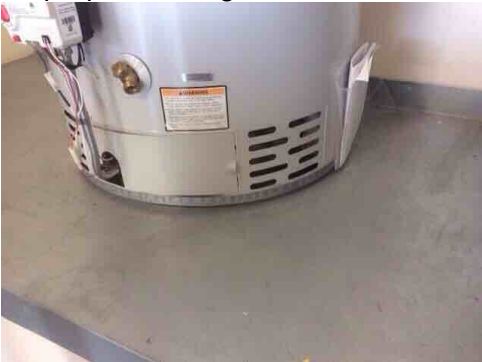
138: - The water heater should be located in an area where leakage of the tank or connections will not result in damage to the area adjacent to the water heater or to floors of the structure. Due to the normal corrosive action of the water, the tank will eventually leak after an extended period of time. It is recommended that a suitable drain pan be installed under the water heater. This pan is to protect the property from damage which may occur from normal condensate formation on the tank or leaks in the tank and pipe connections. The pan must limit the water level to a maximum depth of 2-1/2 inches and be two inches wider than the heater and piped to an adequate drain. Locate the water heater near a suitable indoor drain. Outside drains are subject to freezing temperatures which can obstruct the drain line. The piping should be at least 3/4 inch and pitched for proper drainage.

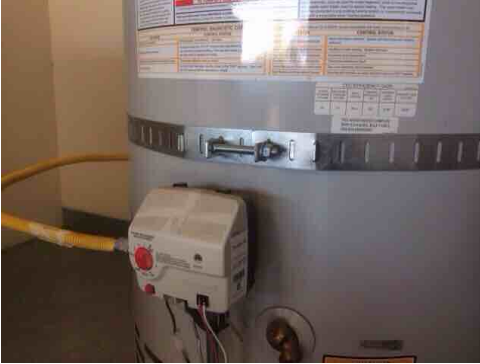
139: - The seismic straps appear to have been installed to meet minimum building standards.

Strapping shall be at a point within the upper 1/3 and the lower 1/3 of the water heater's vertical dimensions. At the lower point, a minimum distance of four (4) inches shall be maintained above the controls to the strap.

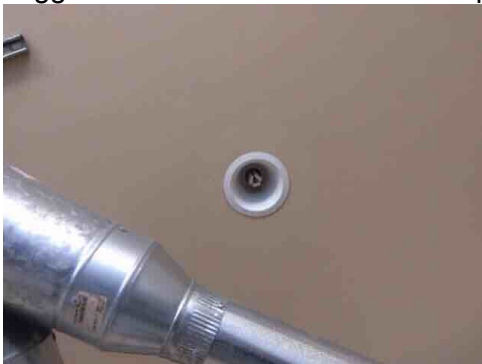
149: - There are recessed lights installed into the fire separation ceiling within the garage. This ceiling is suggested to be maintained with no penetrations except for those rated for such an installation.

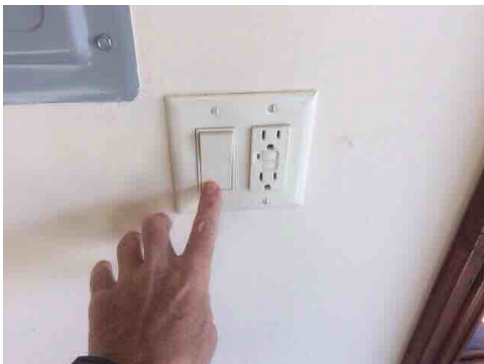
163: - There were light switches present for which the inspector could not determine what they energize. Further evaluation is recommended.

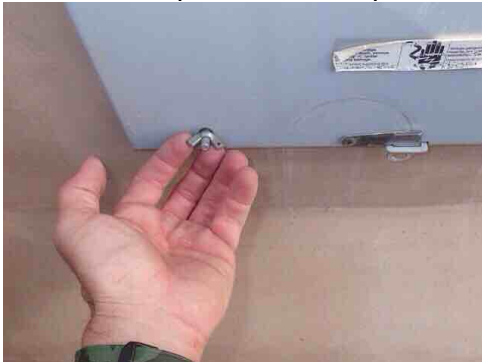
164: - The lock or tag is missing from the electric meter or service entrance panel cover. It is suggested that the local utility company be contacted for replacement. The tag may suggest work was performed within the main service panel for example, a new main breaker may have been added.

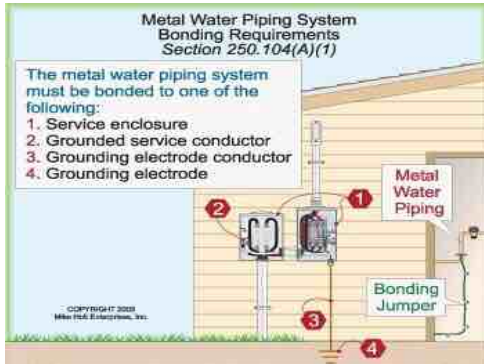
177: - We were unable to verify a cold (and hot) water bond at the main water supply, or supply piping. In accordance to building standards; the bond is suggested to be installed in or attached to a building structures metal piping system(s) including hot water, cold water and the gas piping, that are likely to become energized. These aforementioned components should be bonded to the service equipment enclosure in accordance to building standard. The bonding jumper(s) should be sized in accordance with the NEC, using the rating of the circuit that is likely to energize the piping system(s).

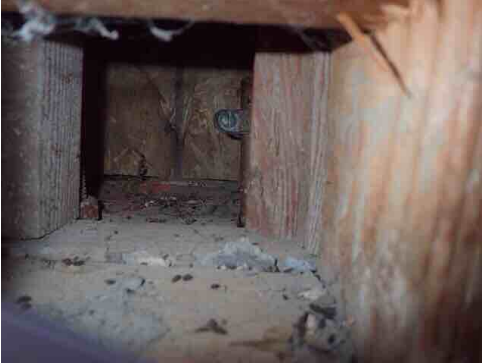
179: - The second GEC / GES was not accessible to verify.

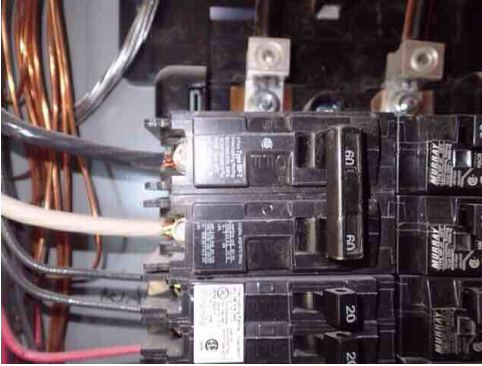
212: - The sub panel box is over fused (fuse or breaker is too large for wire size). The ampacity of a wire is based on the temperature rating of its insulation. Therefore, and according to this rule, the breaker size is in this situation is 60 amps and the conductor size is 8 AWG. This is incorrect and according to this NEC rule, this make up is considered over fused.* Under limited circumstances, such as motor circuits and HVAC equipment, the amperage rating under these conductors may be higher based on section 310.16 of the National Electric Code.

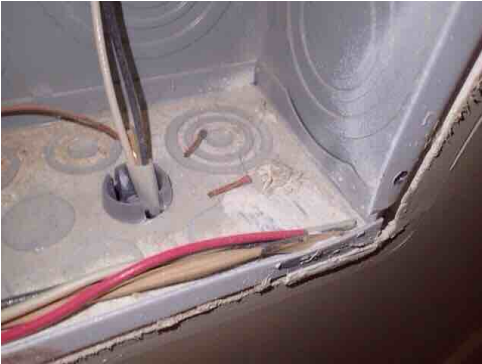
214: - There is exposed wiring that was not properly terminated or is loose in the panel. Wires should be properly terminated with wire nuts to prevent the possibility of contact with other wiring inside the panel.

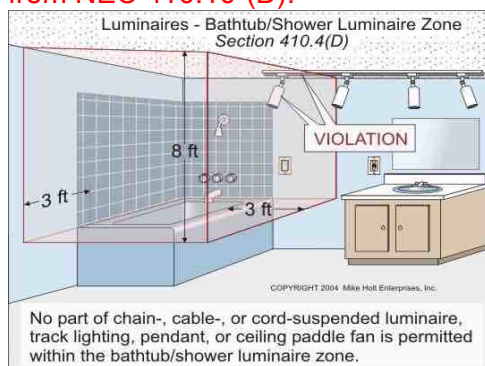
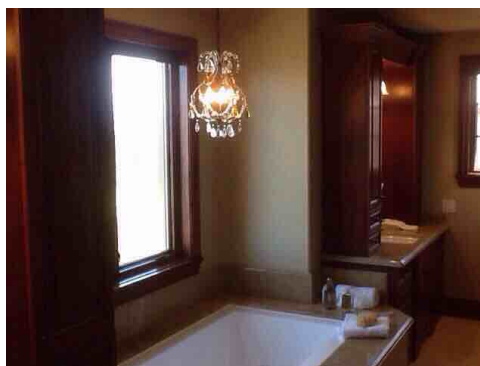
222: - The ceiling lights installed in the second floor south bedroom bathroom does not possess a wet type fixture trim kit and appeared to be installed within the 8 x 3 shower spray zone of the shower enclosure. For some older structures, this may not have been a code requirement, however, improvements are always suggested as old or new code is the minimum standard and is always suggested to be exceeded - Reference from NEC 410.10-(D).

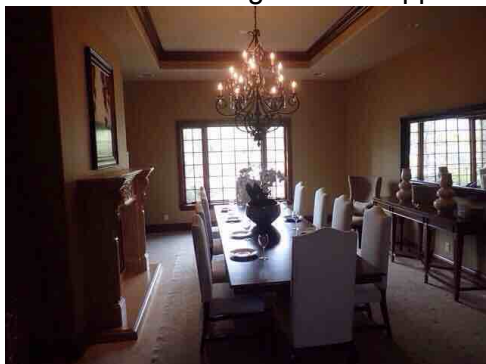
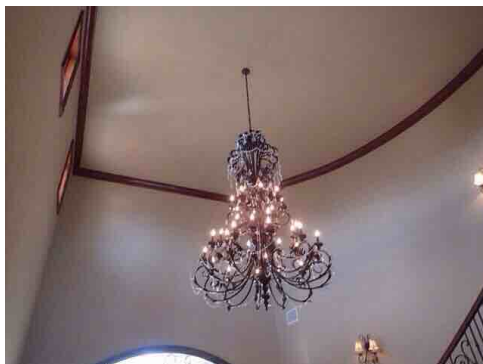
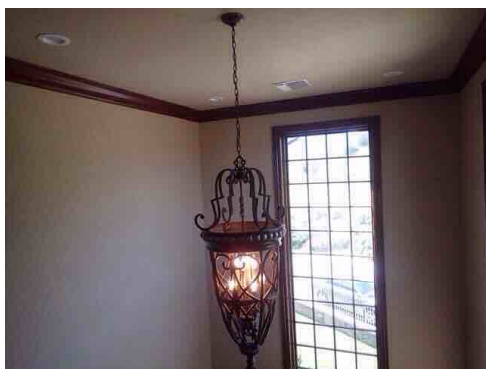
223: - The light fixtures pictured, appear to be somewhat larger than typical and thus, may weigh much. The junction box is suggested to be verified to withstand the weight of the light fixture. The weight limit of junction boxes is limited to 50 pounds.

(B) Maximum Luminaire (Fixture) Weight. Outlet boxes or fittings installed as required by 314.23 shall be permitted to support luminaires (lighting fixtures) weighing 23 kg (50 lb) or less. A luminaire (lighting fixture) that weighs more than 23 kg (50 lb) shall be supported independently of the outlet box unless the outlet box is listed for the weight to be supported.

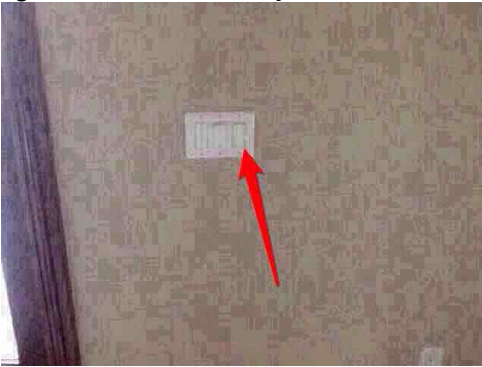
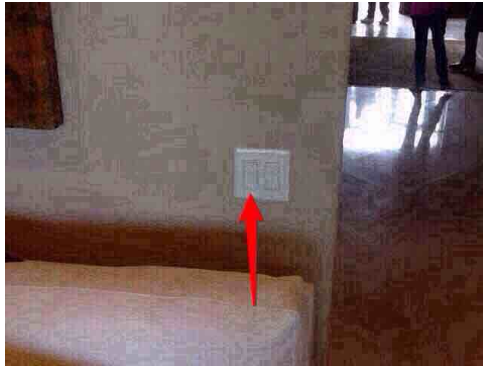
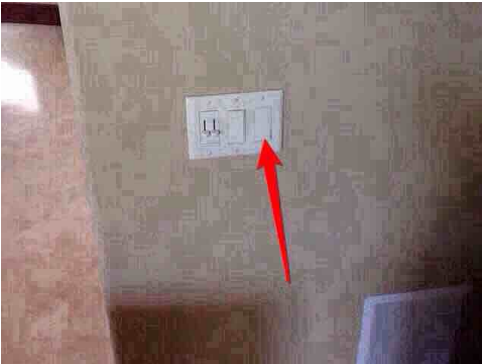
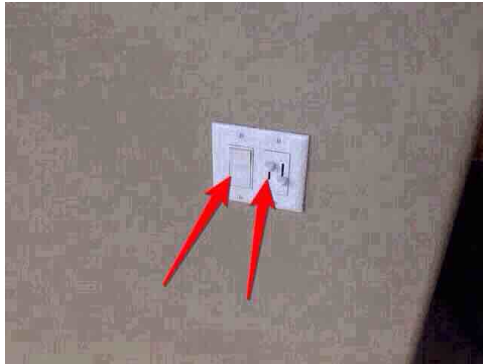
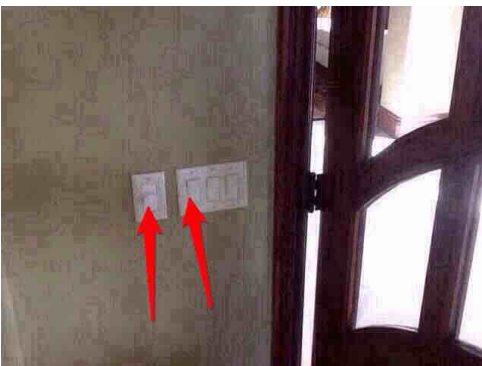
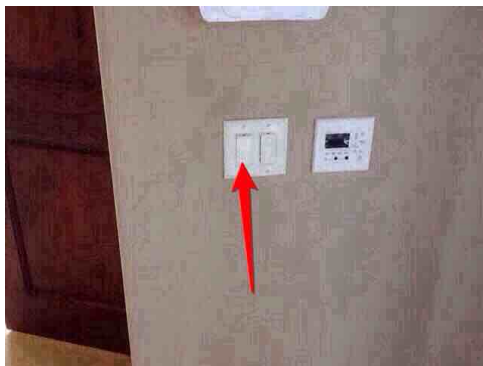
226: - The inspector was unable to determine the function of multiple light switches, throughout the house (first floor south bedroom, family room, formal living room, office, front entry, kitchen, formal dining room, gym, wine room, second floor northwest bedroom, northeast bedroom, second floor south bedroom). Switches may energize either a ceiling light fixture, capped ceiling box, ceiling fan/light combination or a wall receptacle, typically known as "half-hot receptacles" or bulbs which are not operational. Further evaluation may be necessary in identifying the operation of these light switches, including the replacement of various light bulbs, which may be defective.

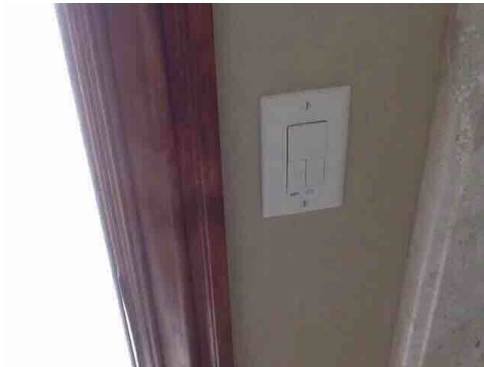
227: - The switch in the exterior bathroom seemed somewhat complex. We were unable to figure out exactly how/what it operates. One of the switches may operate the light outside the door that appears to have a blown bulb. Further assessment is advised.

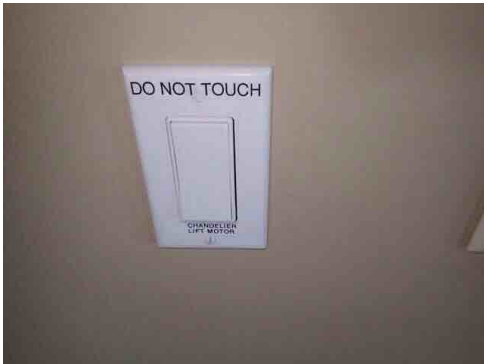
228: - We did not test the switch that operates the chandelier lift in the front entry, as the label advises.

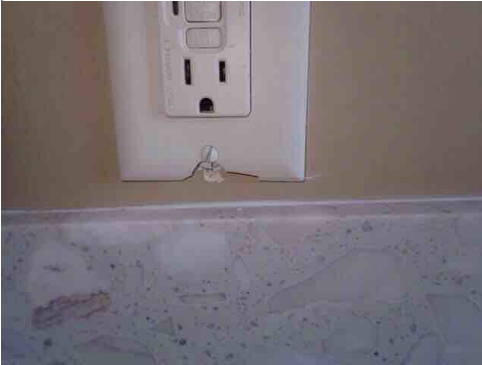
232: - There are light switch and / or receptacle cover plates that are damaged or missing. Replacement of the cover plates is suggested to reduce the potential of shock - NEC 2014 §406.6 & 410.22. Local jurisdictions to some extent, may offer a different version of this standard.

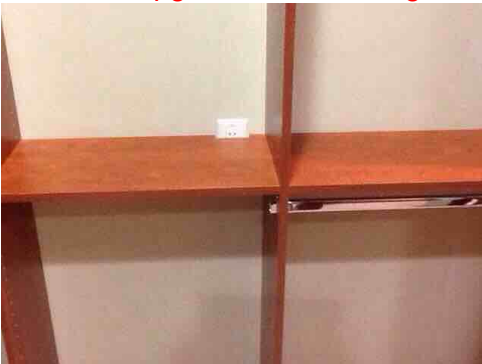
234: - Ungrounded three prong receptacles was/were identified in the first floor south bedroom closet. In many cases, the original two prong receptacle was replaced with the new three prong type without adding a grounding conductor or grounding to the metal junction box (if applicable). Or in a modern house, the grounding conductor is not attached to the receptacle (providing the conductor is present). The receptacles should be upgraded to include grounding conductors where necessary and all wet areas by GFI protection.

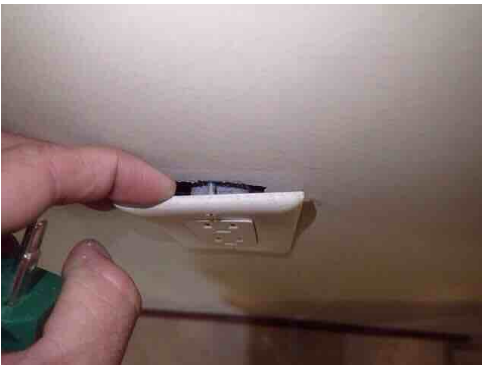
235: - The outlet on the east wall in the laundry room is loose and should be better secured for safety.

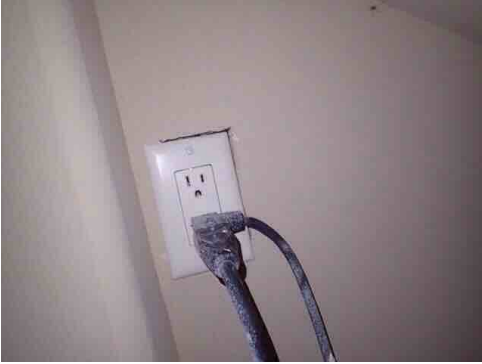
236: - There is a gap in the drywall around the cover plate under the stairwell in the basement. Improvements are suggested.

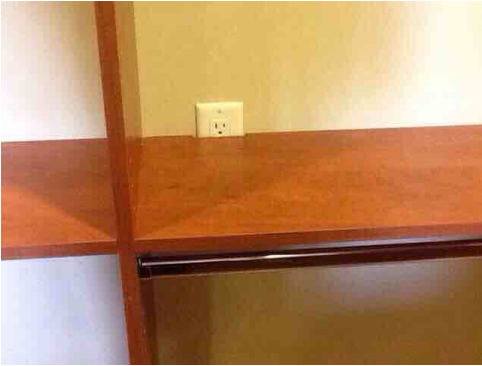
237: - There is a receptacle in the second floor south bedroom closet that is blocked by shelving.

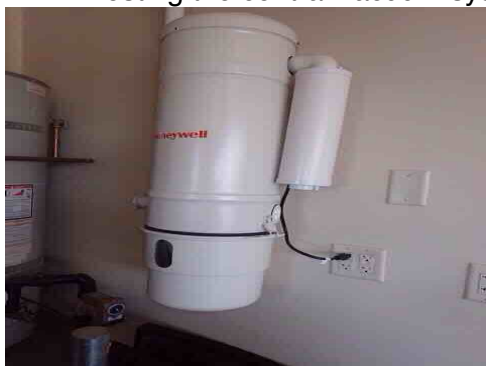
244: - Testing the central vacuum system is not within the scope of the inspection.

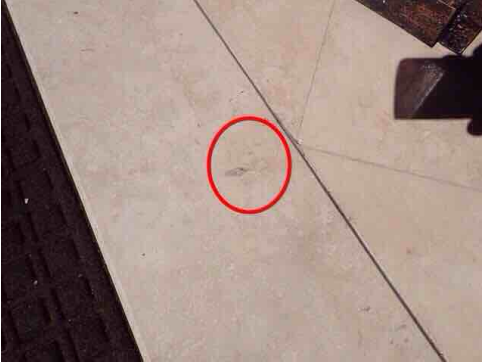
250: - There is no hole drilled into the floor for the bottom flush bolt on the stationary entrance door. Drilling a hole is recommended to ensure the door properly latches.

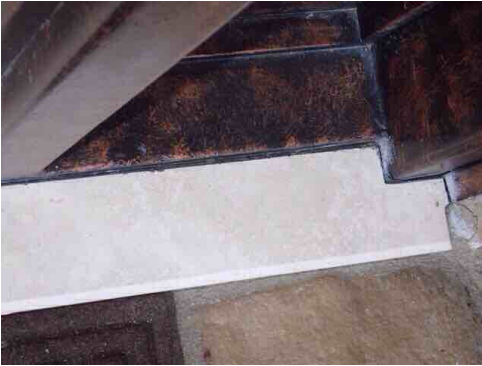
251: - The sill plate at the entrance door is suggested to be better sealed.

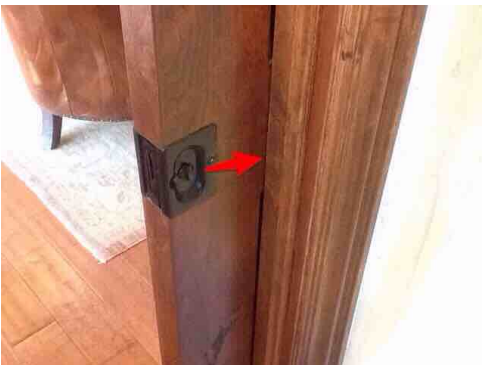
254: - The pocket door in the second floor common bathroom rubs the frame when tested. Improvements are recommended.

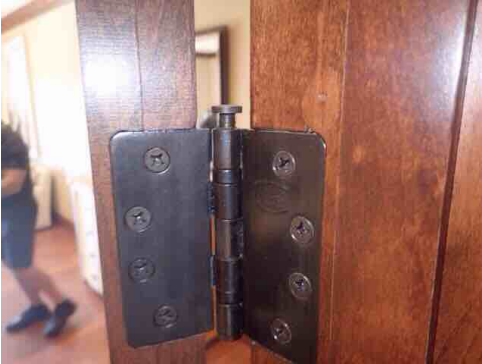
257: - There are loose hinge pins that should be secured to ensure proper operation of the doors.

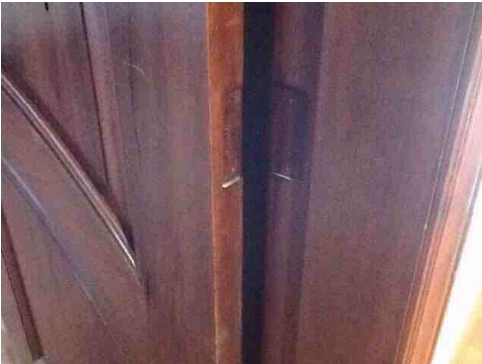
258: - There hinges missing from the double doors in the second floor south bedroom. Improvements are recommended.

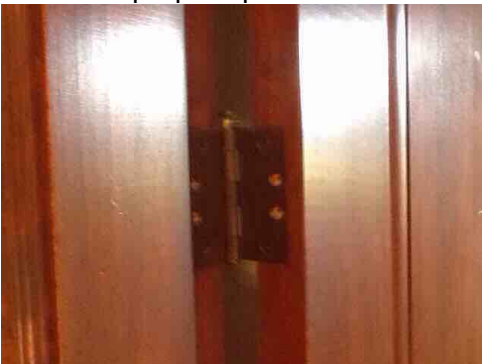
259: - We observed screws missing from some of the door hinges. Installing the missing screws is suggested to ensure proper operation of the doors.

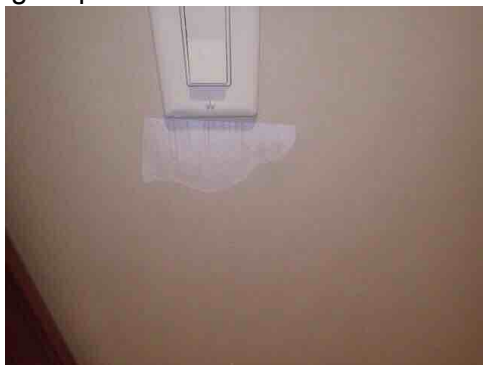
281: - Evidence of prior repairs / patching was observed at the interior walls. Further investigation may be desirable as to the reason for the patching / repairs.

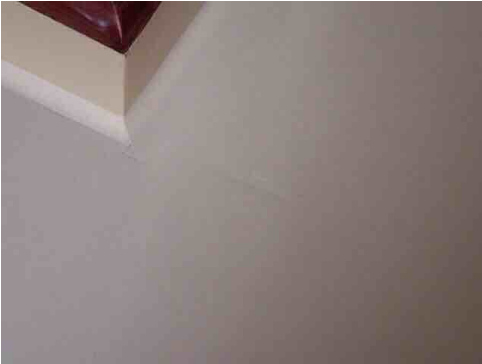
285: - We observed what appears to be peeling/loose drywall tape in the formal dining room. Repairs are suggested.

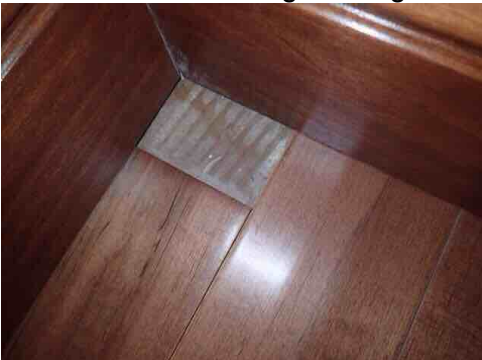
293: - There is flooring missing from the second floor northwest bedroom closet.

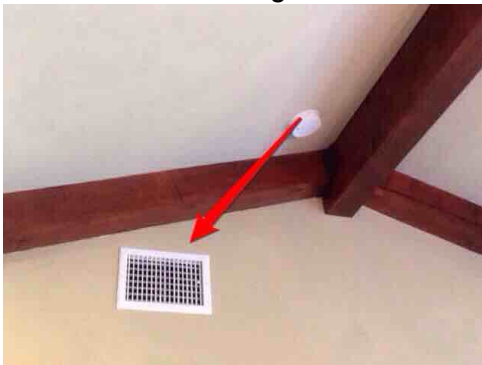
302: - Smoke alarms and smoke detectors shall not be installed within a 36 in. (910 mm) horizontal path from the supply registers of a forced air heating or cooling system and shall be installed outside of the direct airflow from those registers.

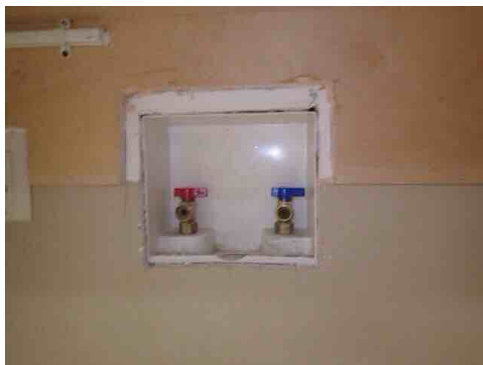
307: - The plastic covers to the plastic boxes that house the water supply lines are missing and suggested to be replaced.

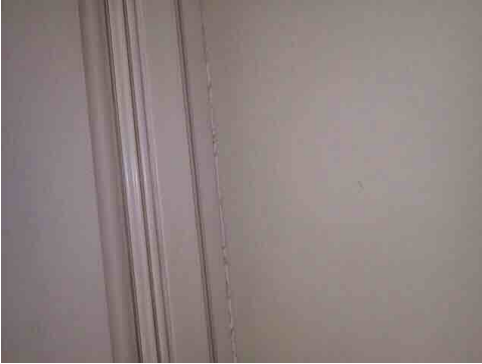
320: - The cabinets are suggested to be better sealed to the wall.

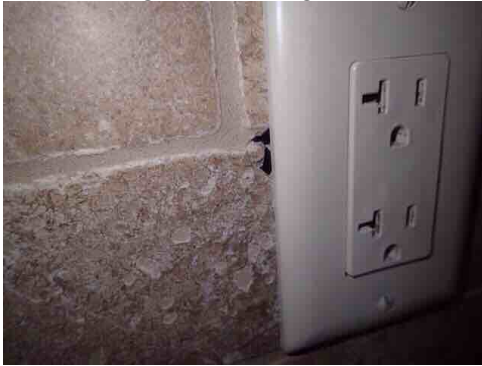
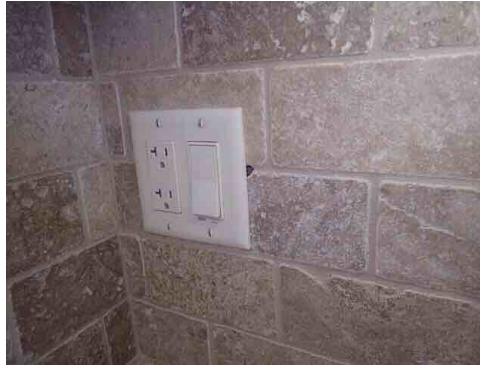
324: - We grout missing from the kitchen backsplash. This is only a cosmetic concern.

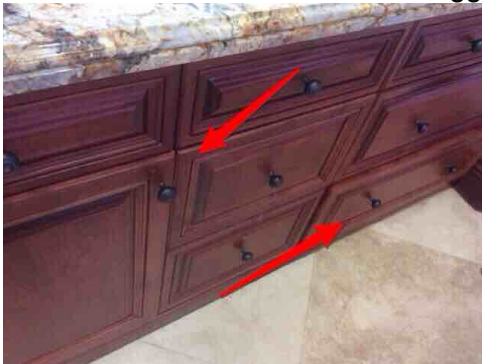
330: - The kitchen cabinets are suggested to be adjusted for better performance.

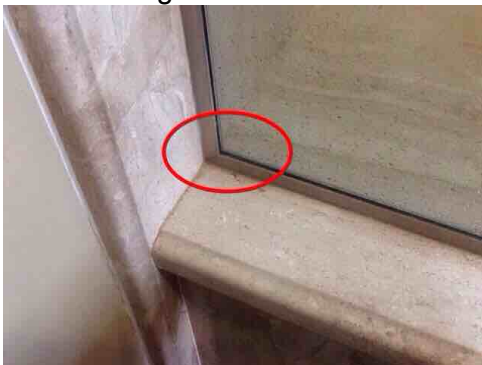
348: - Discoloration was observed around the shower glass enclosure which suggests a point of moisture penetration. Repairs are recommended at this location to prevent possible moisture damage to the flooring or wall covering material.

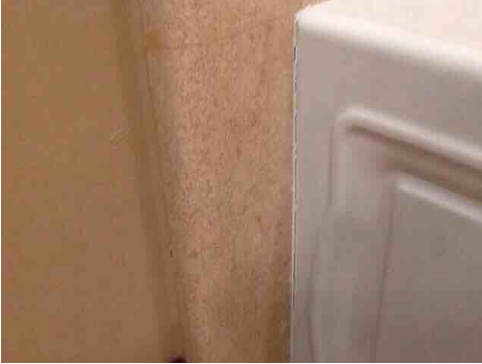
360: - Caulking is recommended where the bathtub meets the wall to prevent moisture intrusion.

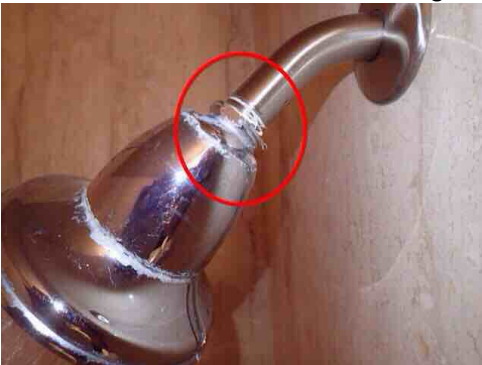
362: - The shower head is leaking. Repair or replacement is recommended.

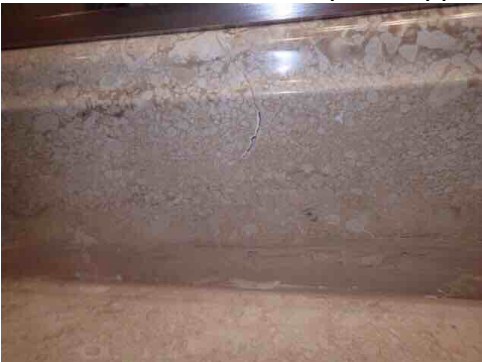
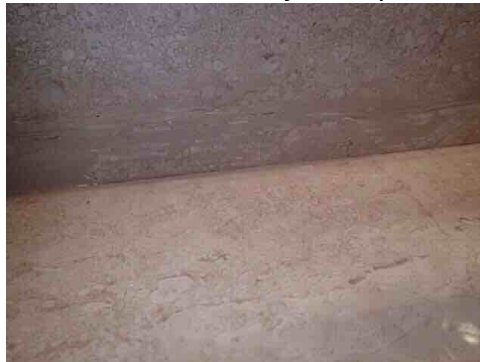
365: - The counter backsplash appears to be cracked and may have previously been repaired.

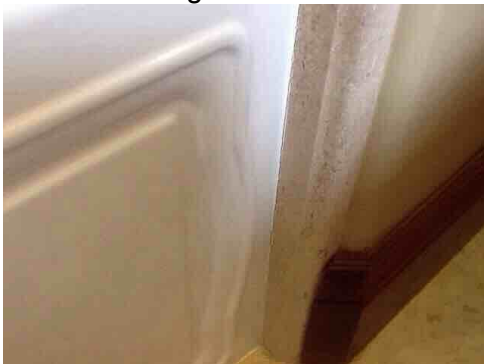
374: - Caulking is recommended where the tub meets the wall to prevent moisture intrusion.

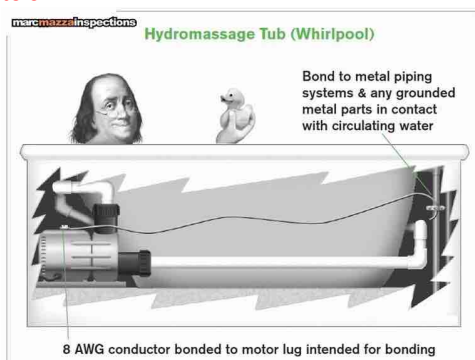
385: - Upon inspection of the spa motor, we were unable to verify a bonding conductor attachment to the pump and interior piping due to inaccessibility. Verification of the bond is recommended prior to use of the spa tub.

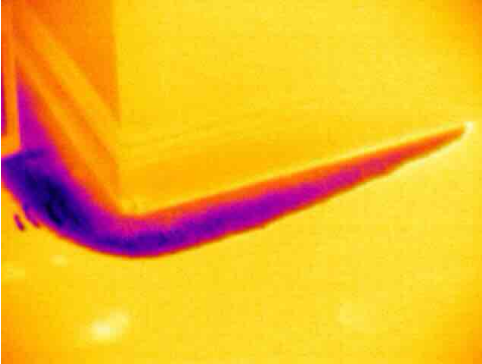
428: - The shower pan was tested and was observed leaking. Repairs are suggested at the pan so the shower enclosure may function properly. Further assessment is advised.

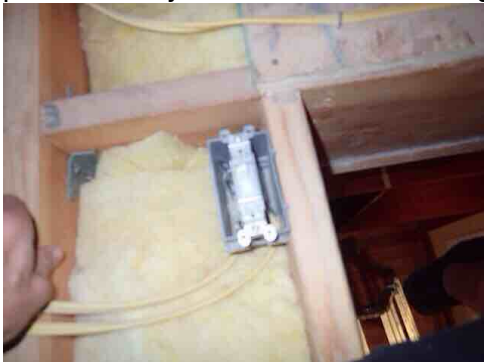
439: - There coverplates which are missing from within the attic. Improvements are recommended as a safety precautionary measure - NEC 2014 §406.6 & 410.22.

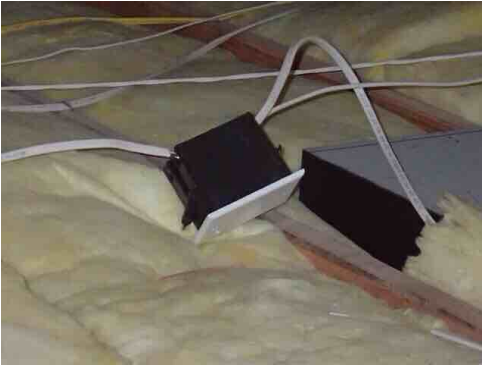
440: - Many of the added junction boxes are loose or not attached securely and the wiring was not properly adhered to a solid surface prior to the junction box as per building standard. Improvements are recommended as a safety precautionary measure.

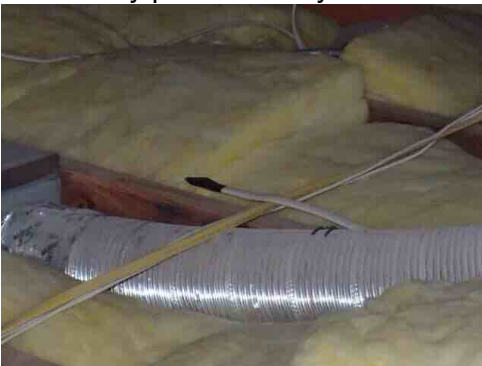
441: - There are loose/exposed wires lying in the attic at the time of the inspection. These conductors are suggested to be installed thru conduit for safety and or terminated properly. Improvements are recommended as a safety precautionary measure.

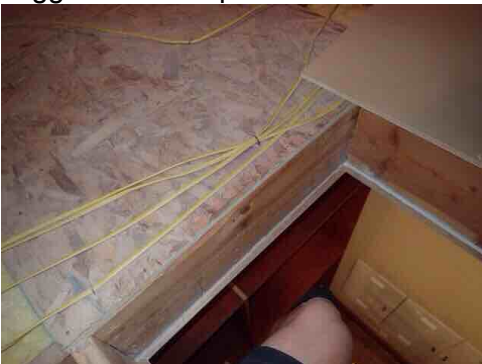
443: - Loose NM (romex) wiring was observed in the attic less than 6 feet from the attic access which is suggested to be protected in accordance with building code - NEC 320.23.

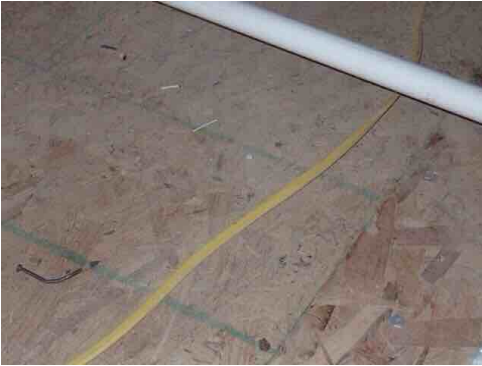
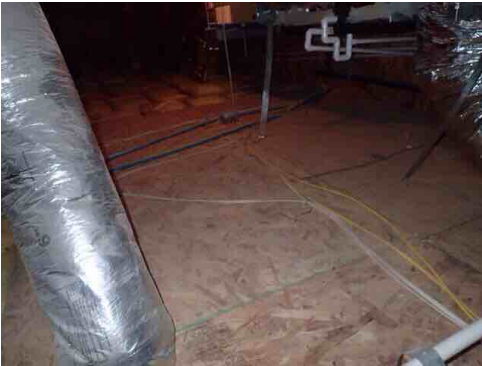
445: - Romex was observed on the platform deck which is suggested to be protected from physical damage.

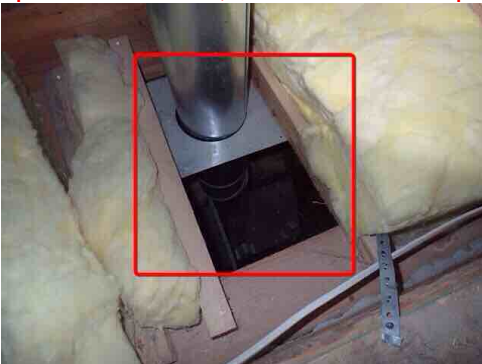
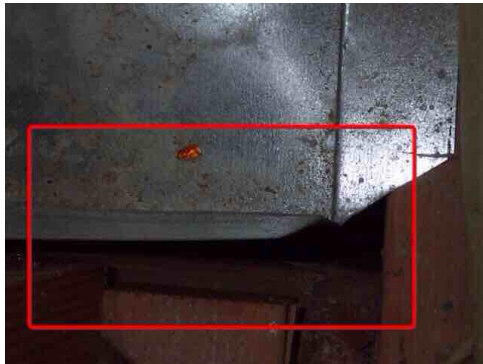
448: - The chimney fire-stop spacer, which is required to surround factory built chimney flues on the floor of an attic, is incomplete or missing and should be sealed completely around the perimeter of the flue vent. This component is designed to isolate flames from the oxygen-rich atmosphere of an attic, and thereby inhibit the spread of flames, and should be repaired.

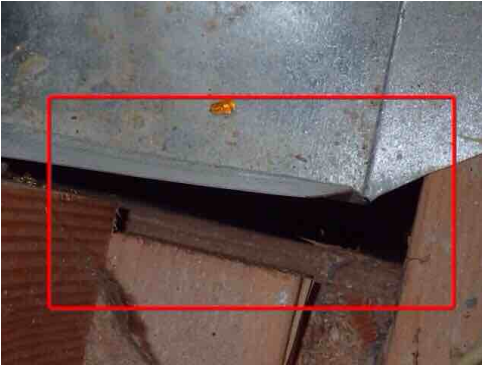
449: - The fire stop / fire blocking around the fireplace flue vent is breached by the wiring installed into the chase which is not installed in accordance to manufacturer's / building standards / specifications (and thus leaves a gap) around its perimeter, where it is suggested to be tightly sealed to the top of the ceiling "plates". Further assessment is advised.
