Property Inspection Report

XXX

Thursday, February 26, 2015

Inspector, Marc Mazza
Mazza Inspection Group
(866) 996-2992
info@mazzainspections.com

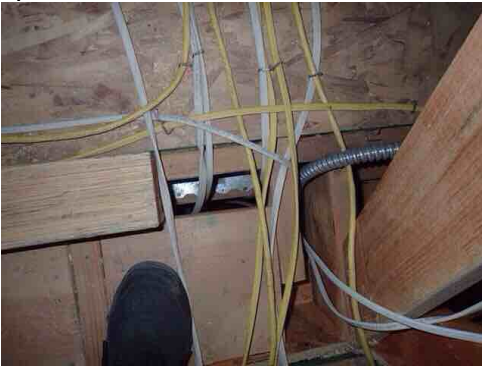
Code Reference CRC R302.11 Fireblocking

In combustible construction, fireblocking shall be provided to cut off all concealed draft openings (both vertical and horizontal) and to form an effective fire barrier between stories, and between a top story and the roof space.

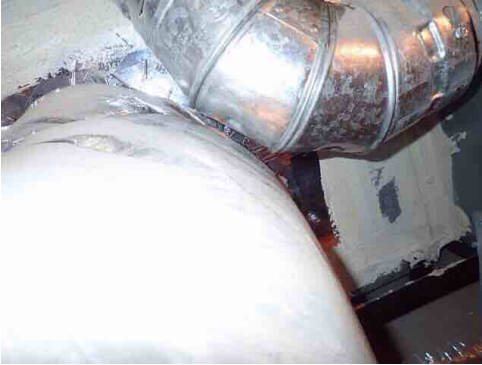
457: - The gas appliance vent pipe should be one inch away from combustible materials (wood, plastic, insulation, drywall, foam, etcetera). This vent is close to combustible materials. Moving the vent to a safer location away from the combustibles is suggested.

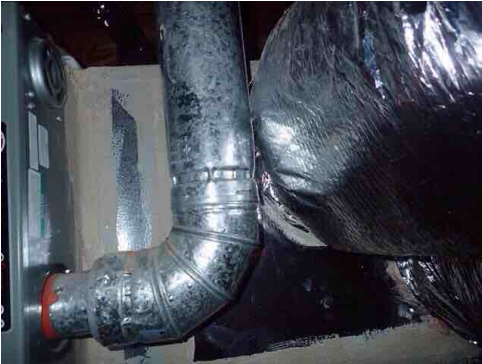
480: - The gas appliance vent pipe should be one inch away from combustible materials (wood, plastic, insulation, drywall, foam, etcetera). This vent is close to combustible materials. Moving the vent to a safer location away from the combustibles is suggested.

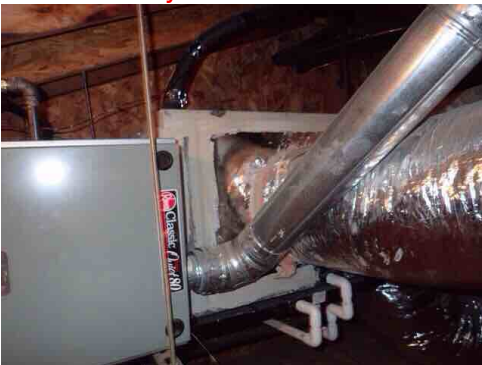
491: - The gas appliance vent pipe should be one inch away from combustible materials (wood, plastic, insulation, drywall, foam, etcetera). This vent is close to combustible materials. Moving the vent to a safer location away from the combustibles is suggested.

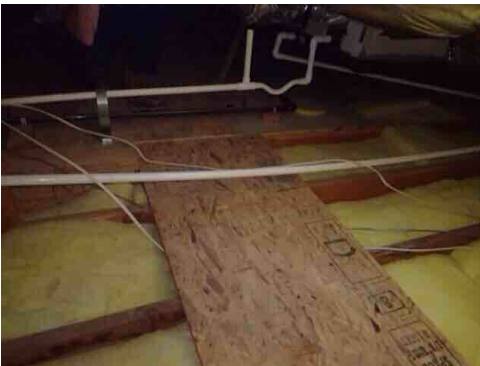
509: - The condensate discharge pipe is not plumbed to drain efficiently. It should be level or slope at one-quarter inch per foot and drain to the exterior in order to drain effectively. This system does not comply and is in need of service.

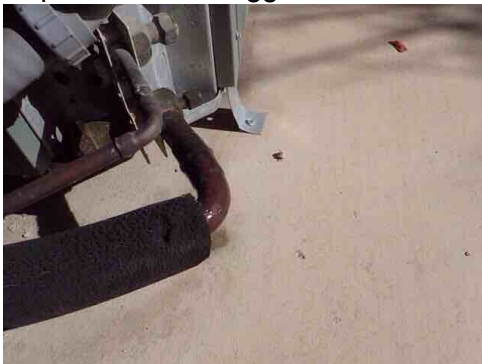
517: - The foam insulation is missing from the refrigerant lines, either at the condenser and/or FAU. Replacement is suggested.

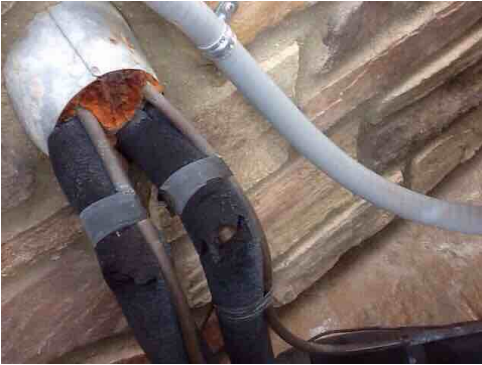
544: - The insulation on the air condition refrigerant lines is deteriorated and suggested to be replaced or improved.

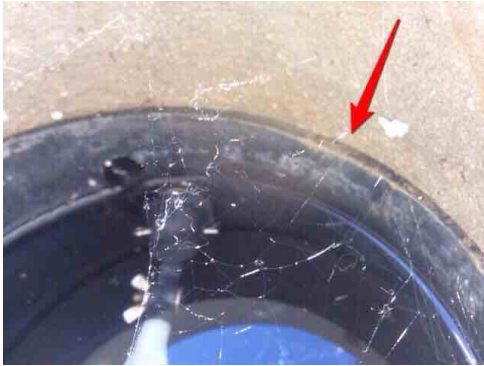
560: - The auto fill box is in need of sealant where connected to the deck.

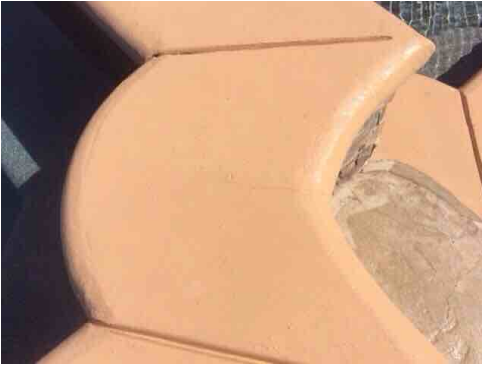
568: - There is cracked / damaged coping on the pool deck, which should be repaired or replaced by a pool specialist.

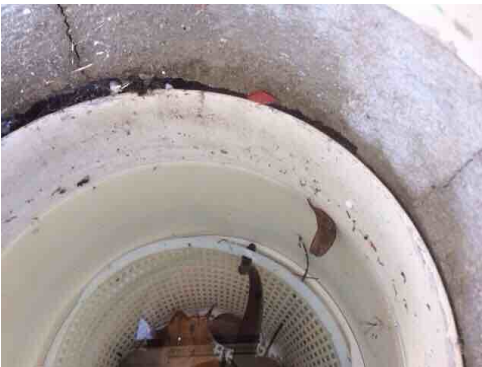
572: - The connection of the skimmer box to the concrete deck is in need of sealant.

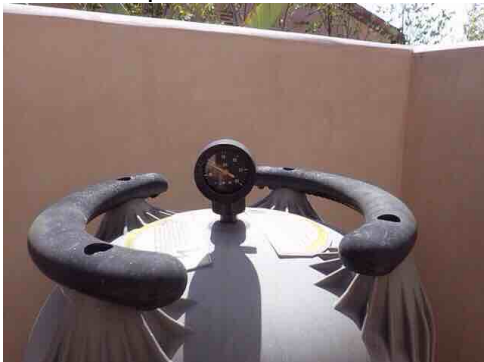
586: - The pool filter is functional. The pressure appears to be acceptable.

587: - The filter grids and backwash valve (if present) are suggested to be inspected prior to the close of this escrow. The grids are susceptible to tears and if damaged will result in a dirty pool/spa. The backwash valve should be tested to ensure it is functional and does not leak.

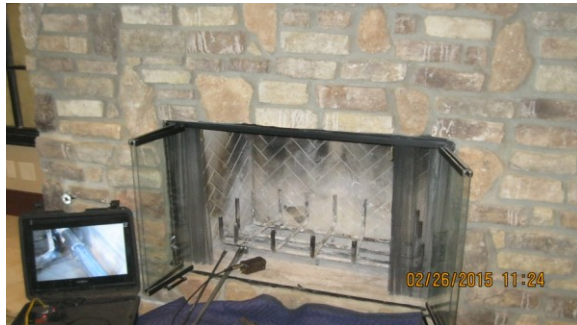
Family Room Fireplace:

Fireplace Manufacturer: Lennox EST 48

The firebox walls are in serviceable condition. The firebox and flue are dirty with soot from use. The chimney and fireplace should be cleaned and serviced once a year to keep the danger of fire from starting in the flue.

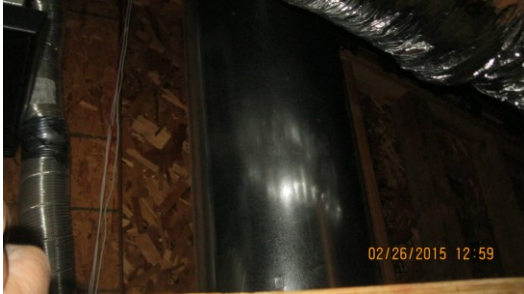
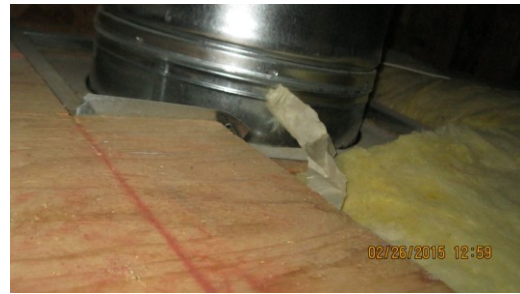
Chase:

When viewed within the attic exposed pipes are visible. This pipe should not be exposed within the attic. There should be vertical firestopping closing off the pipe to prevent heat and sparks from entering into the attic space. There is insulation installed too close to the pipe. A minimum of 6 inches from the pipe is required.

Cut back the insulation further from the pipe.

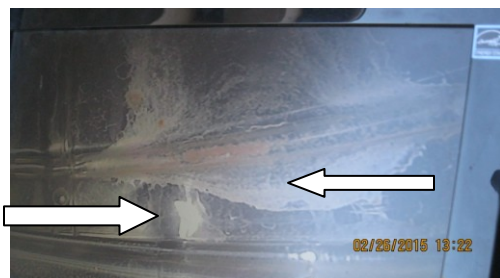
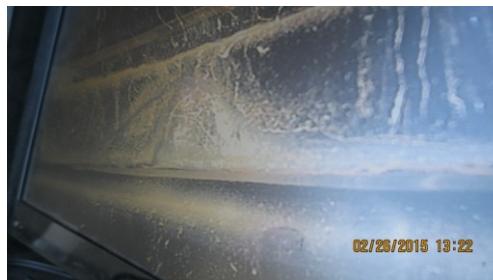
Flue Area:

When viewed via video camera, several sections of pipe that were coming apart were viewed. These separations pose a potential fire hazard as heat and sparks could get past the seams in the pipes.
