COMMERCIAL BUILDING INSPECTION REPORT

SAMPLE REPORT

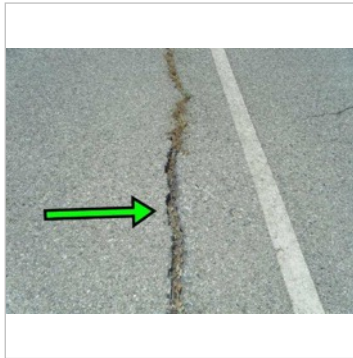
- 1.1.16 Asphalt driveways are not as durable as concrete ones, and typically develop cracks. They are expected to last approximately fifteen to twenty years, and typically need maintenance service.
- 1.1.17 There are predictable cracks in the driveway that would not necessarily need to be serviced.

Figure 1B - Asphalt cracking 2

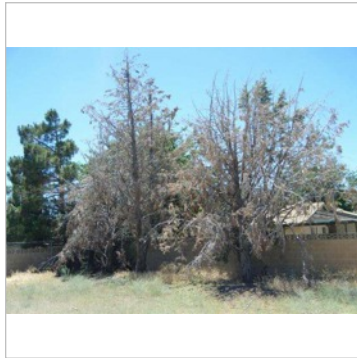
- 1.1.20 There were multiple trees on the property which appear to be dead. We do not possess the expertise to evaluate these trees and therefore suggest the buyer contact an arborist regarding these trees.

Figure 2A - Potential Dead trees

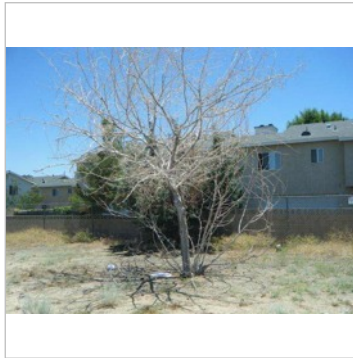
Figure 2B - Potential dead tree

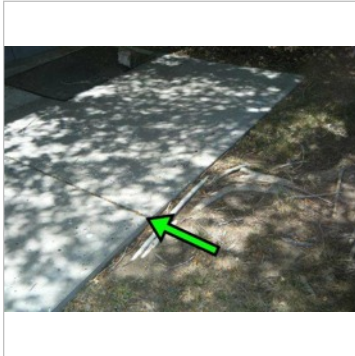
- 1.1.33 There are offsets in the walkways that could prove to be trip-hazards, which should be serviced. ADA standards reference 4.3.7, 4.3.8, 4.54, state that projections shall not exceed 1/2" minimum of 48" in width.

Figure 3A - Sidewalk raised

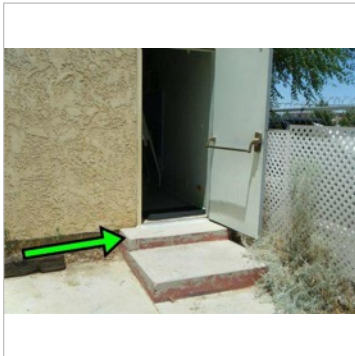
- 1.1.34 The steps located at the south side of the building are not consistent and are more than 3/8" between the two, which may cause an individual trip and is, therefore, a safety hazard. Furthermore, this exit does not possess a landing/ramp which is necessary, as this door opens outward.

Figure 4A - Inconsistent step height

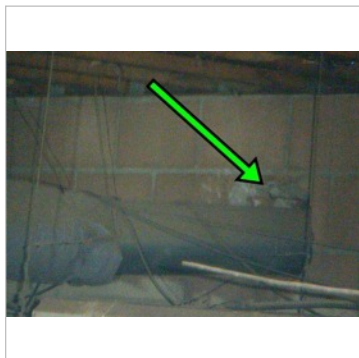
- 1.1.45 The CMU wall was breeched to accommodate an HVAC duct, which runs from the front east child care room to the rear north. The penetration of this wall appears to have been performed in a substandard manner, which may have interrupted the integrity of this wall vertically at this point.

Figure 6A - Hole in CMU wall

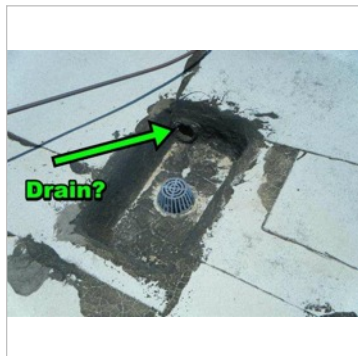
- 1.1.84 There was an opening within the roof scupper, which was not covered and may be a drain. This opening is suggested to be tested to determine if in fact it is a drain.

Figure 14A - Unable to determine if this is a drain

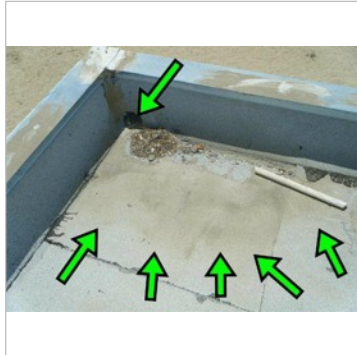
- 1.1.108 Our evaluation of the foam roof is that it is in poor condition. As stated similarly by the roofer, we feel the roof is at the end of its lifespan and in need of replacement. Some of the issues may include, but are not limited to, pitting, peeling, bubbling, ponding and cracking were observed throughout the roof membrane.

Figure 20A - Ponding

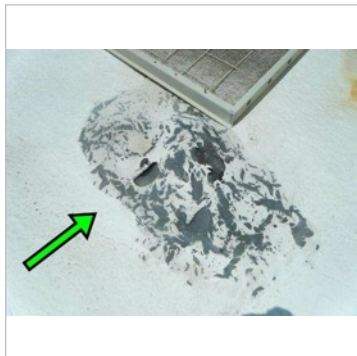
Figure 20D - Bubbling

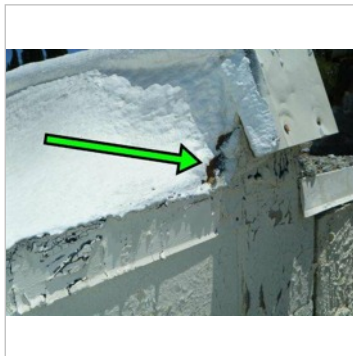
Figure 20E - Holes

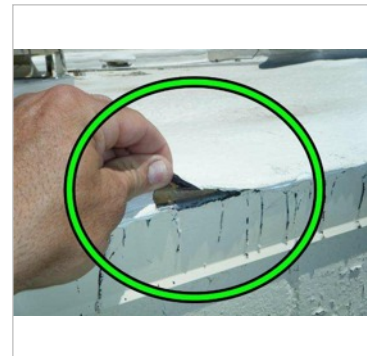
Figure 20F - Peeling

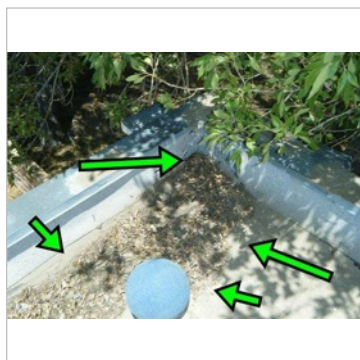
- 1.1.110 The drains and scuppers need to be cleaned and serviced to drain properly.

Figure 21A - Clean drains

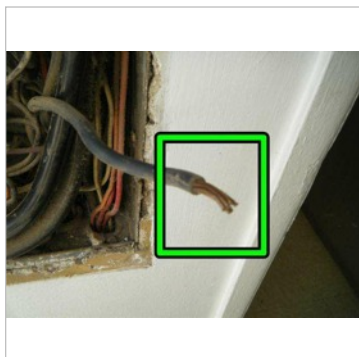
Figure 22D - Not terminated properly 2

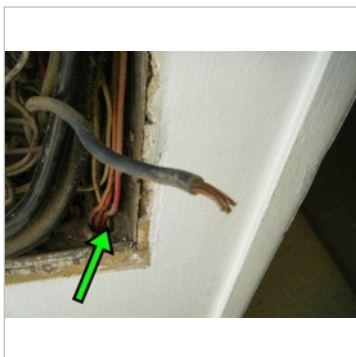
Figure 22E - No bushing here

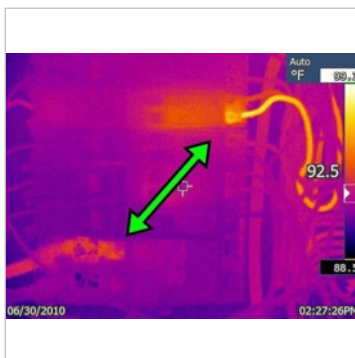
Figure 23B - Hot circuits - two shown here

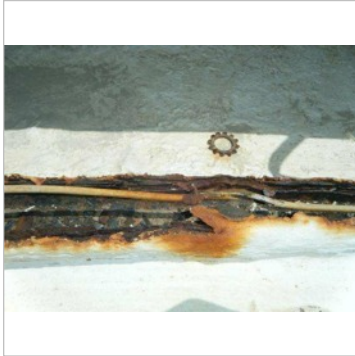
- 1.1.131 We observed multiple runs of electrical conduit, which was damaged, deteriorated and separated, which allows internal conductors to become exposed and, therefore, represent a hazard. These runs of conduit are suggested to be repaired or replaced as necessary.

Figure 28A - Deteriorated conduit

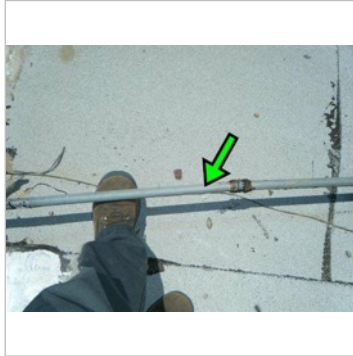
Figure 28B - Not properly secured to deck

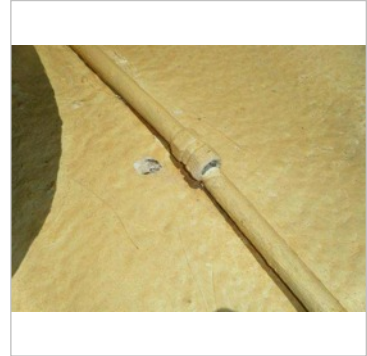
Figure 28C - Separated 2

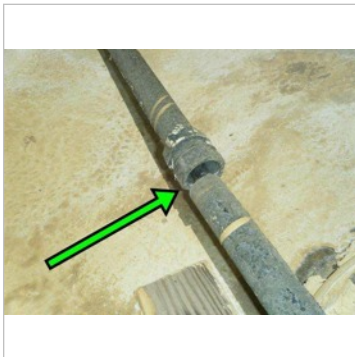
Figure 28D - Separated

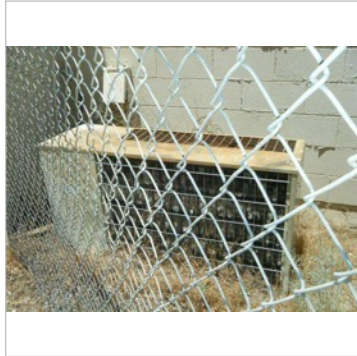
- 1.1.169 The condenser located on the south side of the structure was not operational and the refrigerant lines appear to have been cut.

Figure 33A - Non operational condenser

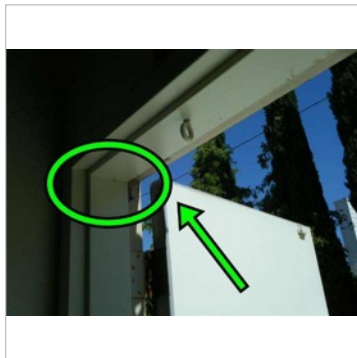
- 1.1.220 The south exit door opens over a step and not over landing, as required per building standards. In addition, this door does not possess a self closing device.

Figure 39A - No self closer

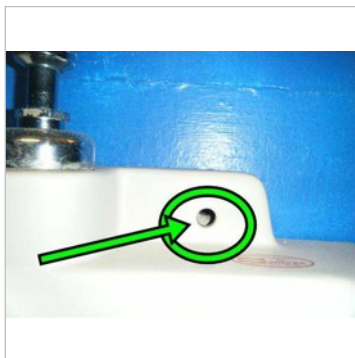
Figure 42B - Missing bolts - urinal

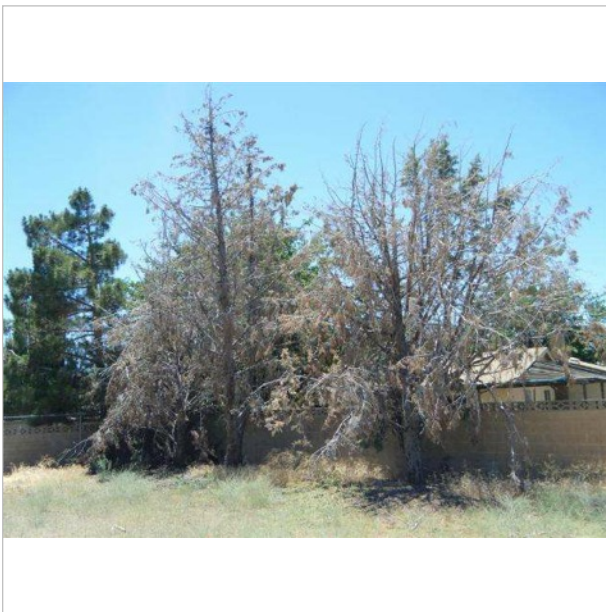
Figure Set 2

Ref: 1.1.20 - Dead trees

Figure 2A - Potential Dead trees

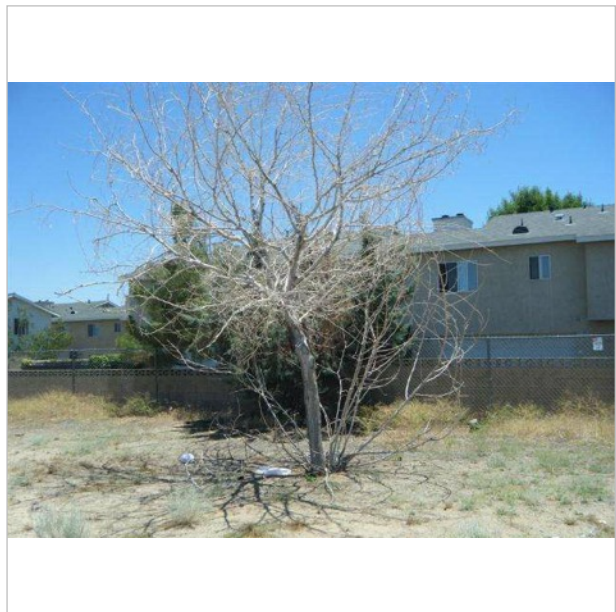
Figure 2B - Potential dead tree

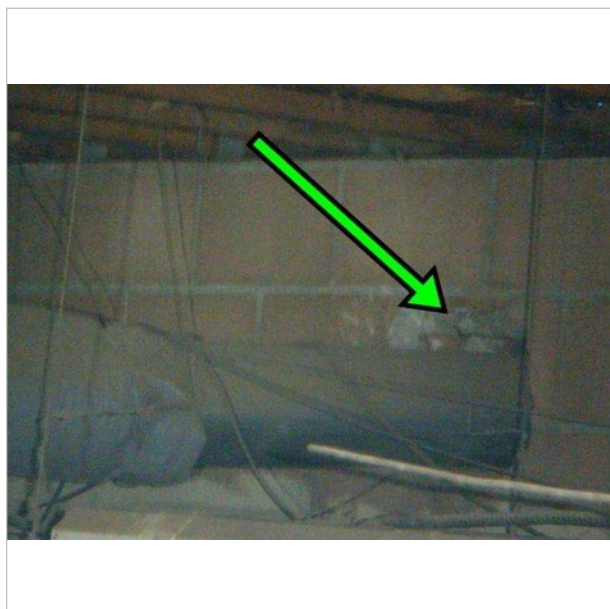
Ref: 1.1.45 - CMU breach

Figure 6A - Hole in CMU wall

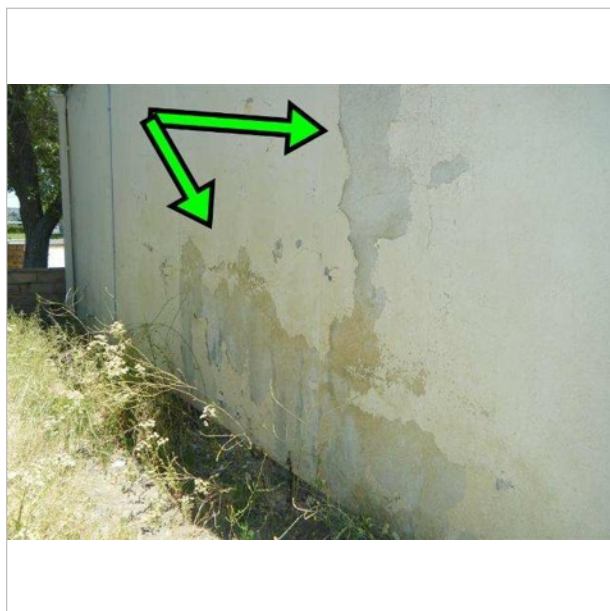
Ref: 1.1.53 - The stucco is peeling in places

Figure 8A - Stucco/paint peeling

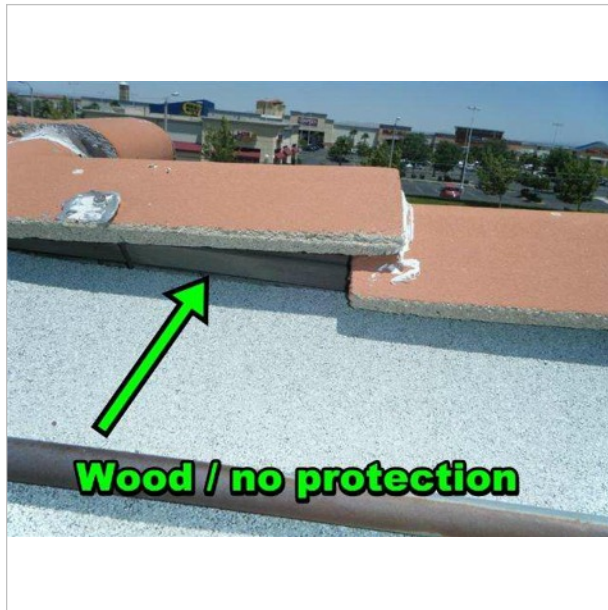
Ref: 1.1.81 - The tops of the parapet walls are not adequately sealed

Figure 12A - Exposed wood at parapet wall

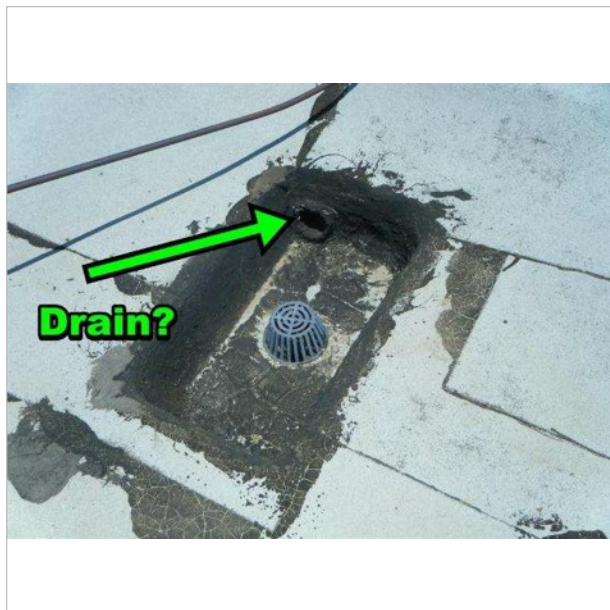
Ref: 1.1.84 - Drain

Figure 14A - Unable to determine if this is a drain

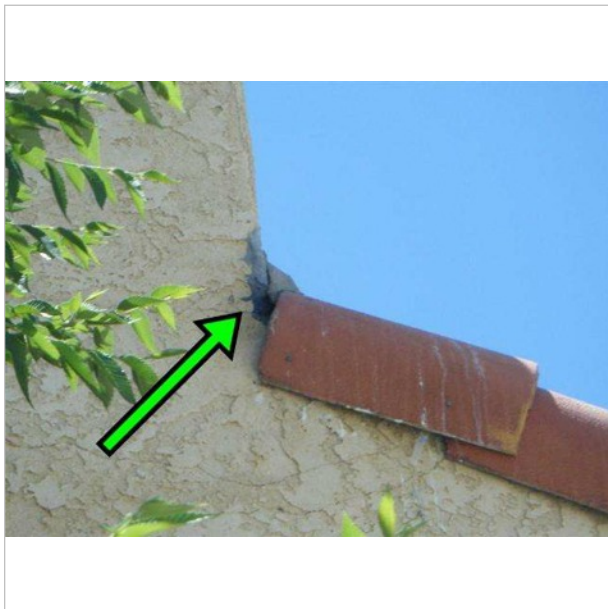
Ref: 1.1.93 - The flashings need to be sealed or serviced

Figure 17A - Sealant is needed here

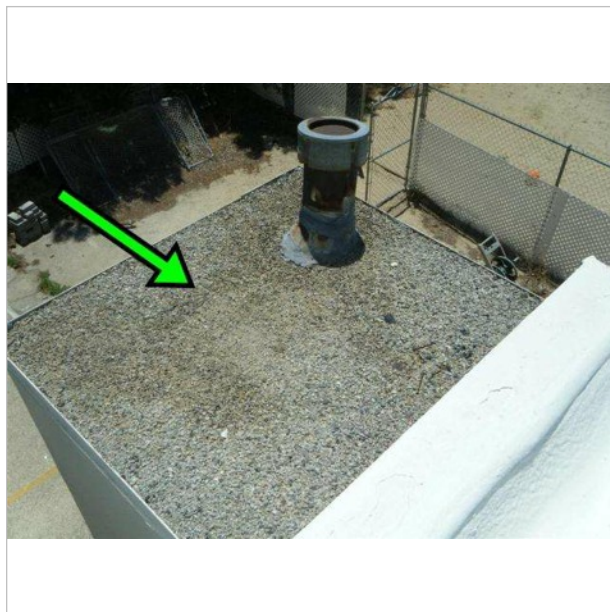
Ref: 1.1.101 - Water is ponding

Figure 18A - Ponding water

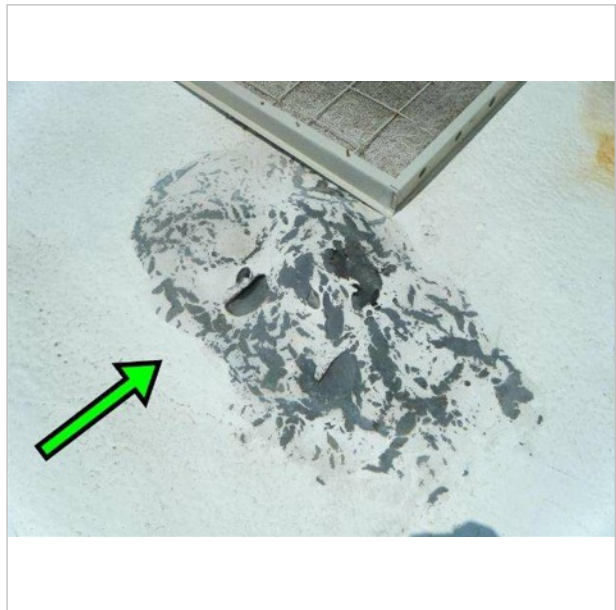
Figure 20D - Bubbling

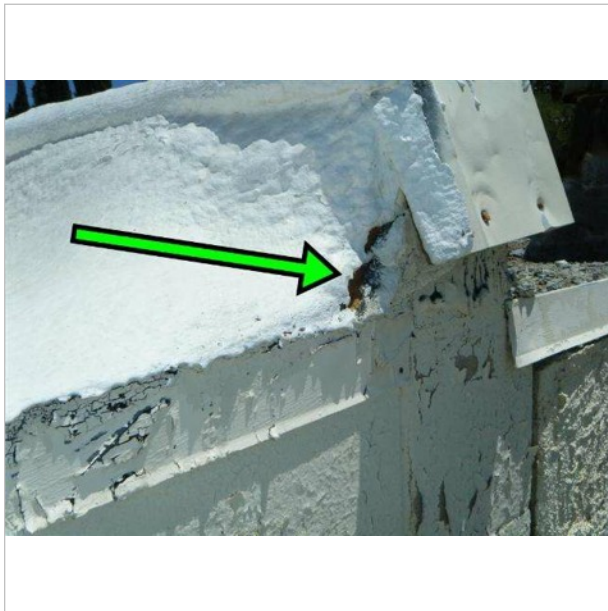
Figure 20E - Holes

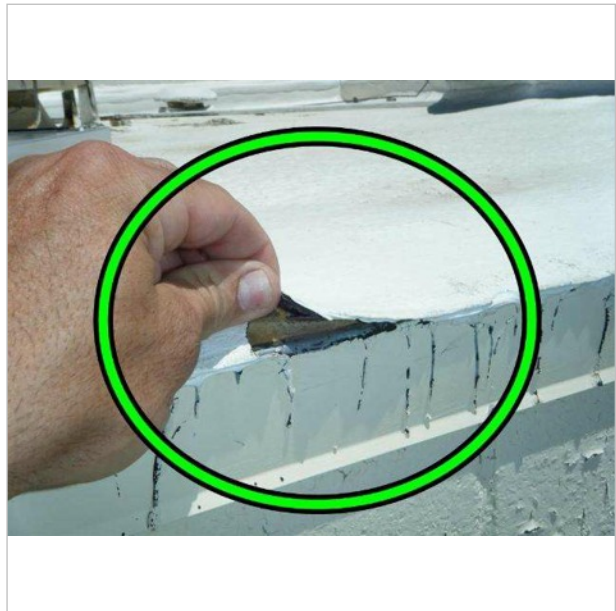
Figure 20F - Peeling

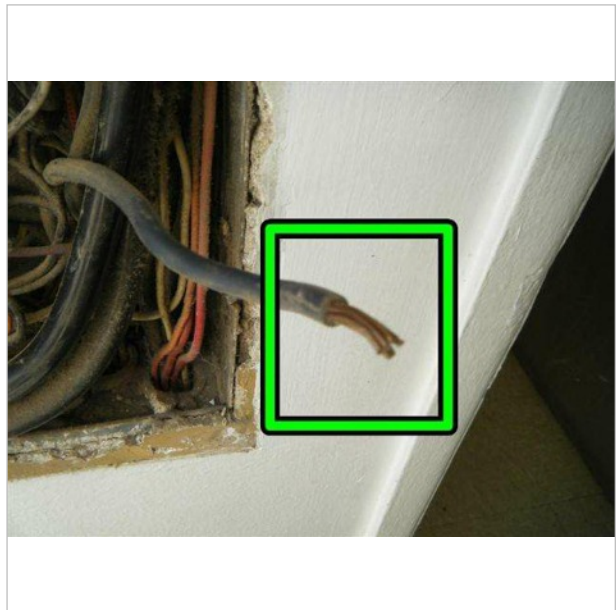
Figure 22D - Not terminated properly 2

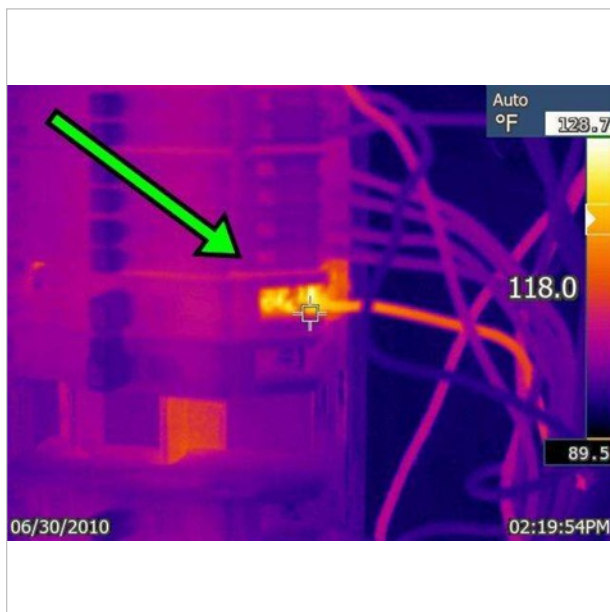
Ref: 1.1.120 - Hot breakers

Figure 23A - Hot circuit/wire connection

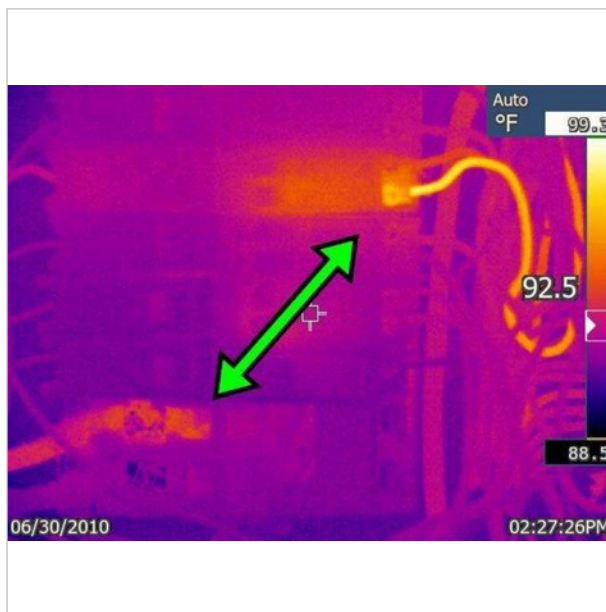
Figure 23B - Hot circuits - two shown here

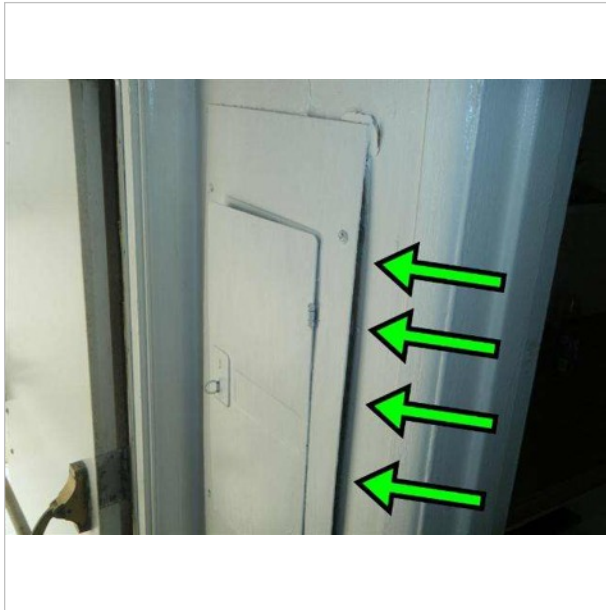
Ref: 1.1.121 - the main panel cover not fit

Figure 24A - Panel did not fit properly

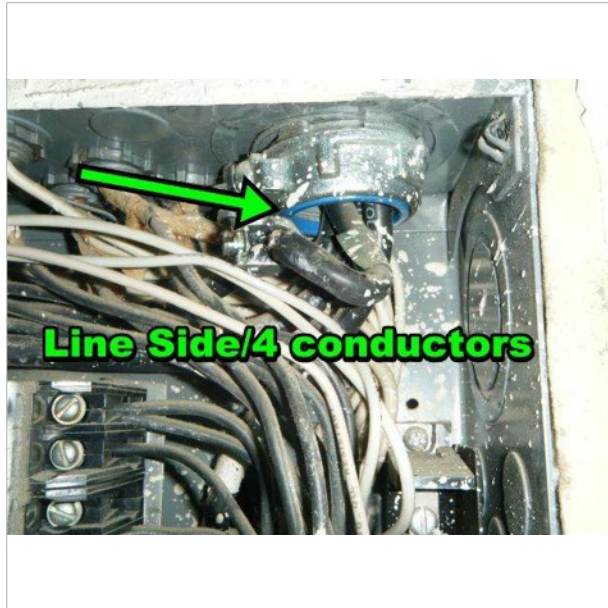
Ref: 1.1.127 - line side 4

Figure 26A - Four conductors line side here / three at the SEP

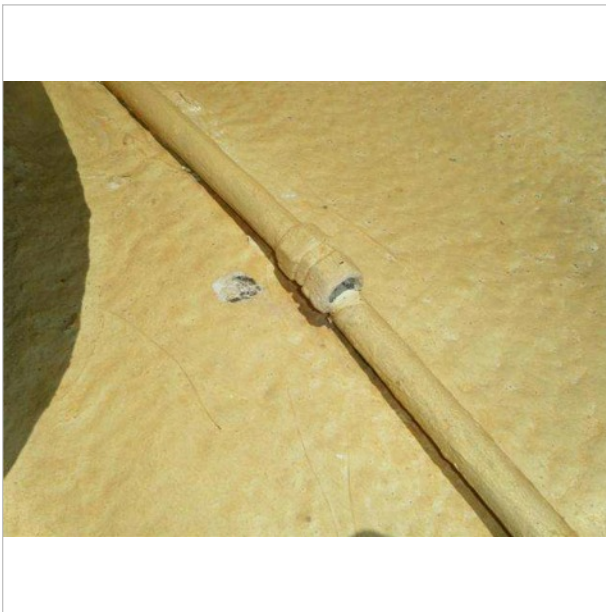
Figure 28C - Separated 2

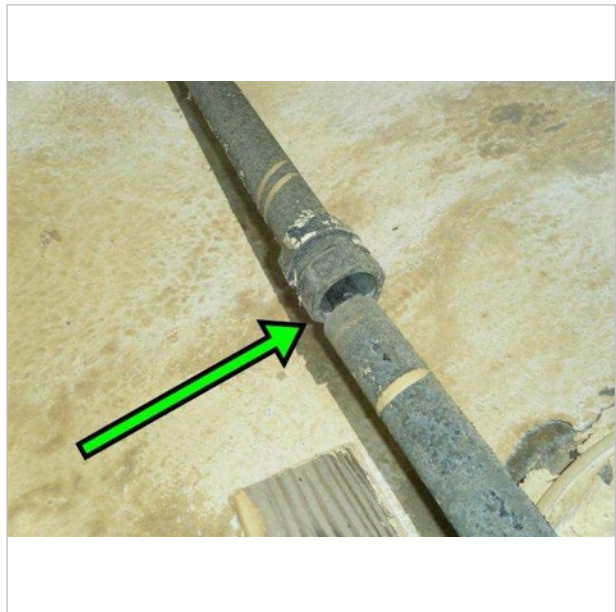
Figure 28D - Separated

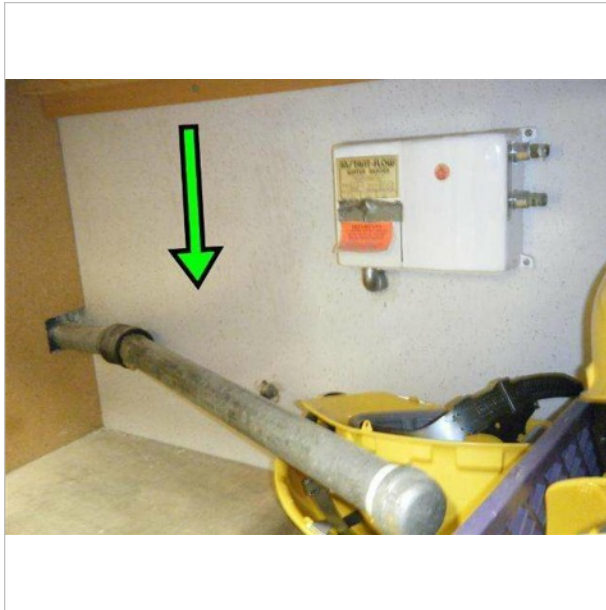
Ref: 1.1.154 - terminated

Figure 31A - Terminated waste pipe

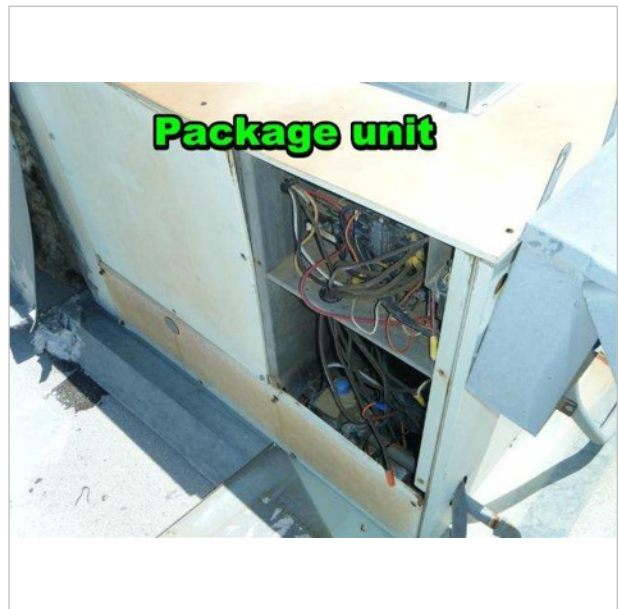
Ref: 1.1.157 - The system is in poor condition and may not be worth servicing

Figure 32B - Package roof unit 2

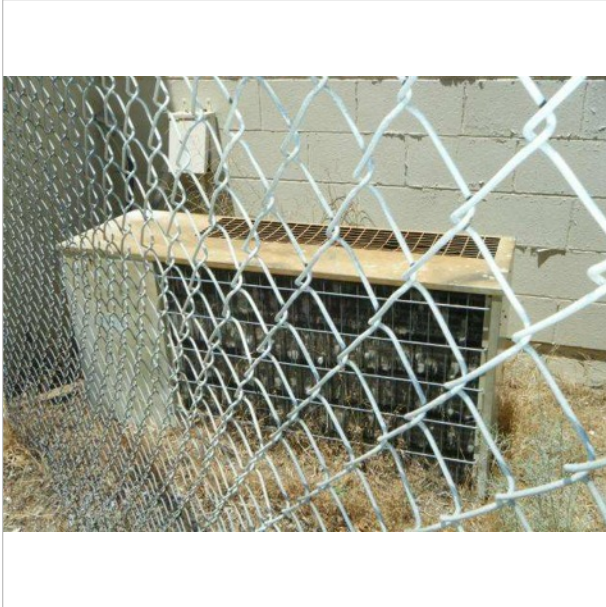
Ref: 1.1.169 - no op

Figure 33A - Non operational condenser

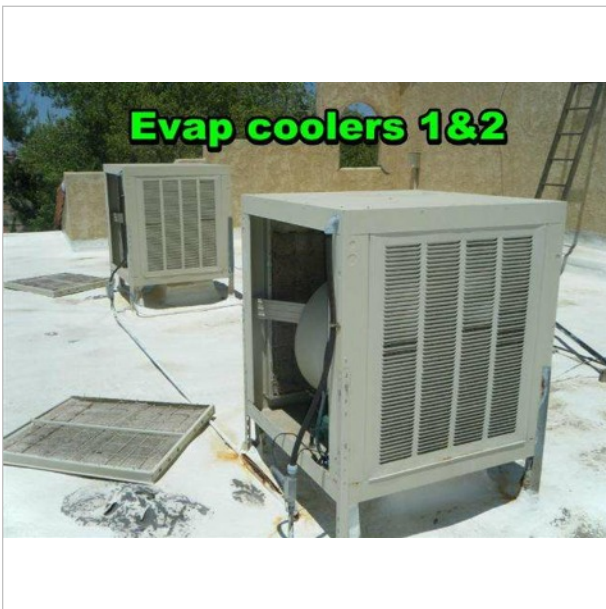
Ref: 1.1.176 - no op

Figure 34A - Evaporative coolers 1&2

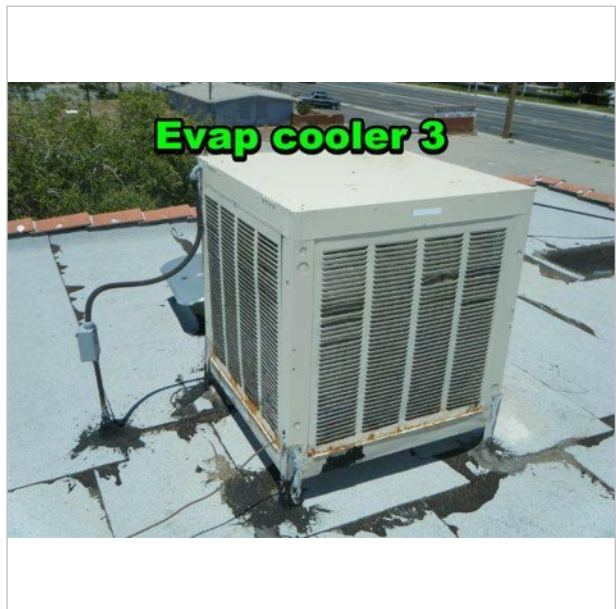
Figure 34B - Evaporative cooler 3

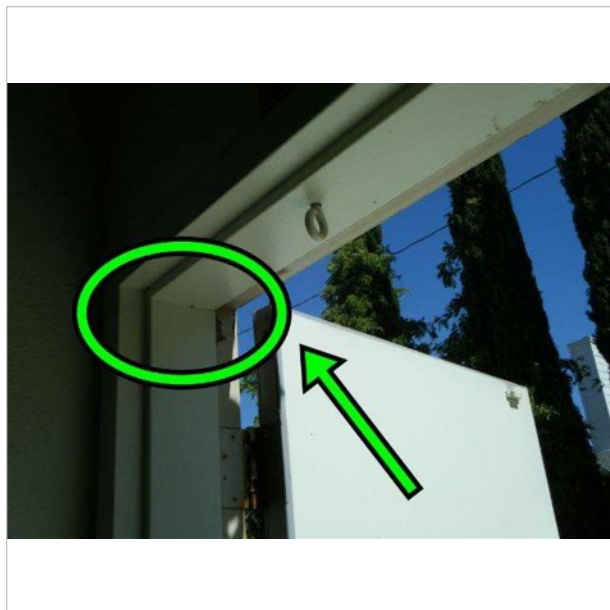
Ref: 1.1.220 - Exit door

Figure 39A - No self closer
